Rail Accident Investigation Branch

# Rail Accident Report

## Collision between road-rail vehicles near Ramsden Bellhouse, Essex 2 May 2021

Report 09/2022  
September 2022

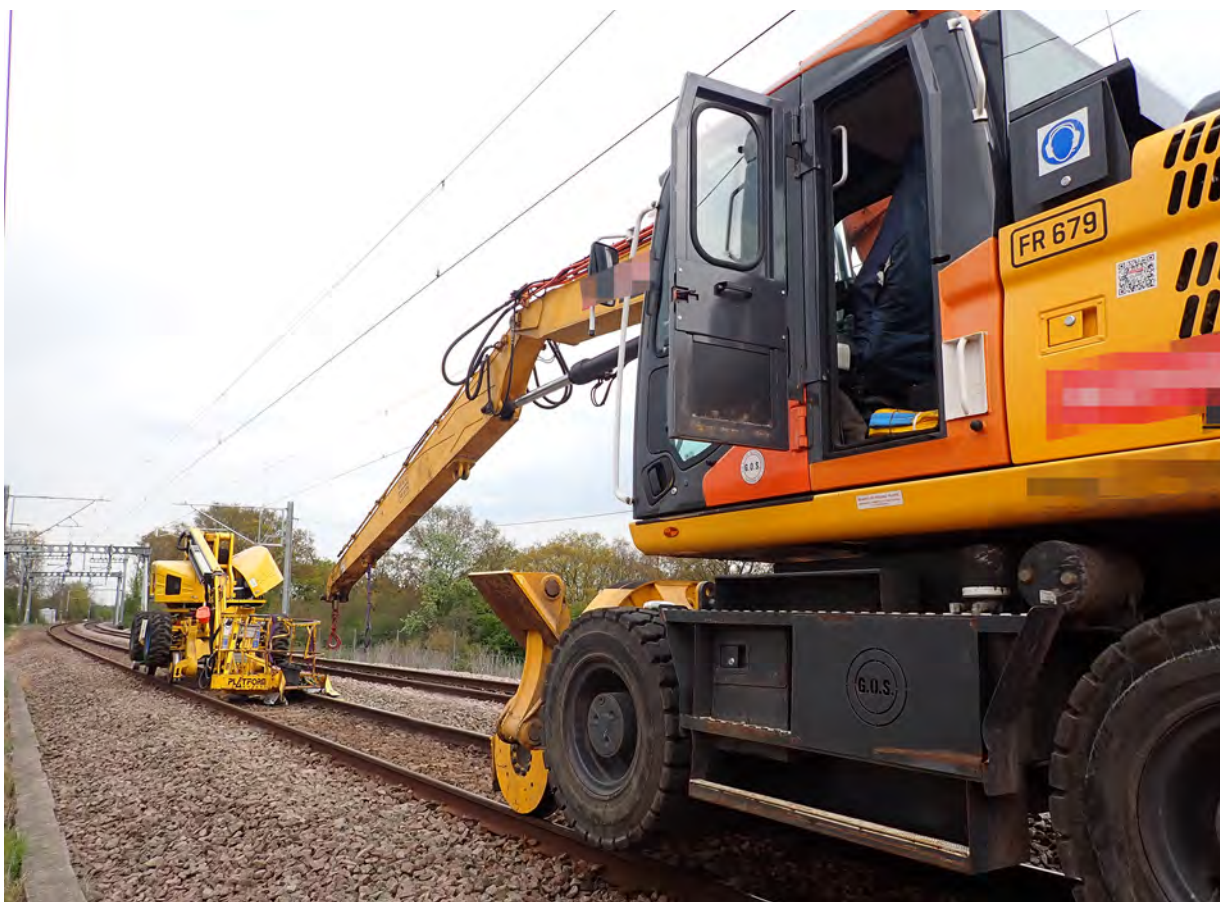
Figure 2: The rail mounted crane and elevated platform involved in the collision after being moved apart

- 33 The crane arm initially struck the rear of the MEWP basket before passing through the basket cage. The crane's arm then struck the front of the structure of the basket and pushed the MEWP, with all wheels locked, along the track for 2.1 metres, before both vehicles came to rest. The MEWP controller, who had seen the crane arm approaching and shouted a warning seconds before the collision, jumped out of the basket.

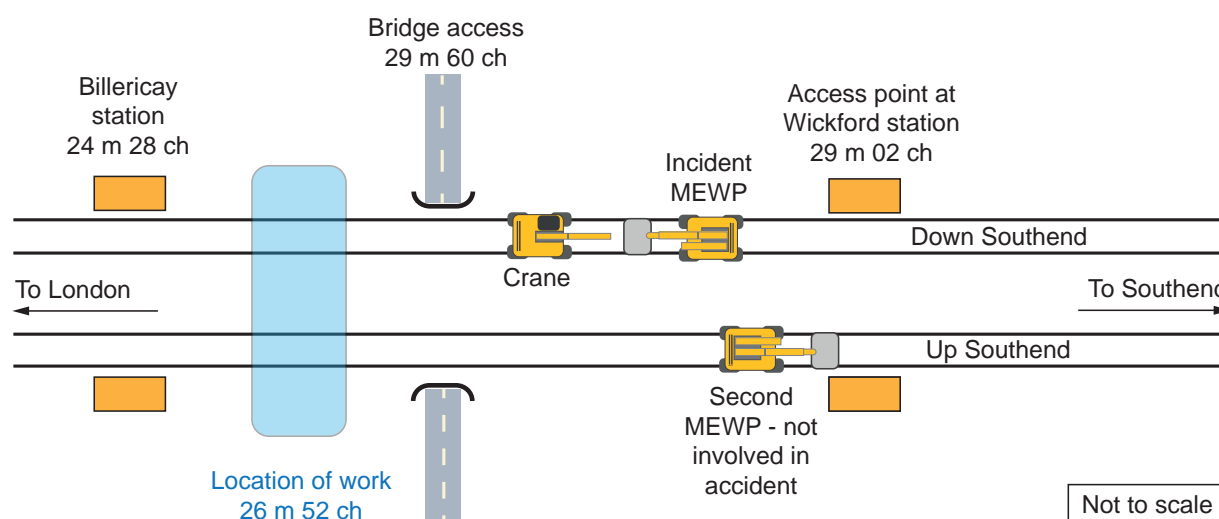
- 7 The group had been working within a work site (the area within a possession managed by an engineering supervisor<sup>3</sup>) at a location which was 26 miles 52 chains from London Liverpool Street station, approximately 2.5 miles (4 km) west of Wickford station (figure 3). When the accident occurred, the group was returning to an access point within the work site at Wickford station, where the machines were taken on and off the track. The machines had been travelling for just over three minutes and had covered 500 metres when the collision occurred. At this location, the railway curves to the right in the direction of travel and is on a low embankment running approximately due east.

Figure 3: Location of work and relative positions of machines immediately before the collision

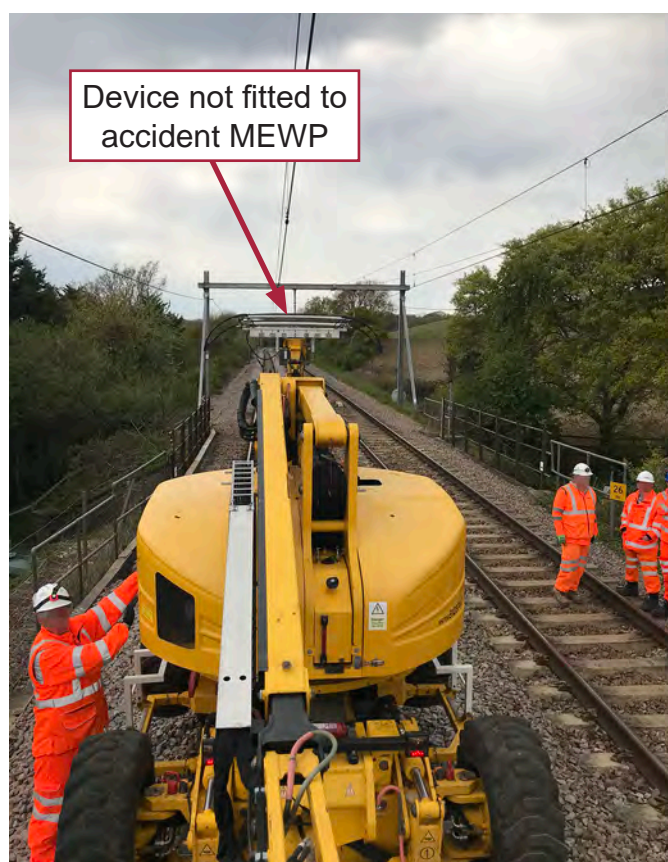
- 27 The two MEWPs left the site of work ahead of the crane and travelled with one on each of the two tracks, together with other members of the workgroup on foot. The MEWP involved in the accident was travelling on the down Southend line, directly ahead of the crane. This MEWP was being driven with the basket at the rear of the machine, and the operator had raised the basket slightly to be able to see the track ahead over the body of the vehicle (see paragraphs 66 to 70 and figure 6).

Figure 6: The view from a similar MEWP with the basket slightly raised at the accident location (in daylight)

- 69 When the machines began the movement back towards Wickford at the end of the working shift, the machine was again oriented with the basket to the rear. The MEWP operator stated that, although it was possible to rotate the body of the machine to bring the basket to the front, in their experience this would result in unwarranted brake applications while travelling. The MEWP operator believed this was caused by spurious operation of safety interlocks, intended to prevent parts of the machine from fouling an adjacent line. RAIB has been unable to find any evidence to substantiate this belief.

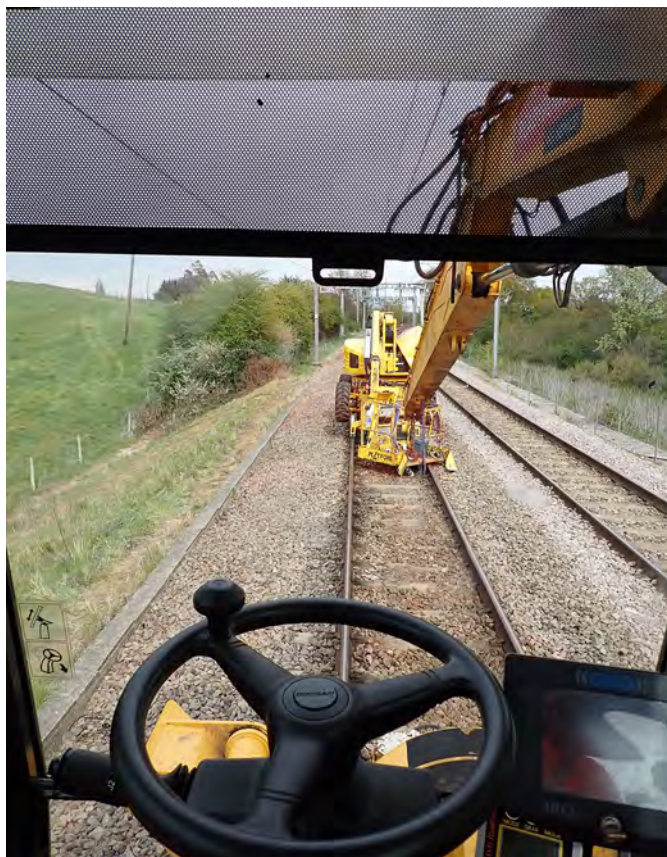
- 30 The crane operator stated that during the journey, he had seen the distance between the machines getting smaller, so he had reduced the speed of the crane. He also stated that the rising sun had become a problem, so he had reached out to pull down a roller blind type sunshade, which is positioned above the windscreen. When examined by RAIB after the accident, the sunshade had been lowered to a point where the MEWP would still be visible to the operator (figure 7).

*Figure 7: The view from the crane operator's seat with the sunshade drawn at the accident location (in daylight)*

38 The crane operator stated that after staring into the rising sun for several minutes the glare had affected his vision, and he lowered the sunshade to try and alleviate the problem (paragraph 30). The crane operator stated that he had not realised that the MEWP had stopped when he looked sideways to relieve the temporary blindness and restore his vision (paragraph 32). Although he was no longer looking forwards, the operator did not slow the crane, which continued towards the stationary MEWP.

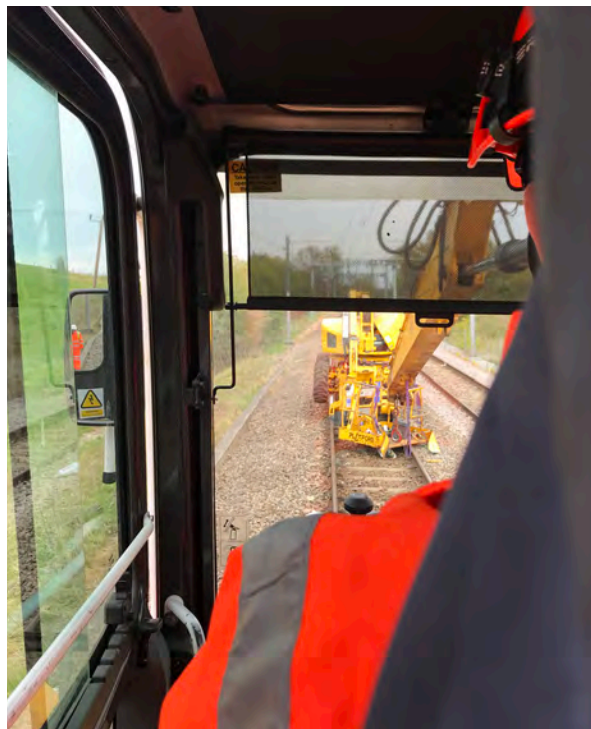
- 49 For the journey from the site of work, the crane controller sat in the cabin of the crane, on a seat facing 90 degrees to the left of the direction of travel and located behind the operator. The view out of the front windscreen from this seat would have been restricted by the operator sitting in the seat in front, but not so much that the view of the MEWP on the track was fully obscured (figure 8).

Figure 8: The view from the rear seat of the crane with a substitute operator (in daylight)

- 50 The crane controller has stated that he had occasionally looked around during the journey, but that the MEWP appeared to be 'far enough' ahead. The controller also stated that he was 'relaxed' with the operator's driving and had been looking out of the side window at the time of the collision, something the seat position would naturally influence a user to do. RAIB has been unable to establish from industry documentation what duties a machine or crane controller is expected to perform when riding on board the machine during a travelling movement, but the actions of the controller indicate that he was not actively supervising the movement of the machine. While it is likely that the controller would have alerted the operator to the stopped MEWP ahead if he had been walking with the machine, it would also have been possible to do this from the seat in the crane cabin.

- 1 *The intent of this recommendation is to clarify the roles and responsibilities of staff in circumstances where on-track plant is travelling.*
