# Rail Accident Report

## **Wrong side signalling failure and derailment at Dalwhinnie, Badenoch and Strathspey 10 April 2021**

Report 10/2022  
September 2022

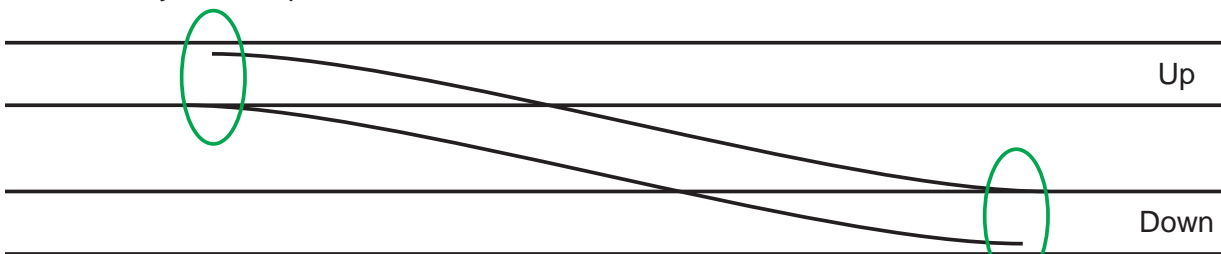
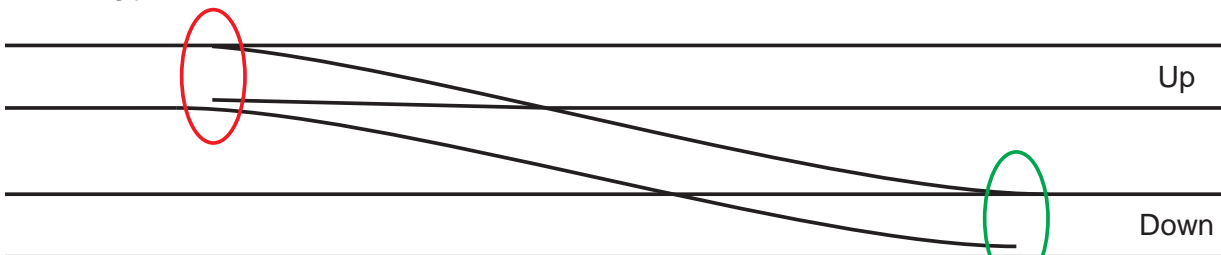
Figure 2: Layout of the railway at Dalwhinnie station showing the route of the train. The lower diagrams shows 13 points in the correct and incorrect (as encountered by the train) positions.

13A point end wrongly set for crossover

**13 points wrongly set (out-of-correspondence)**

13B point end correctly set for down line

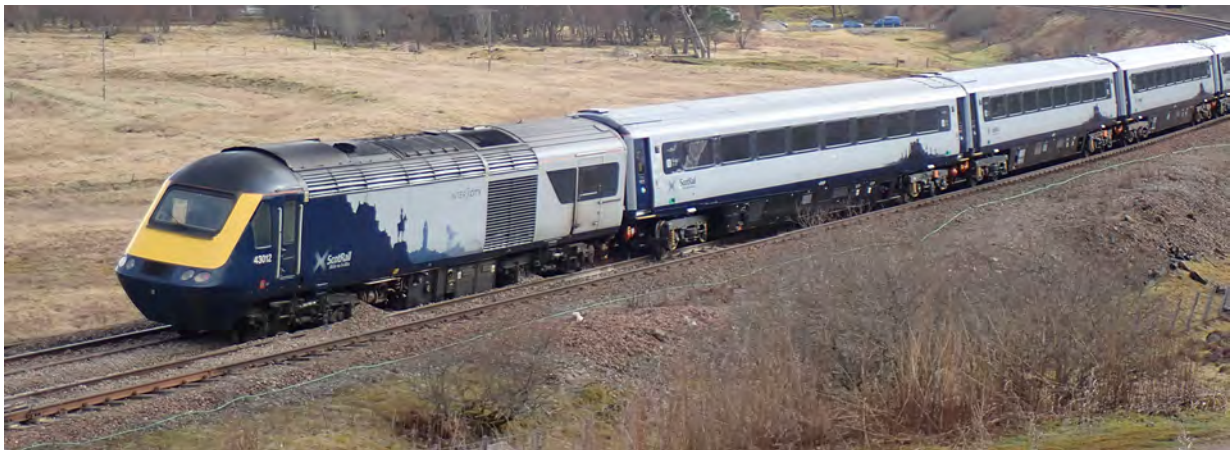
Figure 3: Derailed train – trailing power car and coaches

- 7 The derailment resulted in damage to both the train and the railway infrastructure, mainly the track and signalling equipment at 13 points and the deck of the nearby Ben Alder level crossing. Although no one was injured, trains are permitted to travel at up to 70 mph (113 km/h) through Dalwhinnie station on the up line, while movements over the crossover are restricted to 15 mph (24 km/h) (see paragraph 10). This means that the train could have been travelling at a much higher speed when the derailment occurred; it could also have been carrying passengers. The train could also have encountered a train travelling northbound on the down line.

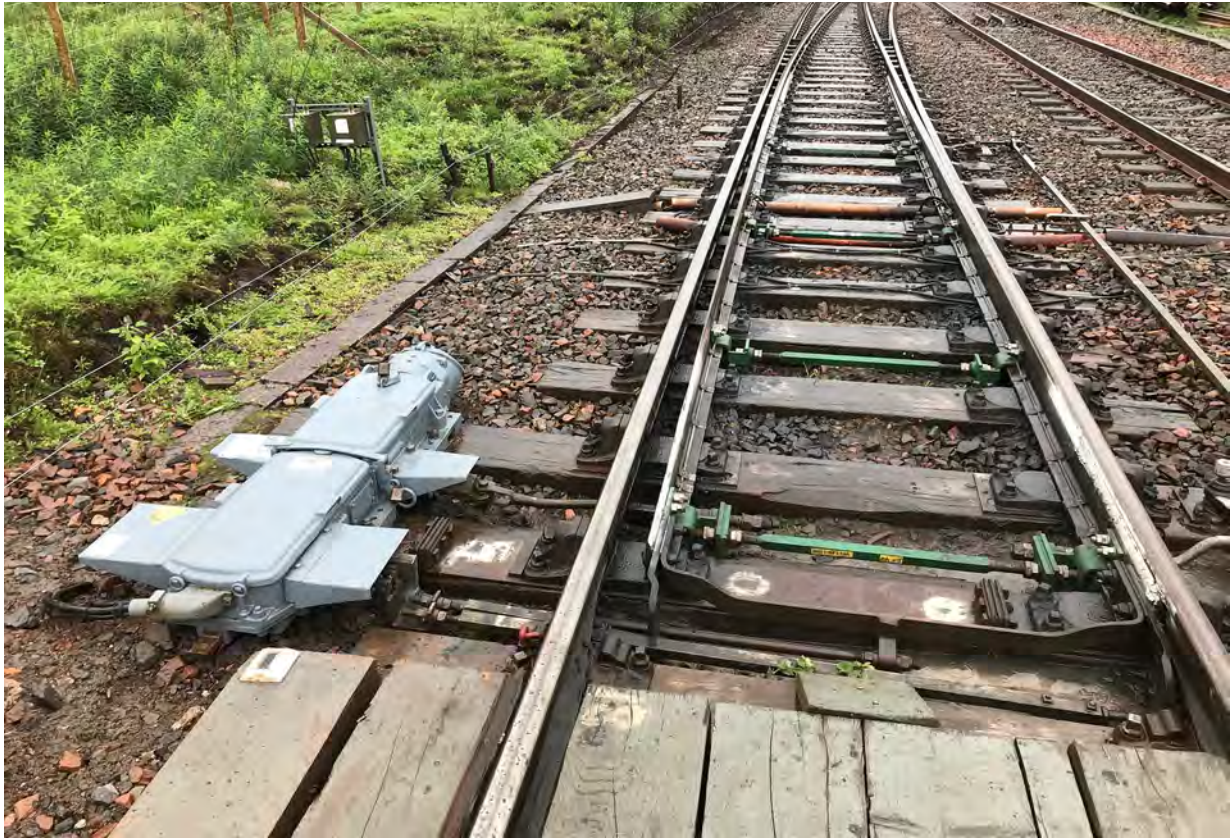
Figure 7: The newly-installed point machine at 13B point end (photograph courtesy of Network Rail)

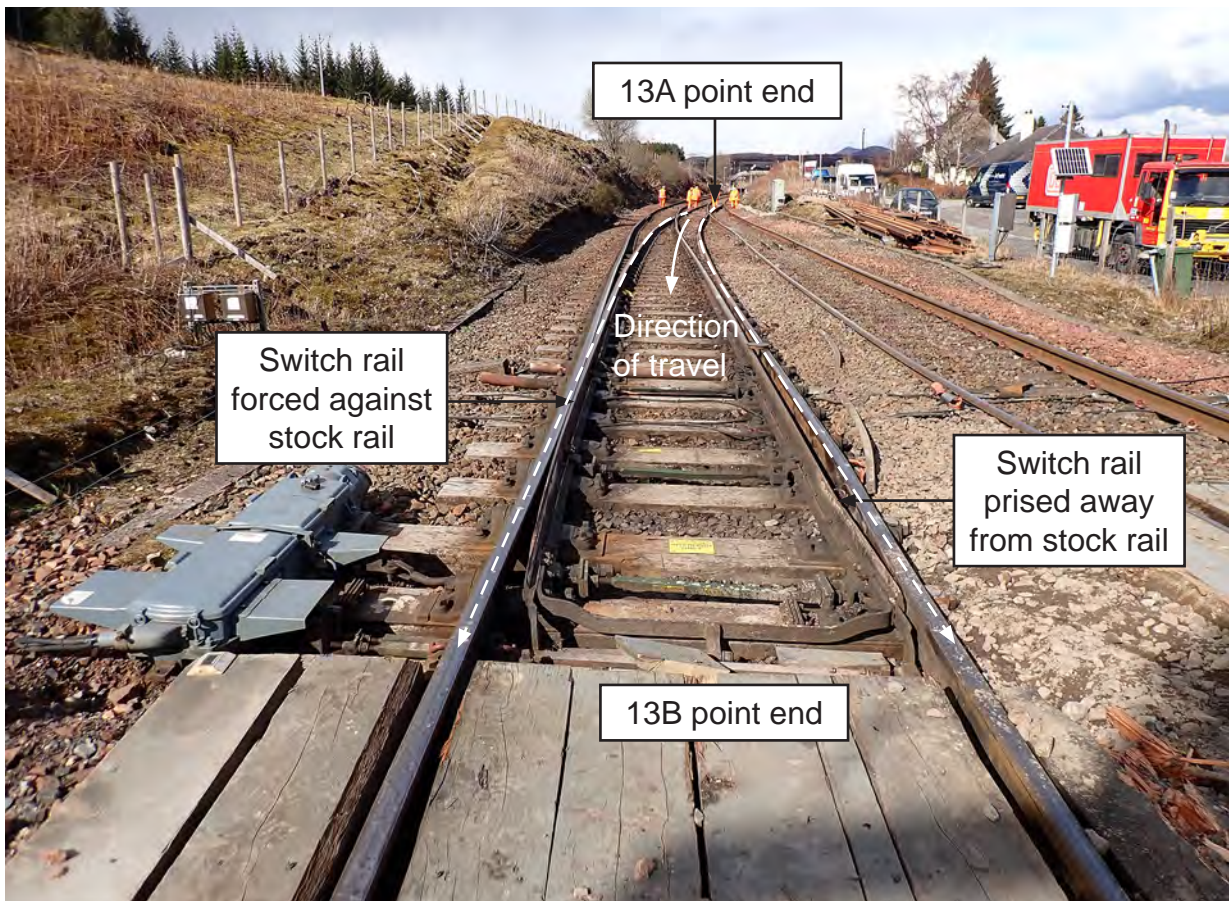
47 RAIB inspected the track and the derailed train at Dalwhinnie finding marks and damage at 13B point end indicating that:

- The left-hand wheels initially encountered the switch rail closed against the stock rail (the fixed rail section within a set of points), and that the train's wheels had prised the switch rail away from the stock rail as they passed.
- The right-hand wheels had forced, and deformed, the opposite switch rail against its stock rail.

Both are consistent with the leading wheelsets being diverted onto the crossover after encountering 13A point end (incorrectly set) in the reverse position, and then encountering 13B point end (correctly set) in the normal position and running through onto the down line in the trailing direction<sup>14</sup> (figures 2 and 8).

Figure 8: Track damage at 13B point end, showing paths of the wheels that ran through

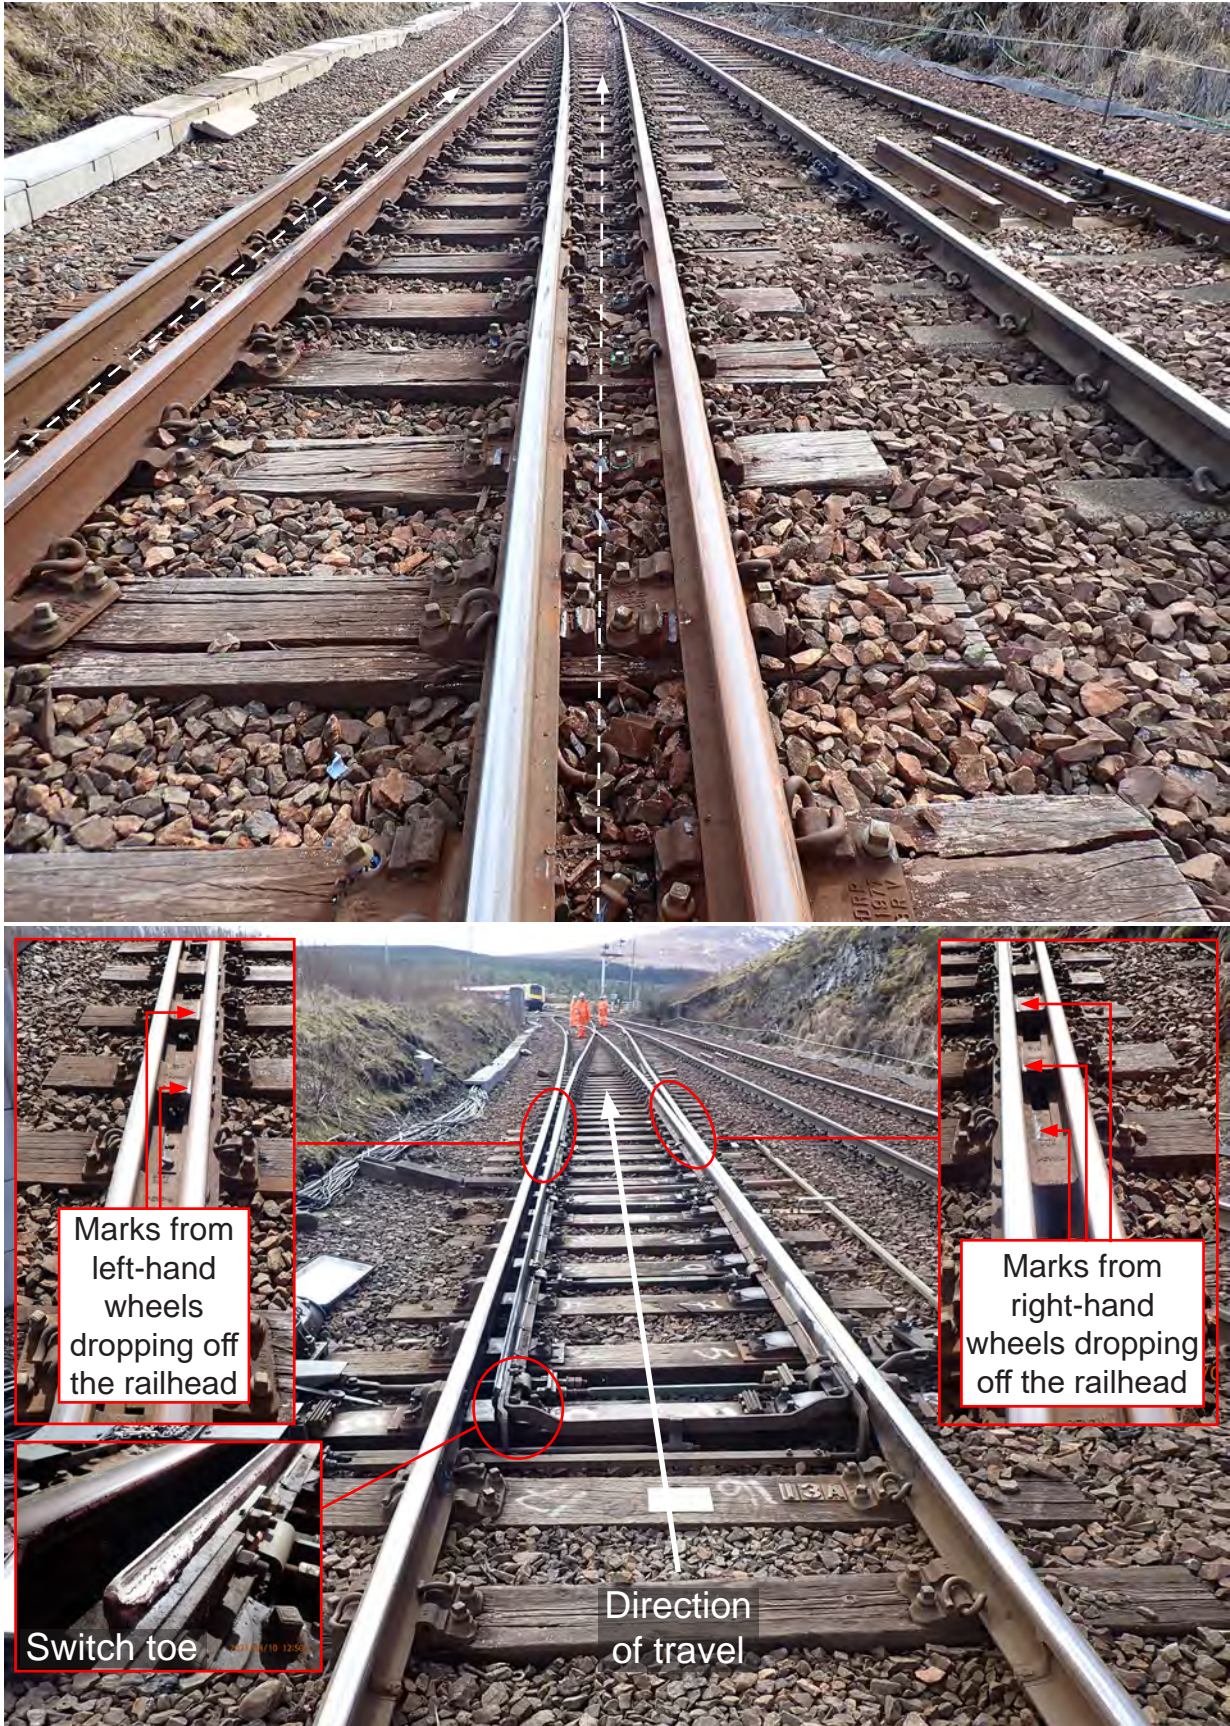
Figure 9: Derailment marks at 13A point end, switch rails in the normal position (as found after the derailment)

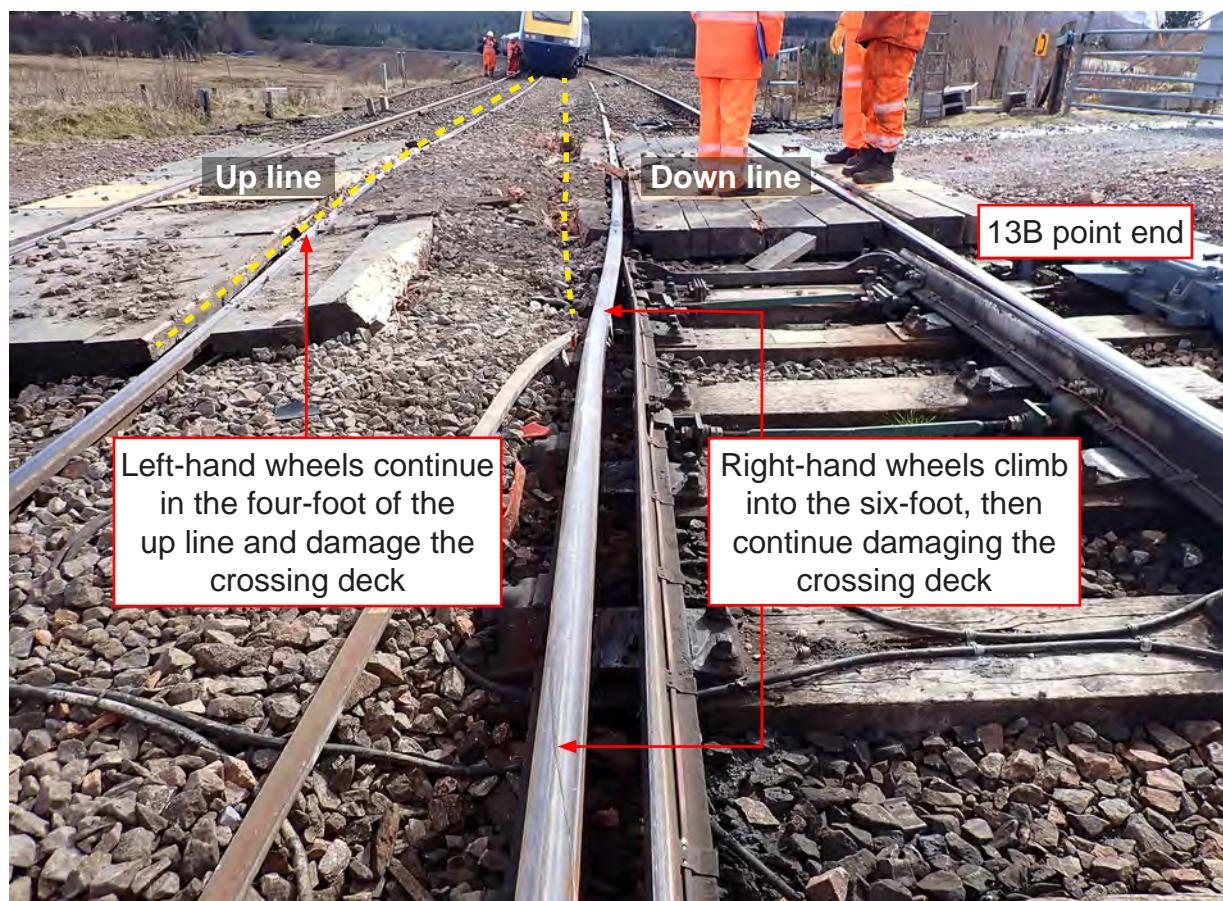
Figure 10: Marks and damage from the last three bogies on the train

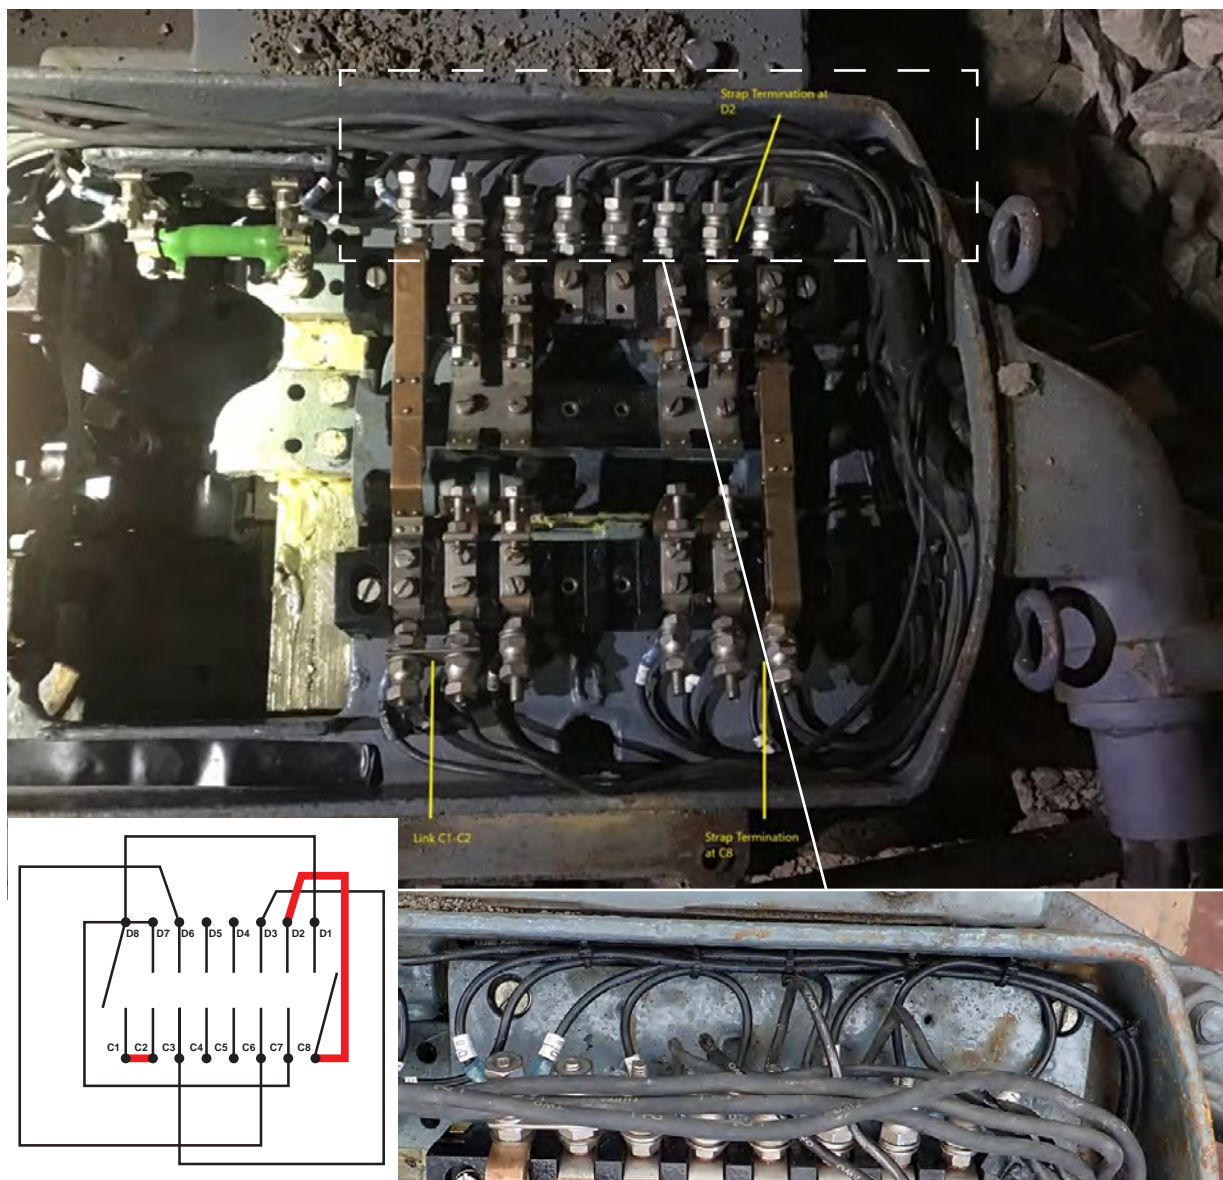
The wiring error was the result of two unwanted conductors, a wire strap and a metal link, within the replacement trailing end point machine. These conductors were only required when this type of point machine was installed at single-ended point locations. The local signalling maintenance team was responsible for installing and testing the replacement point machine. The team did not appreciate that the crossover at Dalwhinnie was unique to the area and that, because of the design of the point position detection circuit that the two point machines shared, these conductors needed to be removed from the point machine when it was installed.

### Signalling asset management and maintenance

- 20 The regional asset manager for signalling (Scotland RAM(S)) is accountable for the management of all signalling assets within the Scotland region. This includes the approval of expenditure for signalling renewal work. Signalling renewals can range from large scale re-signalling schemes, involving major signalling suppliers and extensive design work, to the scheduled replacement of components and individual items of equipment, such as point machines. Network Rail refers to the latter as minor signalling renewal work.

Figure 12: Additional link and wire strap (red) found in point machine at 13B point end (main photograph courtesy of Network Rail – annotation Network Rail). Inset photograph below shows example of use of cable ties to bind wires

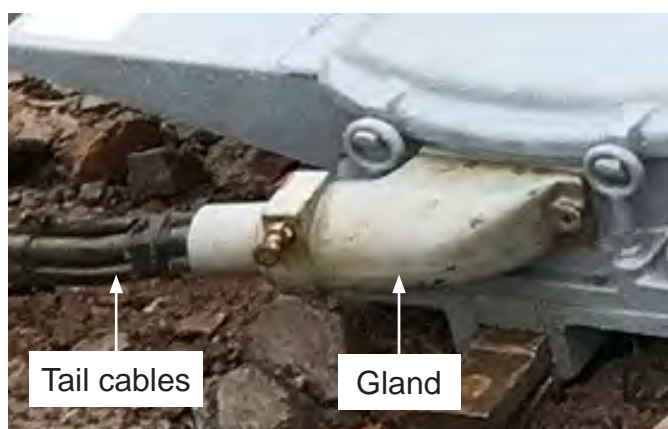
127 The condition of the gland shown on the photograph of the newly-installed point machine is consistent with the tail cables having been transferred in this way (figure 14). Witness evidence supports both this, and that installer A’s focus did not extend to considering the internal detection circuit wiring. He had not considered this necessary because of the pre-installation checking work that he had done (paragraph 106).

*Figure 14: Enlargement of figure 8 showing the tail cables and gland. Paint discolouration is evidence that the gland is from the point machine that was replaced (photograph courtesy of Network Rail)*

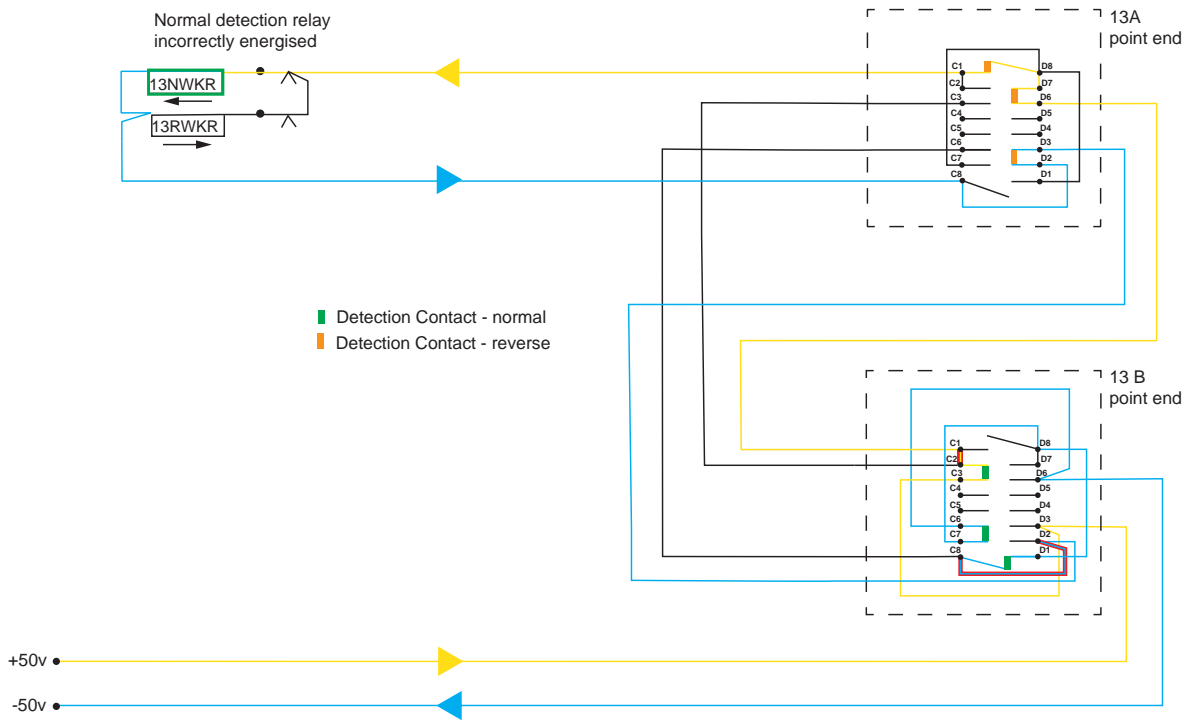
- B9 With the switch rails at 13A point end in the reverse position, and those at the 13B point end in the normal position (paragraph 81), 13 points were out-of-correspondence. For this condition, analysis of the as-designed circuit shows that neither of the detection relays should have energised (figure B3). However, with the two additional conductors in the point machine at 13B point end (between terminals C1 and C2; and C8 and D2) detection relay 13NWKR is incorrectly energised (figure B4).

Figure B4: Detection circuit for 13 points with additional conductors (red) showing 13A point end reverse and 13B point end normal – detection relay 13NWKR is incorrectly energised
