# AIRCRAFT ACCIDENT REPORT 1/2023

Report on the accident to  
**Leonardo AW169, G-VSKP**  
at King Power Stadium, Leicester  
on 27 October 2018

Report on the accident to  
Leonardo AW169, registration G-VSKP  
at King Power Stadium, Leicester  
on 27 October 2018

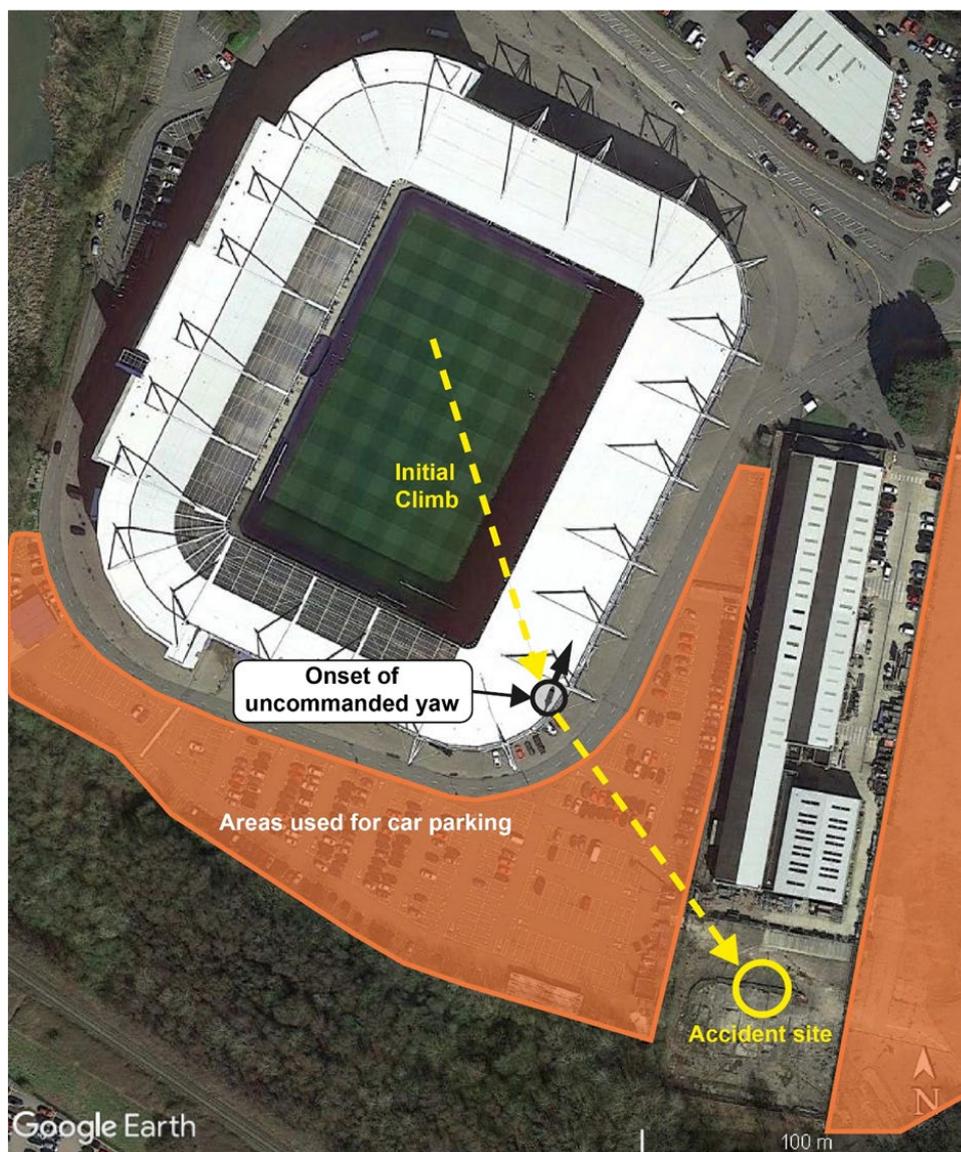
**Figure 2**

The helicopter struck the ground on a stepped concrete surface, while still rotating and with the landing gear retracted (Figure 2). It came to a stop and then rolled onto its left side and was rapidly engulfed in an intense post-impact fire. Stadium staff and emergency services were quickly at the scene but were not able to gain access to the helicopter because of the intensity of the fire.

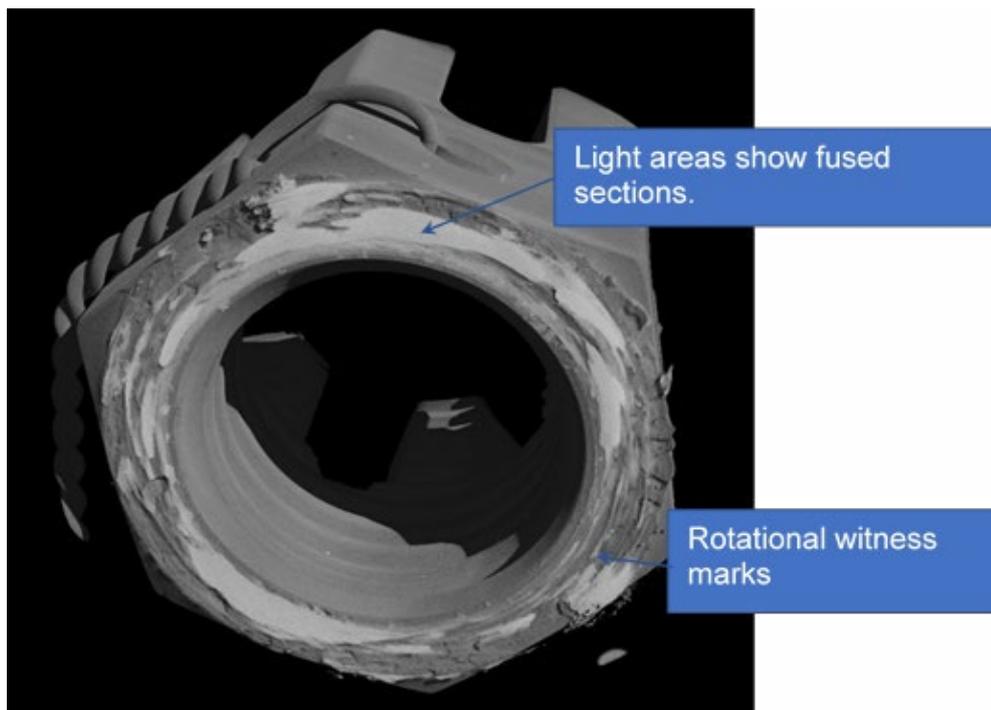
**Figure 26**

Use of a stereo microscope to view the component, identified wear debris between the nut and the pin carrier and deformation of the nut consistent with softening of the material. The inspection also confirmed the presence of an impression mark on the edge of one of the castellations on the nut, consistent with the size and shape of a split pin. The pin carrier and nut were then scanned using an X-ray Computed Tomography (CT) Scanner based at the facilities of  $\mu$ -VIS X-ray Imaging Centre at the University of Southampton. This passes X-rays through components from different angles to produce multiple cross-sectional images, which are then combined as a 3-D model. The model allowed the interface between the two components to be 'virtually sectioned'. This confirmed areas of fusion and evidence of rotation (Figure 26).

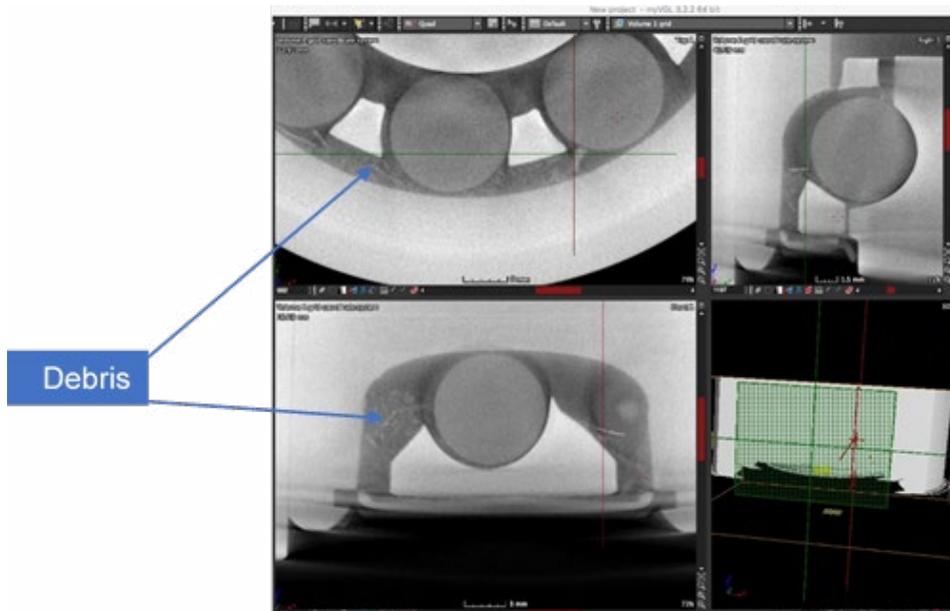
**Figure 32**

The scan also showed evidence of debris accumulating in the bearing raceways (Figure 32).

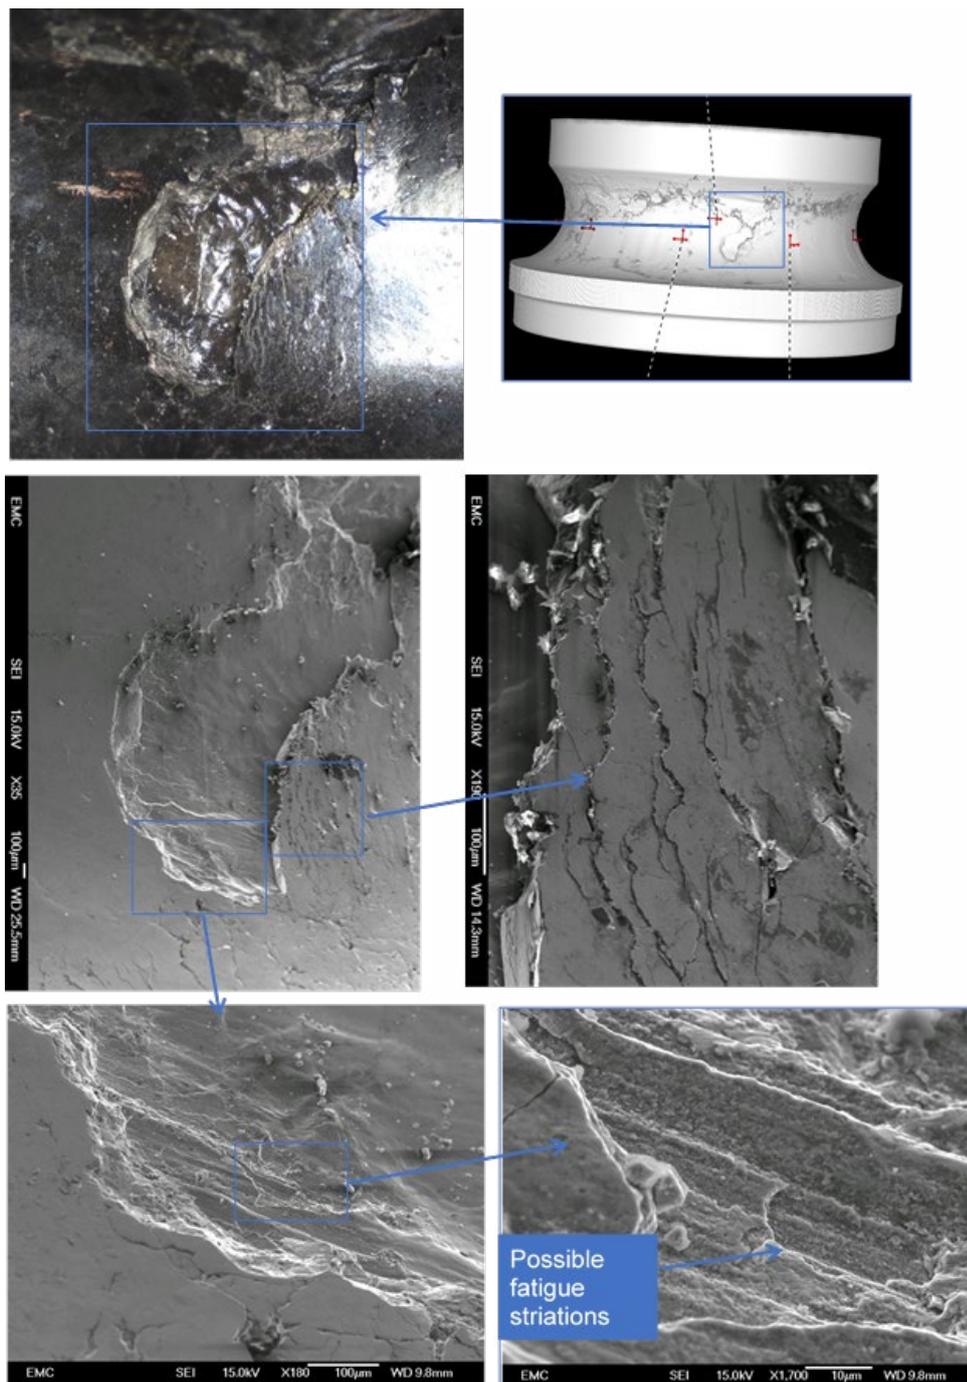
**Figure 35**

SEM images showing the large pit with fatigue and secondary cracking

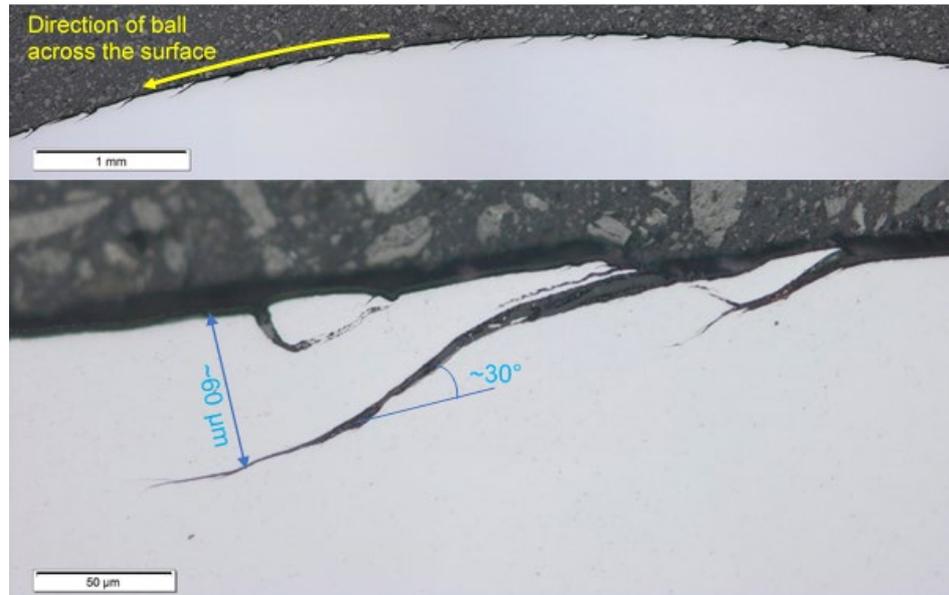
**Figure 36**

The outboard row inner race was typified by repeating inclined cracks. The cracks had a depth and angle typical of a rolling contact fatigue damage mechanism and had initiated from the surface, with material released at the initiation point of the cracks. (Figure 36).

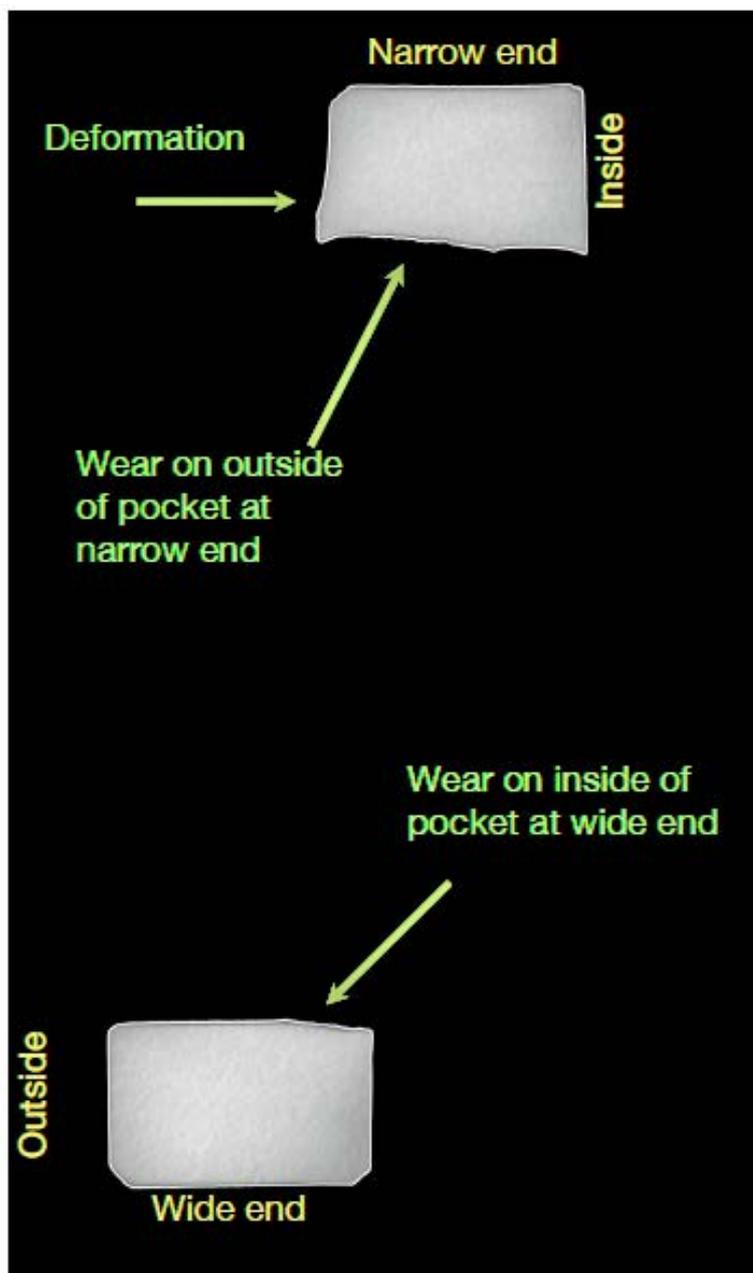
**Figure 41**

cages (Figure 41 and 42), but also a wear lip on the inner running surface of the wide end of the cages (Figure 43). On the inboard cage there was also a wear scar on the outside of the narrow end of the cage (Figure 44).

CT scan cross section of pocket on inboard cage showing wear on the top and bottom surfaces

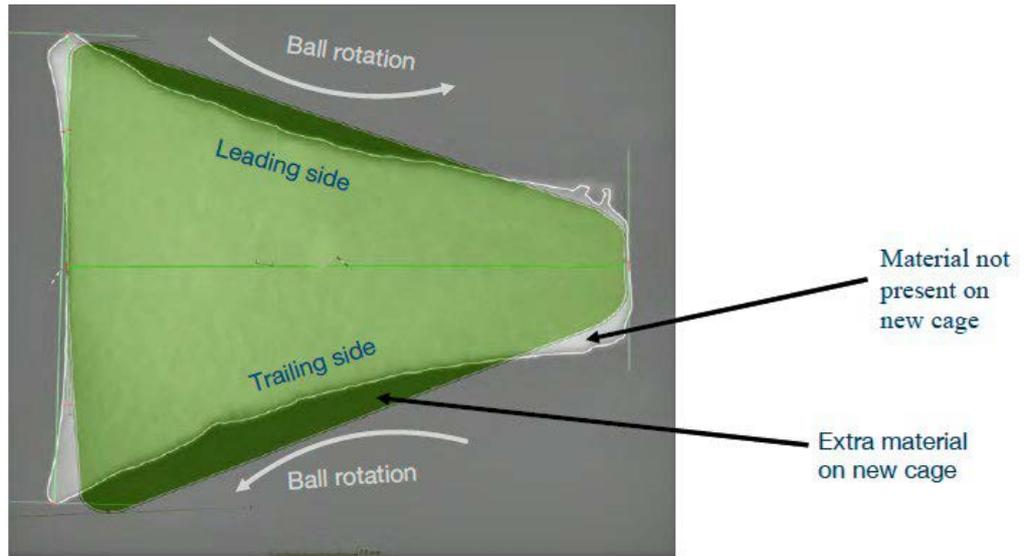
**Figure 42**

Material removal and displacement relative to a new cage (shown in green) on the cage section between ball pockets

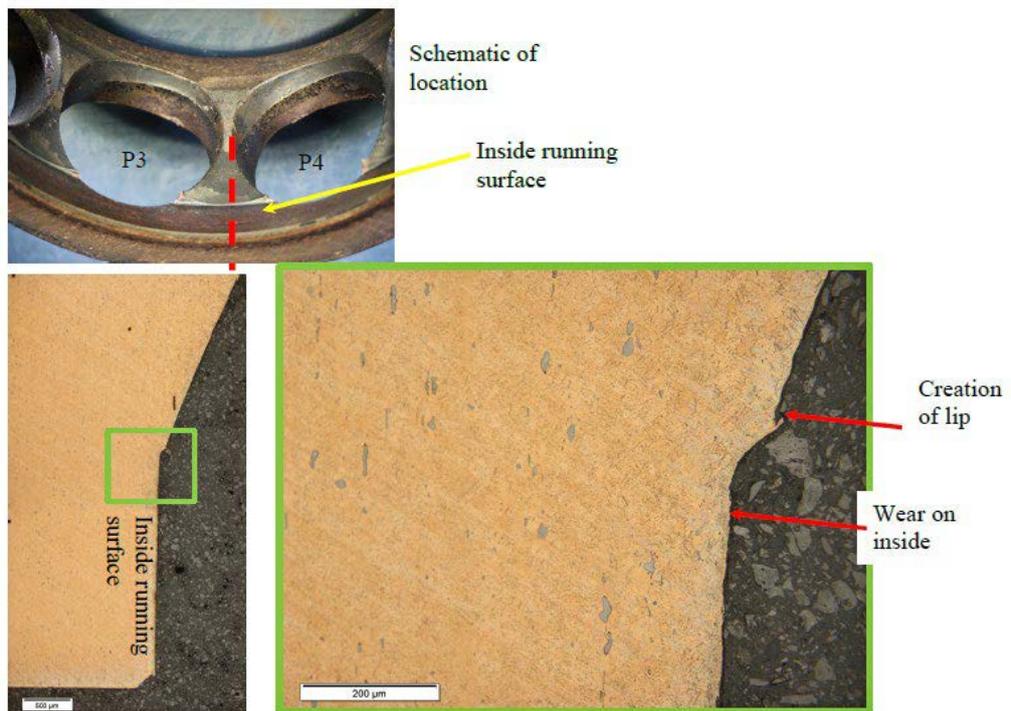
**Figure 43**

Optical and SEM images of wear on the inside of the wide end of the outboard cage

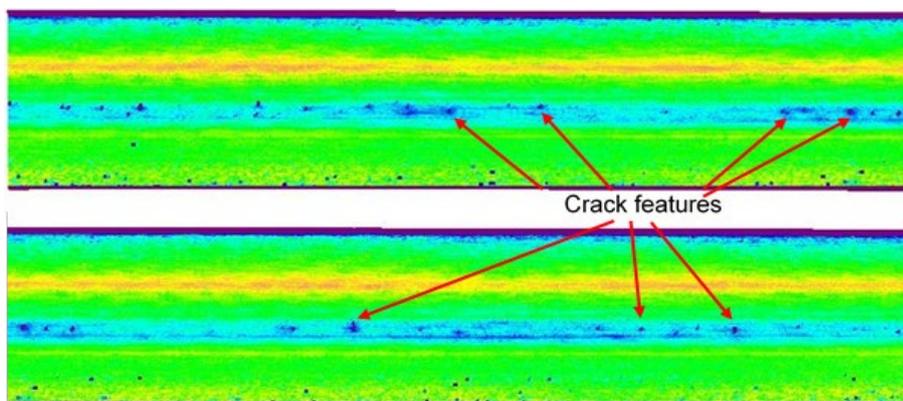
**Figure 46**

The races were then scanned using the non-contact optical scanning technique (RedLux OmniLux). This allowed the identification of raised features in the worn running path on the inboard inner race (Figure 46).

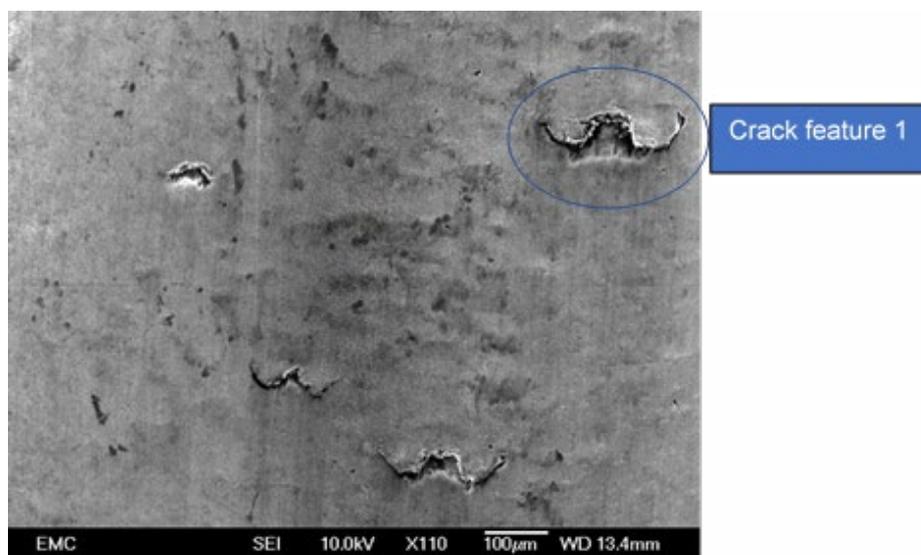
**Figure 47**

The inner races were inspected using an SEM, with the images then processed using MeX software to create height maps. The outboard inner race showed evidence of the original manufacturing grinding marks across the race surface, except for the running area band, where they had been worn smooth. The inboard inner race exhibited crack features, which displayed the same orientation and aspect ratio but varied in size (Figures 47 and 48).

SEM image of inboard inner race showing variation in crack sizes

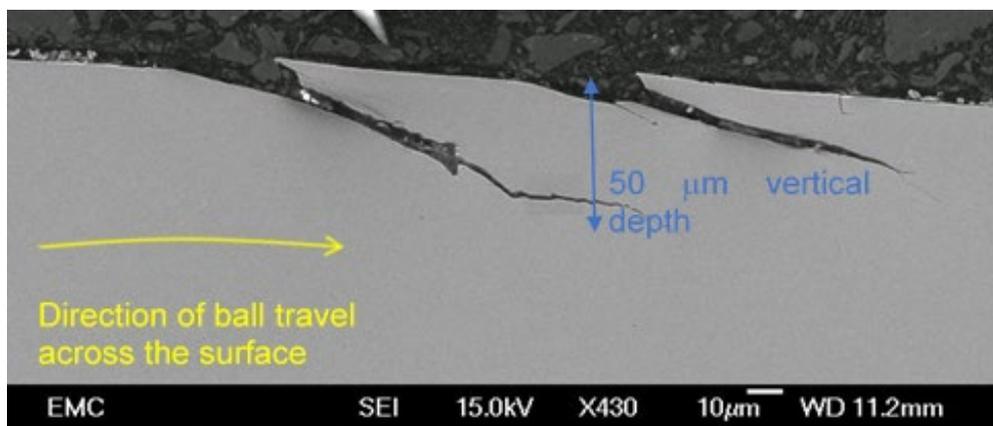
**Figure 49**

A circumferential and radial section was cut from the inboard inner race and inspected using the SEM. This showed that the larger cracks extended to a depth of 50  $\mu\text{m}$  and were consistent with those seen on the accident bearing (Figure 49).

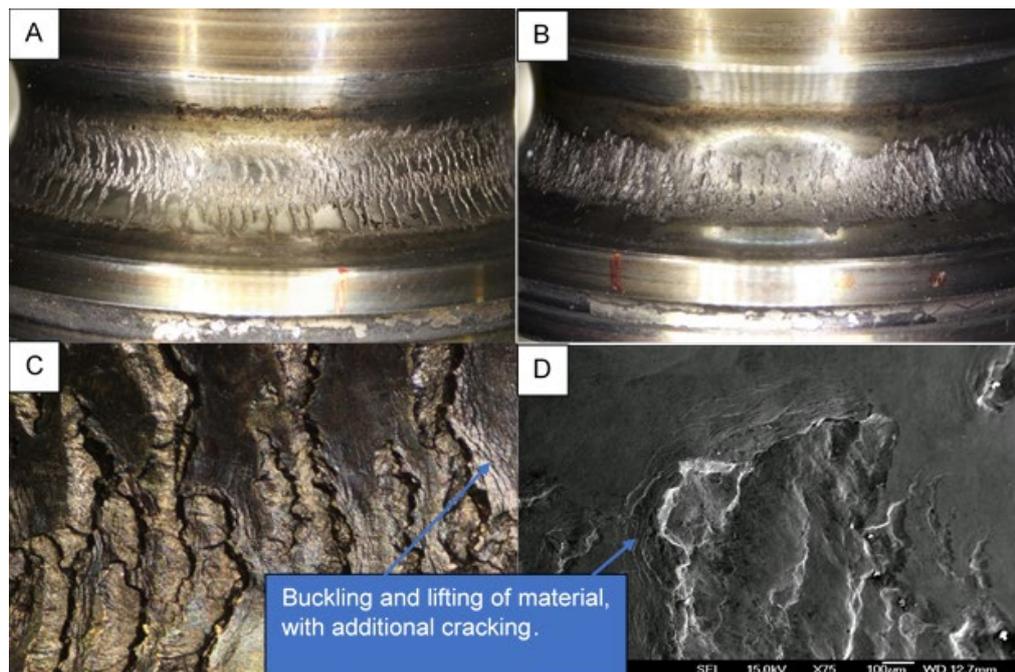
**Figure 51**

Initial inspection showed burnt grease residue and heavy damage to both the inner races. Two balls from the outboard race exhibited spalling damage, with the other balls showing evidence of crazing. The cage from the inboard row was cracked completely through in one location and partially cracked in another. There was also wear in various ball pockets from contact with the balls. The bearing components were CT scanned and cleaned, before being inspected by optical microscope (Figure 51).

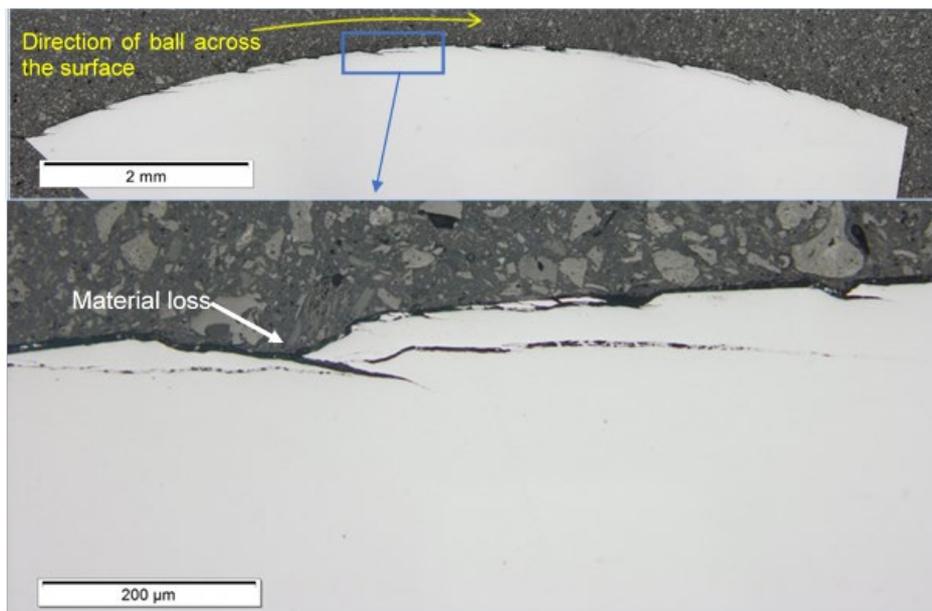
**Figure 52**

The inboard and outboard inner races were sectioned both radially and circumferentially to assess the subsurface cracking. This showed angled, surface initiated cracks consistent with the other bearings that had been analysed but showing evidence of additional material loss to create macropitting (Figure 52). Etching of the radial section and hardness testing confirmed the presence of a DER of microstructural change extending approximately 0.2 mm downwards from the surface (Figure 53). The radial section from the outboard inner race showed some initial material transfer from the cage to the surface of the race. The damage on this race extended over a larger arc of the running surface compared to that seen on bearing s/n 14134.

Microscope view of circumferential section from inboard inner race showing angled, surface initiated cracking with material loss

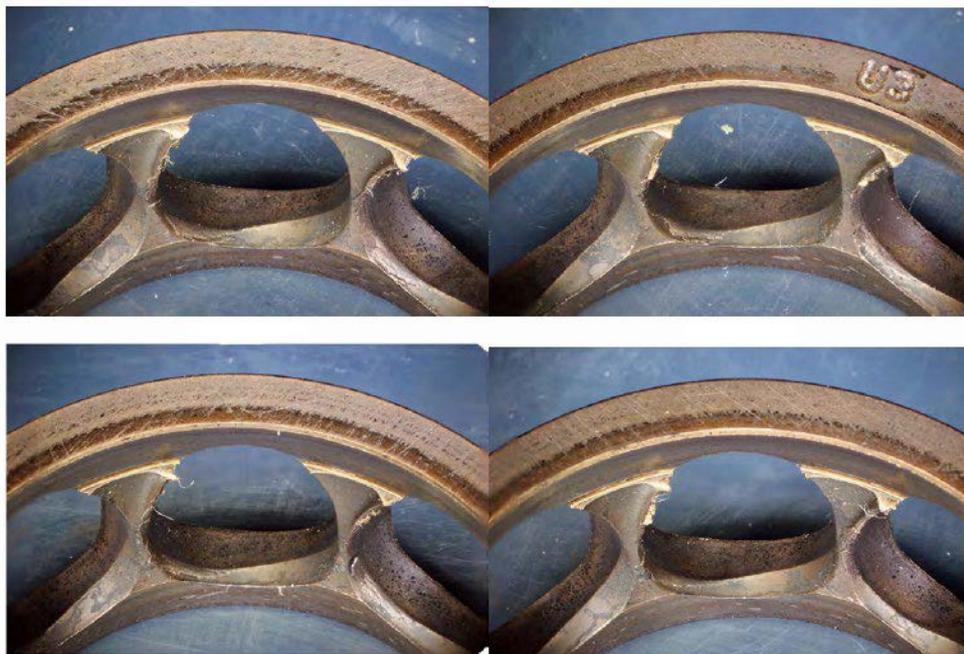
**Figure 54**

The inboard cage had two fractures in pockets on the narrow end and one on the wide end, but remained in one piece. Both the cages from this bearing had a wear lip on the inside surface of the wide end of the cage (Figure 54).

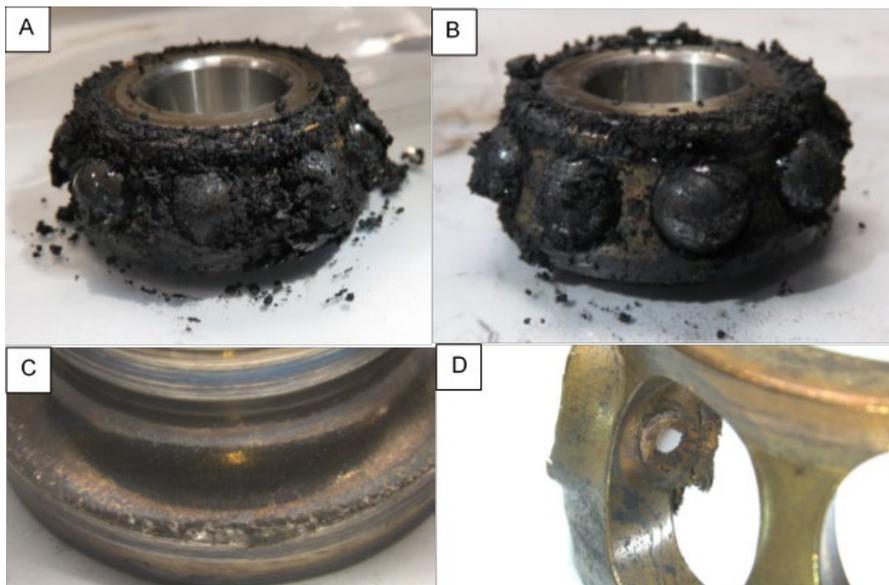
Figure 55

When the bearing was opened, it was found to have significant damage over the whole running surface of the bearing on the inboard row, inner and outer races (Figure 55). Material had been displaced from a wear path the same radius as the radius of the balls and pushed up above the shoulder of the race (Figure 56).

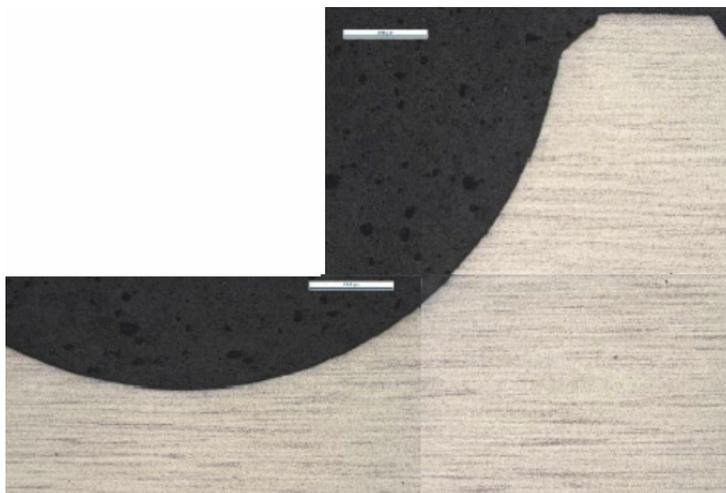
**Figure 58**

surface and extensive micropitting (Figure 59). However, there was no DER below the surface as found on the other bearings (Figure 58).

Inboard inner race radial section with no evidence of DER

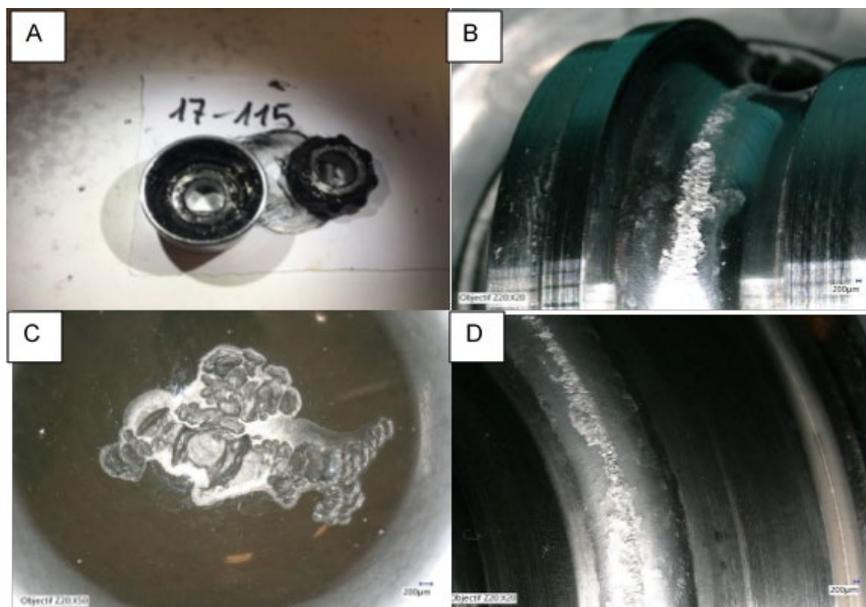
**Figure 60**

The inner and outer race on one side of the bearing was found to be damaged with significant spalling and material loss on both the races and on one of the balls (Figure 60).

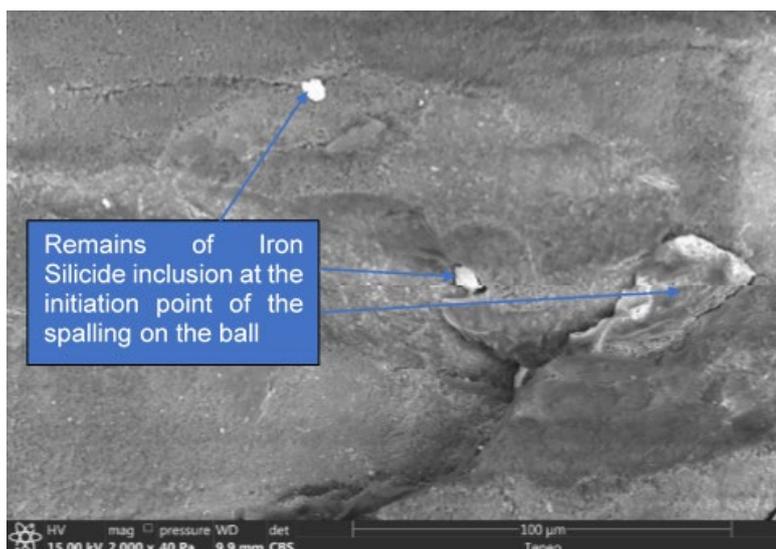
**Figure 61**

Forensic investigation by the bearing manufacturer confirmed that the ball had spalled due to a large iron silicide inclusion in the ceramic material (Figure 61).

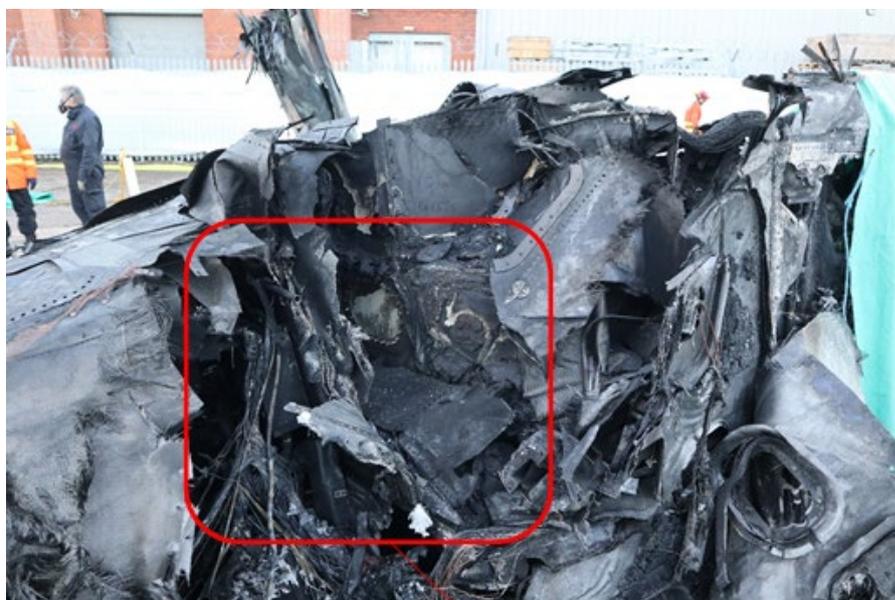
Location of fuel tank

Damage observed to the lower fuselage of the helicopter showed evidence of buckling and failure in the region directly below the main fuel tanks. It was consistent with this section of the fuselage striking the raised step on the accident site. Examination of the damage showed evidence that parts of the fuselage structure had been driven into the fuel tank structure as a result of impact forces (Figure 63).

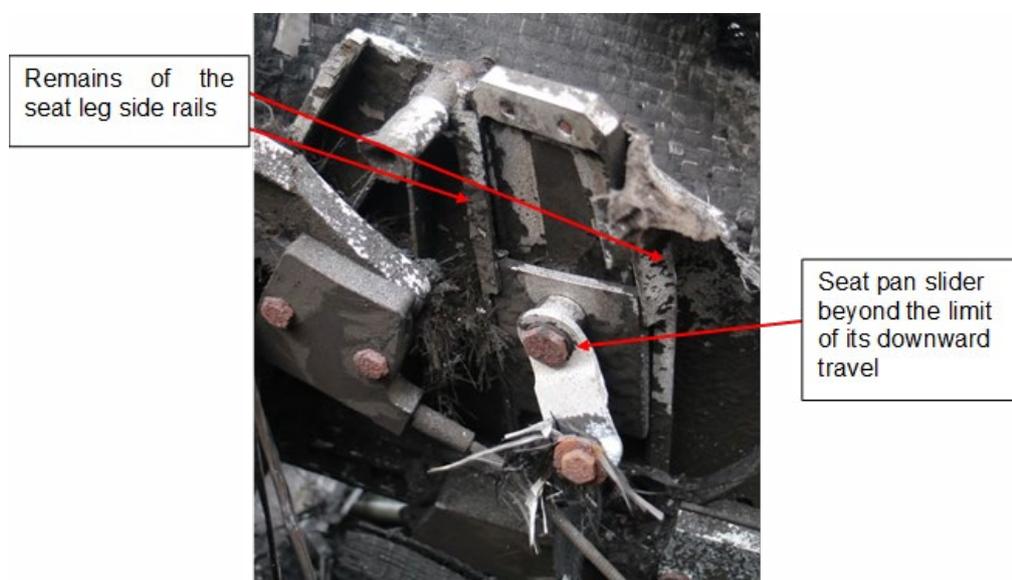
**Figure 64**

After recovery of the helicopter to the AAIB, an examination of the helicopter's cabin was carried out to locate the cockpit and passenger seat impact absorption features and to determine if they had operated correctly during the accident. Due to the damage caused by the post-impact fire it was not possible to identify specific components of the two cockpit seats. The four rearward facing seats in the passenger cabin had been extensively damaged, but the lower sections of the seats remained in-situ. The level of damage to the seats did not allow reference to the stroke index marks to determine if the seat impact absorption systems had operated. However, examination of the position of the seat pan sliders within the seat leg rails, confirmed that the impact absorption system of the two outboard seats had operated and seat pan slides had exceeded the limit of their downward travel (Figure 64).

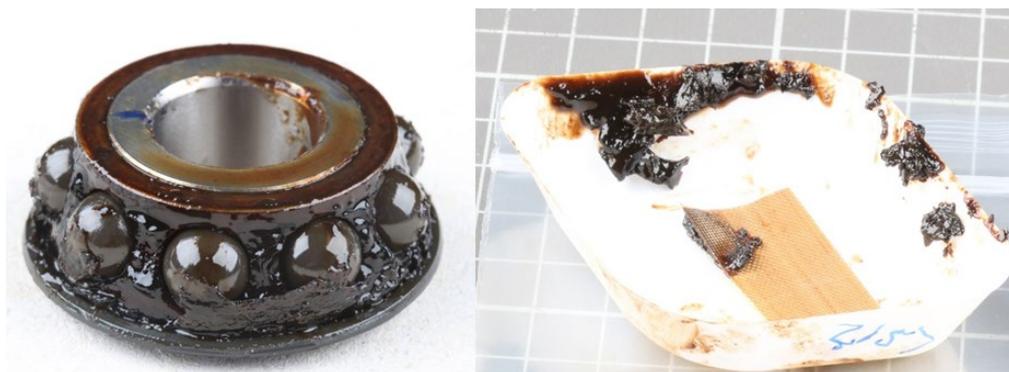
**Figure 65**

The grease was found to be black in colour, with some separation of the oil and the matrix. It had also become sticky and lumpy in consistency, indicating a change of condition due to ageing (Figure 65).

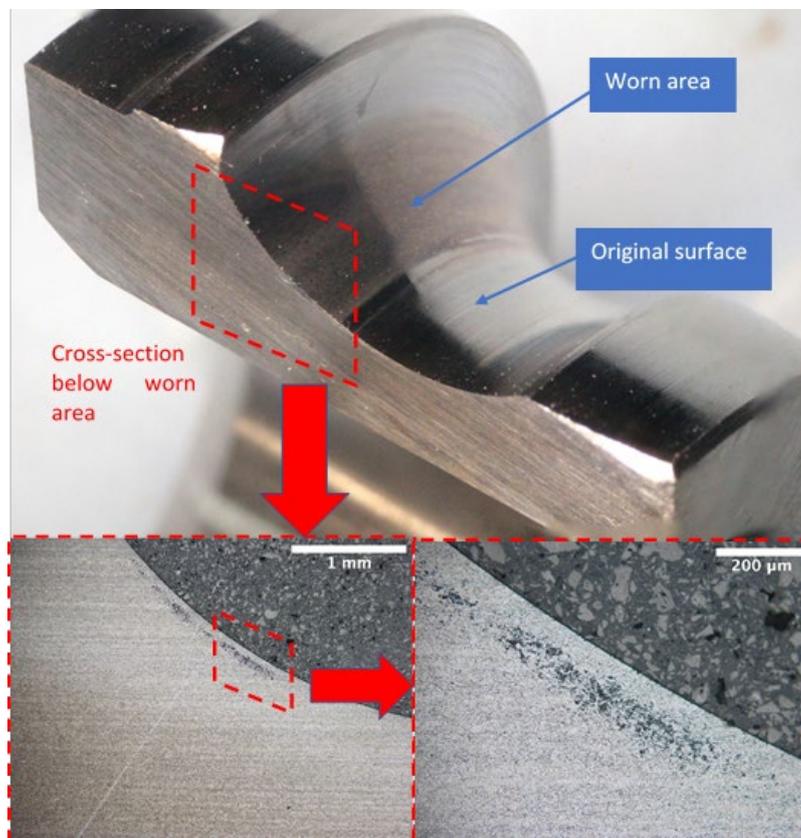
**Figure 67**

material properties change on any of the races. The inboard race of the loaded side of the bearing did, however, exhibit a DER below the race surface, where the wear line showed the balls had been running (Figure 67).

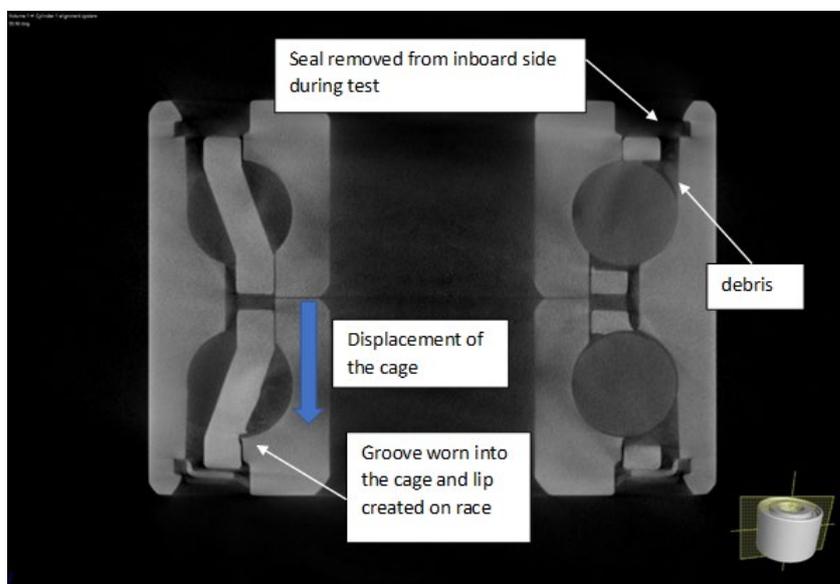
**Figure 74**

A groove had been worn in the cage and a lip worn on the race where they were in contact (Figure 74). Large amounts of debris were also seen within the bearing races.
