Rail Accident Investigation Branch

Rail Accident Report

Signal passed at stop and near miss, Deansgate-Castlefield tram stop, Manchester 17 May 2019

Report 06/2020
August 2020

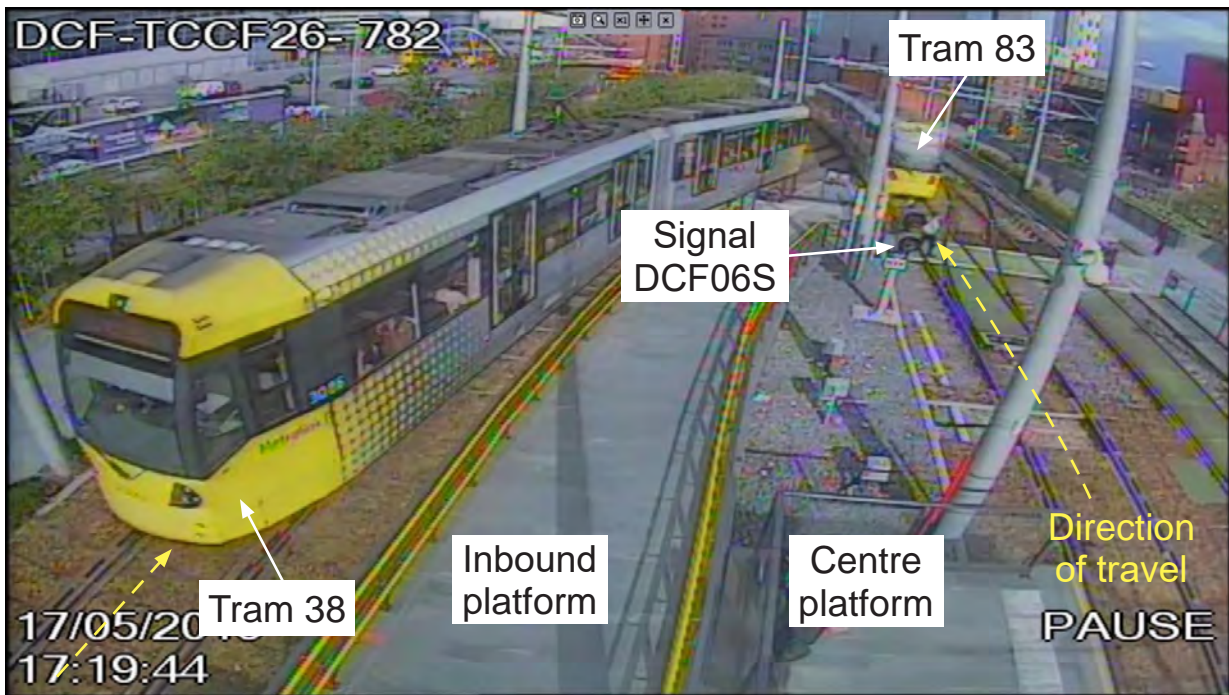
- 3 Tram 83 then entered the junction where the lines from the inbound and centre platforms join to form the single inbound line towards St Peter's Square tram stop. This placed it in conflict with Metrolink tram 38, which was approaching the same junction from the inbound platform, under a proceed signal. The driver of tram 38 glanced to his right as he neared the junction and saw tram 83 approaching. He was able to stop his vehicle in time to narrowly avoid a collision (figure 2).

Figure 2: CCTV image from Deansgate-Castlefield tram stop, showing the incident (image courtesy of Keolis Amey Metrolink)

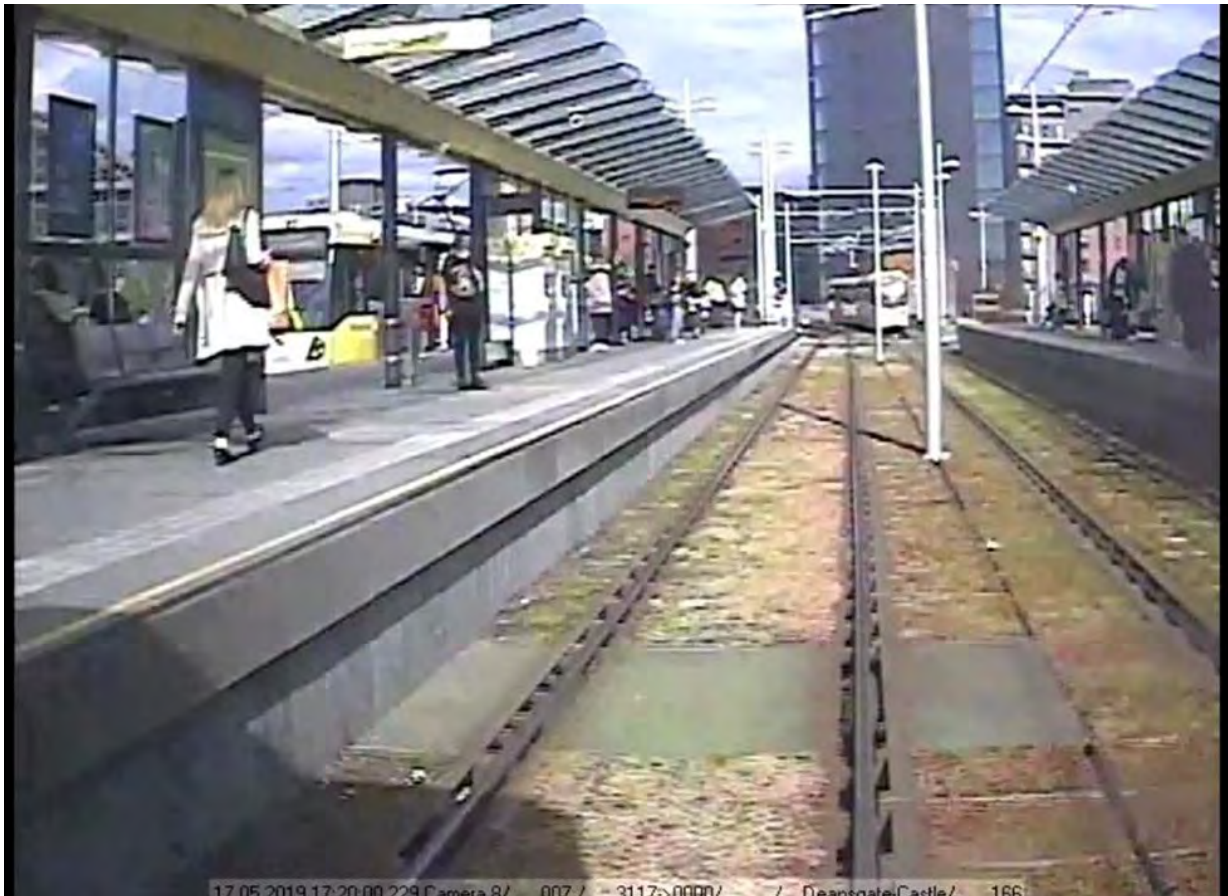
- 29 At 17:19:02⁷ hrs, tram 83 was travelling at 8 mph (13 km/h) as it approached the pedestrian crossing at the west end of the centre platform. At this point the driver moved the TBC from BRAKE into COAST. Four seconds later, with tram 83 travelling at 8 mph (13 km/h) and passing down the centre platform (figure 7), the driver moved the TBC from COAST into DRIVE, with a traction demand of +1%. Signal DCF06S is visible in FFCCTV images shortly after this point. It can be seen showing a stop aspect, which applied to tram 83.

Figure 7: FFCCTV image from tram 83 as the TBC moved from COAST and into DRIVE at +1% (image courtesy of Keolis Amey Metrolink)

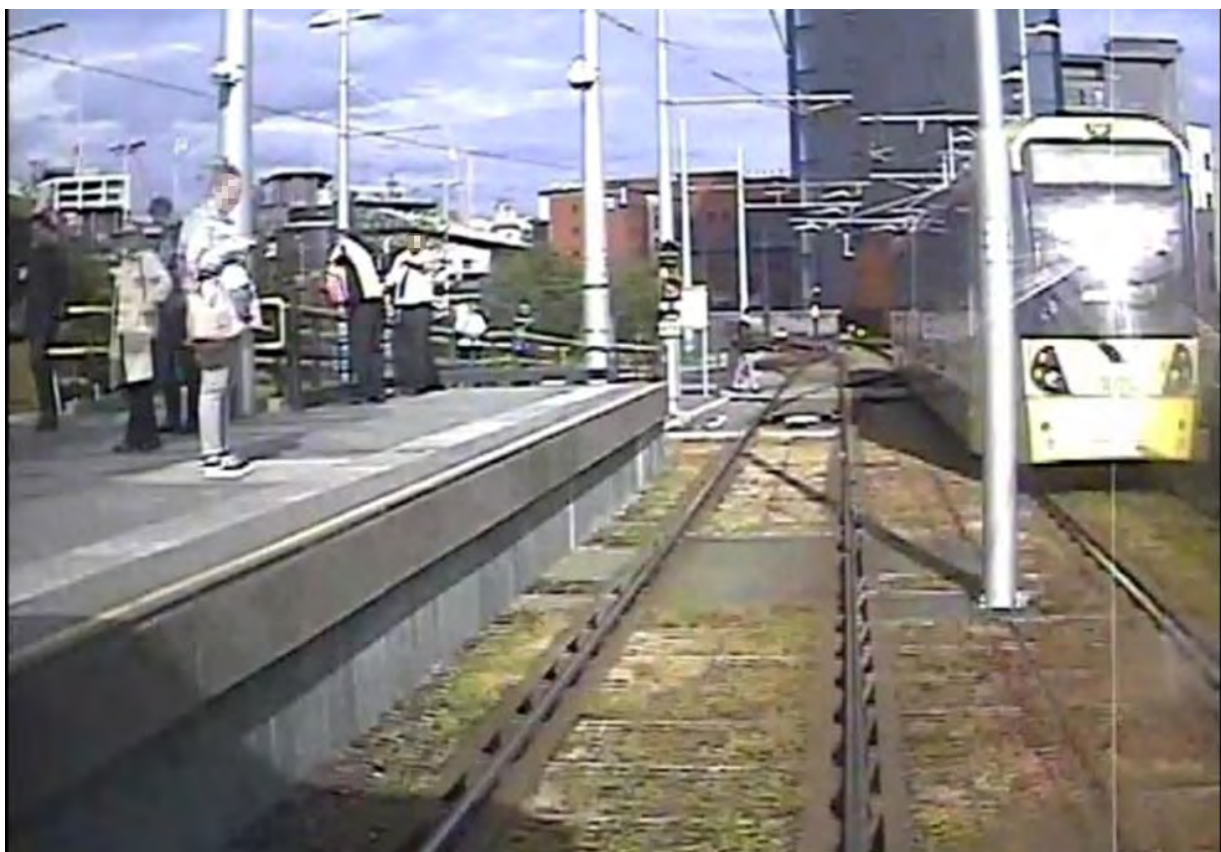
- 30 At 17:19:13 hrs, DCF07S signal changed to proceed and tram 38 started to move away from the inbound platform a few seconds later. Tram 83 was by now further along the centre platform (figure 8). FFCCTV shows that signal DCF06S was still showing a stop aspect and that PPI DCF06P was showing a left indication.
- 31 At 17:19:17 hrs, tram 83 was travelling at 10 mph (16 km/h) and approaching the end of the centre platform. The driver moved the TBC from DRIVE to BRAKE, with a brake demand of -1%. Signal DCF06S remained at stop. Two seconds later, tram 83 passed clear of the platform and approached the pedestrian crossing at the east end of the tram stop (figure 9). This was being used by members of the public. The driver sounded the tram's whistle twice and increased the brake demand to -38%.

Figure 8: FFCCTV image showing the position of tram 83 as tram 38 (extreme left) moved off from the inbound platform (image courtesy of Keolis Amey Metrolink)

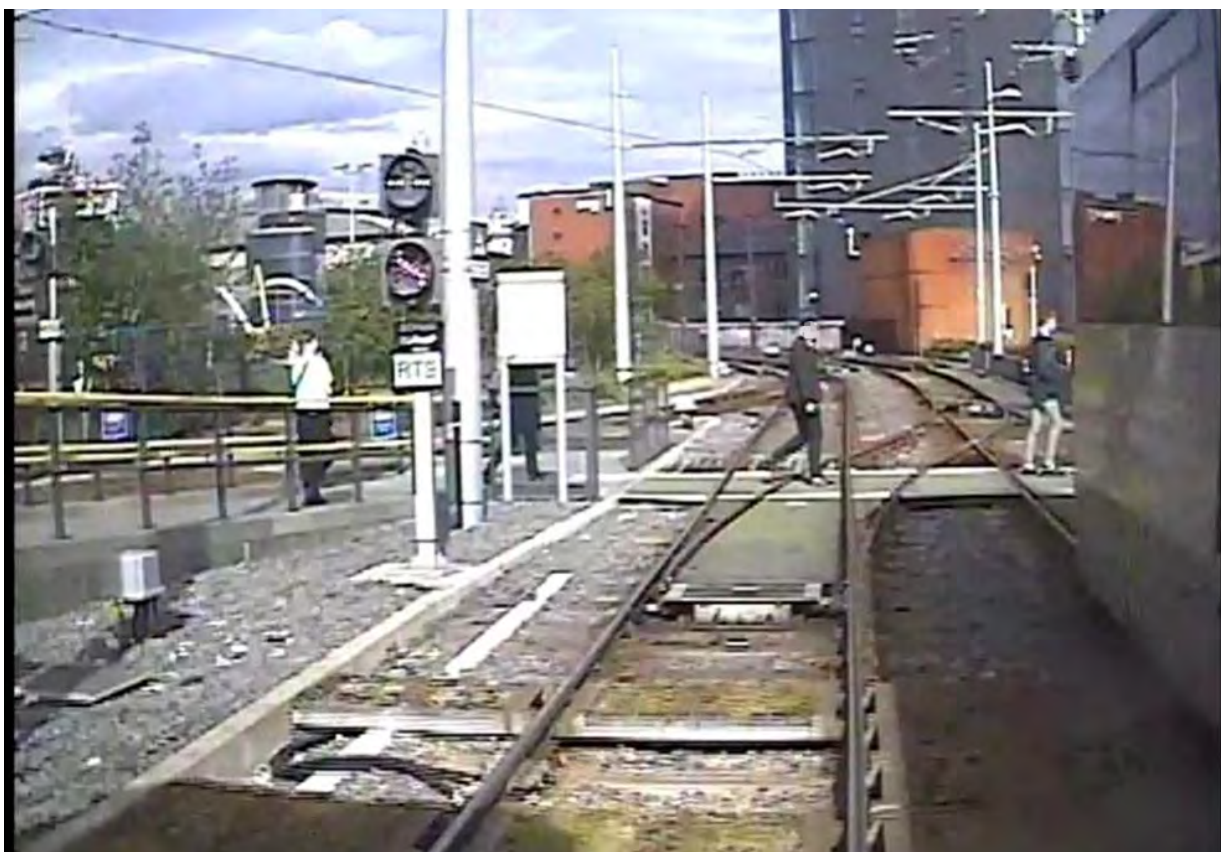
Figure 9: FFCCTV image showing signal DCF06S at STOP as tram 83 approached (image courtesy of Keolis Amey Metrolink)

- 32 Tram 83 passed signal DCF06S while it was showing a stop aspect at a speed of 9 mph (14 km/h). As the tram got closer to the pedestrian crossing, a member of the public realised that it had not stopped at the platform⁸ and stepped back to allow it to pass (figure 10). Once the front of the tram was over the crossing, the driver moved the TBC from BRAKE into DRIVE, with a traction demand of +1%. The driver of tram 83 made no further control inputs as the tram passed onto junction DCF07J.

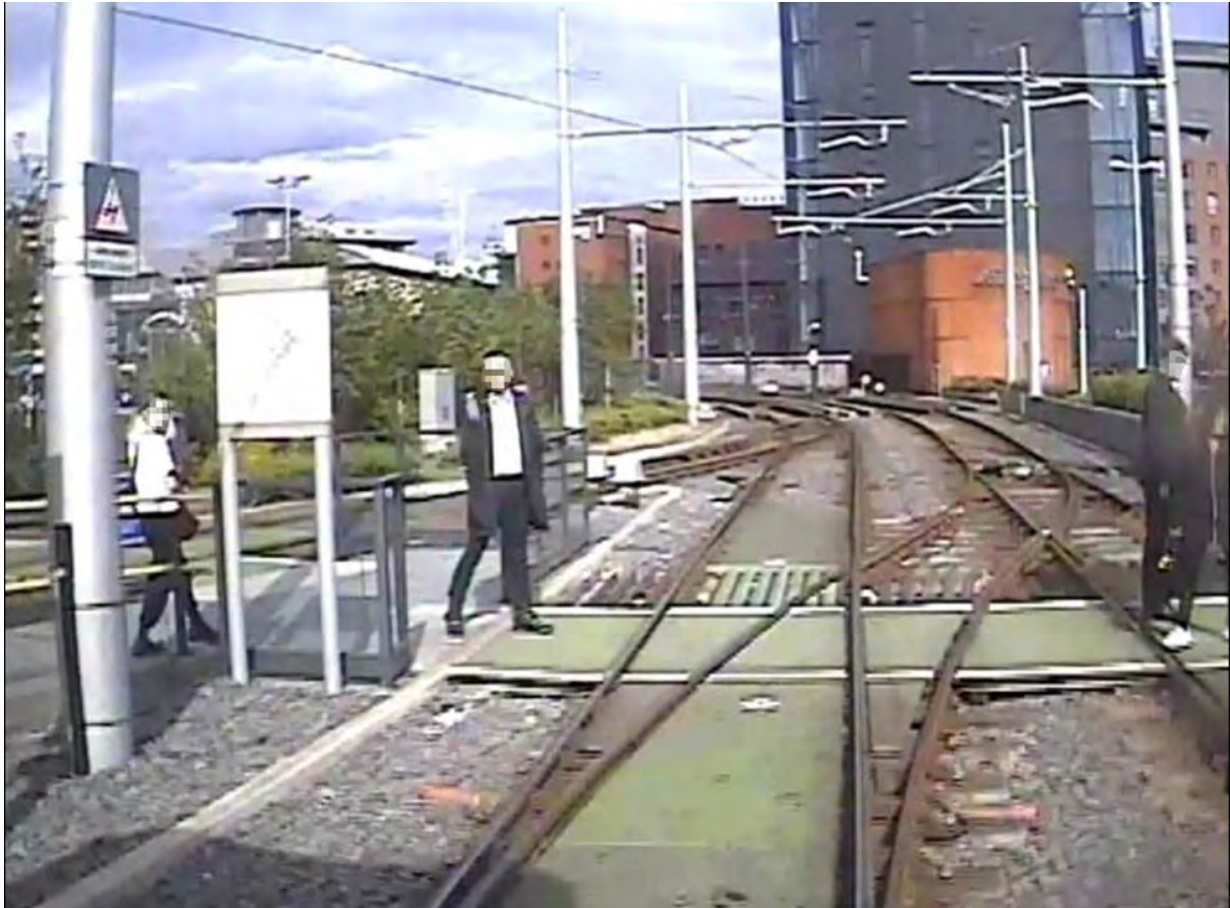
Figure 10: FFCCTV image showing the pedestrian crossing as tram 83 approached (image courtesy of Keolis Amey Metrolink)

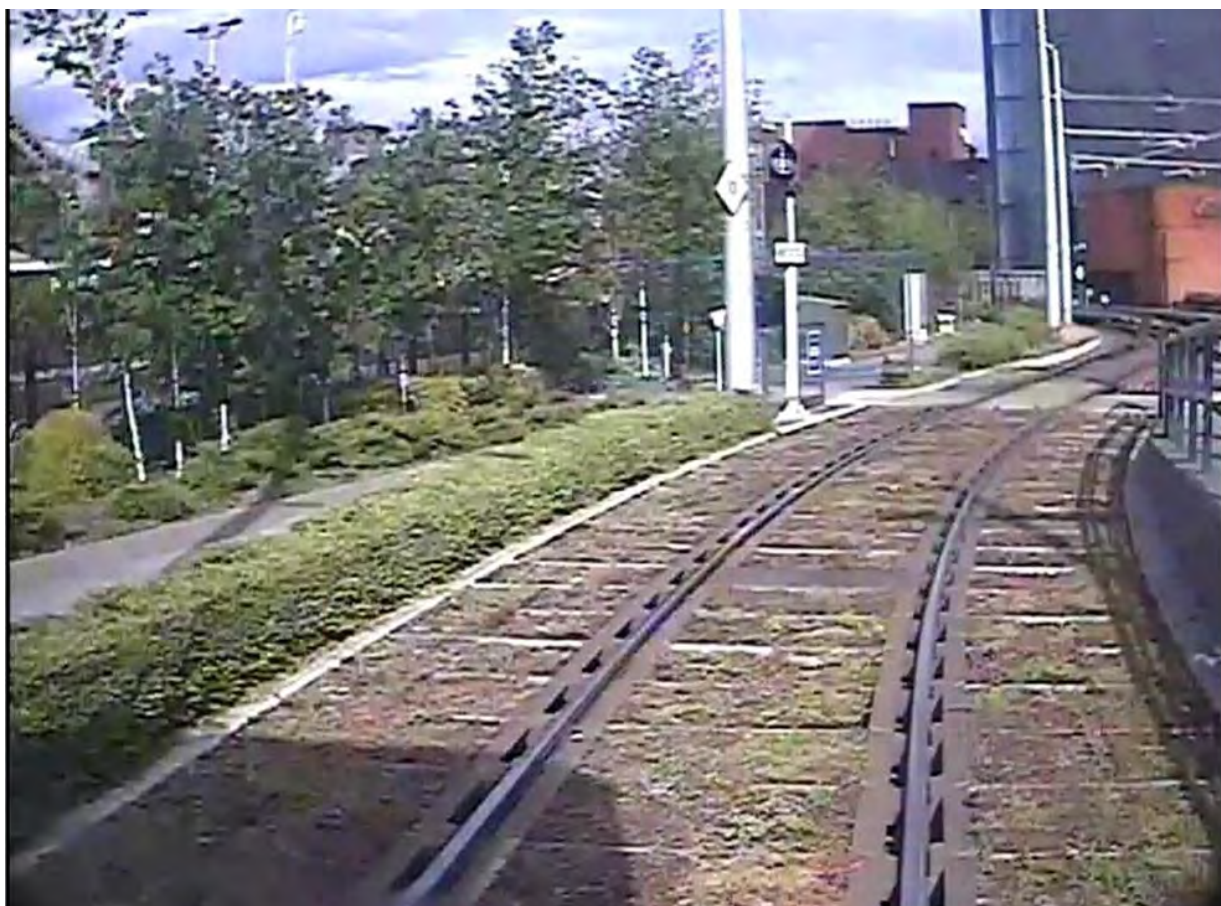
- 33 Junction DCF07J is not subject to a 'Give Way' arrangement. Under the line-of-sight principle (paragraph 9), the driver of tram 38 was therefore only required to check that signal DCF07S was showing a proceed aspect and that the line ahead was clear of obstructions, before he departed from the inbound platform. FFCCTV confirms that these conditions were met as tram 38 departed (figure 11). In this instance, the driver of tram 38 happened to glance to the right as he was approaching the junction. He saw that tram 83 was also approaching the junction and was able to bring tram 38 to a stand and narrowly avoid a collision (figure 2). The driver of tram 38 subsequently reported the near miss to Metrolink's Network Management Centre.

Figure 11: FFCCTV image from tram 38 showing signal DCF07S and the line ahead (image courtesy of Keolis Amey Metrolink)
