Rail Accident Investigation Branch

Rail Accident Report

Fatal collision between a tram and a pedestrian at Cleveleys, Lancashire 24 November 2021

Report 14/2022
November 2022

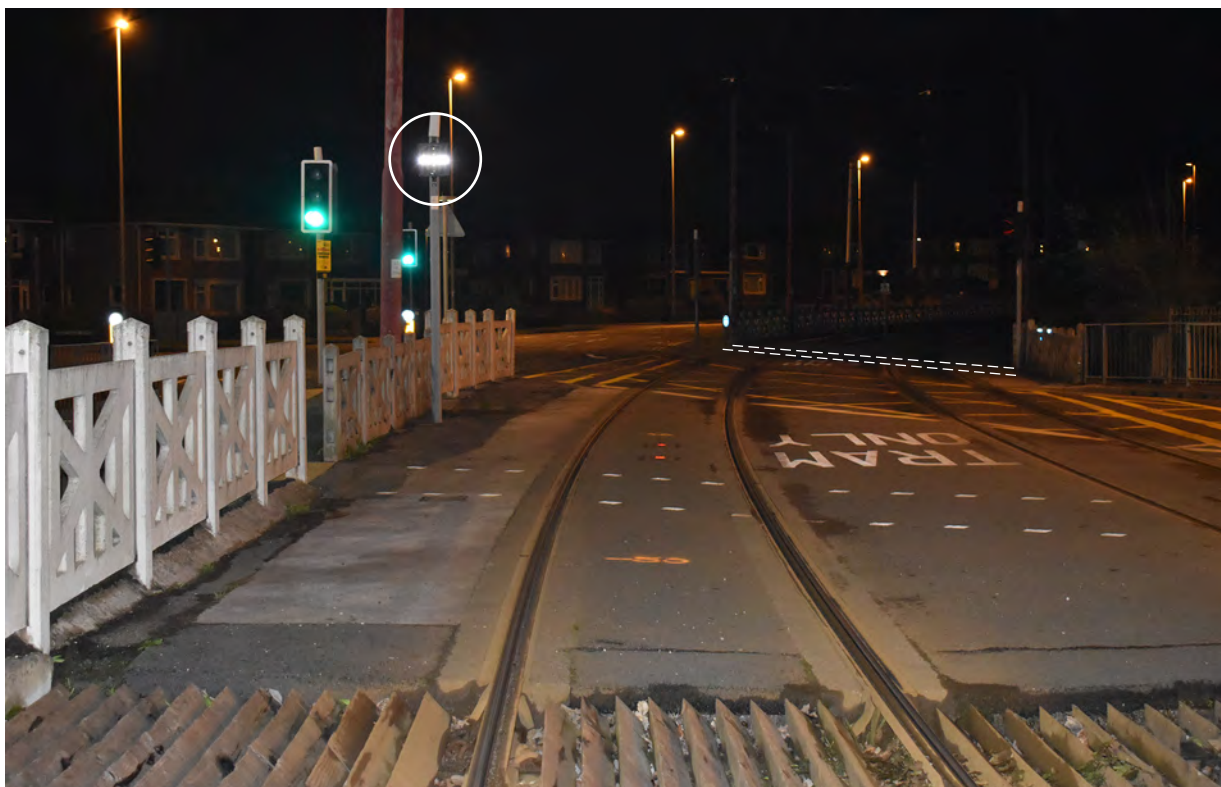
Figure 3: The tram signal (circled) and road traffic signals on approach to the junction, with pedestrian crossing indicated (image courtesy of Lancashire Police).

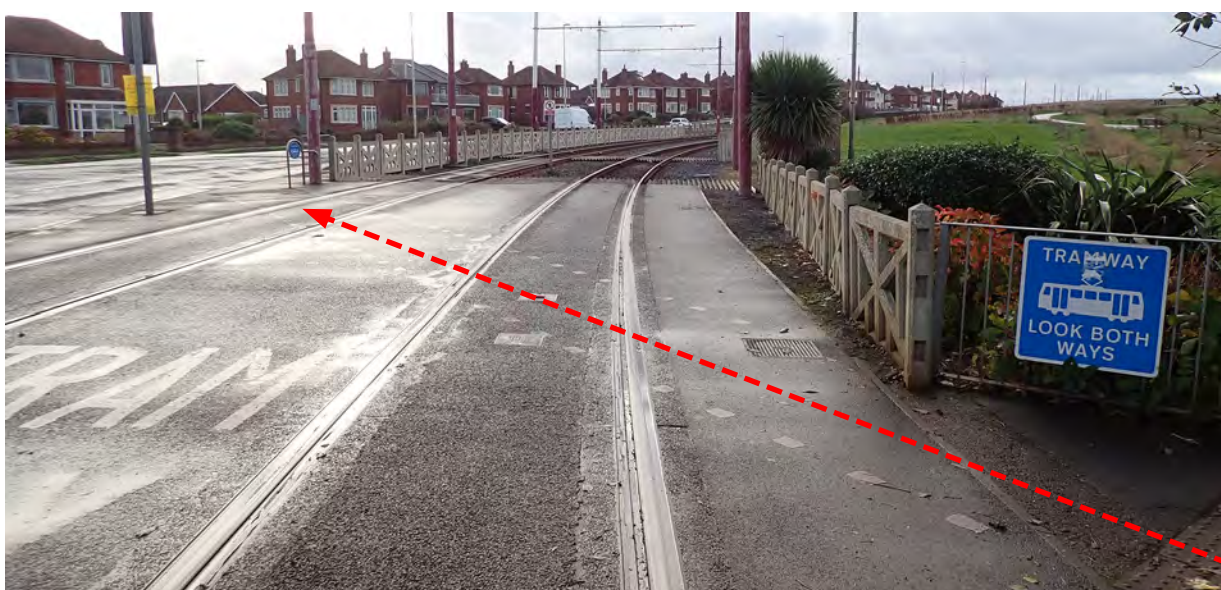
Figure 4: The warning sign on the western end of the crossing and the direction of the pedestrian.

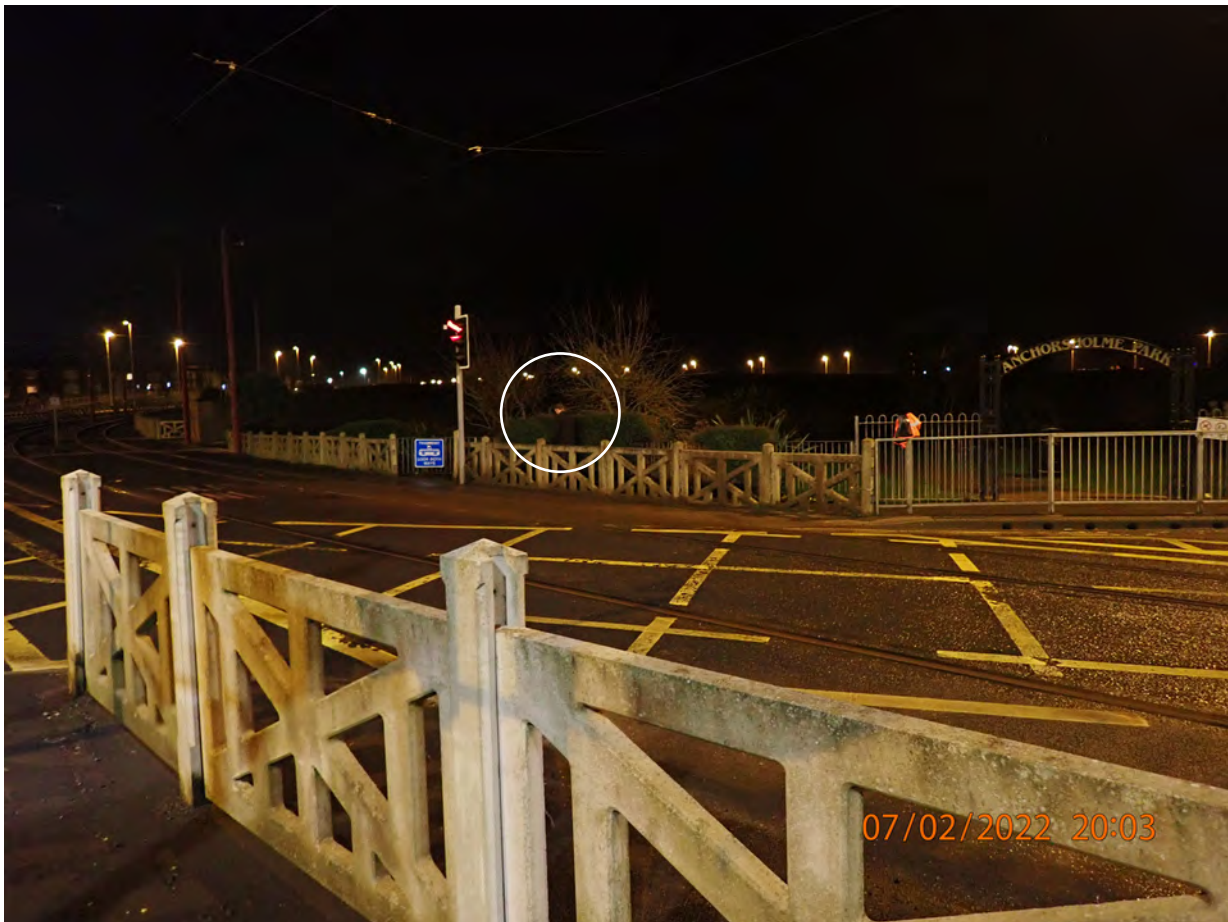
- 54 However, at the time of the accident, there was no street lighting within 20 metres of the western end of the crossing. Measurements of the intensity of lighting undertaken by RAIB after the accident indicated lighting levels of between 2 and 6 lux⁸ on the ground, both on the crossing and the pavement at the western end. These values are lower than lighting levels recommended by industry guidance (see paragraph 86). These measurements were consistent with another set of readings taken on behalf of Blackpool Council.

- 55 To gain a better understanding of the visibility of the pedestrian, RAIB undertook testing at the crossing at night, around two hours after sunset (reflecting the timing of the accident). During these tests, a member of RAIB staff dressed in dark clothing, similar to that worn by the pedestrian, walked towards the crossing from the entrance to Anchorsholme Park. They were observed by other RAIB staff adjacent to the tram signal (figure 3) that the tram was being controlled by before crossing the junction. This test demonstrated that the person near to the park entrance was difficult to see (figure 8).

- 57 RAIB considers that the person was difficult for the tram driver to see because the lighting levels at, and on the final approach to, the crossing were very low (see paragraph 84). This was compounded by the dark backdrop of shrubs and other foliage immediately behind the footpath which provided no discernible contrast to an individual dressed in dark clothing. The light-coloured concrete fencing between the tramway and the road on the south side of the junction, although not solid, obscured the lower half of an average-height adult pedestrian. Once on the crossing, although no longer partially obscured by fencing, pedestrians will still not be well illuminated (paragraph 54), potentially making them difficult to see.

Figure 8: A person in dark clothing (circled) walking towards the crossing from the western pavement.

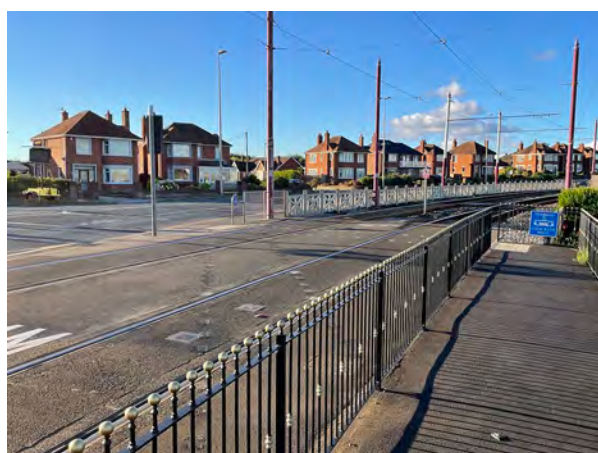
Figure 9a: The revised crossing layout, photographed from the western end of the previous crossing, with remains of previous crossing markings visible.

- 115 Following the accident, Blackpool Council commissioned a review of the design of the crossing and undertook works to implement a revised design.
- 116 The new layout (figures 9a and b) removed foliage and extended the western approach to the crossing to make the crossing perpendicular to the tramway. New ornamental fencing was moved back into Anchorsholme Park and two additional streetlights have been ordered for installation on either side of the tramway near to the crossing. A traction pole adjacent to the western end of the crossing has also been relocated to improve sighting.

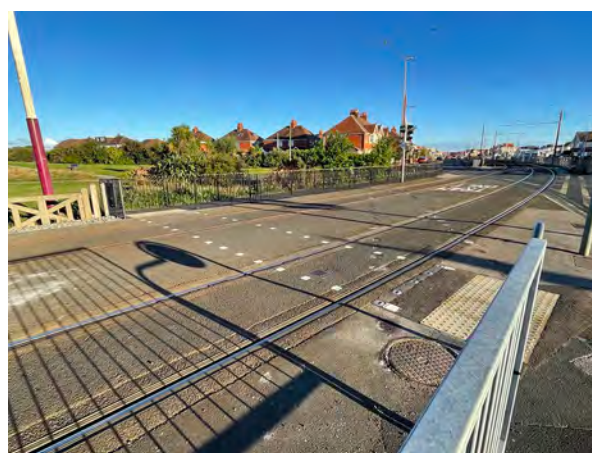
Figure 9b: The revised crossing layout looking towards the western end.
