Rail Accident Investigation Branch

Rail Accident Report

**Near miss at Farnborough North footpath level crossing
19 May 2022**

Report 04/2023
April 2023

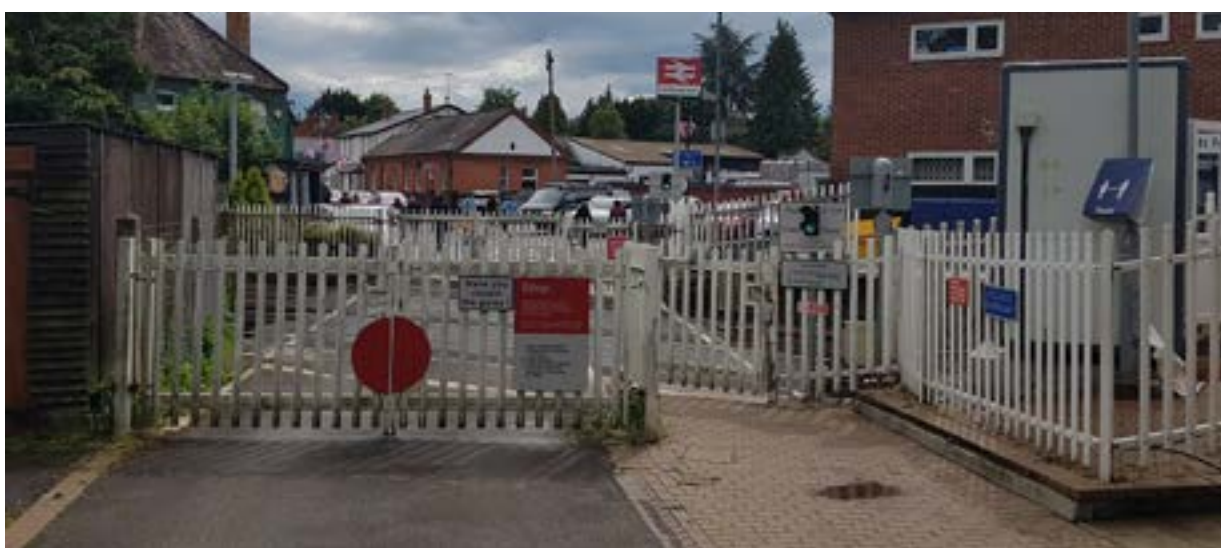
- 22 Signs at the crossing located underneath the miniature stop lights contain the following text (figures 4 and 5):
1. *Cross only when green light shows*

Figure 4: View looking west from near platform 1 showing user worked crossing (left), footpath crossing (centre) and side of crossing attendant's cabin (right).

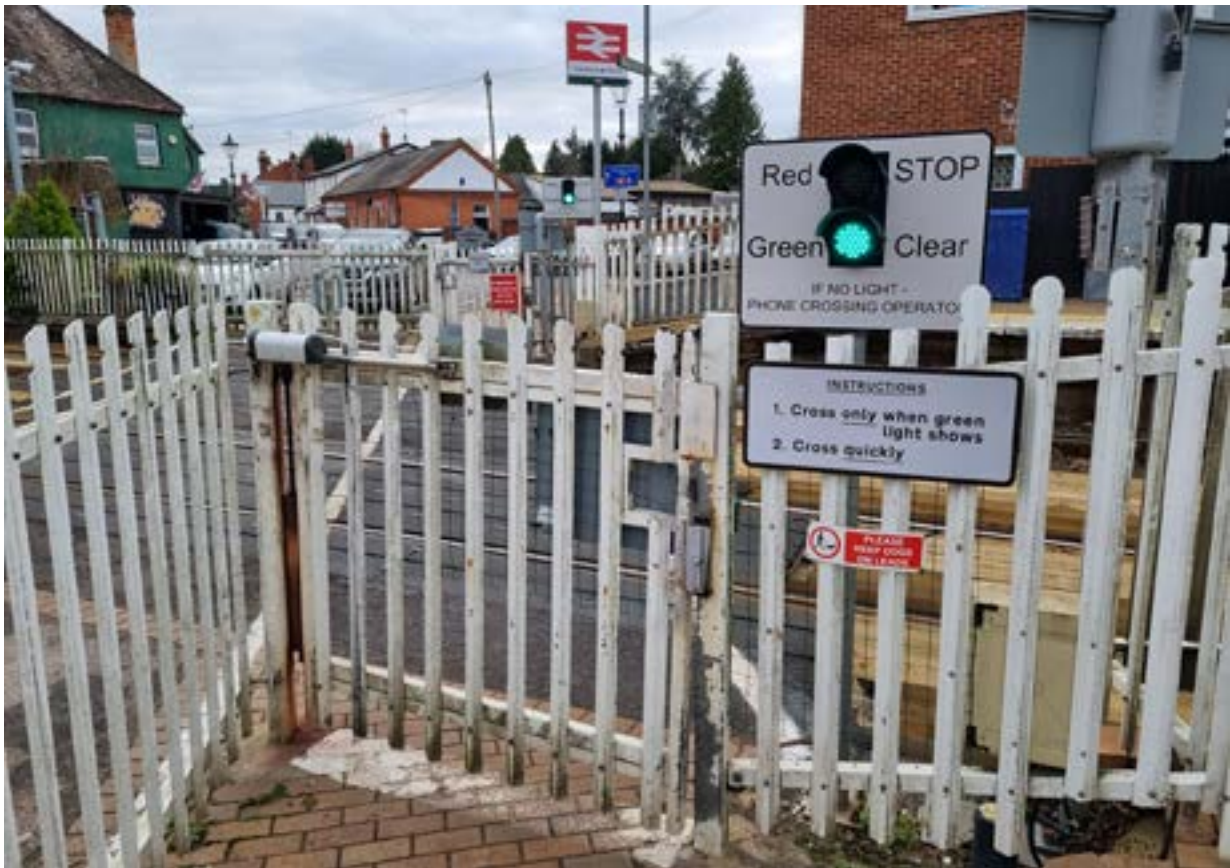
2. *Cross quickly*
- 23 Additional miniature stop lights were installed at the crossing in 2013. The new lights were fitted 'back-to-back' with the existing lights, presenting users with a warning light on both the near and far sides of the crossing. The enhancement was intended to reduce risk to users by providing redundancy and to allow users to check the status of the crossing while they are traversing it. The audible alarm was also installed at this time.

Figure 5: Footpath crossing gate near platform 1 with back-to-back miniature stop lights, visible on both sides of the railway.

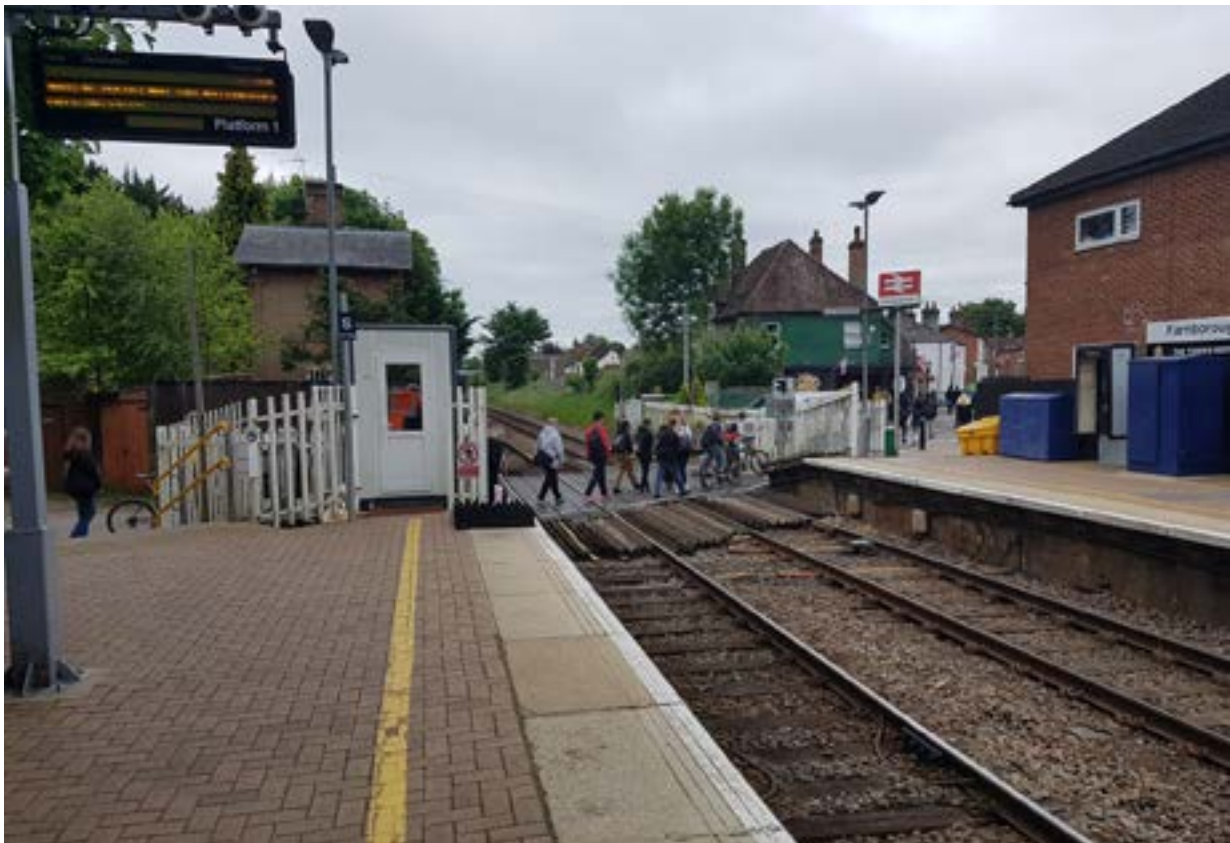
Figure 6: View looking south along platform 1 (not on the day of the incident) showing passenger information screen, crossing attendant's cabin and footpath crossing.

- 24 A crossing attendant has been provided from early morning until late at night since November 2014, and is located in a cabin on the end of platform 1 near the crossing (figure 6). The original cabin, installed in 2014, was replaced with a more modern version in 2020. The attendant is instructed to turn a switch to operate electro-magnetic locks on each pedestrian gate when the red miniature stop lights illuminate and the audible alarm starts sounding at the footpath crossing. The miniature stop lights are visible from the cabin windows (figure 7). The gates are not linked directly to the signalling/crossing system, and the electro-magnetic locks will only be effective at holding closed a gate which is already closed. If a gate is held open by a user, the lock will be ineffective.

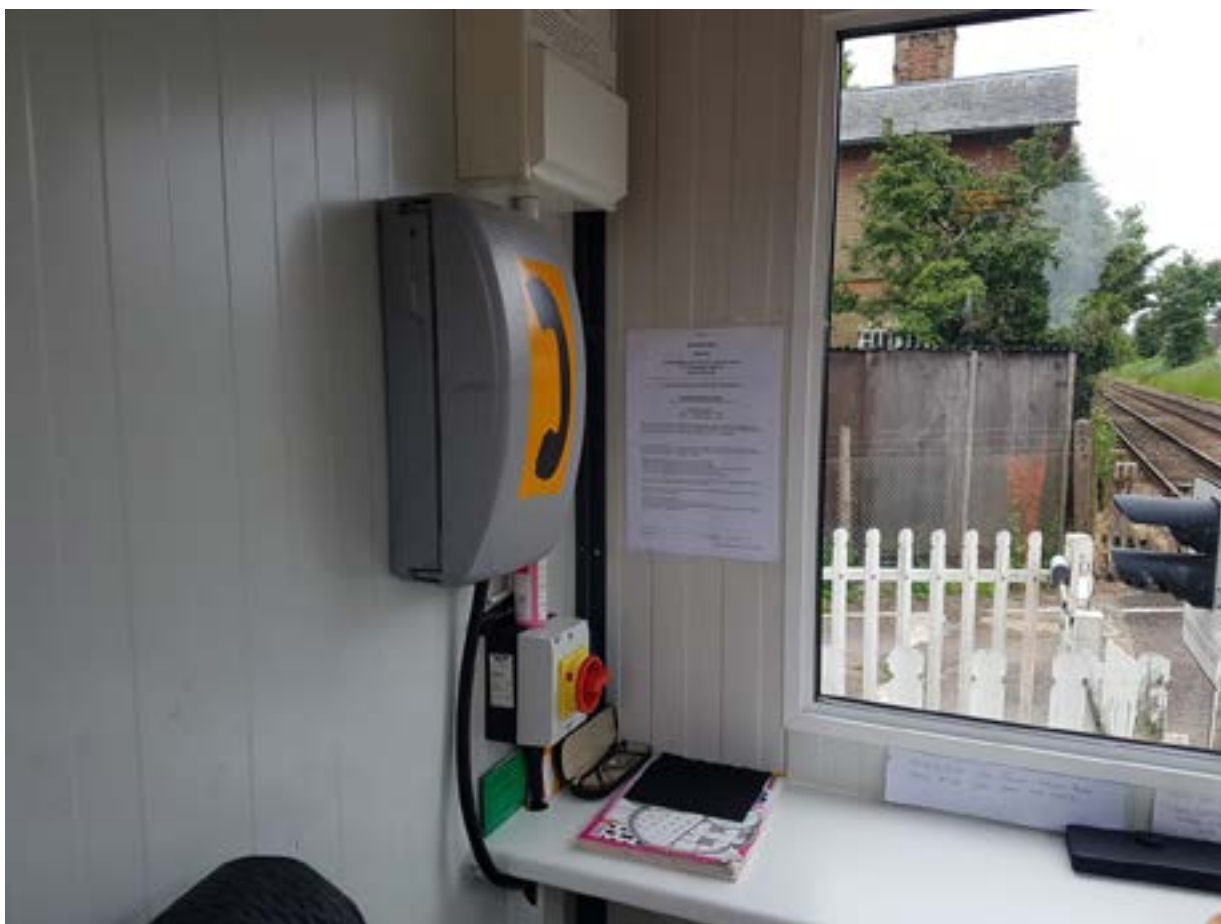
Figure 7: Crossing attendant's cabin showing gate locking switch below the telephone (installed after the incident) with view of crossing and miniature stop light equipment.

- 39 Because crossing users were holding the gates open for the person following them, energising the locks had no effect on the flow of pedestrians (paragraph 24). The crossing attendant recognised the risk of users continuing to cross while the miniature stop lights and audible alarm were indicating the approach of a train and shouted a warning from the cabin window. This, however, had no effect and the flow of crossing users continued. The crossing attendant then left the cabin and directly intervened to close the gate, which prevented users entering the crossing from the platform 1 side at about the same time that train 1V38 came into view. The actions of the crossing attendant may have prevented a serious accident.

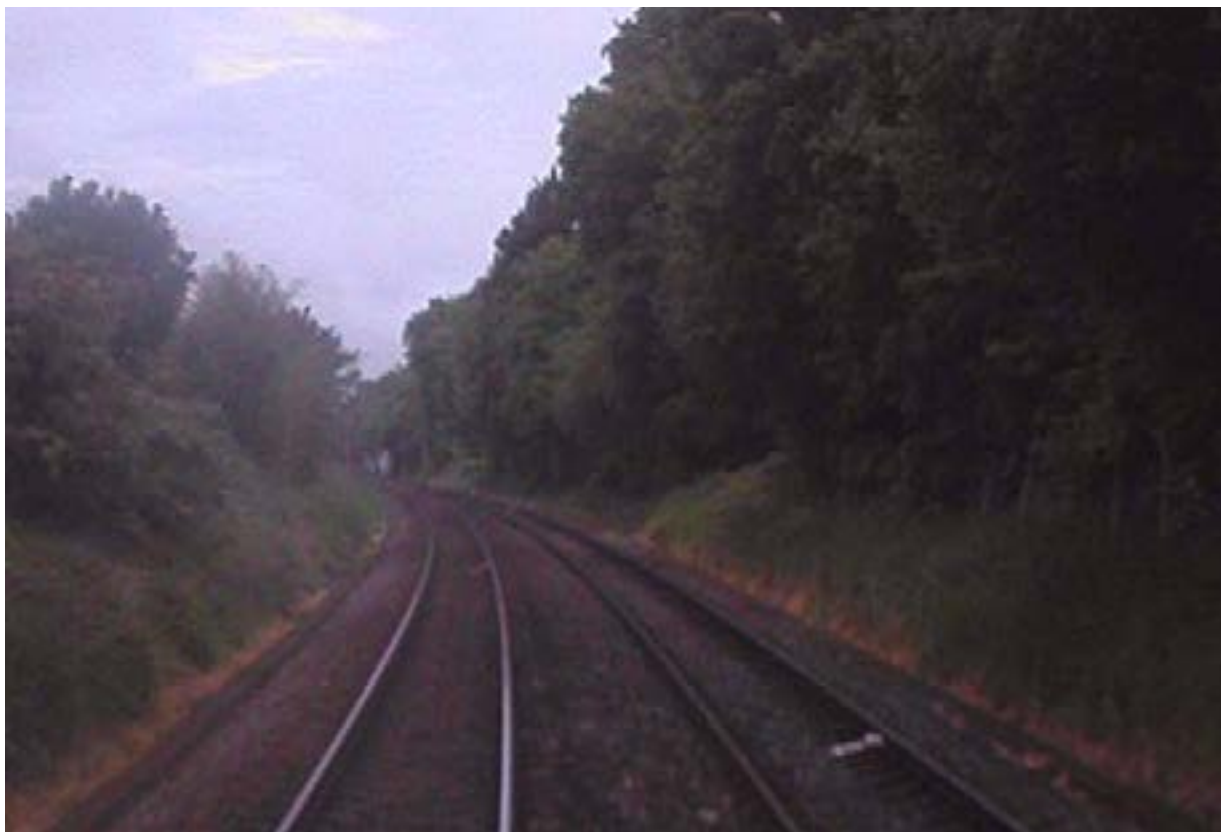
- 40 Train 1V38 approached Farnborough North on the down line at 69 mph (111 km/h). Forward-facing CCTV images show that the crossing was not visible until the train was about 320 metres away from it (figure 8). The driver observed a group of people on the crossing. Data from the on-train data recorder shows the driver quickly applied the emergency brake and sounded the horn continuously for the next 10 seconds. In a statement to Great Western Railway, they said, "The people slowly moved to the side of the track as I approached" (figure 9).

Figure 8: Forward-facing CCTV image from train 1V38 at 08:21:18 hrs. The crossing is 320 metres ahead and is just visible round a bend in the track.

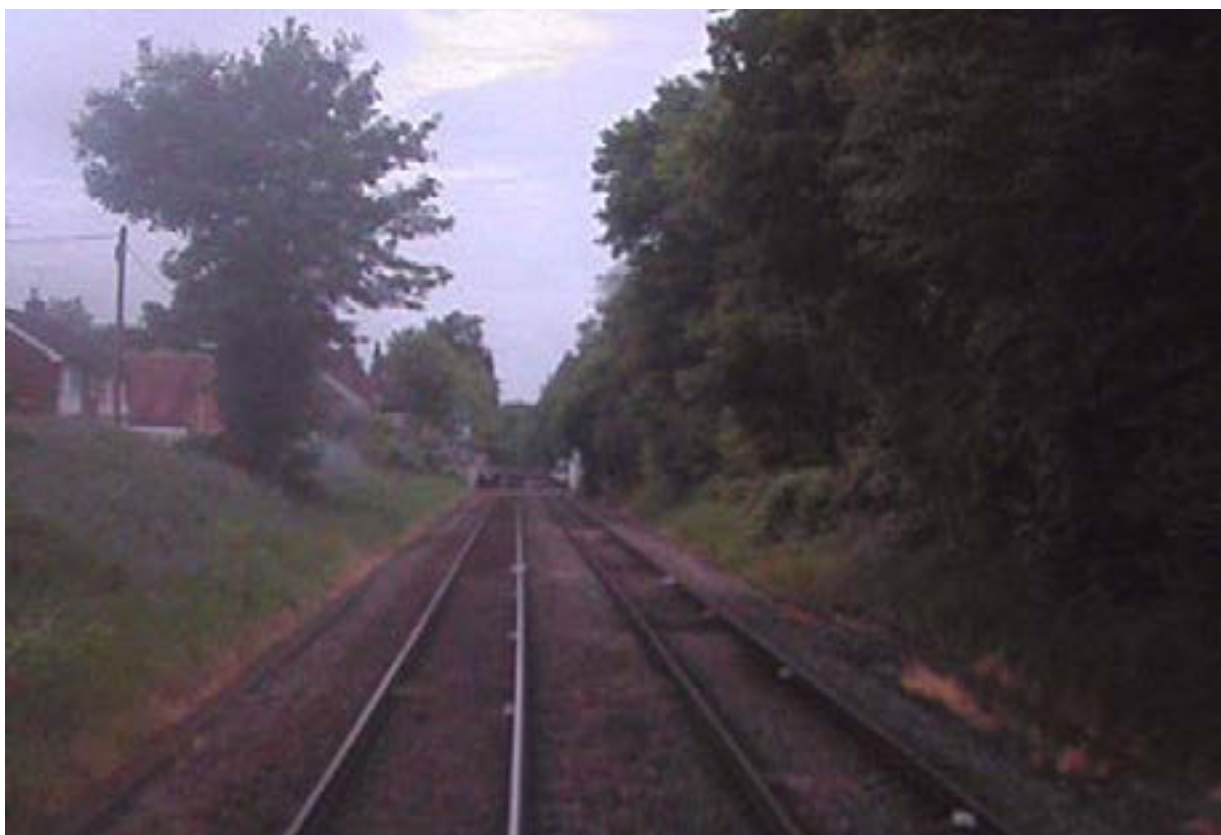
Figure 9: Forward-facing CCTV image from train 1V38 at 08:21:23 hrs. The crossing is 175 metres (8 seconds) ahead and pedestrians are visible.

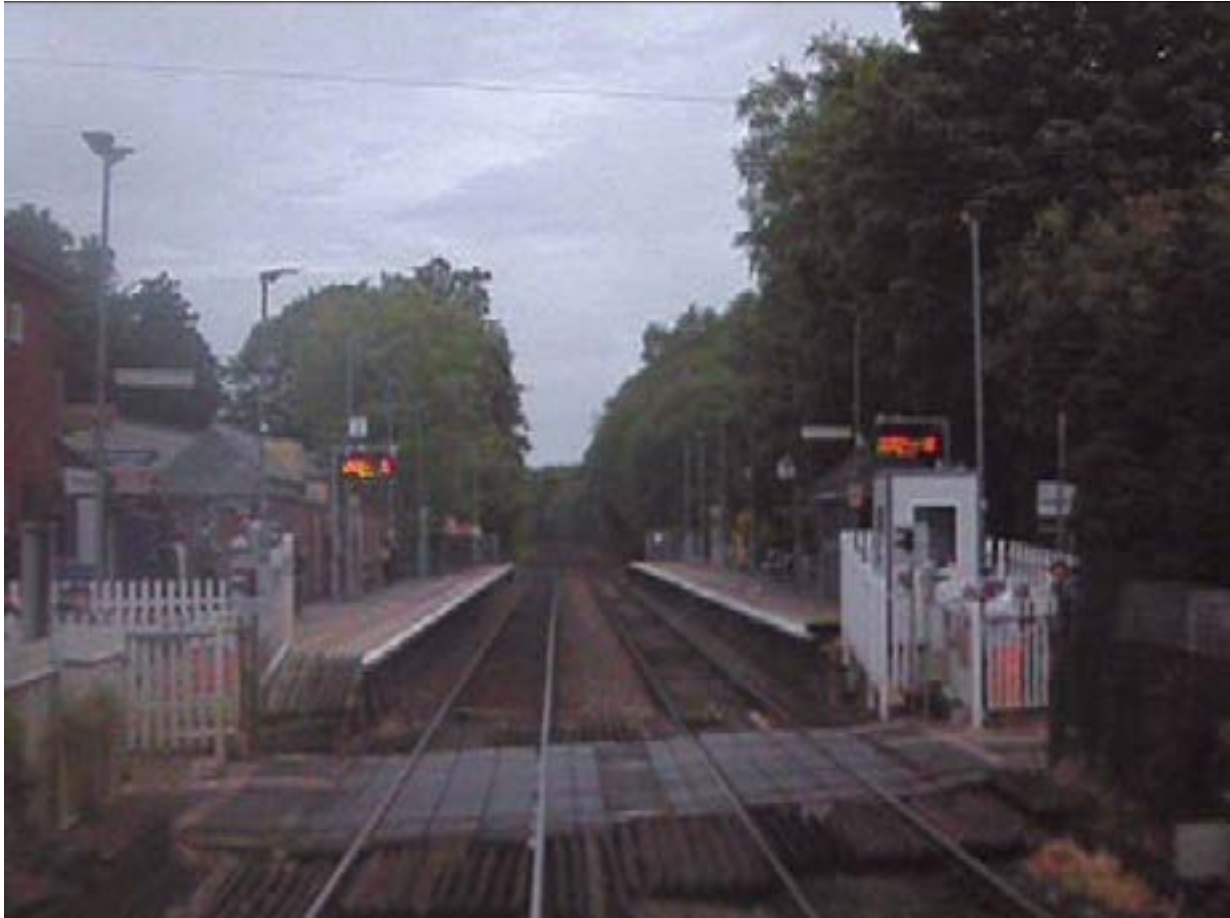
- 41 The users were clear of the crossing about six seconds before the train passed over it at 35 mph (56 km/h). The forward-facing CCTV equipment (figure 10) fitted to train 1V38 shows the crossing attendant standing behind the up-side gate with the remaining crossing users as the train passed.

Figure 10: Forward-facing CCTV image from train 1V38 at 08:21:30 hrs, one second before it passed over the crossing. The crossing attendant is visible (orange) behind the right-hand pedestrian gate.

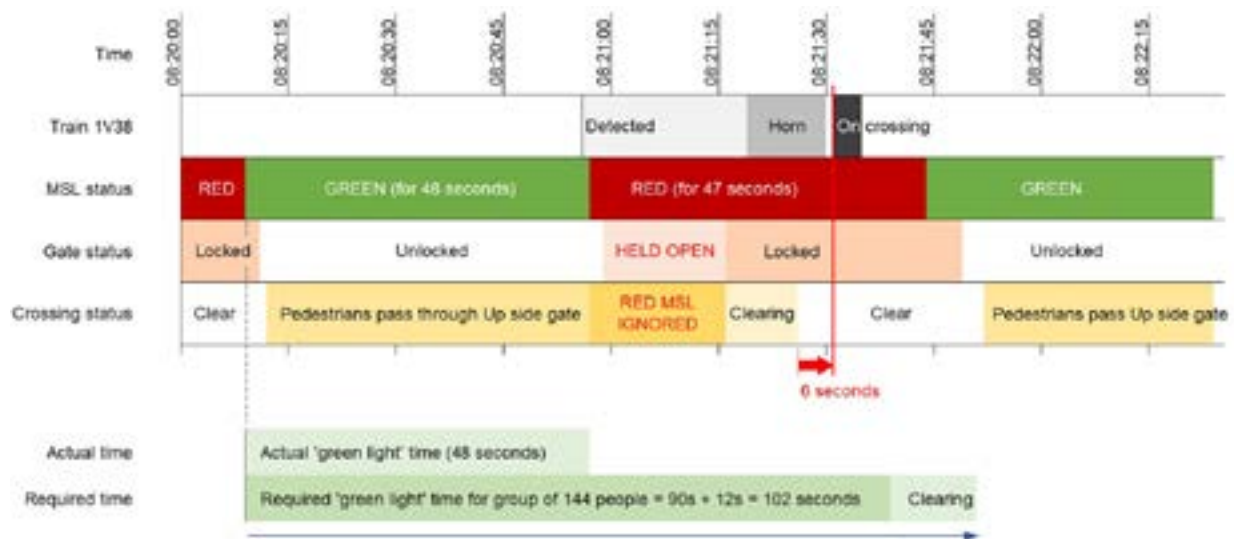
- 51 After displaying a green light for 48 seconds, the miniature stop lights changed to red and the audible warning started. If the flow of pedestrians had stopped immediately, then the earlier flow of pedestrians suggest that the crossing would have been completely clear about 12 seconds later, around 22 seconds before the train passed over the crossing. However, on 19 May, it actually took 28 seconds to clear the crossing after the lights and alarm activated because pedestrians continued to enter and use the crossing after this point in time, stopping only when the crossing attendant left their cabin and physically intervened to close the up-side gate. This reduced the time between the crossing being clear and the train passing to six seconds (figure 11).

- 52 CCTV images show that users exited the crossing at an average rate of 1.6 people per second. Assuming a similar rate (and including 12 seconds crossing time), the 16 second additional delay in clearing the crossing indicates that around 25 people ignored the red lights and audible warning. It also suggests that the whole group of 144 users would have required about 102 seconds to use the crossing.
- 53 Network Rail standard NR/L3/XNG/308⁶ defines using a footpath crossing to cross the railway when the miniature stop lights are red as misuse. At Farnborough North, the level crossing manager had recognised this risk and taken steps to understand and manage the behaviour of crossing users to improve safety.

Figure 11: Diagram showing sequence of events.

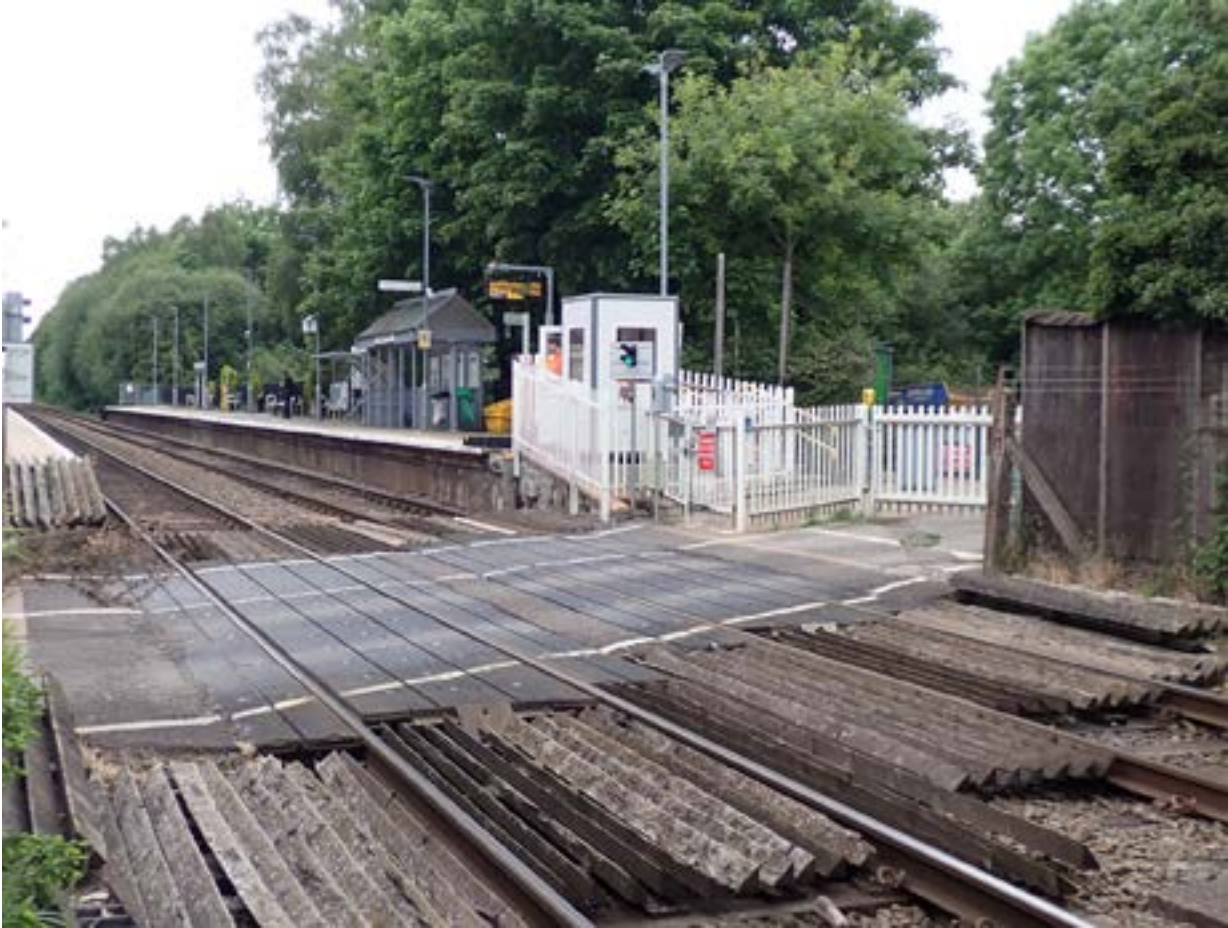
- 84 The crossing attendant's duties were described by a notice in the attendant's cabin. It stated *'The first duty of the crossing attendant is to ensure the safety of pedestrians over the miniature stop light footpath section of the crossing.'* Attendants were instructed to lock the gates when the miniature stop lights showed red, using a switch in the cabin, and to release the locks when the miniature stop lights showed green (paragraph 24). However, some crossing attendants also checked the platform information screens or mobile phone apps to avoid releasing the gates if another train was approaching or to decide when to take a personal needs break. Witness evidence indicates that this ad hoc method of working has arisen because crossing attendants thought that they had inadequate information to safely make the decision to release the gates, especially in the morning peak period when there were large groups of users.

Figure 12: Crossing keeper's cabin within a fenced compound.

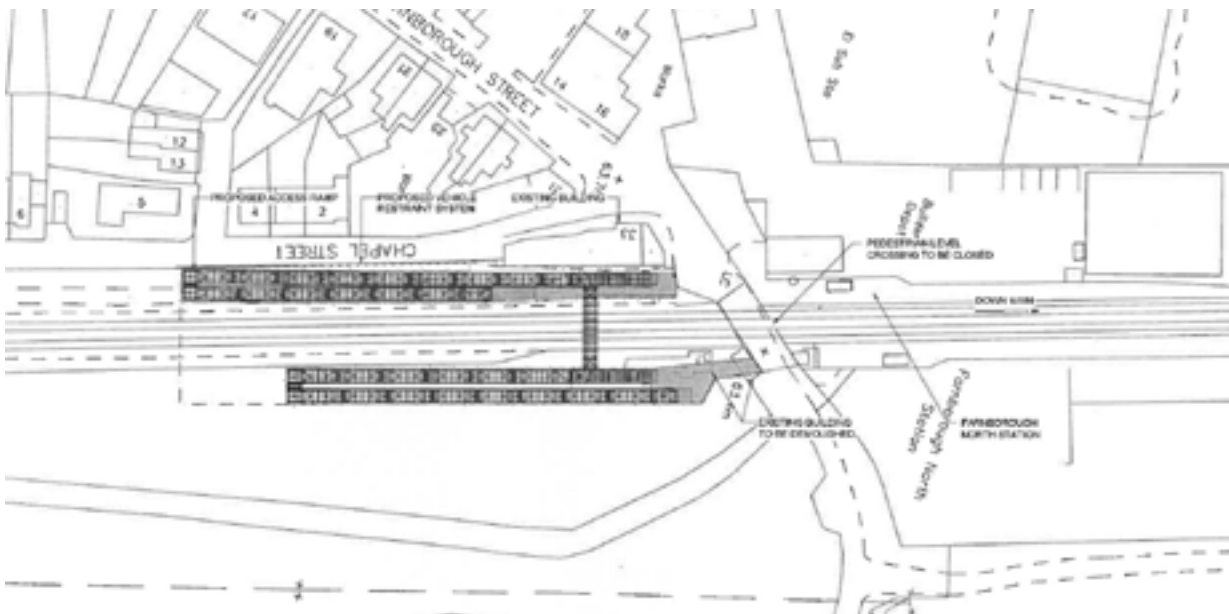
- 98 On 18 May 2018, Network Rail submitted a planning application for a stepped footbridge south of the crossing with ramps running south of the bridge (figure 13 and figure 14). The principal planning officer responded three days later stating that the application was invalid for a number of reasons. For example, the required ecological survey was not referenced in the application pack and not all the existing buildings to be demolished were shown. They requested further information before the application could be considered. However, Network Rail did not provide further information in response to the issues raised.

Figure 13: Diagram of proposed 2018 footbridge (extract from Network Rail drawing UA007617-20-01-ECV-DRG-ARC-104 revision P01 dated 09/03/18). Farnborough North station is on the right.

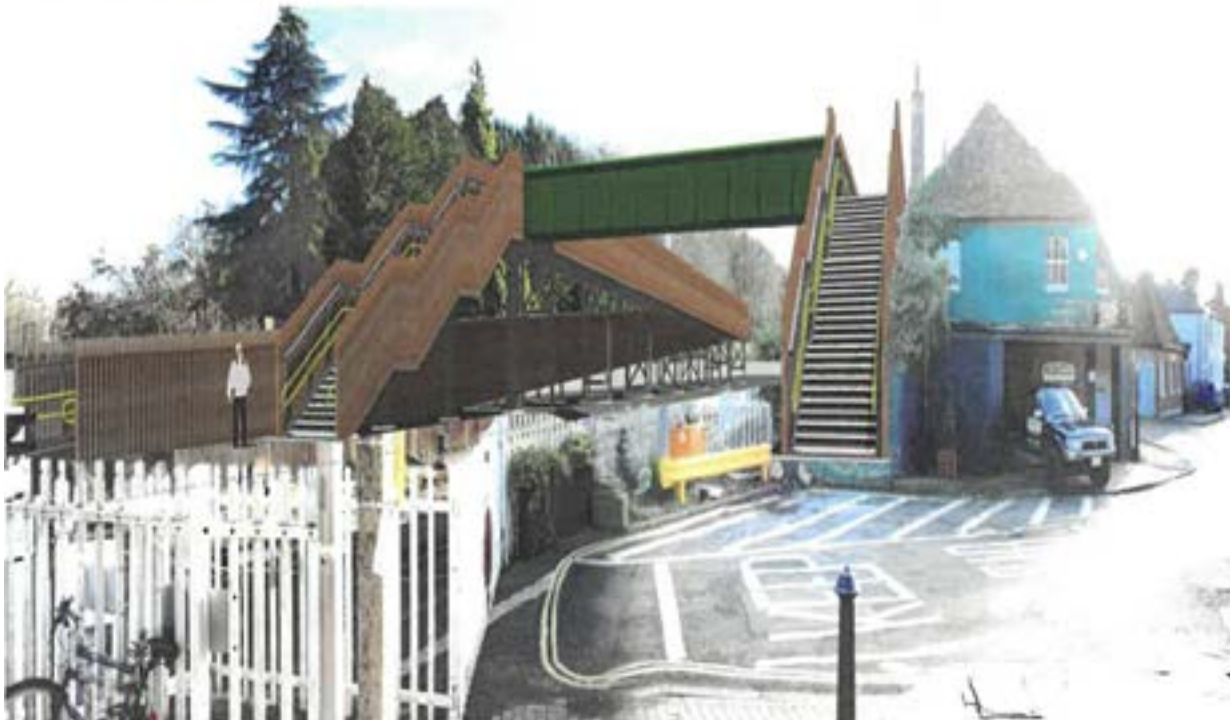
Figure 14: Visualisation of proposed 2018 footbridge looking south from near platform 2 (Network Rail).

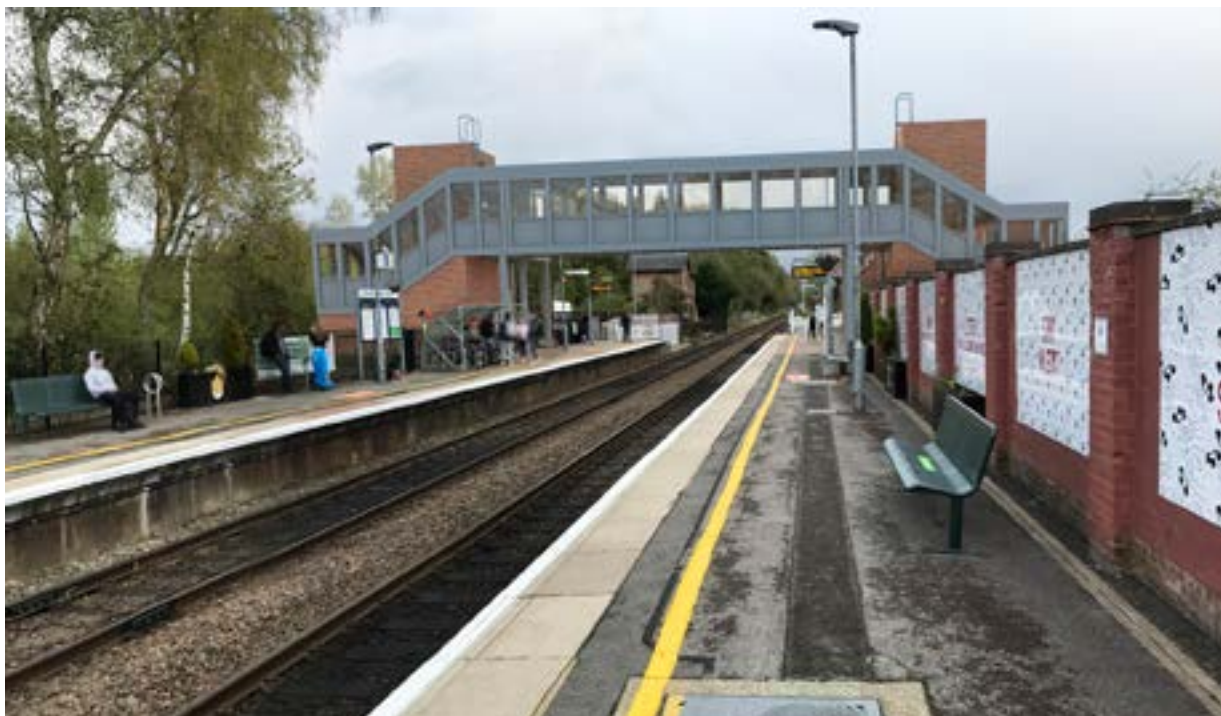
- 101 Dialogue between Network Rail and Rushmoor Borough Council restarted in February 2021. In April 2021, Network Rail made a new pre-application submission for a proposed twin-tower footbridge with steps and lifts (figure 15). The principal planning officer's response noted that this scheme was significantly more compact and would comprise the use of sympathetic materials as to not detract from the character and appearance of the Conservation Area. It also noted that if the lifts were not to be in operation when the station was closed, this would alter the current 24/7 access to the station. It stated that these factors must be balanced against the safety needs of the crossing closure and the harm that would result from an alternative ramped bridge.

Figure 15: Visualisation of proposed 2024 footbridge with stairs and lifts (courtesy of Network Rail).
