Accident

Aircraft Type and Registration:	Piper PA-22-150, G-AREL	
No & Type of Engines:	1 Lycoming O-320-A2B piston engine	
Year of Manufacture:	1960 (Serial no: 22-7284)	
Date & Time (UTC):	25 April 2023 at 1324 hrs	
Location:	Hamilton Farm Airstrip, Ashford, Kent	
Type of Flight:	Private	
Persons on Board:	Crew - 1	Passengers - 1
Injuries:	Crew - None	Passengers - None
Nature of Damage:	Nosewheel collapsed and bent backwards. Right wingtip damaged.	
Commander's Licence:	Private Pilot's Licence	
Commander's Age:	73 years	
Commander's Flying Experience:	339 hours (of which 93 were on type) Last 90 days - 3 hours Last 28 days - 1 hour	
Information Source:	Aircraft Accident Report Form submitted by the pilot

Synopsis

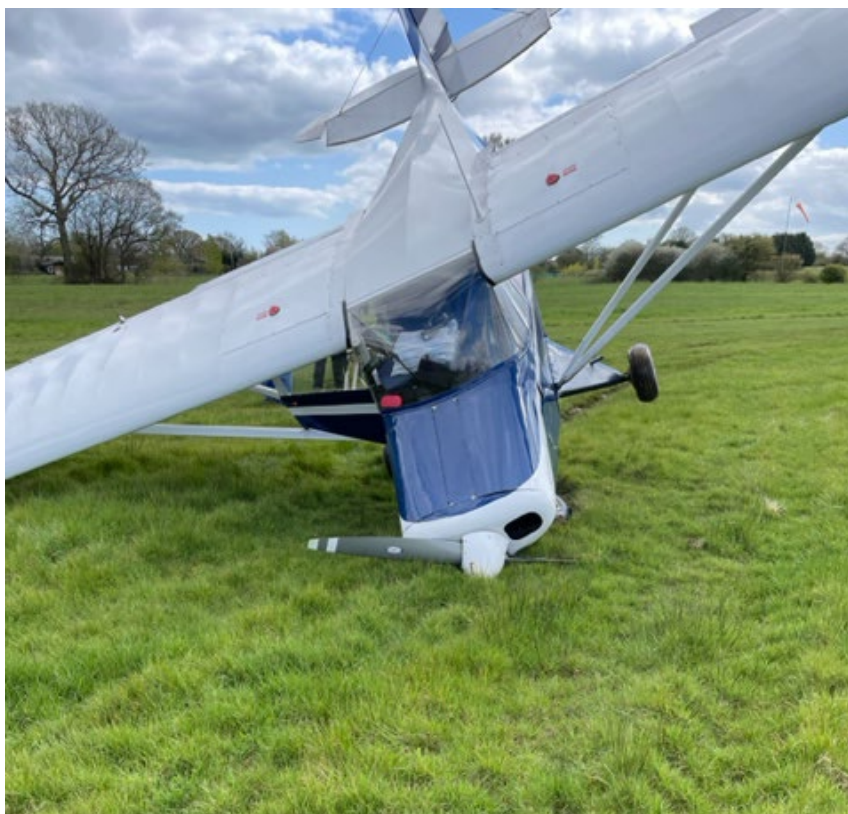
Figure 1

The takeoff run commenced, but the aircraft was not at takeoff speed or airborne at the decision point so, as planned, the pilot closed the throttle and began to brake. Under braking the aircraft began to veer to the left and, despite the pilot's control inputs, he was unable to prevent it leaving the runway. Although the aircraft was already significantly slowed, the nosewheel dug in abruptly and collapsed, tipping the aircraft onto its nose and right wing. Neither occupant was injured and they were able to vacate the aircraft without assistance.

G-AREL at the accident site (used with permission)

After careful planning and preparation, the pilot attempted to takeoff from Runway 04 at Hamilton Farm. As he reached the midpoint of the runway the aircraft was not yet at takeoff speed or airborne, and therefore he closed the throttle as planned and aborted the takeoff. As he braked, the aircraft veered to the left and the pilot was unable to prevent the aircraft leaving the runway where the left wheel dug in the aircraft pitched onto its nose and right wing.
