Accident

Aircraft Type and Registration: EAA Biplane, G-BPUA

Date & Time (UTC): 3 June 2023 at 1125 hrs

Location: Great Oakley Airfield, Harwich, Essex

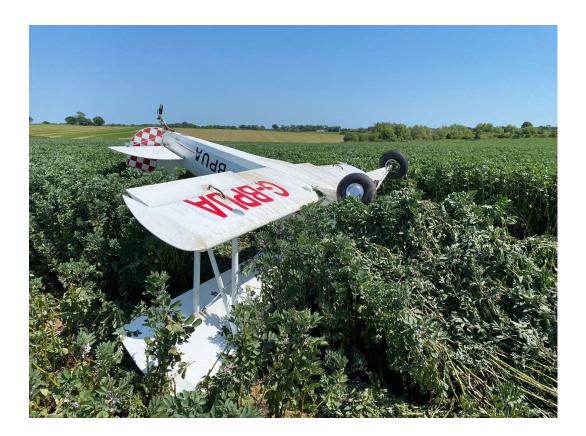
Following a stable approach, on flaring to land the aircraft bounced to a height of approximately 6 ft and the pilot decided to go around. He applied full power, but the aircraft was slow to accelerate. The aircraft bounced twice more, gradually climbing and veering to the right of the runway, before the main wheels struck a crop in a field adjacent to the runway. G-BPUA came to rest inverted (Figure 1) and the pilot exited the aircraft unharmed.

The aircraft sustained structural damage to the landing gear, wings and fuselage tubes. The engine was shock loaded and the propeller shattered.

Figure 1G-BPUA in the crop field
