Accident

Aircraft Type and Registration:	Piper PA-28R-200, G-EPTR	
No & Type of Engines:	1 Lycoming IO-360-C1C piston engine	
Year of Manufacture:	1972 (Serial no: 28R-7235090)	
Date & Time (UTC):	19 May 2023 at 1354 hrs	
Location:	Perth Airport	
Type of Flight:	Training	
Persons on Board:	Crew - 2	Passengers - None
Injuries:	Crew - None	Passengers - N/A
Nature of Damage:	Engine shock loaded, propeller bent, flaps damaged, scoring of underside of aircraft.	
Commander's Licence:	Commercial Pilot's Licence	
Commander's Age:	56 years	
Commander's Flying Experience:	6,388 hours (of which 6,104 were on type) Last 90 days - 52 hours Last 28 days - 27 hours	
Information Source:	Aircraft Accident Report Form submitted by the pilot

Synopsis

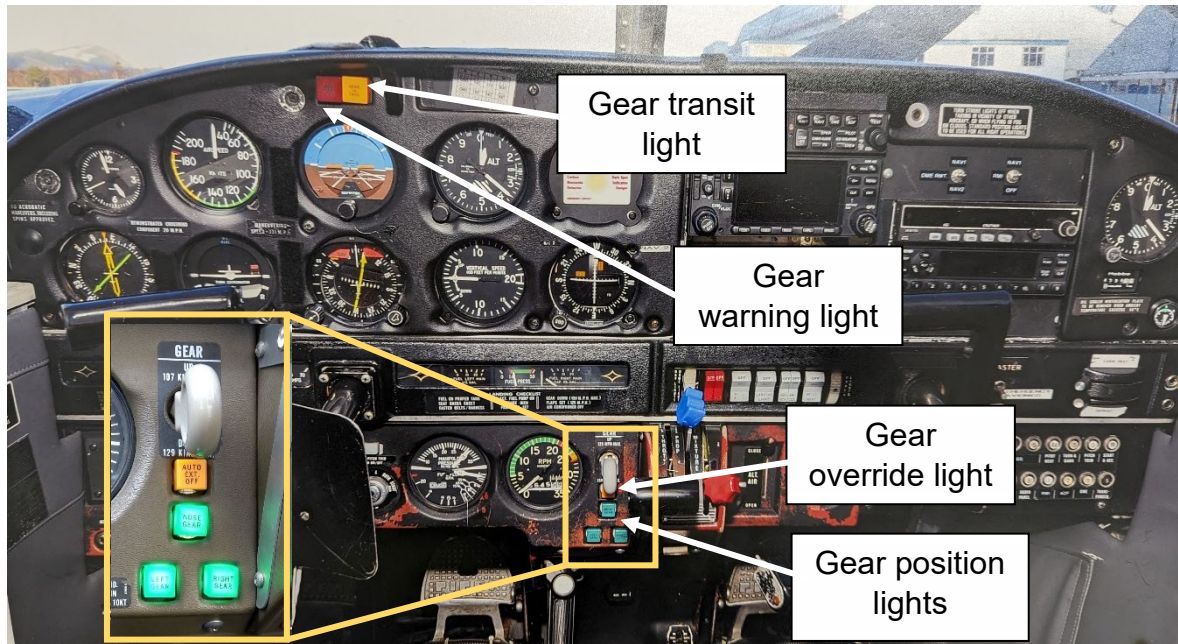
Figure 1

Landing gear down and locked positions are indicated by three green lights located under the selector switch mounted on the instrument panel to the left of the throttle quadrant. A yellow warning light, located at the top of the instrument panel, illuminates while the gear is in transit, or not in the full up or locked down position. When all the lights are out it indicates the gear is up. The positioning of the gear indicating lights means that an instructor in the right seat must lean over to see them.

Cockpit layout of the aircraft type

The set up of the lights in the cockpit also presented a challenge to the instructor in the right hand seat who needed to lean over to see them. While the instructor was very familiar with the type, this still represents an addition barrier to noticing the lights are not illuminated green on final.
