# ***AAIB Bulletin***

**9/2023**

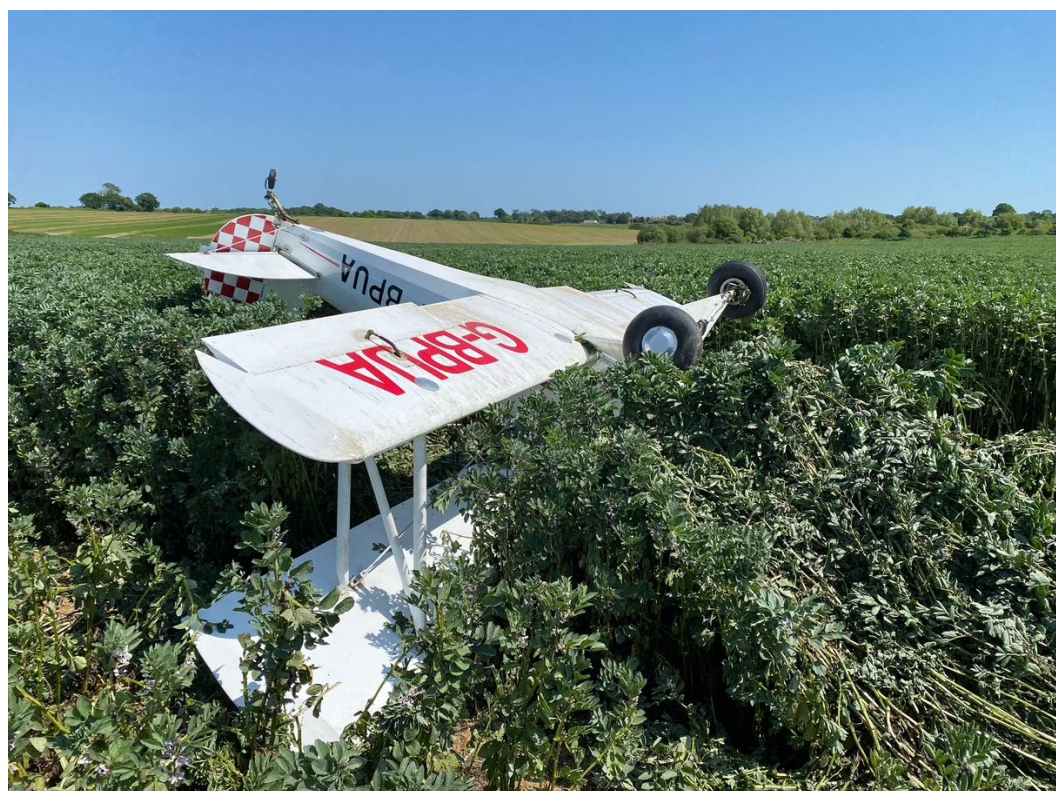
Following a stable approach, on flaring to land the aircraft bounced to a height of approximately 6 ft and the pilot decided to go around. He applied full power, but the aircraft was slow to accelerate. The aircraft bounced twice more, gradually climbing and veering to the right of the runway, before the main wheels struck a crop in a field adjacent to the runway. G-BPUA came to rest inverted (Figure 1) and the pilot exited the aircraft unharmed.

The aircraft sustained structural damage to the landing gear, wings and fuselage tubes. The engine was shock loaded and the propeller shattered.

**Figure 1**  
G-BPUA in the crop field

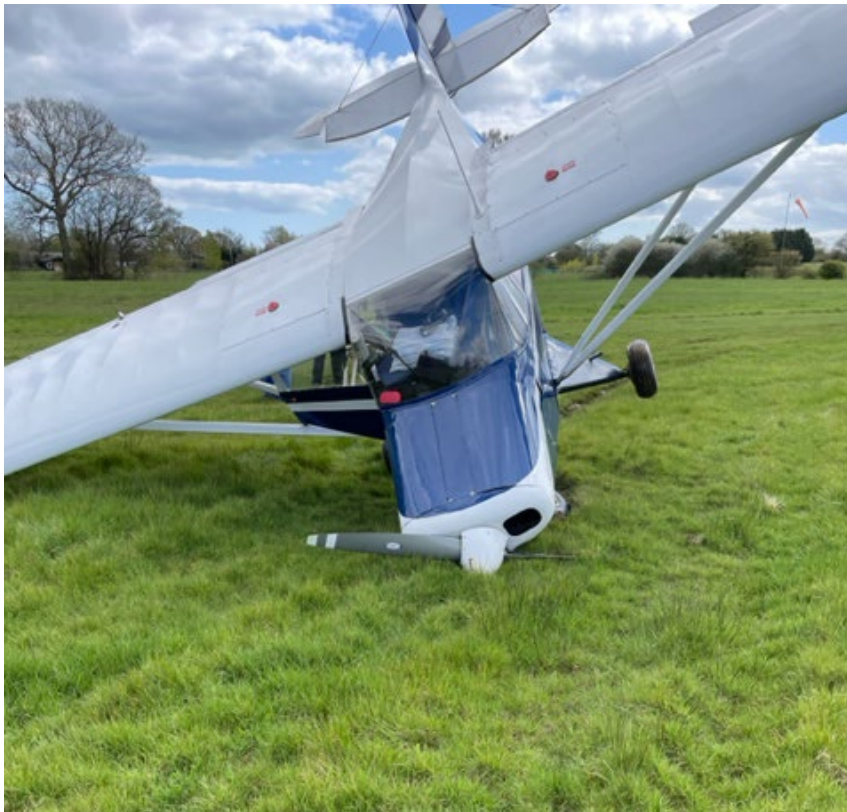
**Figure 1**

G-AREL at the accident site (used with permission)

After careful planning and preparation, the pilot attempted to takeoff from Runway 04 at Hamilton Farm. As he reached the midpoint of the runway the aircraft was not yet at takeoff speed or airborne, and therefore he closed the throttle as planned and aborted the takeoff. As he braked, the aircraft veered to the left and the pilot was unable to prevent the aircraft leaving the runway where the left wheel dug in the aircraft pitched onto its nose and right wing.

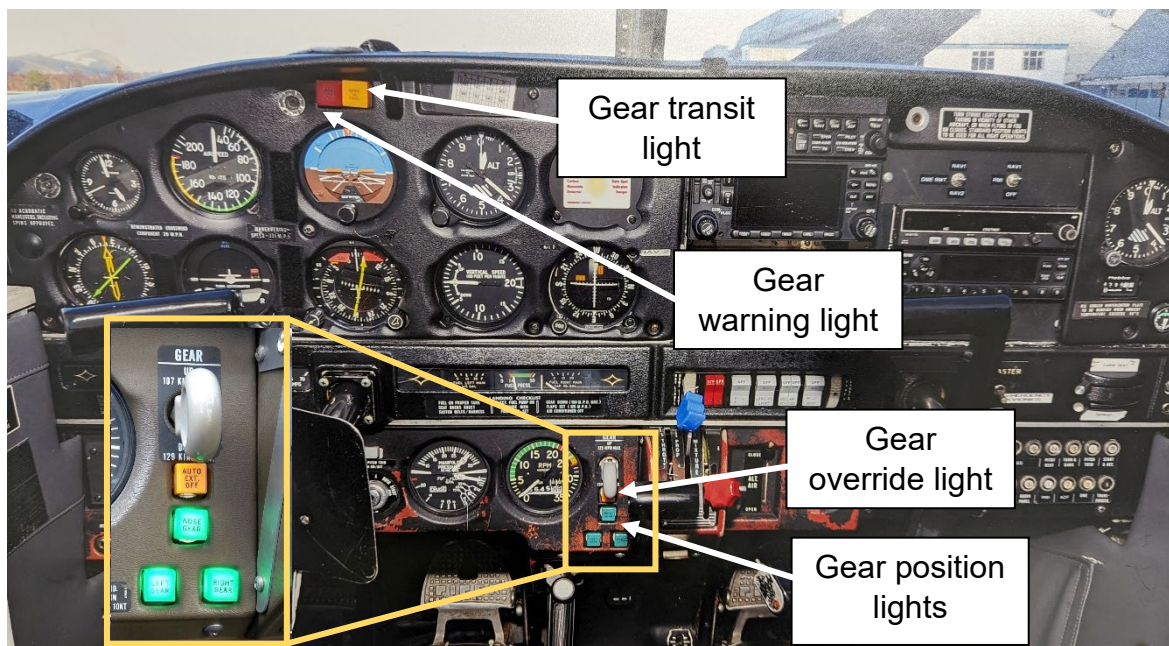
**Figure 1**

Landing gear down and locked positions are indicated by three green lights located under the selector switch mounted on the instrument panel to the left of the throttle quadrant. A yellow warning light, located at the top of the instrument panel, illuminates while the gear is in transit, or not in the full up or locked down position. When all the lights are out it indicates the gear is up. The positioning of the gear indicating lights means that an instructor in the right seat must lean over to see them.

Cockpit layout of the aircraft type

The set up of the lights in the cockpit also presented a challenge to the instructor in the right hand seat who needed to lean over to see them. While the instructor was very familiar with the type, this still represents an addition barrier to noticing the lights are not illuminated green on final.
