SB3/2023

Serious passenger injury on board a sea safari rigid inflatable boat

MAIB SAFETY BULLETIN 3/2023

The Marine Accident Investigation Branch is carrying out an investigation into a serious passenger injury on board a sea safari rigid inflatable boat.

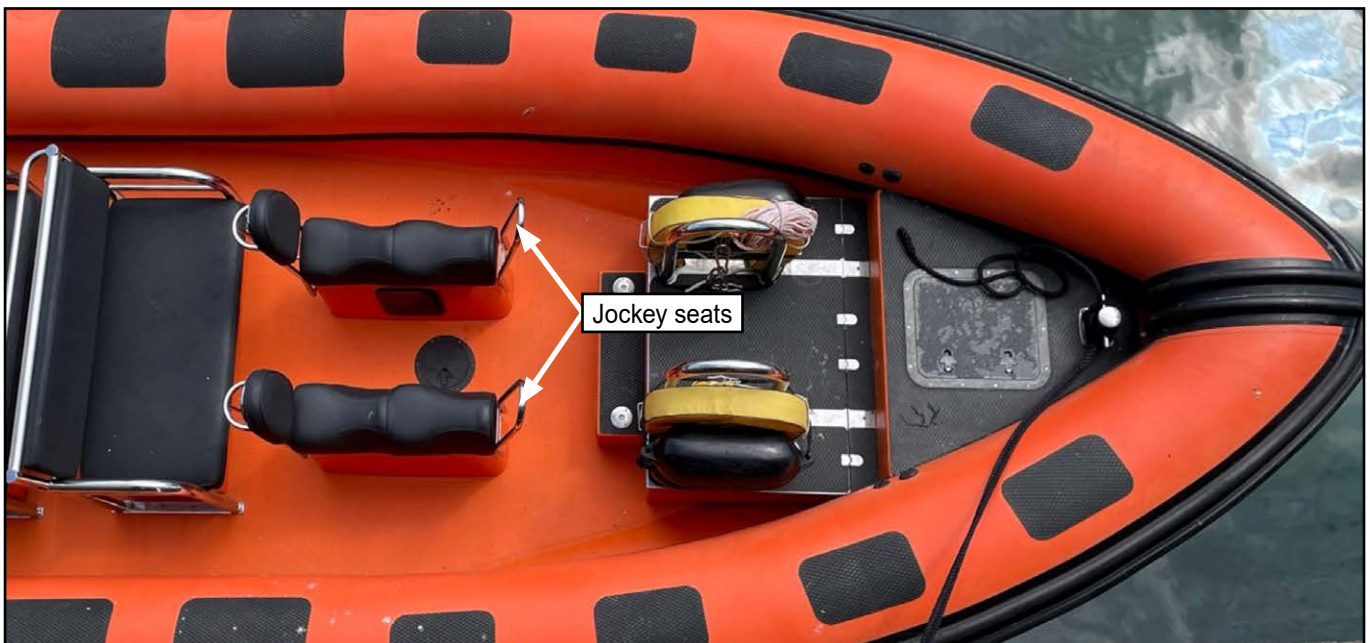
On 7 June 2023, a passenger on a rigid inflatable boat (RIB) sea safari suffered a spinal injury that left them paralysed from the waist downwards. Twelve passengers had boarded the RIB and, once it was clear of the jetty, the two crew gave them a safety briefing and instruction on the wearing of lifejackets. The RIB then proceeded out to sea and was increasing speed in choppy sea conditions when it encountered a steep-sided wave. The boat fell off the wave and slammed violently into the trough, dislodging a passenger from a forward jockey seat (**Figure 1**). The passenger immediately lost feeling in their legs.

Figure 1: Front of RIB with jockey seats

When the boat hit the trough, the resulting force applied to the passenger's spine was of sufficient magnitude to fracture a vertebra. With a normal BMD level and no pre-existing conditions to increase their susceptibility to this type of injury, the factors contributing to the fracture related to the activity being undertaken. These included:

- the speed and movement of the RIB in the sea conditions
- the forward location of the seat that the passenger was using
- the passenger's seated posture and their ability to react and compensate for the RIB's motions
- the passenger's awareness of the hazards associated with the RIB's movement.

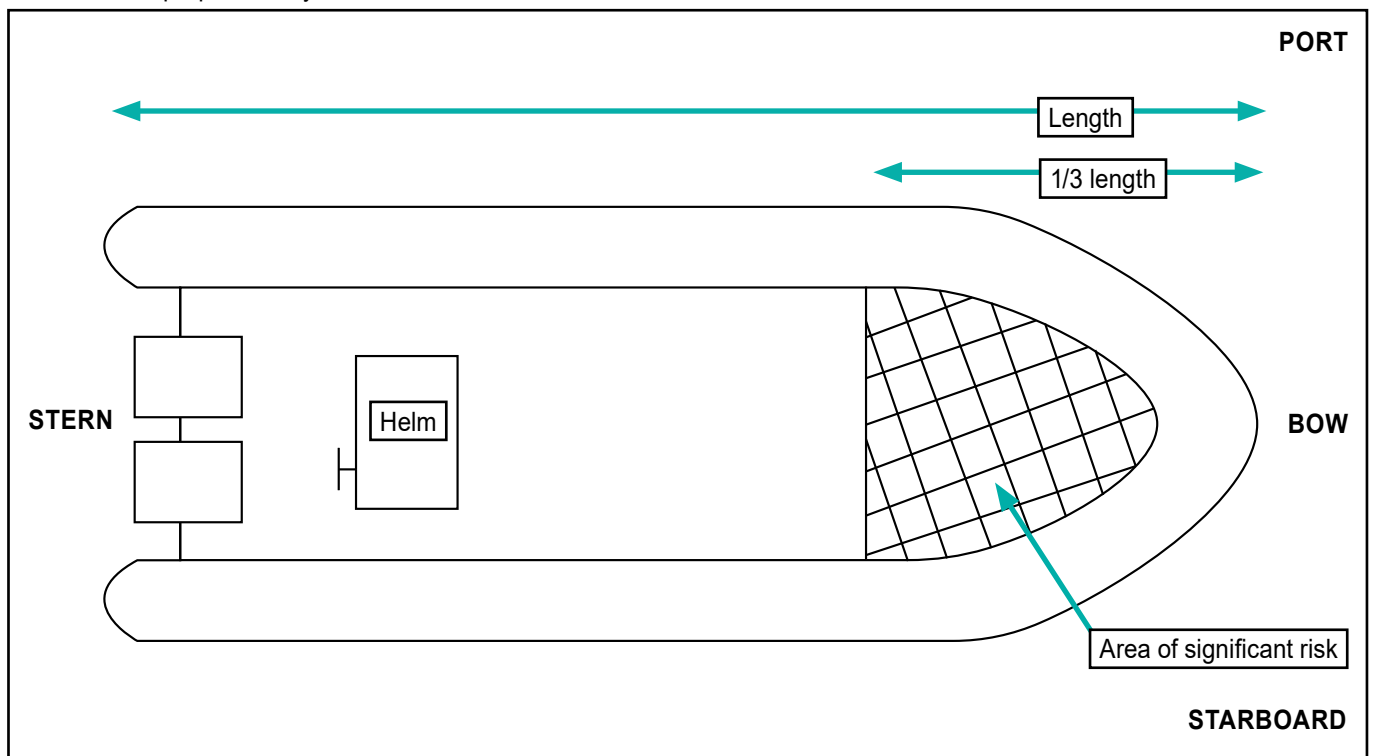
Commercial passenger tours using RIBs, including sea safaris and thrill rides, have experienced a surge in popularity across the UK, with a corresponding increase in the occurrence of accidents. Since 2001, the MAIB has been notified of 54 accidents during RIB rides that have resulted in lower back injuries, 17 of which resulted in spinal fractures. Initial analysis of these previous accidents as part of this investigation indicates that passengers seated in the front third of a RIB's overall length (**Figure 2**) are exposed to a significantly higher risk of lower back injuries than those seated further back, as the vertical motions experienced are generally greater towards the bow.

Figure 2: RIB outline highlighting the area of significant risk

There is a significantly higher risk of spinal fractures to people seated in the front area of RIBs, regardless of speed.

Owners and operators of small commercial passenger vessels are strongly advised to:

- Urgently review their operations and risk assessments, with reference to the CoP and MGN 436 (M+F). This review should assess and mitigate the risks associated with the requirement to seat passengers in the front area of a RIB and ensure that the risk assessment includes and addresses the variability of weather conditions and the ability of passengers.
- Review their passenger pre-departure briefing and ensure that it includes a specific explanation of how to use the seat(s) and their associated handholds, including how to maintain the correct posture and stability to mitigate against injury.
