INCIDENT

Aircraft Type and Registration:	AW169, G-UNIB	
No & Type of Engines:	2 Pratt & Whitney Canada PW210A turboshaft engines	
Year of Manufacture:	2022 (Serial no: 69152)	
Date & Time (UTC):	21 February 2023 at 0800 hrs	
Location:	Humberside Airport, North Lincolnshire	
Type of Flight:	Hoist operations	
Persons on Board:	Crew - 3	Passengers - 4
Injuries:	Crew - None	Passengers - None
Nature of Damage:	Hoist hook and 20 cm of cable severed from hoist	
Commander's Licence:	Airline Transport Pilot's Licence	
Commander's Age:	55 years	
Commander's Flying Experience:	5,440 hours (of which 490 were on type) Last 90 days - 50 hours Last 28 days - 25 hours	
Information Source:	Aircraft Accident Report Form submitted by the commander plus further enquiries by the AAIB

Synopsis

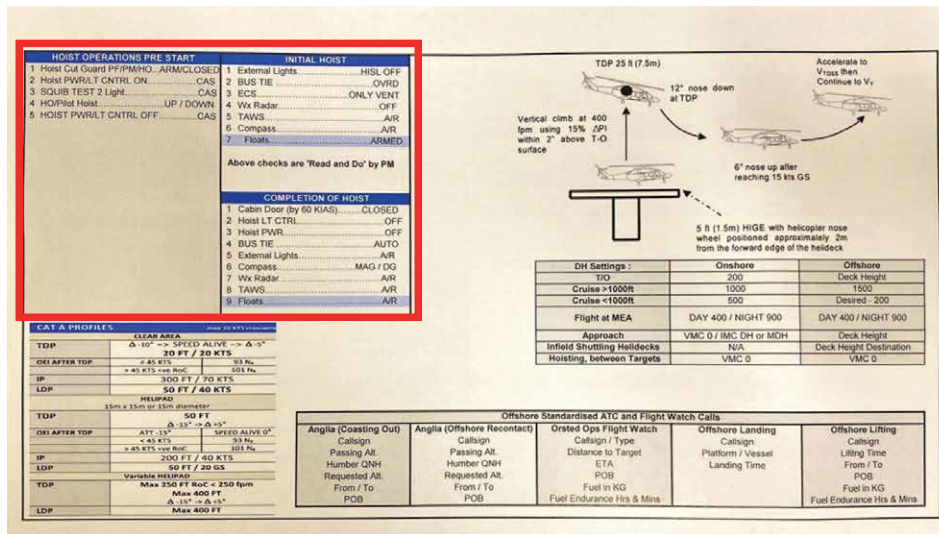
Hoist operation checklists and aircraft operating information

The company start up procedure in Figure 3 contained no mention of checking for the presence of the HOIST CUT ARM caution with all cut guards lowered as stated in the RFM 'SYSTEM CHECKS AFTER ENGINE START CHECKS' (Figure 12). Whilst the application of hoist power is not required until RFM Step 5, there is no mention in the company checklist that Step 1 should be carried out with hoist power OFF. There was also no mention in the company checklist of the warning in Step 5 of the RFM to check for the presence of the HOIST CUT ARM caution when the hoist power is selected ON before continuing with the pre-start checklist.

The company procedures have since been amended to include the requirement to ensure the hoist power is off, all cut guards are lowered and there is no CUT GUARD ARM caution present before proceeding to Step 1. In addition, a warning has been added after Step 2 to ensure the HOIST FOUL caution extinguishes after hoist power is applied and there is no HOIST CUT GUARD caution present on the PFDs before proceeding to Step 3.

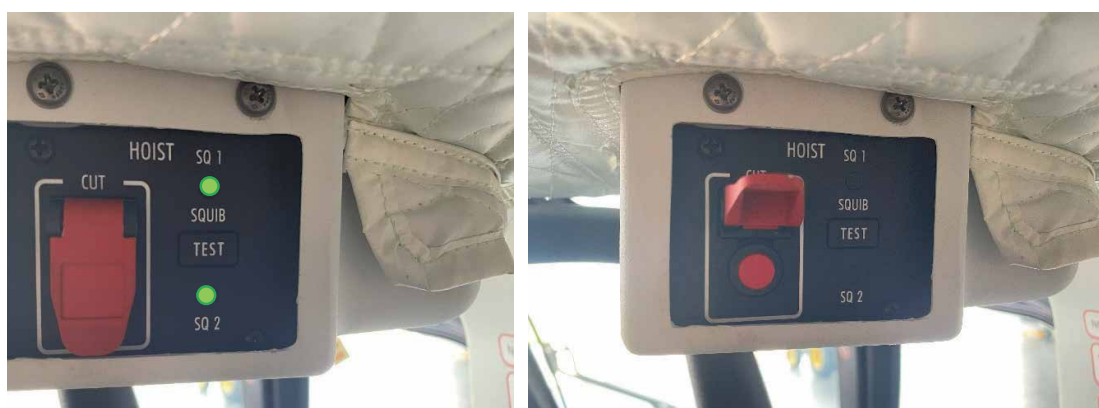
Figure 4

HO control panel showing cut switch guard, squib test button and LEDs illuminated (left) and the panel with the cut switch guard lifted showing the cut button (right)

HLO1 was at the aircraft, loading and securing equipment into the helicopter's cabin whilst working around the HO. The HO repeated the guard lift process using the HO's panel in the cabin with a similar result. At this point he noticed that the two green LEDs (SQ 1 and SQ 2) on the HO panel were illuminated, but proceeded to press the squib test button, Step 3 in the hoist operations pre-start checklist shown in Figure 3, regardless.

After the incident, both squib LEDs on the HO's panel illuminated immediately power was applied to the hoist (Figure 4).

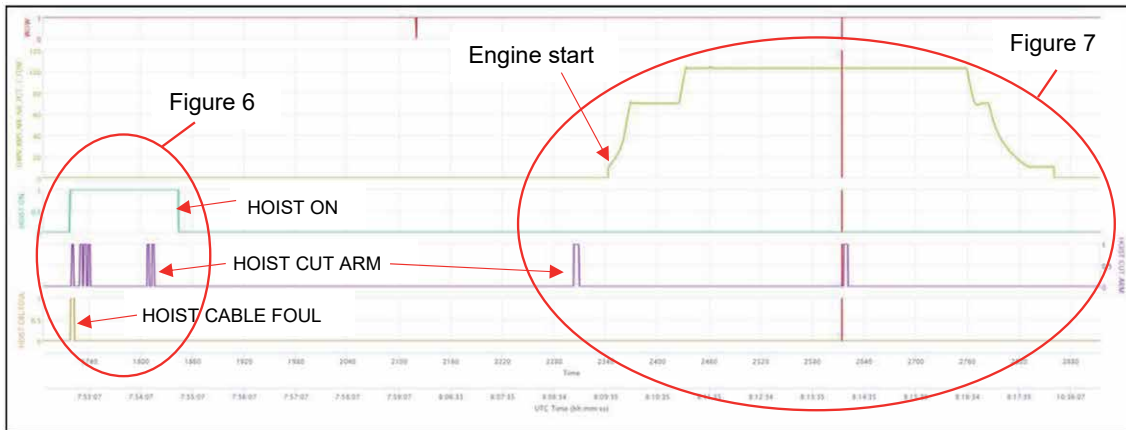
On the date of the incident, there were four separate CAS events recorded. The first lasted approximately 7 minutes and recorded the application of ground power. The second event started at approximately 07:41:00 hrs and showed that an engine cranking procedure had occurred which was later confirmed to be for an engine compressor wash. The third of the four events occurred during the incident period. Figure 5 shows the Flight Data Monitoring (FDM) timeline taken from 07:53:00 to 08:18:00 hrs showing the third (Figure 6) and fourth (Figure 7) CAS events.

FDM messages recorded by the DTD showing the third and fourth events

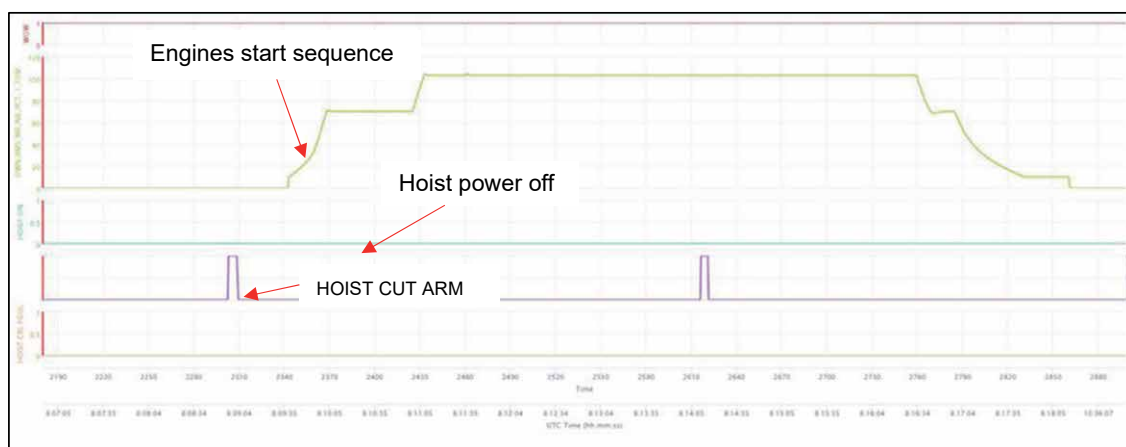
Event 4 expanded timeline - HOIST CUT ARMED cautions before and after engines start

The fourth event began whilst engine 1 was running in APU mode at 08:08:58, during which there was a two second activation of a HOIST CUT ARM caution. The caution occurred again at 08:14:12, but in this case both engines were running and the helicopter's rotors were turning. Both caution activations took place with no power applied to the hoist system. At 08:16:33 both engines were selected to IDLE and then to OFF. CAS recordings ceased at 08:18:15.

The fourth hoist CAS event shown in Figure 7 occurred once the hoist cable had been cut. After the Captain had left the aircraft to report the incident, the PF was requested to start the engines to ensure there was no residual water remaining in the engines following the earlier compressor wash. During this period, the PF attempted to check the hoist cut CAS messages by raising the cut guard on his collective twice to observe that the appropriate cautions were displayed on the PFDs. The hoist power was not switched on during these additional checks.

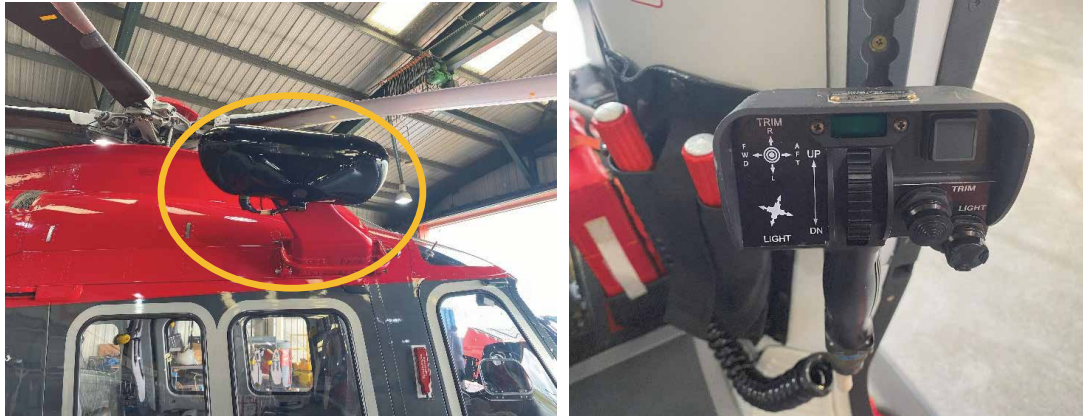
Figure 8

External Goodrich hoist assembly after cable had been cut (left) and HO's pendant (right)

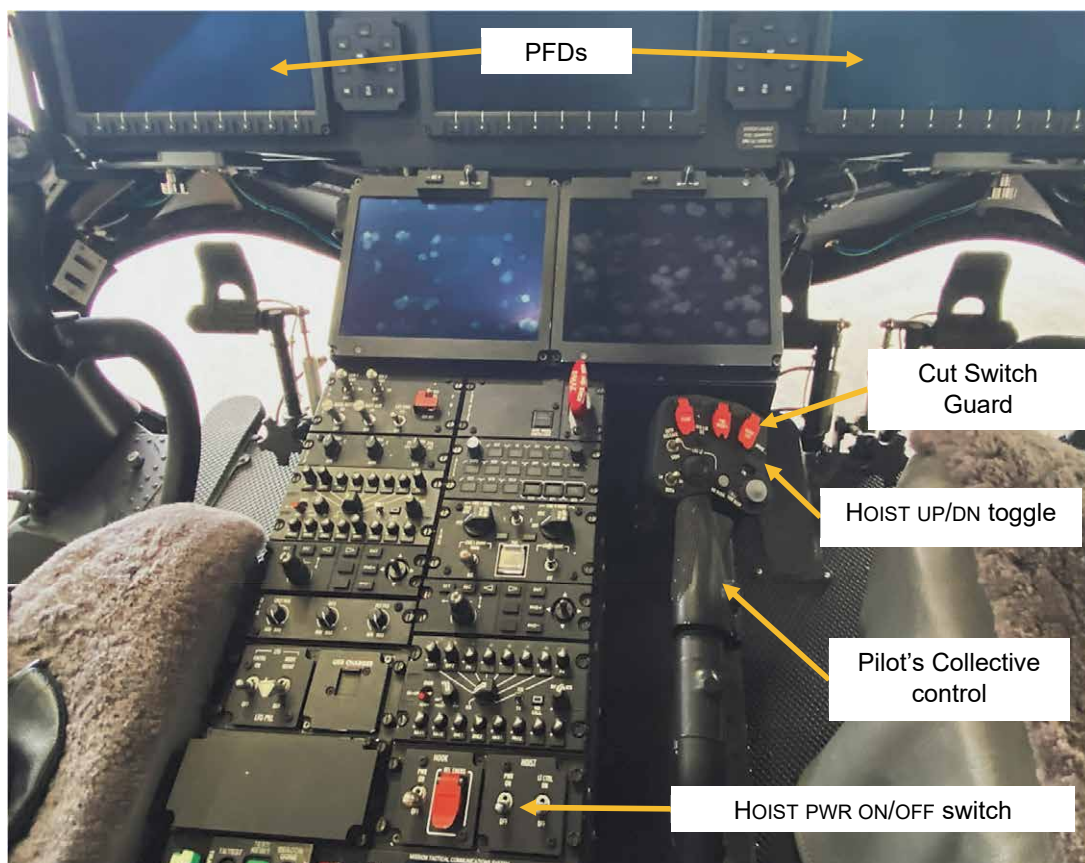
Figure 9

To release the winch cable if it becomes fouled and risks the safety of the aircraft, the cable can be cut using the hoist cut buttons located on each pilot's collective control (Figure 9) and the HO's control panel located in the cabin roof behind the headrest of the right pilot's seat.

Cockpit showing PFDs, right pilot's collective with cut switch guard plus HOIST UP/DWN toggle button and hoist power switch
