SERIOUS INCIDENT

Aircraft Type and Registration:	Piper PA-31-350, G-FCSL	
No & Type of Engines:	2 Lycoming TIO-540-J2BD piston engines	
Year of Manufacture:	1972 (Serial no: 31-7852052)	
Date & Time (UTC):	28 March 2023 at 1330 hrs	
Location:	South of Salisbury, Wiltshire	
Type of Flight:	Private	
Persons on Board:	Crew - 2	Passengers - 1
Injuries:	Crew - None	Passengers - None
Nature of Damage:	Right engine No 2 cylinder detached, mechanical and superficial fire damage to the engine and cowling	
Commander's Licence:	Commercial Pilot's Licence	
Commander's Age:	57 years	
Commander's Flying Experience:	7,244 hours (of which 2,501 were on type) Last 90 days - 49 hours Last 28 days - 7 hours	
Information Source:	Aircraft Accident Report Form submitted by the pilot and enquiries made by the AAIB

Synopsis

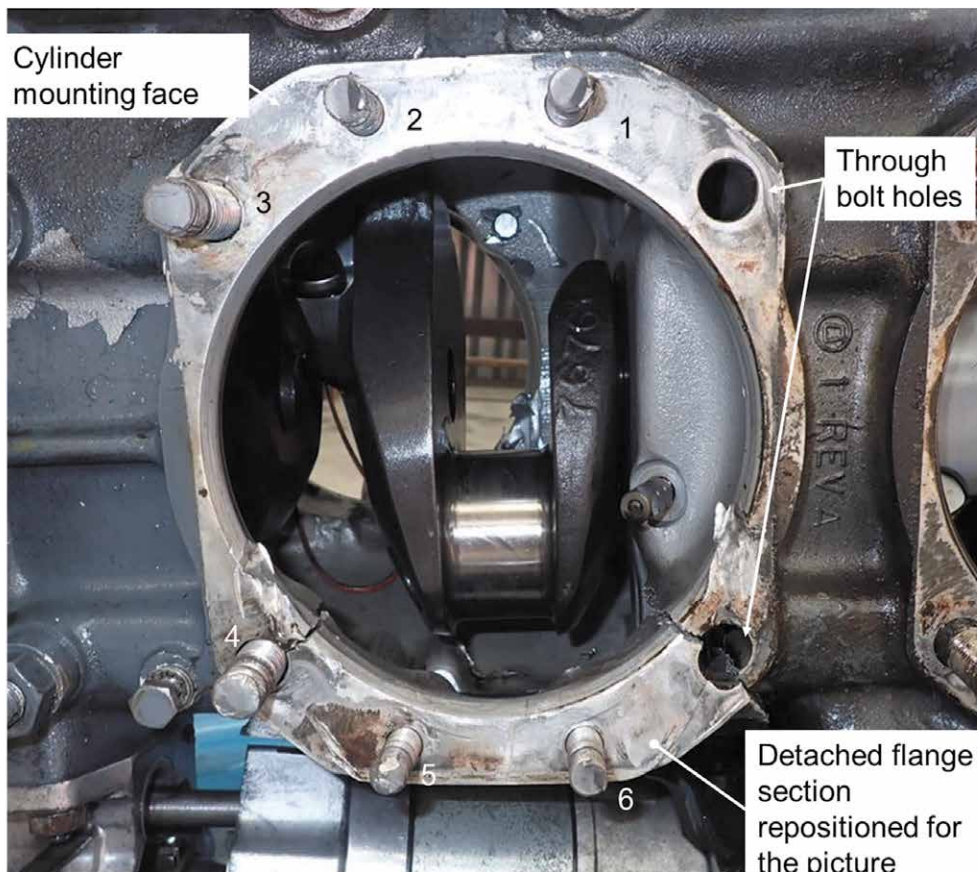
Each cylinder has a flange at the lower end which is held onto the crankcase by six threaded studs and two through-bolts. Four of the studs are 5/16 inch in diameter and the other studs and through bolts are 3/8 inch in diameter. All the studs and through-bolts had failed at the interface between the nut and the flange leaving a piece of each stud and through-bolt in the associated nut. One of the 3/8 inch diameter stud nuts was not found but its corresponding stud had broken in the same position as the other studs. Figure 2 shows the flange and identifies the location of the studs.

Cylinder mounting flange and location of the studs

Mechanical damage to the No 4 stud corrupted the fracture face so a clear identification of its failure mechanism could not be made. However, studs No 3 and No 5 (situated either side of stud No 4) exhibited different fatigue failure characteristics to the other studs and through-bolts. Their fatigue crack features were indicative of a loss of preload³ or tightness of their nuts. The No 4 stud nut was not found which might suggest that its stud failed earlier, although it is not known how much earlier⁴, and was followed by the No 3 and No 5 studs. With these studs failed, the cylinder flange was no longer rigidly attached to the crankcase cylinder mounting face around approximately one third of its circumference at its front edge. This resulted in non-uniform high cycle loads, predominantly tensile bending loads, within the remaining studs (No 1, 2 and 6) and both through-bolts, hence their unidirectional fatigue fracture features.
