Rail Accident Investigation Branch

Rail Accident Investigation: Interim Report

**Loss of speed restrictions on the Cambrian line
20 October 2017**

Report IR1/2018
October 2018

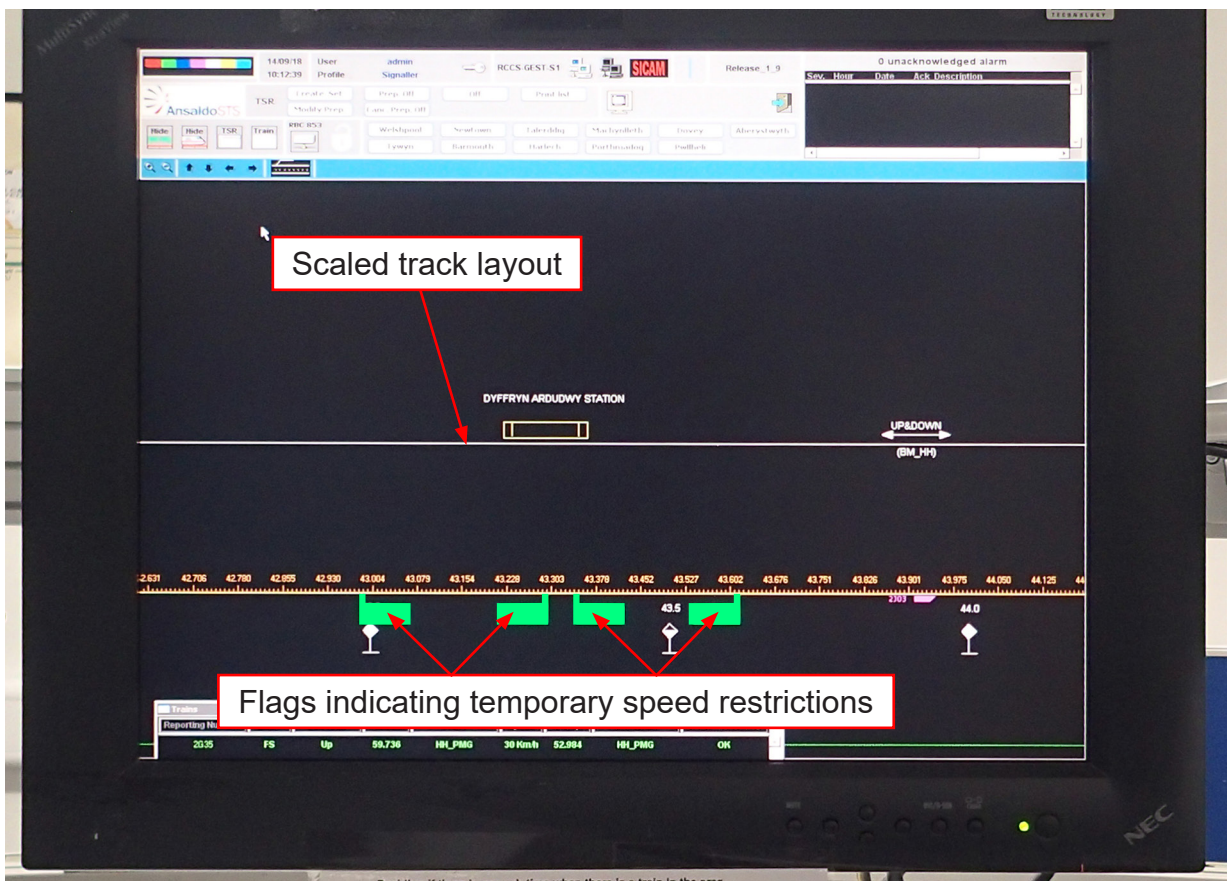
Figure 5: GEST terminal interface screen, here showing a single track with a station and flags at the beginning and end of two temporary speed restrictions

- 31 The signallers should have been alerted to the failure to transmit the restrictions by the restriction flags turning red on the GEST terminal interface screen. When asked by the Ansaldo STS engineer the following day, several members of staff at the control centre checked and confirmed that the restriction flags were green on the GEST terminal screen. Although this was several hours after the initial rollover had occurred, there is no evidence that the flags were any colour other than green since the rollover the previous evening.

- 32 The GEST system is an integral part of the overall signalling system and safety related decisions relating to the management and control of trains are made based on the information displayed by the GEST terminal screen. Checks within the safety critical system software should have prevented the incorrect displaying of the green restriction flags on the GEST terminal interface screen.
