Rail Accident Investigation Branch

Rail Accident Report

**Train driver struck by a train near West
Worthing Middle Siding, West Sussex,
1 February 2022**

Report 02/2023
February 2023

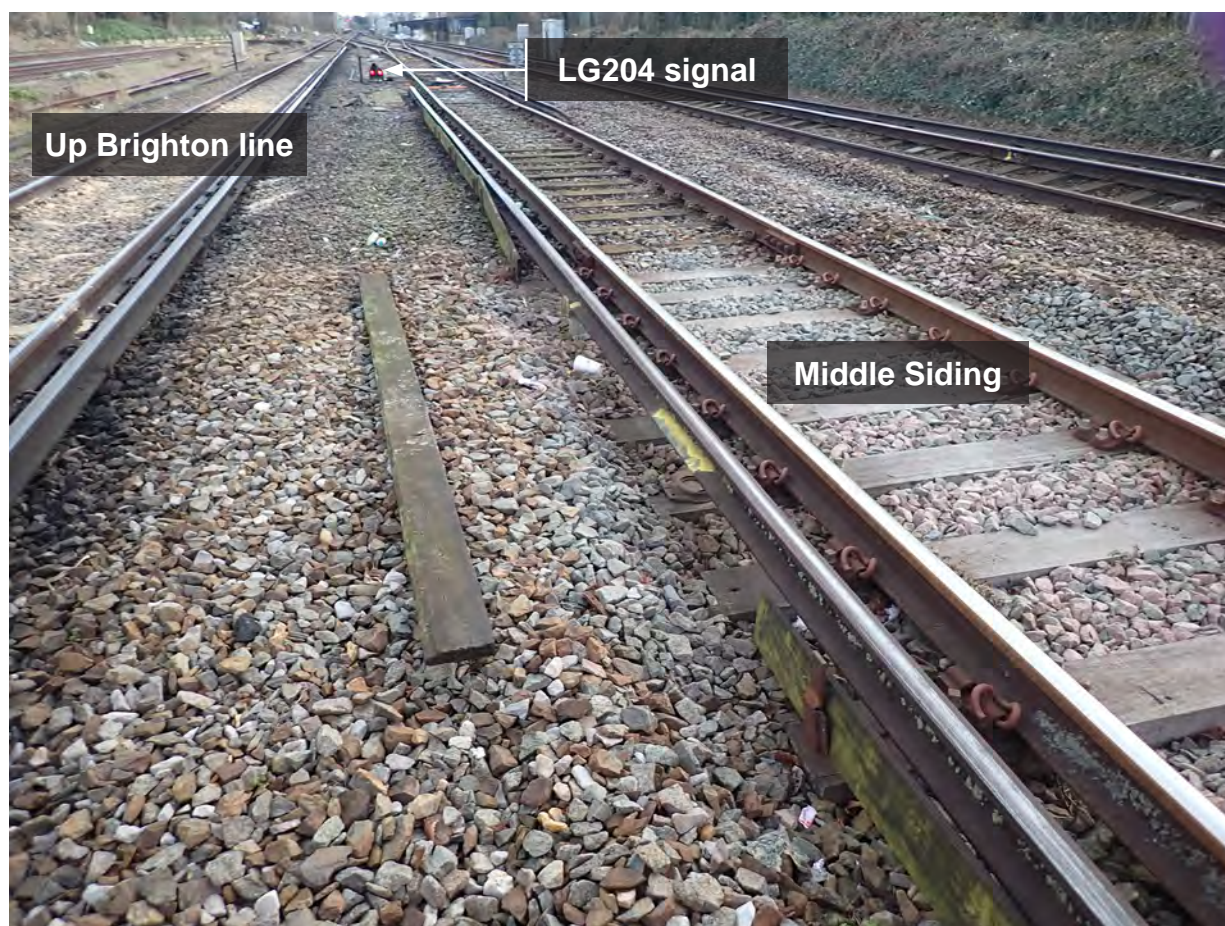
Figure 4: Photo showing the middle siding to the right of the image, the up Brighton to the left, and signal LG204 at the top.

- 13 The conductor rail at West Worthing Middle Siding is partially protected by conductor rail boarding. This boarding consists of long wooden planks (a non-conducting material) which are fixed alongside the conductor rail (figure 4) to reduce the risk of someone accidentally coming into contact with it, for example, when stepping over the rails. Following the accident, a length of this boarding was found detached and on the ground below the open cab door (see paragraph 98).

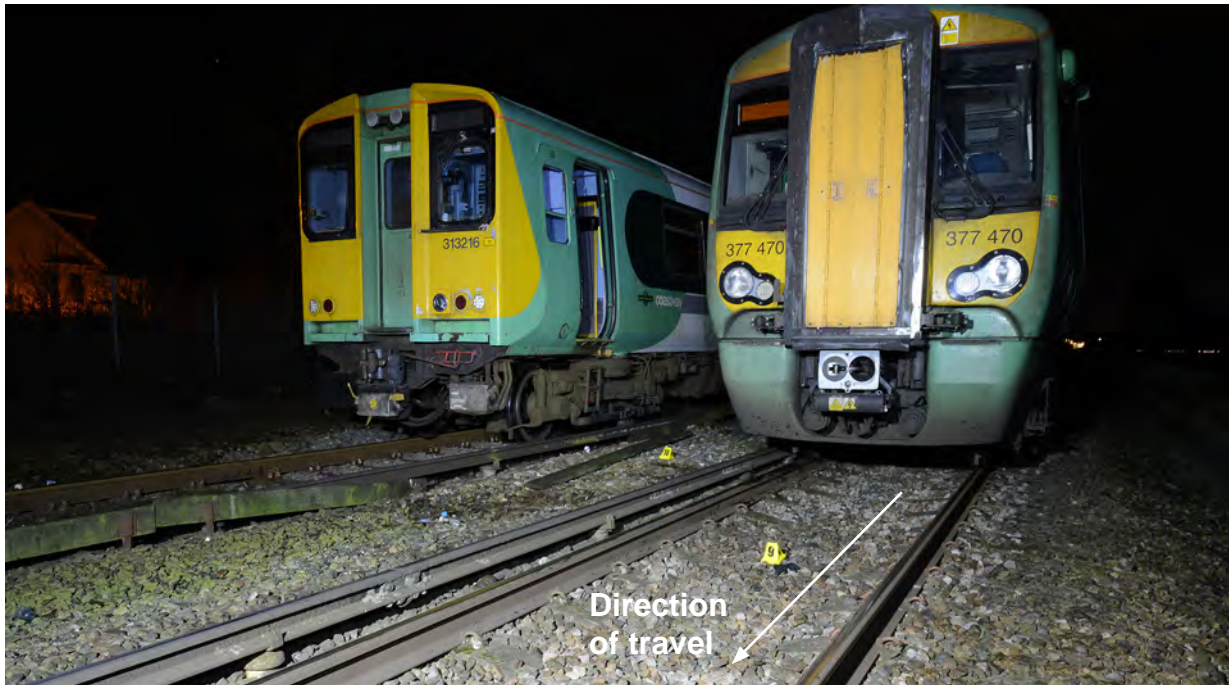
Figure 5: Photo showing stationary train to the left and examining train on the right (image courtesy of British Transport Police).

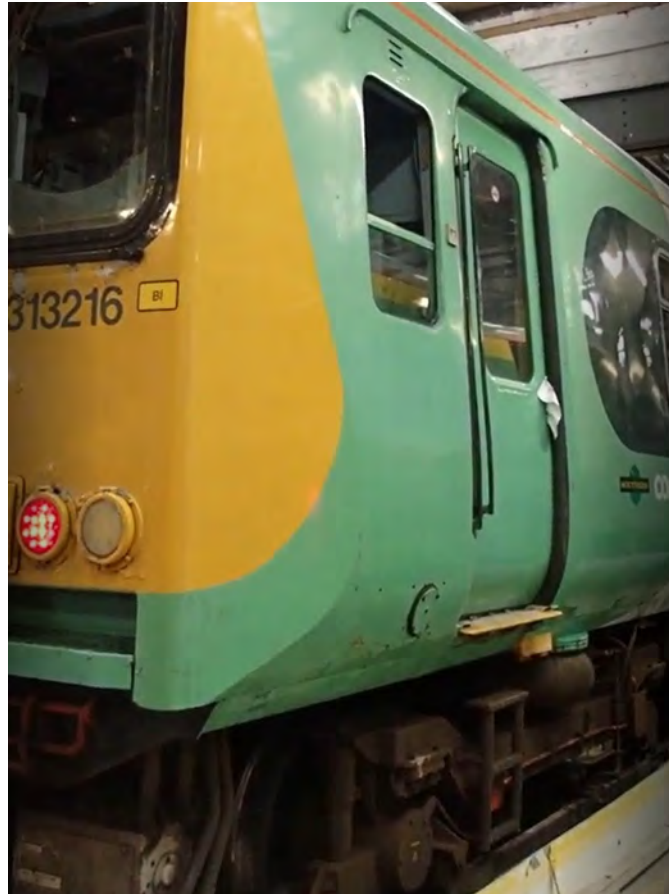
- 95 Class 313 units have a footstep at the base of the cab doorway, which allows access to the cab from platform height. When descending to track level, drivers will face the train and step off this footstep and on to a short ladder below. This is made up of three rungs, or steps which have a non-slip surface. Drivers use handrails built into either side of the cab door for support as they descend (figure 6).
- 96 Post-accident, both the cab access steps and the handrails adjacent to the doorway were examined. They were found to be free of faults and the steps were found to have their non-slip surfaces intact.

Figure 6: Image showing showing the driver's steps and handrails on train 5U57.

- 97 While no faults were found with the handrails and steps, it remains possible that the driver slipped and/or fell backwards from the footstep or cab access steps while descending from the train. Although the driver would have lacked the horizontal speed to land directly on the up Brighton line (paragraph 48) a fall backwards from the train while descending would have placed him in the six-foot. It is possible that the driver then inadvertently moved towards the up Brighton line as a result of trying to regain his feet or due to a loss of balance (see paragraphs 98 to 107).

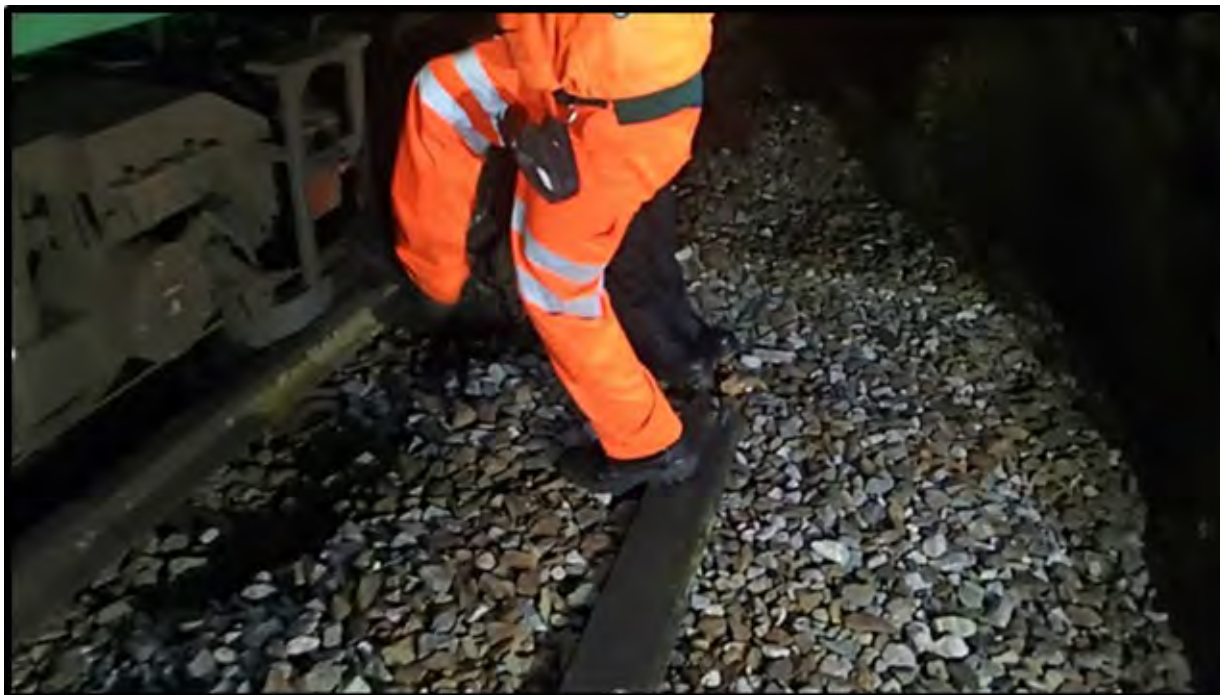
- 98 After the accident, it was observed that a section of conductor rail board, 4.08 metres long, was detached from its fixing points and was laying on the ground directly under the driver's open door. This board had numerous scuff marks and some boot prints on its surface (figure 4).
- 99 RAIB engaged a forensic science laboratory to look for evidence that the driver's shoes had contacted the detached conductor rail board. The laboratory concluded that there was no positive evidence of contact, but that the absence of evidence does not mean that such contact did not occur.

100 During the RAIB site visit and reconstruction, the detached conductor rail board was placed back into the position from which it was recovered after the accident. It was found that, when climbing down the steps from the driving cab door, the board was contacted by the boot of the person climbing down on four out of five occasions. It is therefore possible that when climbing down from the driving cab, or having climbed down, the driver's foot came into contact with the detached board. This may then have caused him to lose his balance and stumble into the path of the approaching train (figure 7).

Figure 7: Still from RAIB reconstruction video showing how the detached conductor rail board can present a tripping hazard.

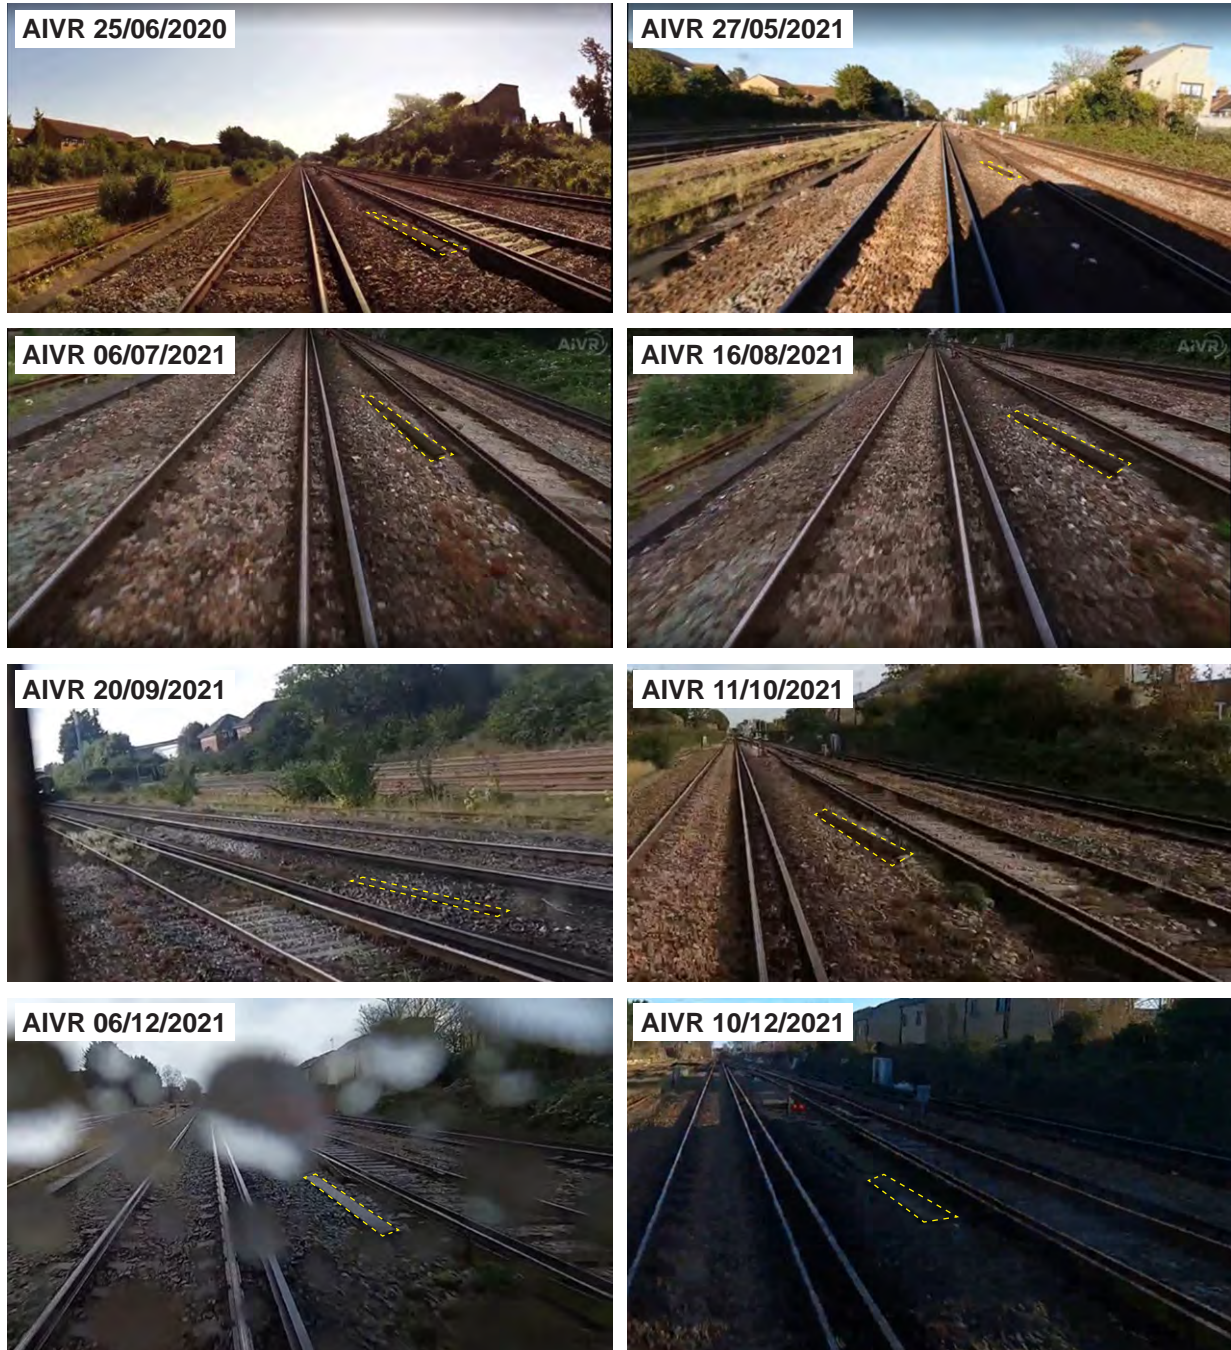
103 RAIB obtained video evidence from Network Rail's Automated Intelligent Video Review (AIVR) inspection trains that captured the location of the accident on eight occasions between June 2020 and December 2021 (figure 8). All of the footage showed the detached conductor rail board in approximately the same location that it was found on the night of the accident. Public domain video evidence uploaded to YouTube in 2016, containing a forward-facing view of the route from Barnham to Brighton, also shows the detached conductor rail board in what appears to be the same position as it was found on the night of the accident (figure 9).

Figure 8: Pictures of the detached conductor rail board taken from videos recorded by the AIVR train.

104 In accordance with Network Rail standards, the conductor rail in this location is subject to an annual inspection. Before the accident, the last time this section of conductor rail was inspected was on 5 May 2021. No faults with the conductor rail boarding were recorded as part of this inspection, probably because this location is not required to have conductor rail boarding installed under the latest standards. This is also likely to have been the reason that no faults were raised in relation to the detached board and why it was allowed to remain detached, but on the track, for a period of at least six years before the accident occurring.

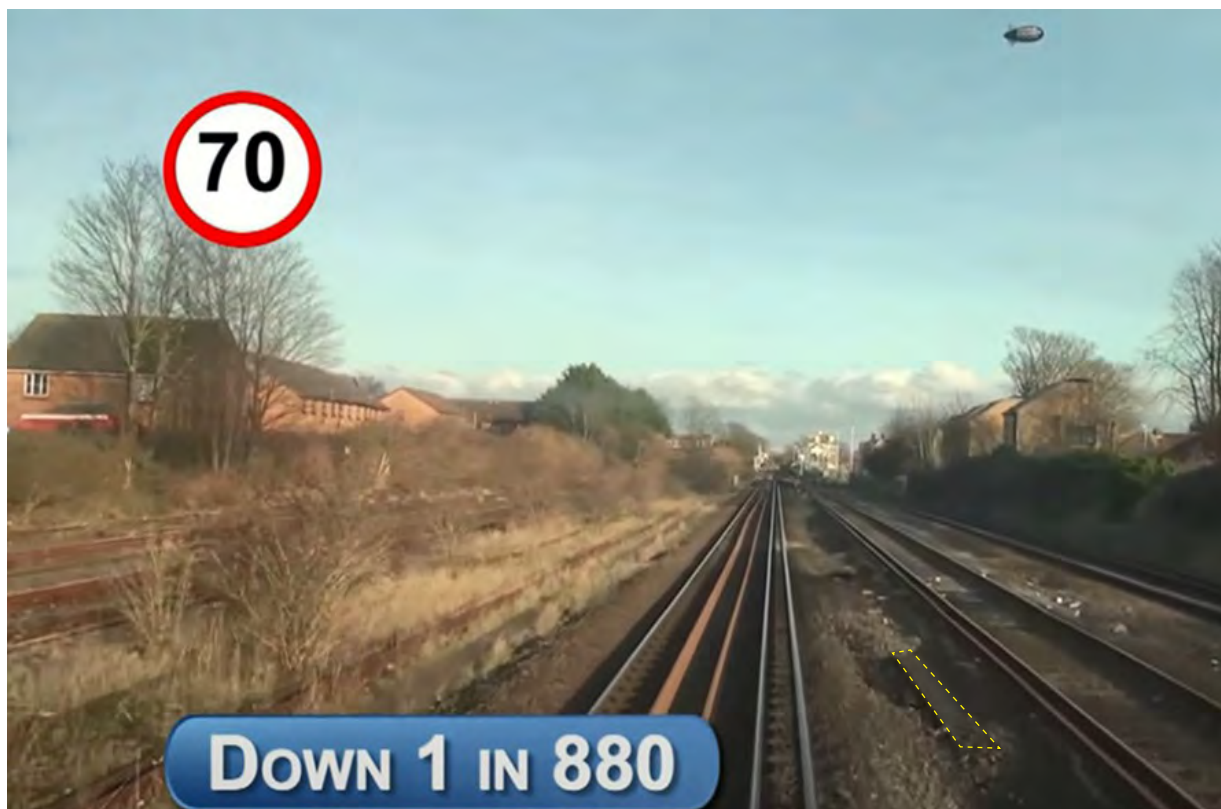
Figure 9: Still image of the detached conductor rail board taken from a video uploaded to YouTube 27/10/2016 (courtesy of Paul Hubbard).

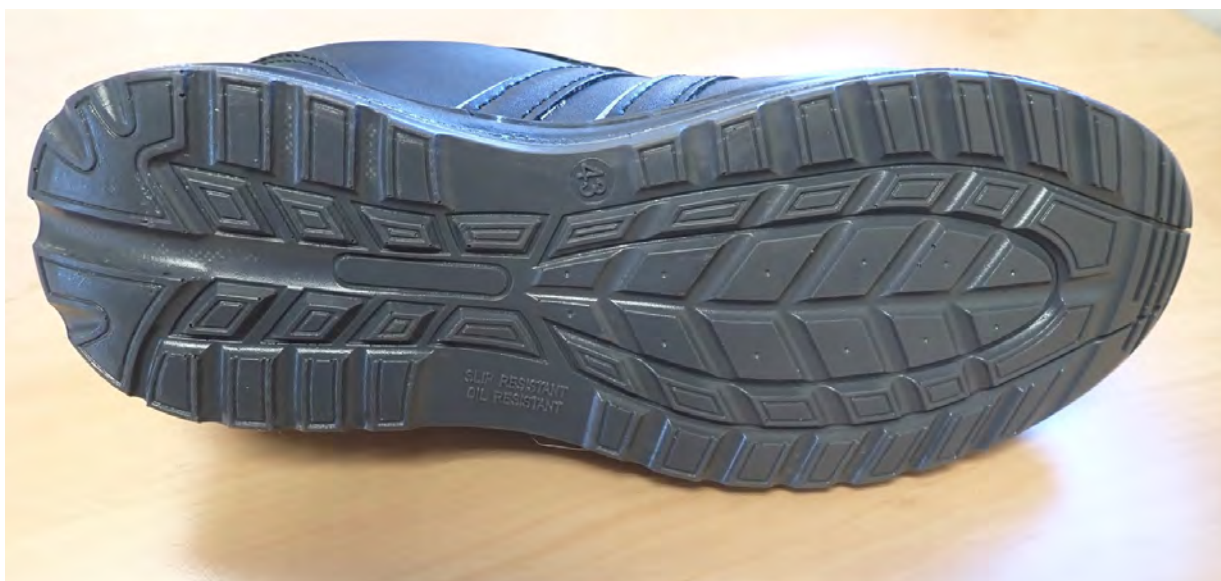
127 At the time of the accident, the driver was wearing a composite trainer style safety shoe designed to conform to protection level S1P under standard EN ISO 20345:2011 'Personal protective equipment — Safety footwear', issued in July 2014. Examination of the shoes worn by the driver showed that their soles included cleats (a protruding tread pattern) and had the non-standard marking 'SLIP RESISTANT'.

Figure 10: Image showing sole of shoe of the same type as that worn by the driver at the time of the accident.

- 129 RAIB examined a new S1P shoe of a comparable type to those being worn by the driver at the time of the accident (figure 10). This examination found that the cleats on the shoe were deep enough to meet the requirements of the S3 level of protection. For this reason, RAIB has concluded that, although the driver was wearing shoes of a type not specified by GTR for work on track when the accident occurred, this was not a factor in the accident.
