AAIB Bulletin

10/2023

Published 12 October 2023.

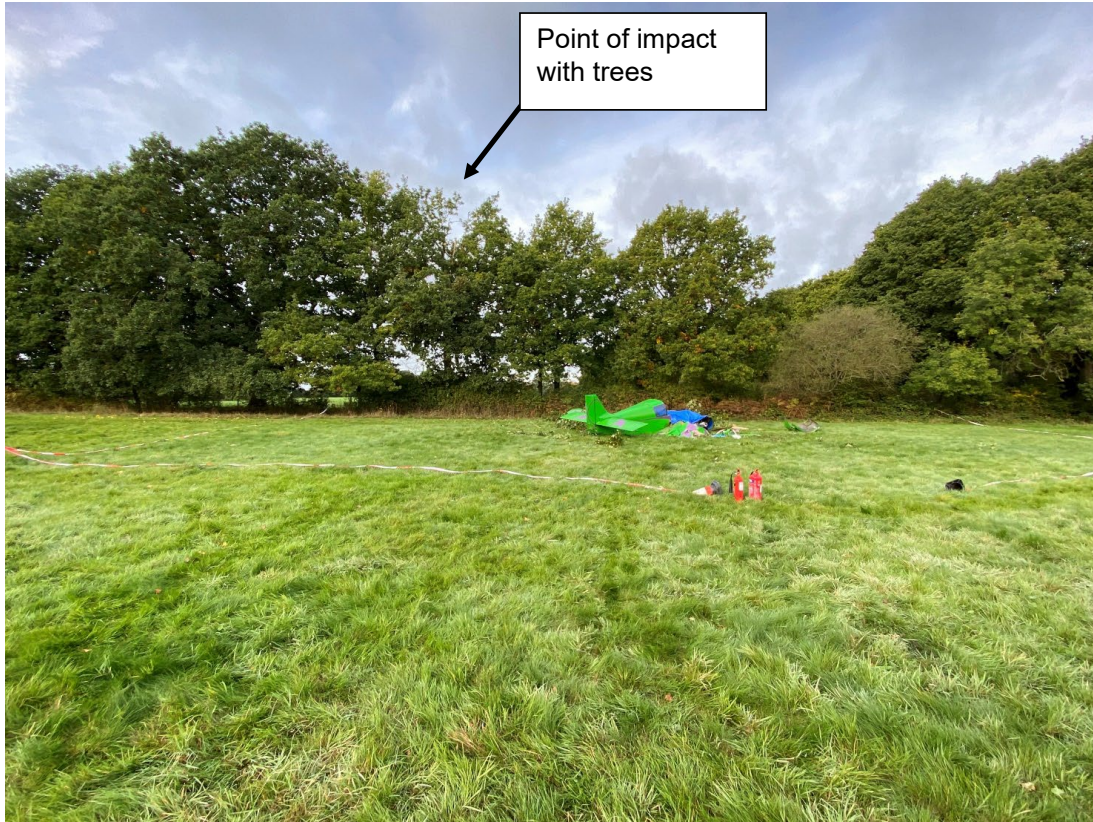
Figure 1
Accident site

The accident site was located in a field just beyond and to the right of the departure end of grass Runway 03 at Jackrell's Farm airstrip. The aircraft was upright and all the aircraft structure was present except for the outer two thirds of the right wing. Damage to trees on the adjacent field boundary and tree debris on the accident site indicated that the aircraft had struck the trees, which were approximately 15 m tall. The outer portion of the right wing was found on the opposite side of the tree line, with some small items of aircraft skin found in the trees. A single impact mark on the right wing leading edge close to the wing tip was consistent with the wing having struck a tree. The force of the right wing impact with the tree caused the aircraft to yaw to the right, pivoting around the impact point before continuing to the ground.

There were no appreciable ground marks other than in the immediate impact area, which indicated a predominantly vertical descent in a level attitude.

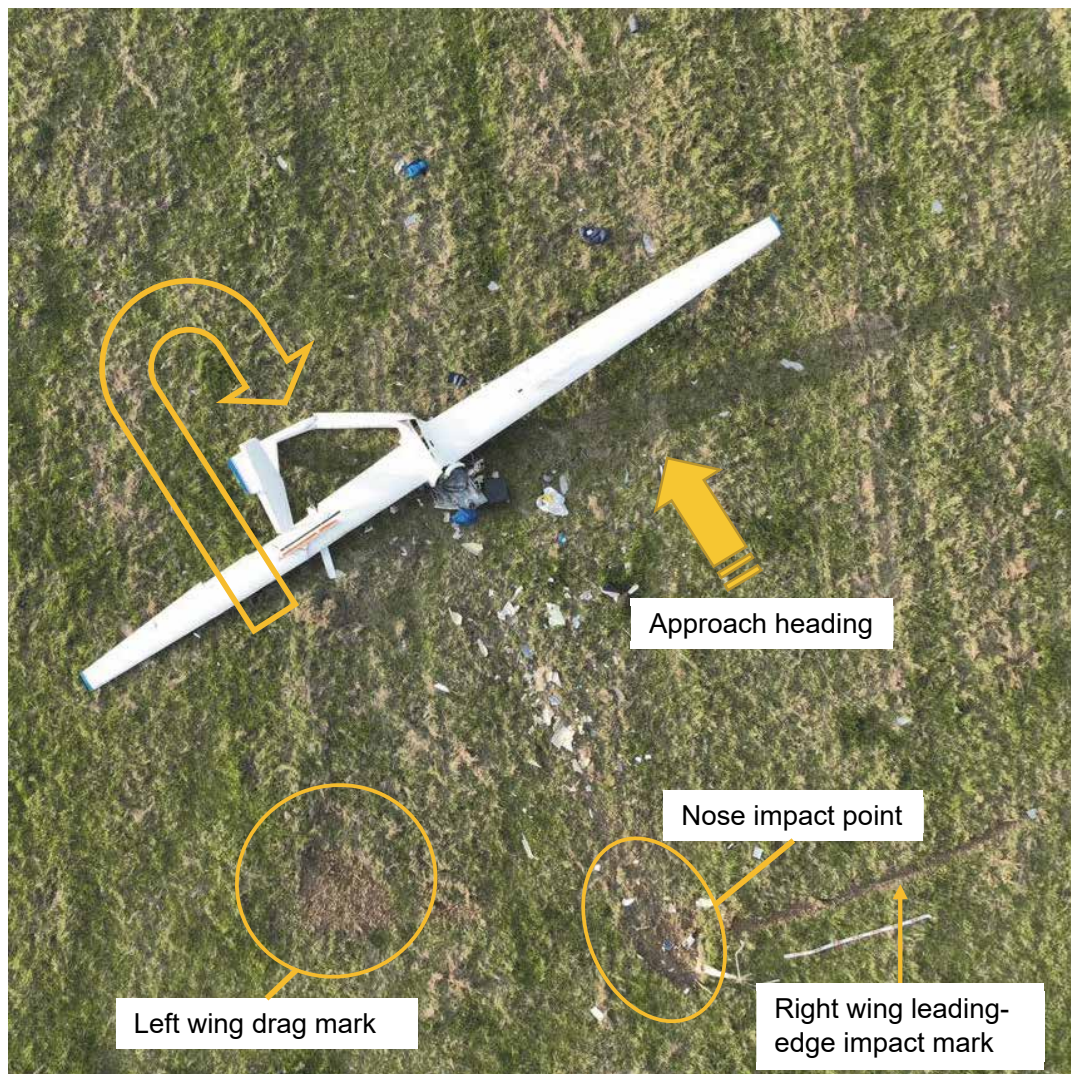
Figure 5

The ground marks and damage to the aircraft structure indicated that the aircraft struck the ground with the right wing slightly low and in a steep nose-down attitude. Ground marks and scratches found on the lower surface of the left wing showed that after the right wing and nose had struck the ground, the aircraft rotated to the right, dragging the left wing along the ground as the aircraft's momentum carried it forwards. The aircraft came to rest pointing towards the initial impact point with the tail boom structure disrupted in two places and bent towards the right wing (Figure 5). The nose and cockpit structure were fragmented, leaving only the severely damaged flight controls, some twisted cockpit structure and the

two uppermost seat harness shoulder straps still anchored to the aircraft. The lower two seat harness anchor points had been torn from the structure as the cockpit broke apart.

Overhead picture of wreckage showing ground marks

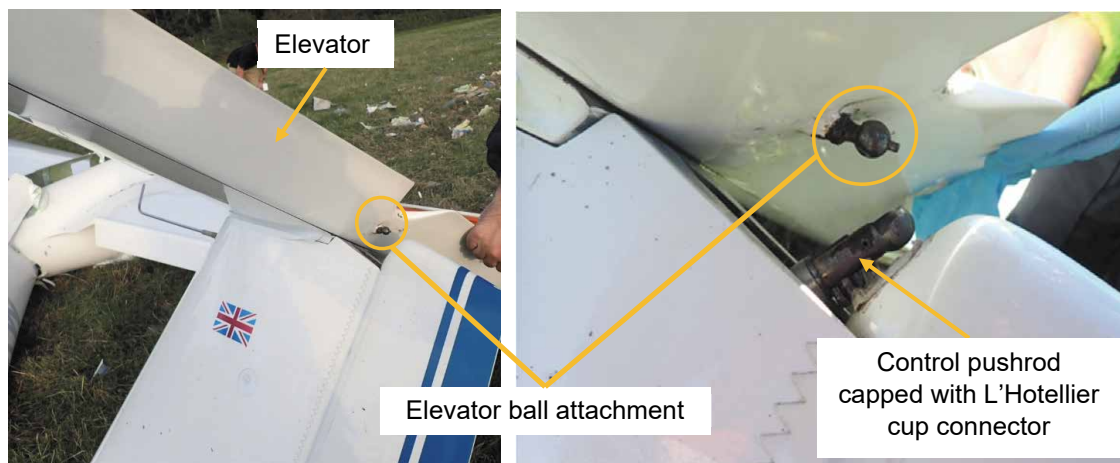
Figure 14

Examination at the accident site of G-CFRW revealed that all the flight controls other than the elevator were correctly connected. The elevator was found disconnected at the L'Hotellier joint (Figure 14).

Images at the accident site showing that the L'Hotellier ball and cup were not connected

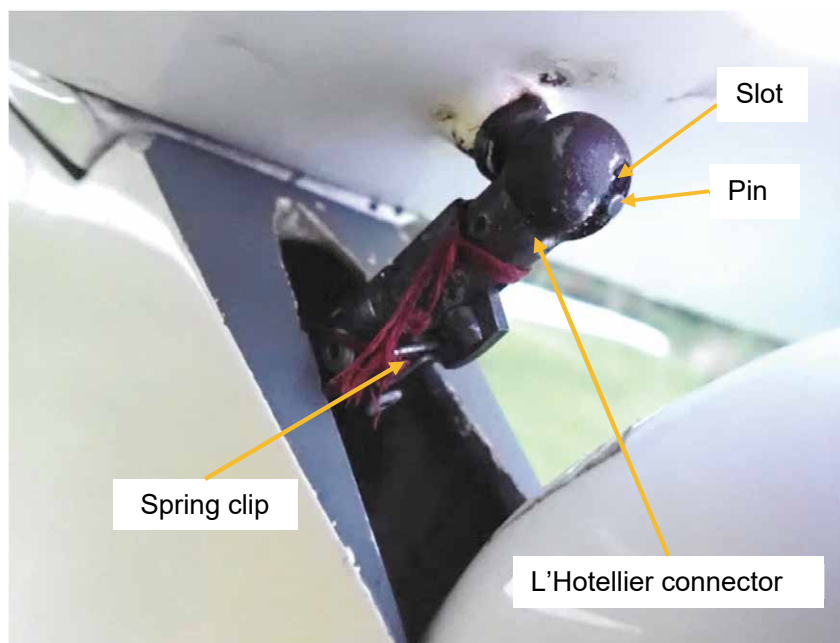
For comparison, Figure 15 shows an example of how the connection should look on a similar aircraft when correctly assembled. The red string attached to the spring clip was a personal modification by the owner of that aircraft to prevent the spring clip from dropping into the tail fin. It also helped the clip to remain visible and attached to the L'Hotellier cup connector when not fitted to the lock plate.

An example of correct elevator connection with spring clip fitted

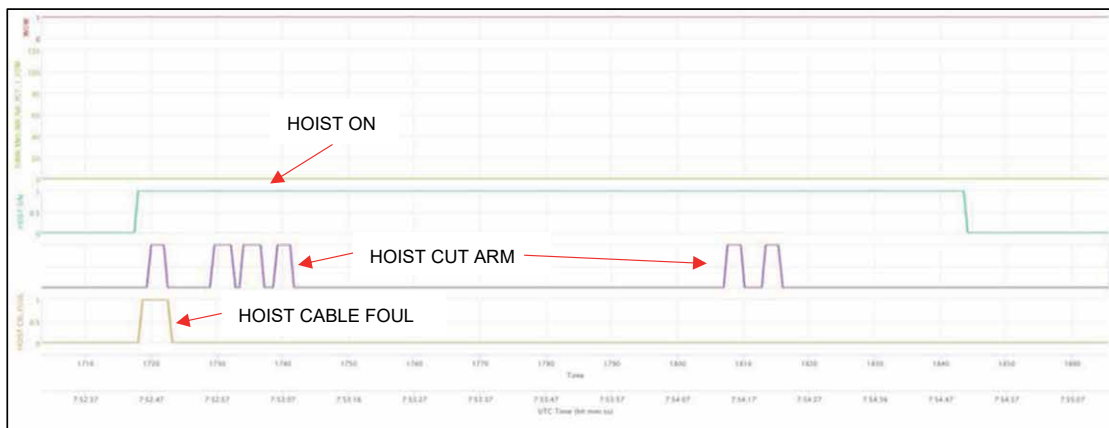
The third event started at 07:52:49 hrs when the HOIST ON advisory message was activated, confirming that hoist power had been switched on, see Figure 6 expanded event timeline. At approximately the same time, the HOIST CUT ARM and HOIST CABLE FOUL cautions were briefly displayed on the PFDs. In the seconds that followed, a sequence of three HOIST CUT ARM messages were recorded. The data also shows an additional sequence of two caution messages starting at 07:54:15 hrs, with each lasting approximately two seconds. Hoist system power was switched off 36 seconds later at 07:54:51 hrs. The fourth event occurred after the hoist cable had been severed, see Figure 7 expanded event timeline.

Event 3 expanded timeline showing lifting sequence of hoist switch cut guards

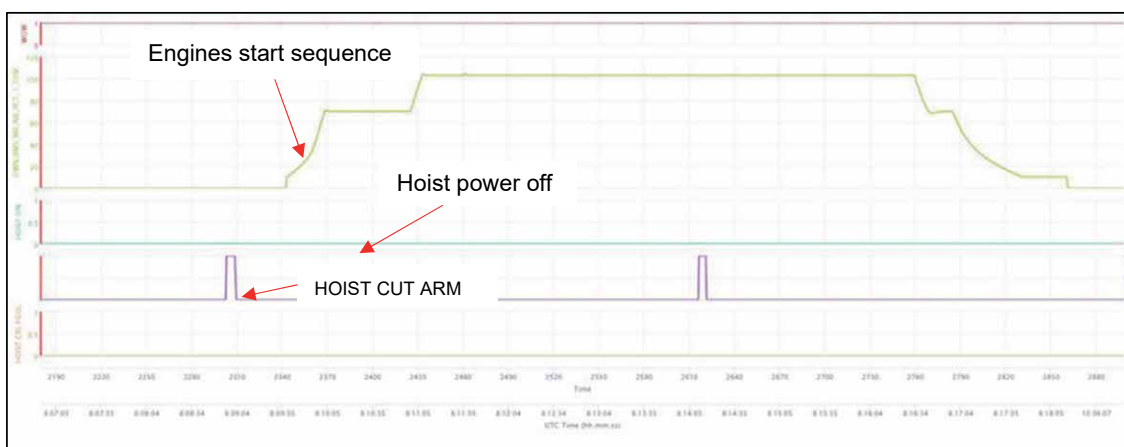
Figure 7

Event 4 expanded timeline - HOIST CUT ARMED cautions before and after engines start

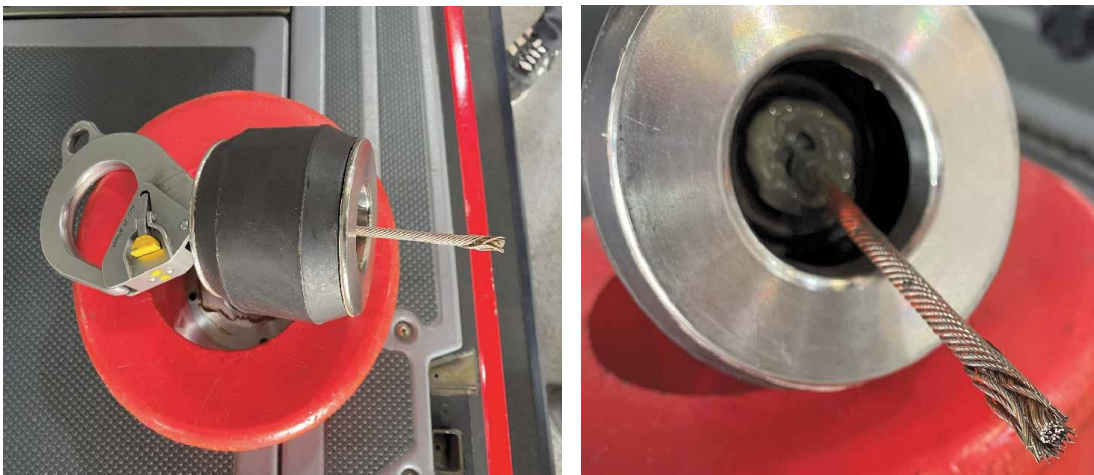
Figure 10

The high tensile steel, multistrand hoist cable had been severed approximately 20 cm from the hook assembly (Figure 10). There was no other damage to the aircraft found during the examination.

Hoist hook showing severed cable

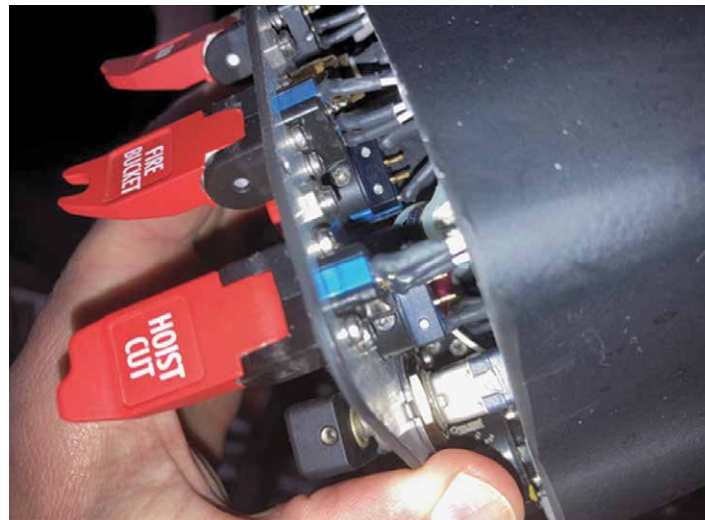
Figure 11

Pilot's collective hoist cut button (1 of 2) wiring visual examination

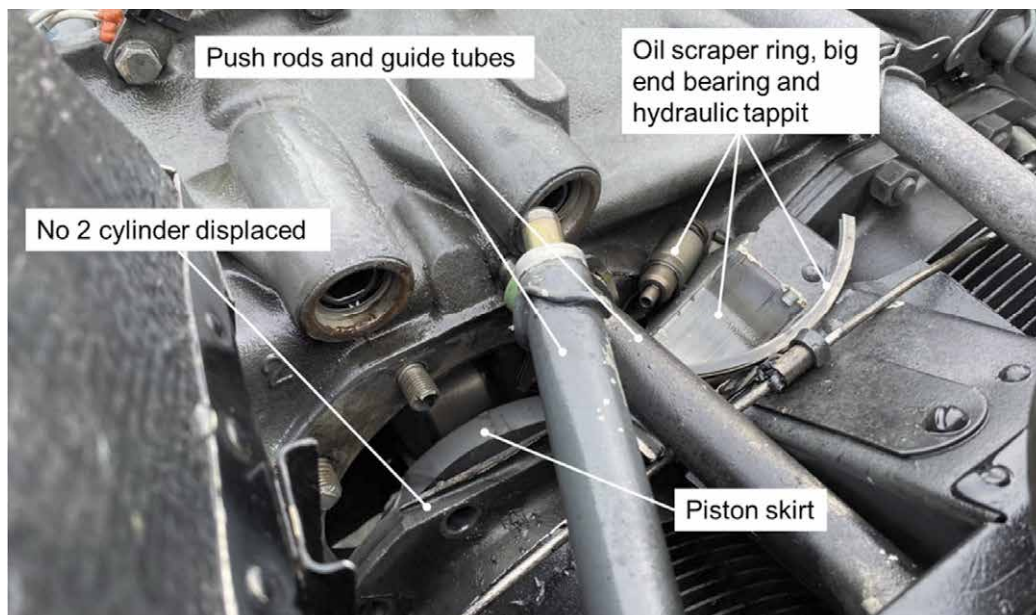
Figure 1

The front left side cylinder (No 2) had become detached from the crankcase with all six of the attachment studs and both through-bolts¹ broken. A section of crankcase with the remains of two of the studs in place had also detached and was lying in the bottom of the lower cowling. The piston ring damage had caused the piston to jam in the lower part of the cylinder and the connecting rod had separated from the big end bearing half shell. The cylinder inlet and exhaust manifolds were also displaced. The engine and accessories were covered in oil and there were signs of fire on and around the turbocharger. Several components associated with the cylinder and piston were found on and around the engine (Figure 1).

No 2 cylinder and distribution of parts

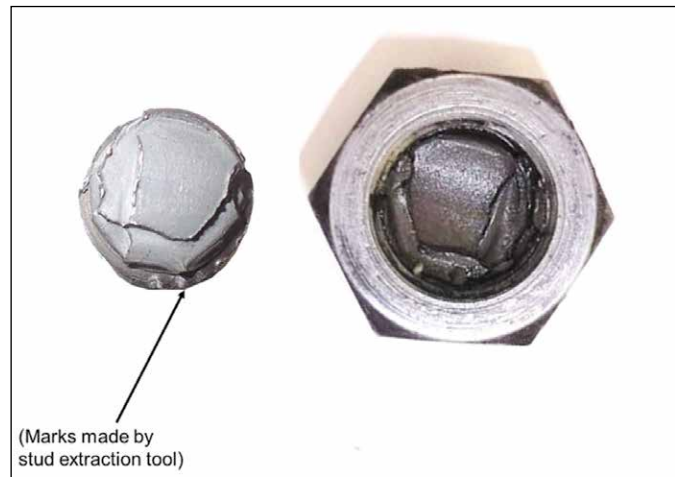
The studs and through-bolts were removed from the crankcase using an extraction tool for examination. All were found with the characteristics of a high cycle fatigue failure. The studs numbered in Figure 2 as No 3 and No 5, were found to have different fatigue features than the other studs and through-bolts. The No 4 stud fracture face had suffered mechanical damage which was caused by the piston skirt impacting it during the failure sequence. This was likely to have occurred at the same time as the crankcase section was broken away. The No 4 stud nut was not found. The No 3 and No 5 studs appear to show several fatigue crack faces, initiated from multiple sites from the thread root around the circumference of the stud. Figure 3 shows both No 3 stud fracture faces (the portion of the stud that remained within its nut was loose).

Stud No 3 and associated nut
