Defence
Safety Authority

Service inquiry

Loss of F-35B Lightning
ZM152 (BK-18) of 617
Squadron RAF, embarked on
HMS QUEEN ELIZABETH

17 November 2021

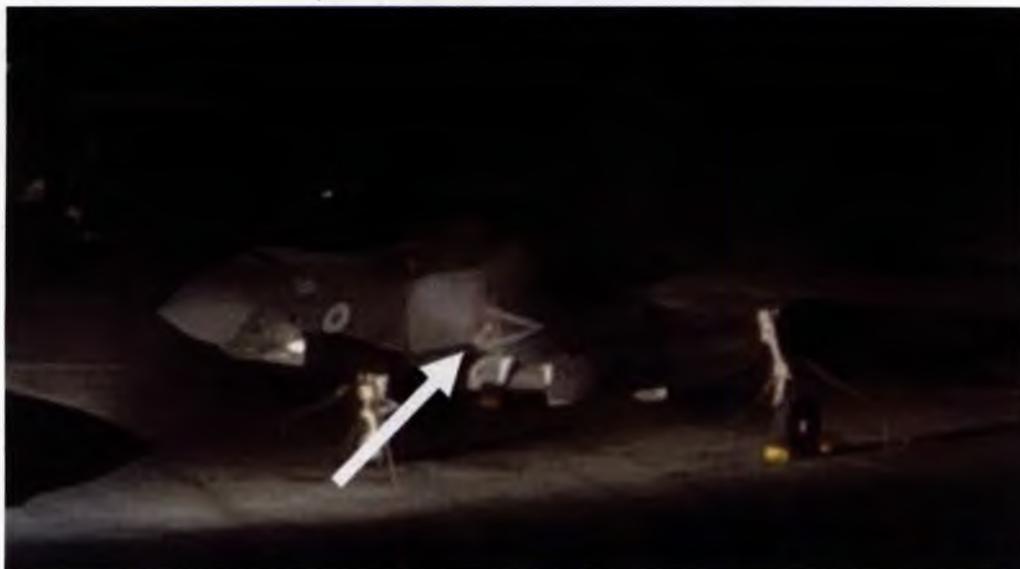
Figure 1.3.12 – BK-18 at 19:54 on 16 Nov 21 with left blank just visible in intake.²⁵

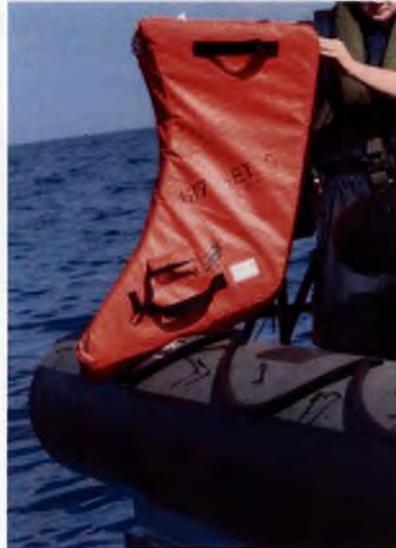
Figure 1.3.15 – Left intake blank recovered by QNLZ sea boat.

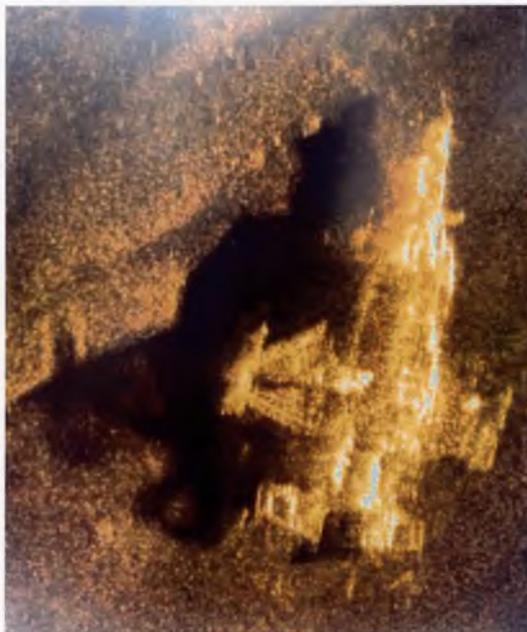
Figure 1.3.16 – BK-18 on the seabed prior to recovery.

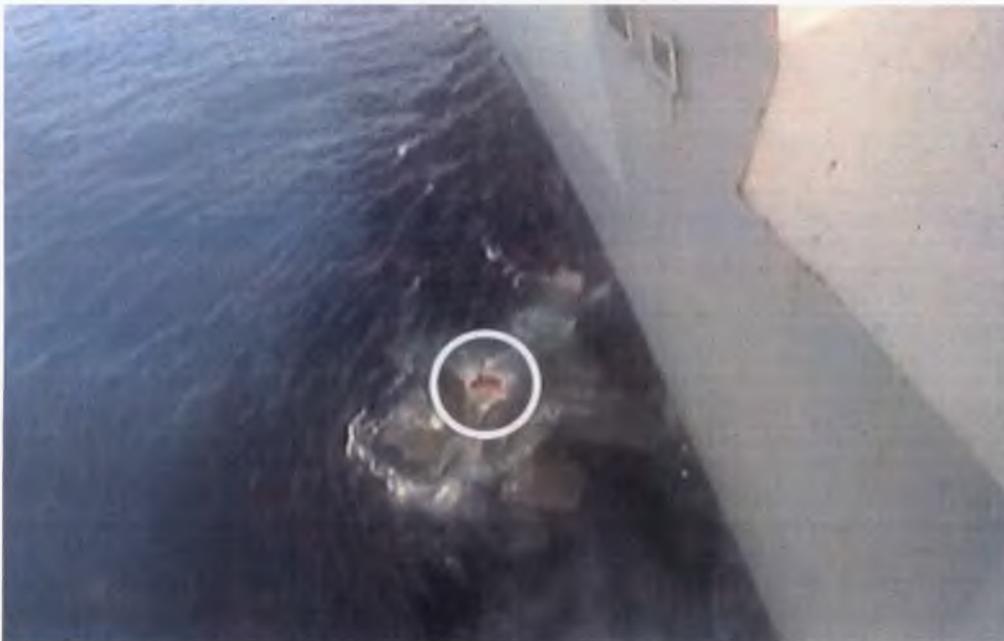
Figure 1.4.3 – Left intake blank floating out of BK-18.

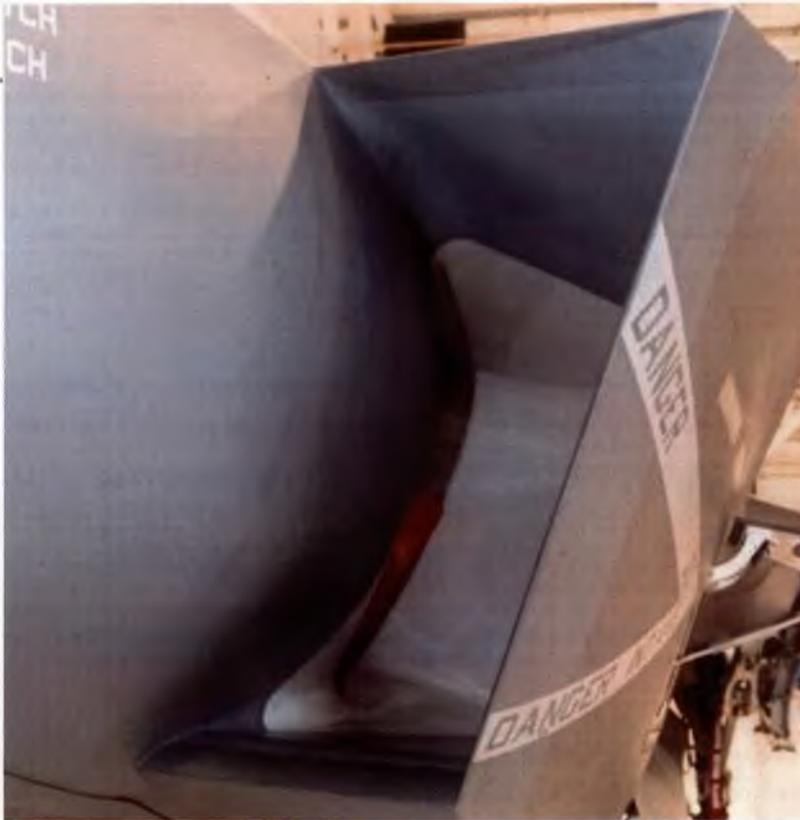
filtered light in a dark intake would have decreased the likelihood of it being seen (Figure 1.4.4). The panel concluded that not using white light for servicing was a **contributory factor**.

Figure 1.4.4 – Reproduction of F-35B with displaced left intake blank in shadow.

1.4.29. Recommendation. Director Force Generation should define the procedures for use of white light on the Queen Elizabeth Class flight decks at night in order to ensure engineering standards and practices can be achieved.

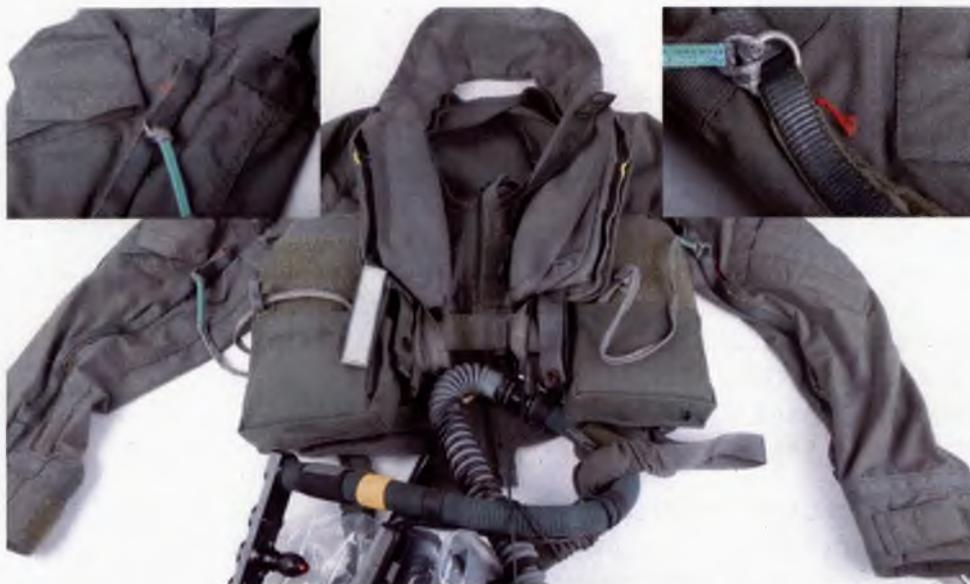
other factor. RAFCAM determined that all other aircrew equipment worked correctly.

Figure 1.4.6 – BK-18 pilot’s flight jacket. AREL red tie on left sleeve remained intact.

1.4.52. Recommendation. The Lightning Type Airworthiness Authority should provide clear guidance to aircrew and survival equipment technicians on the correct selection, fitment, and use of arm restraint extension lines (AREL), to include length selection and use of ‘white whistles’, in order to improve the likelihood of correct AREL function.

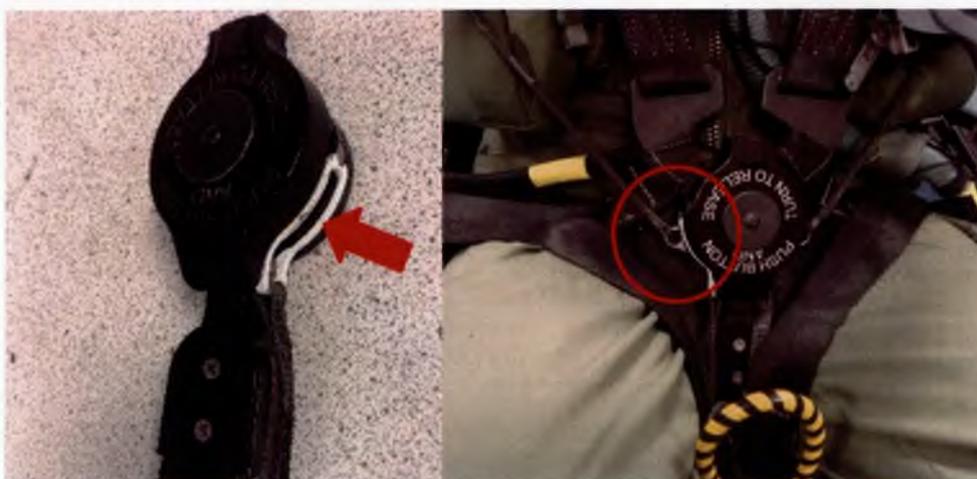
Figure 1.4.7 – ‘White whistle’ into which the lower lug of the AREL was fitted.

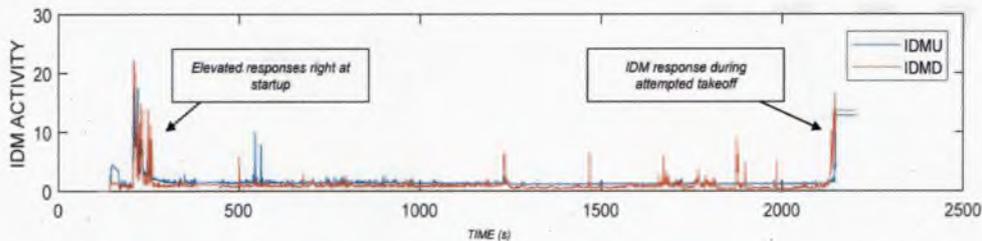
1.4.119. BK-18's IDMS data (Figure 1.4.16) showed readings on the IDMD throughout the period the engine was at idle which increased as air flow through the engine increased. The IDMU and EDM showed no such indications. If the FOD was significant enough to cause engine damage it is likely that an associated engine caution or warning would have been triggered. The data suggested there was FOD in the vicinity of the IDMD, but behind the IDMU.

Figure 1.4.16 – BK-18 IDMS trace from start-up to accident.⁴⁸

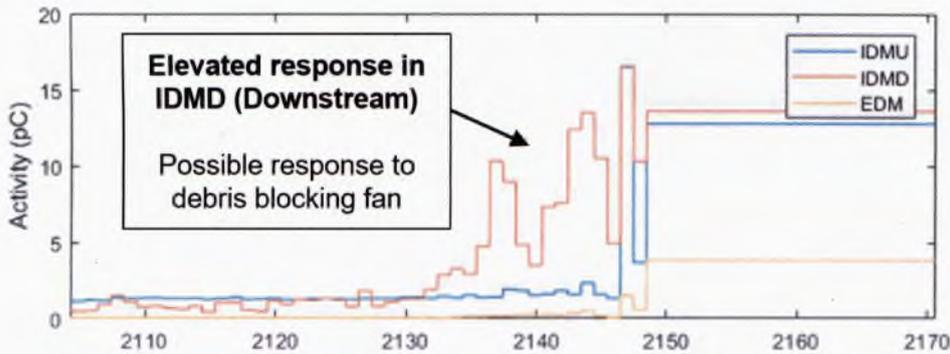
1.4.120. Analysis of the time period from 2129 to 2135 seconds (just prior to brake release) showed an elevated IDMD response during the period at 34% Engine Thrust Request (ETR) (Figure 1.4.17). An increase at 2135 seconds (97% ETR, brakes release) remained after the selection of idle at 2141 seconds. The ejection at 2145 seconds was likely to have caused the elevated readings at that point. The aircraft impacting the water at 2148 seconds creating the final elevated then flat readings. The panel concluded that the left intake blank was laying against the front face of the engine. The panel went on to investigate the effect of the blank on the engine's performance.

Figure 1.4.17 – IDMD elevated response from BK-18.⁴⁹

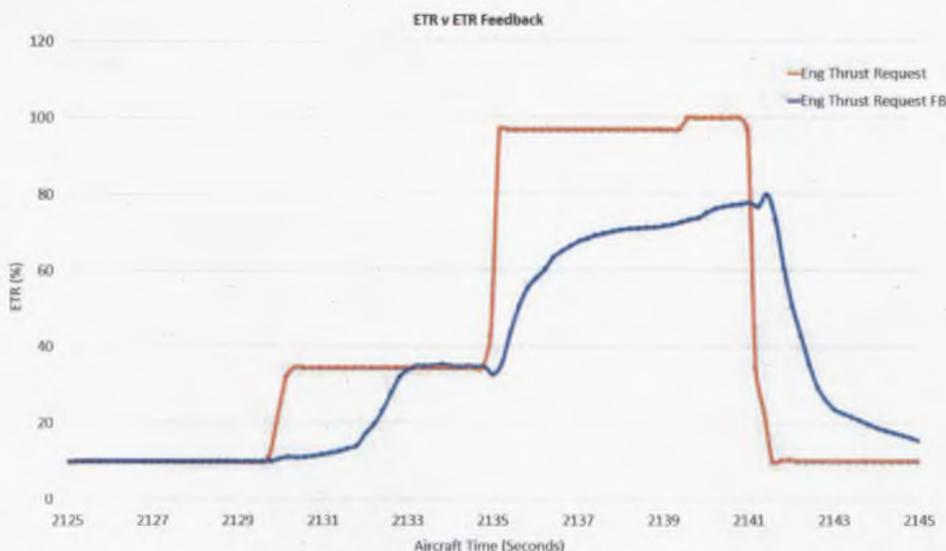
Figure 1.4.19 – BK-18 engine power demand versus delivered.⁵¹

1.4.123. There was a minimum of 17% deficit between demanded and delivered thrust, which equated to 38,000lb thrust requested, but only 31,500lb of thrust delivered. There was a lag between the time the 97% and 100% ETRs were demanded, and the 80% maximum was delivered (Figure 1.4.19). The time spent at a significantly lower than demanded thrust resulted in the poor acceleration.

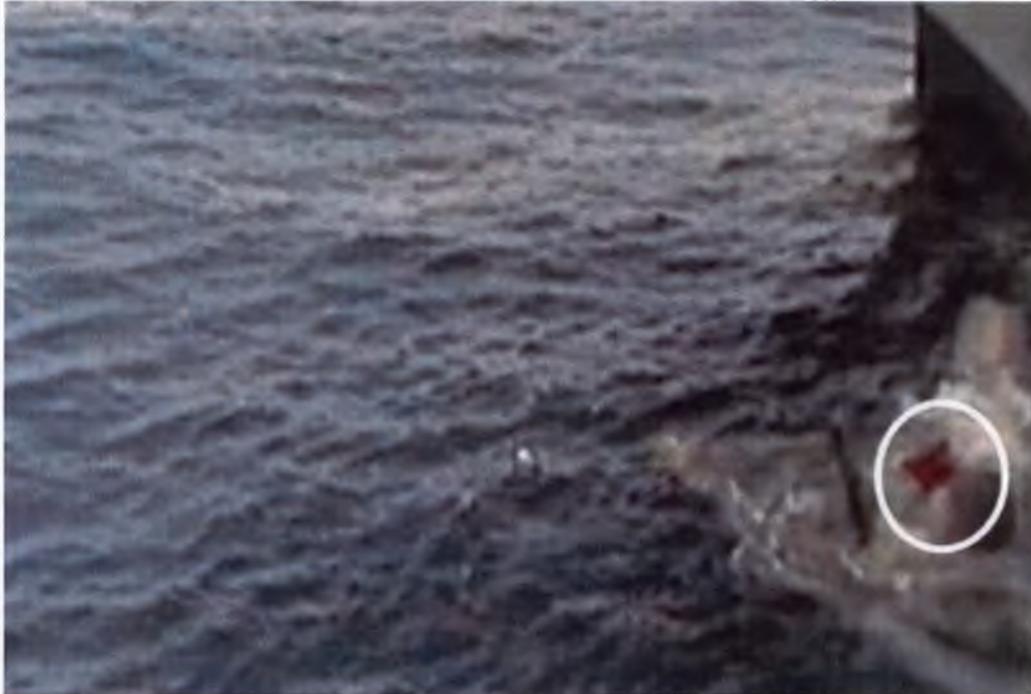
Figure 1.4.20 – Intake blank (circled) on top of BK-18.

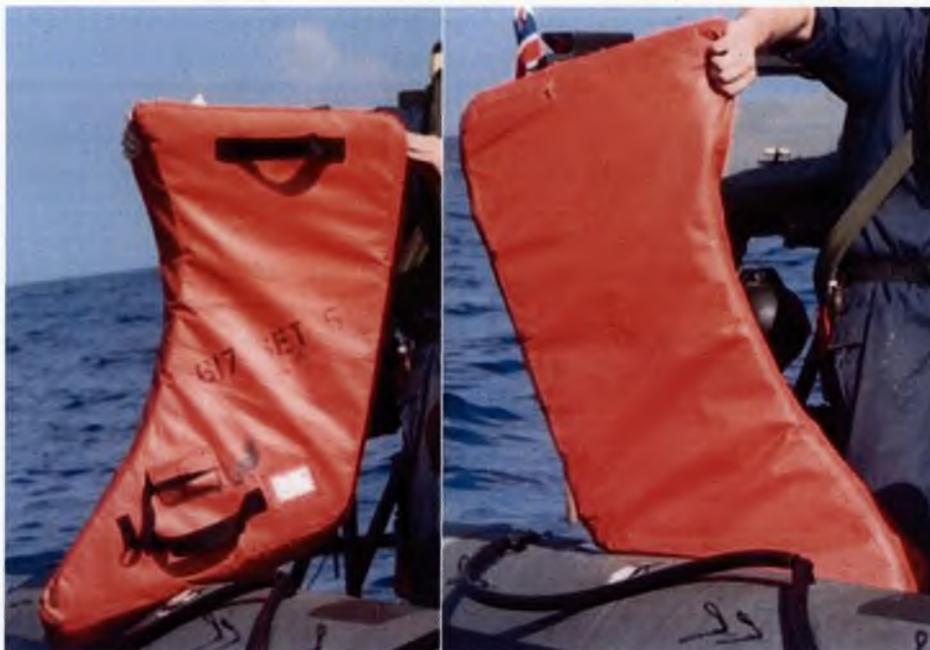
Figure 1.4.21 – BK-18 left intake blank on recovery from the sea.

1.4.127. Examination of the wreckage of BK-18 and the intake blank by 1710 NAS revealed damage to the front face of the engine, to the rubberised

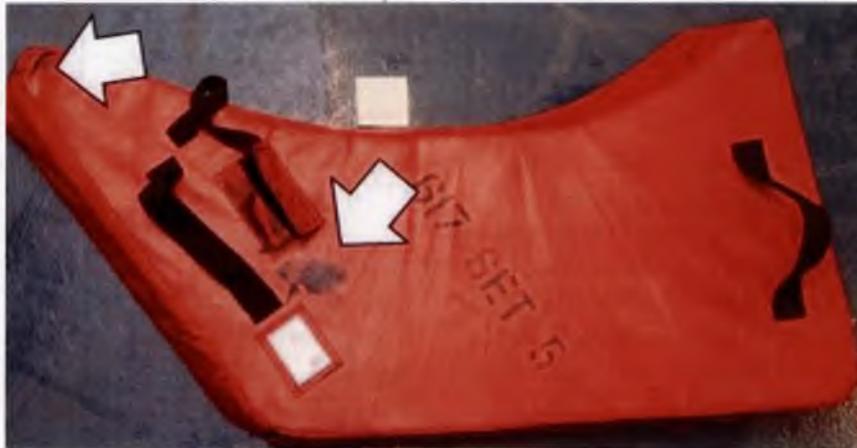
Figure 1.4.22 – BK-18 left intake blank. Arrows show black marks which were subject to chemical analysis.

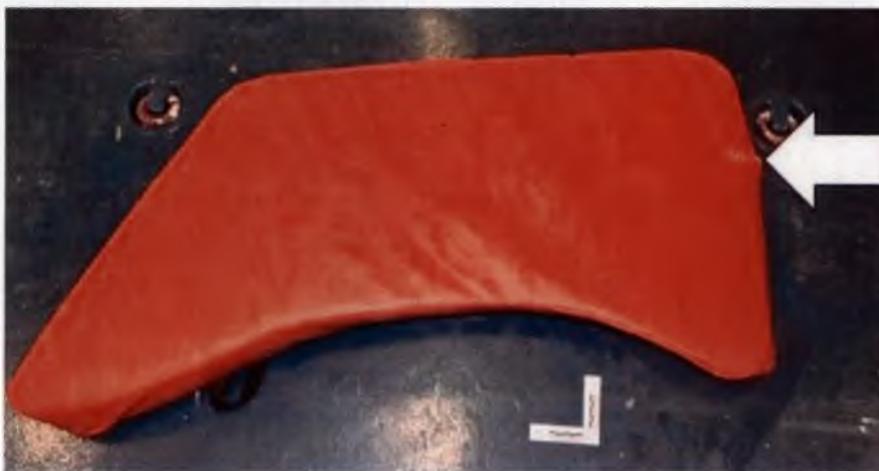
Figure 1.4.23 – Cuts to the top edge of BK-18 left intake blank.

1.4.128. Based on all the evidence, the panel concluded that the left intake blank was at the front face of the engine compressor during the aircraft launch and determined this to be the **causal factor**. This factor is addressed by the recommendation at para 1.4.36.

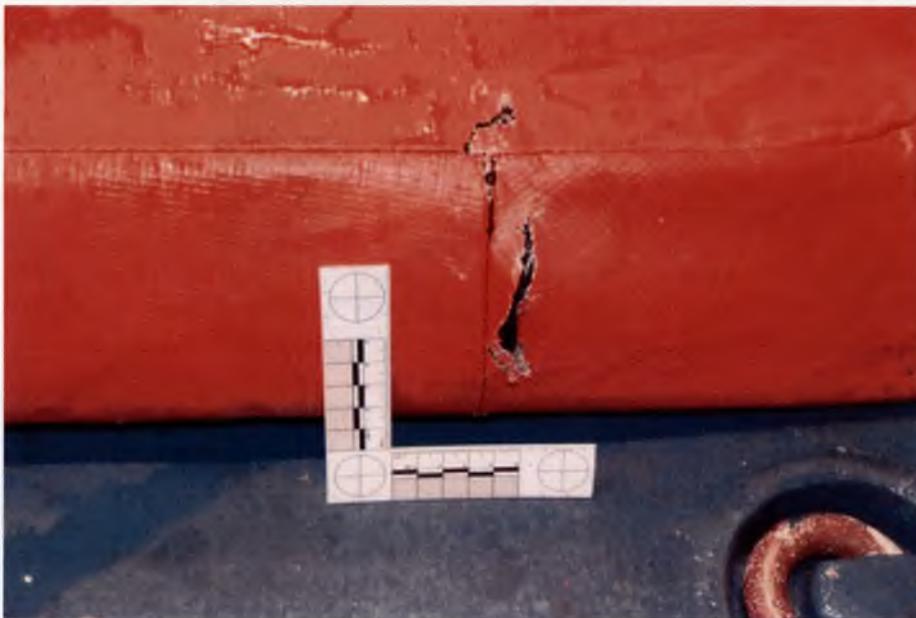
Figure 1.4.24 – Close up view of damage to BK-18 left intake blank top edge.

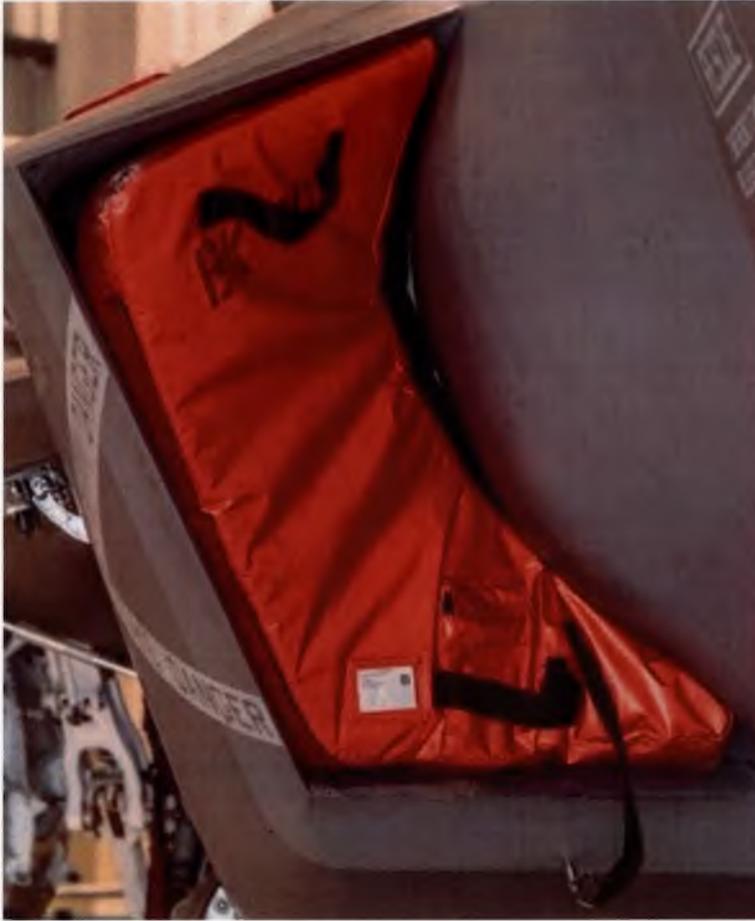
Figure 1.4.26 – Example of poorly installed intake blank seen at RAF Marham.

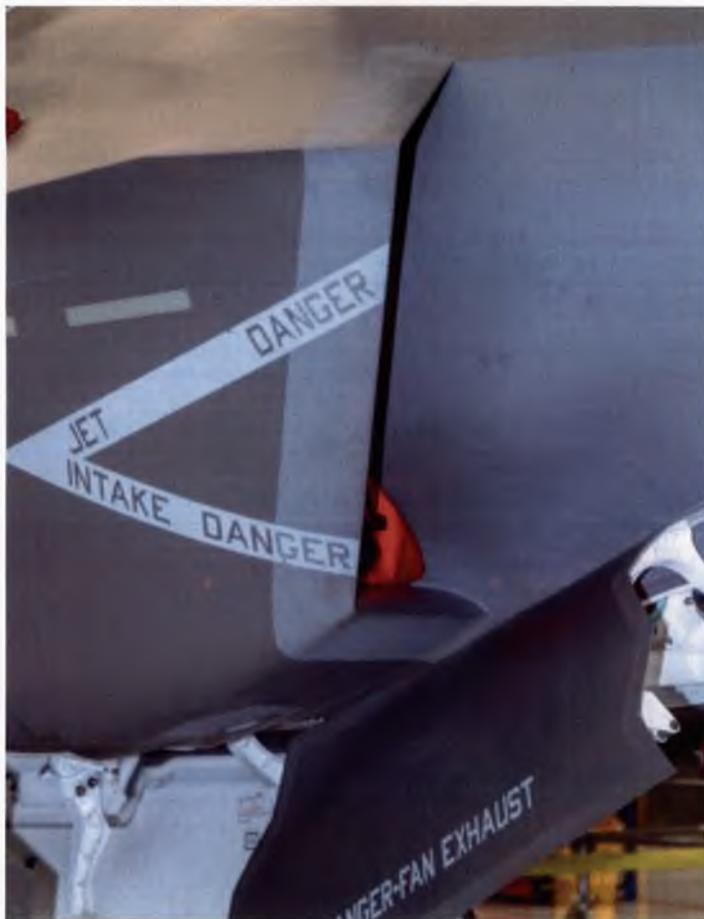
1.4.139. The intake blank was fitted using the photographs in the intake blank engineering evaluation test plan as a guide. It was notable that the inboard lower corner was exposed even when the rest of the blank was protected by the airframe (Figure 1.4.27). The curvature of the intake behind where the blank was fitted was complex in this region and the investigation noted that the geometry limited the ability of the blank to be pushed further aft into the intake.

Figure 1.4.27 – Blank fitted using Lockheed Martin engineering test plan. Intake blank inboard lower edge remains exposed.

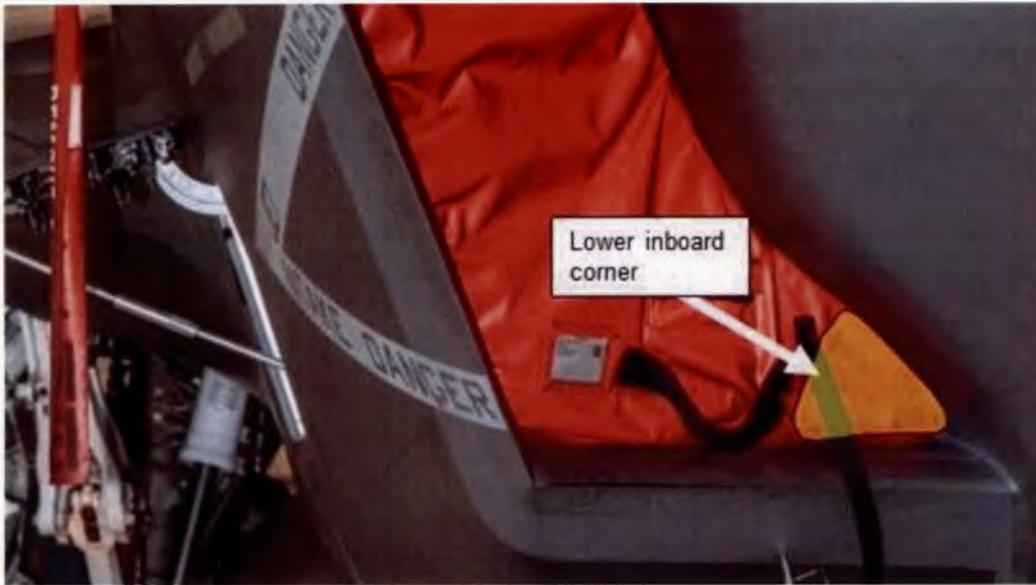
Figure 1.4.28 – Example of observed intake blank fitted to aircraft under maintenance, highlighting the inboard lower corner.

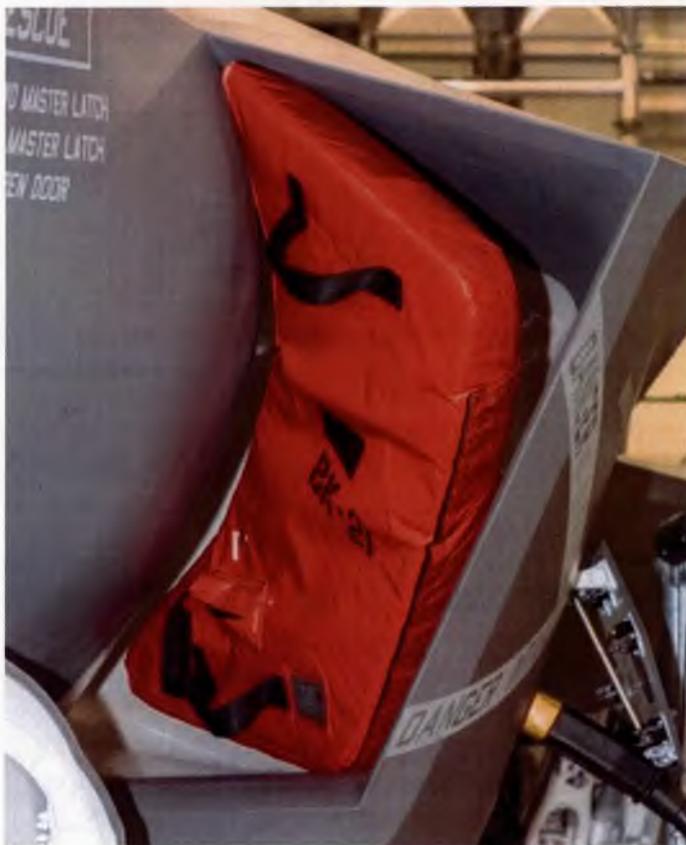
Figure 1.4.29 – Blank in the process of rotating following application of force in the bottom inner corner.

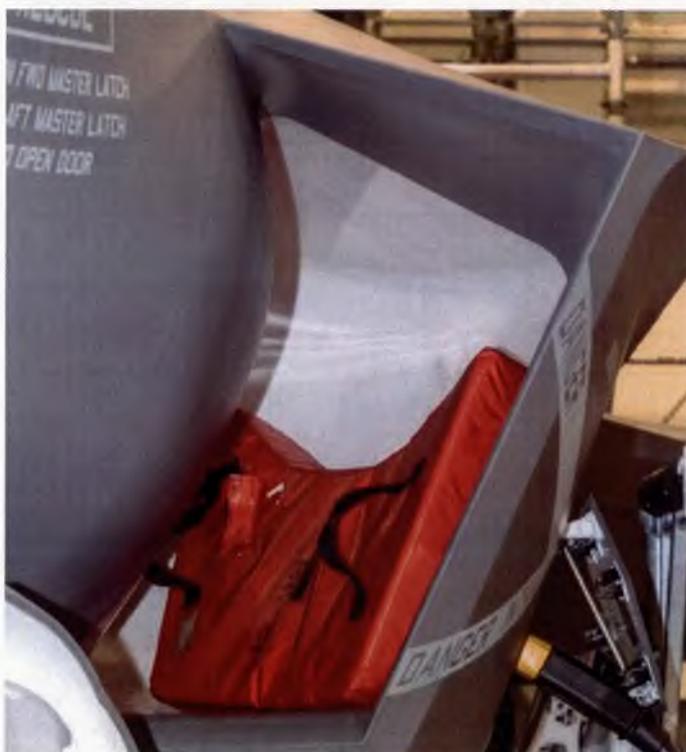
Figure 1.4.30 – Intake blank orientation after displacement.
