## SERIOUS INCIDENT

| <b>Aircraft Type and Registration:</b> | Pierre Robin R2160, G-BLWY | |
| <b>Location:</b> | Deenethorpe Airfield, Northamptonshire | |

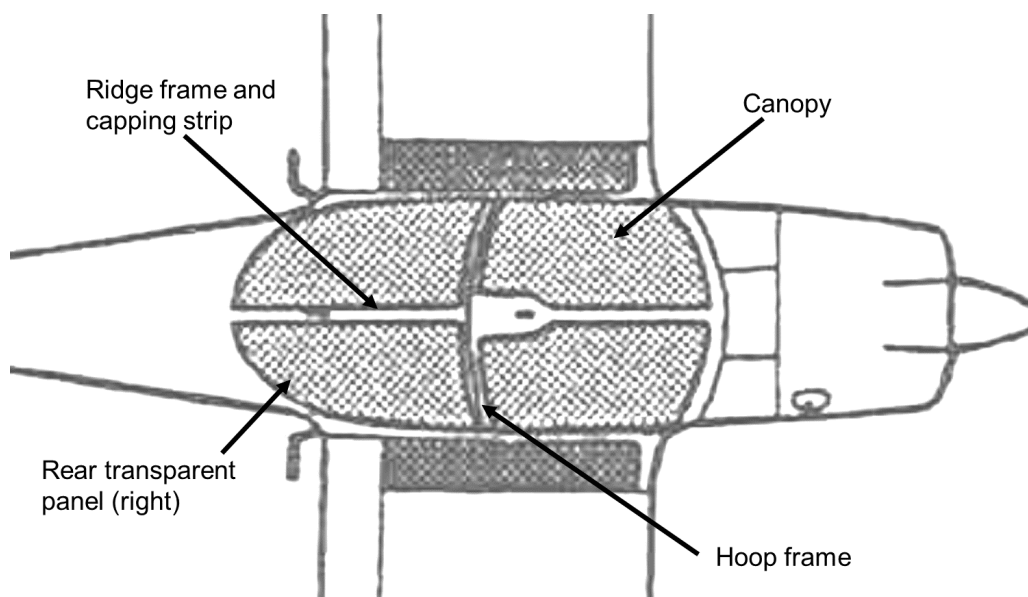
**Figure 1**

There are two (left and right) transparent panels over the rear area of the cockpit which extend from the edge of the fuselage to a central ridge frame (Figure 1).

Cockpit transparent panels and associated structure

The panels are bonded to the fuselage structure and supporting framework by a sealing adhesive. In addition, a line of screws along the side and rear edge of the panel secures the panel to the fuselage. A capping strip, held in place by screws, is fitted over the edges of each panel where they attach to the ridge frame.
