AAIB Bulletin

11/2023

Published 10 November

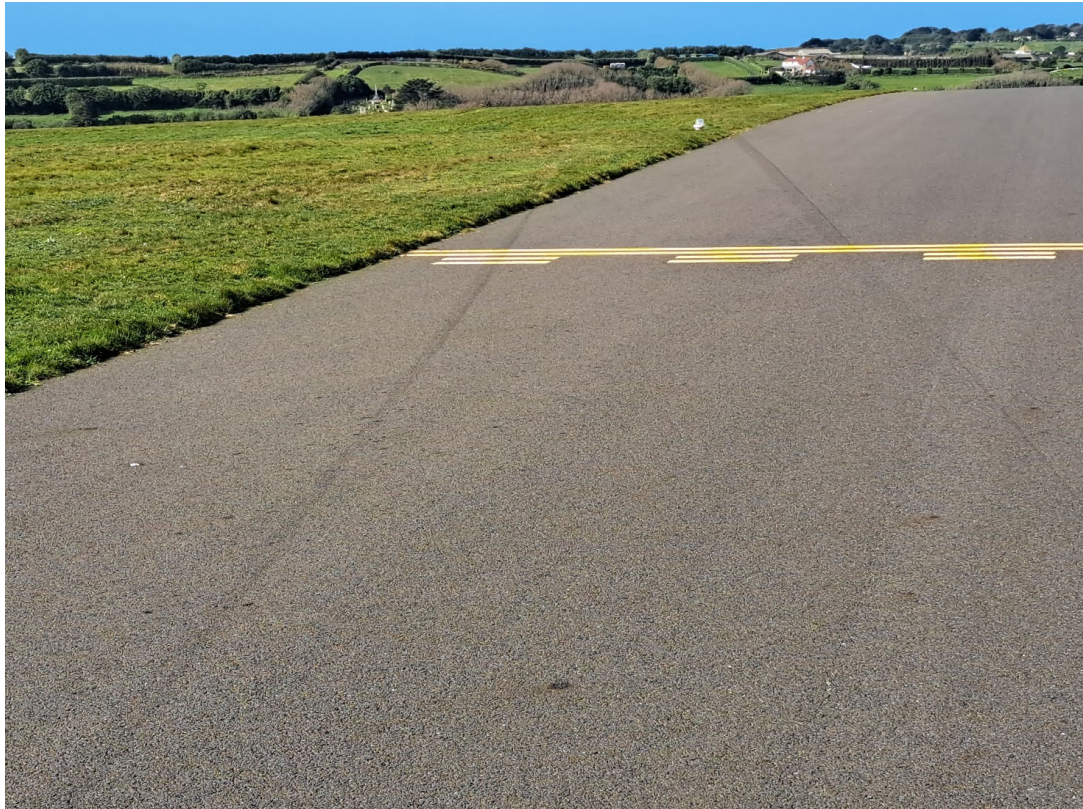
Figure 1

Inspection after landing revealed no damage to the aircraft. Tyre marks were found leaving the runway just past the runway intersection and extending approximately 12 m onto the grass (Figure 1).

Tyre marks found on Runway 27 leaving the runway to the left

It is likely that the combination of the gusting wind and the amount of in-to-wind aileron applied caused the aircraft to roll right and weathercock into wind. This caused the aircraft to veer left and leave the paved surface. The commander's decision to go around prevented a more serious outcome.

The operator has provided additional live wind information to their pilots in their crew room to give a better indication of the frequency and intensity of gusts over the previous 30 minutes. It is thought this will assist its pilots by giving them more knowledge about the wind conditions they are likely to experience in St Mary's.

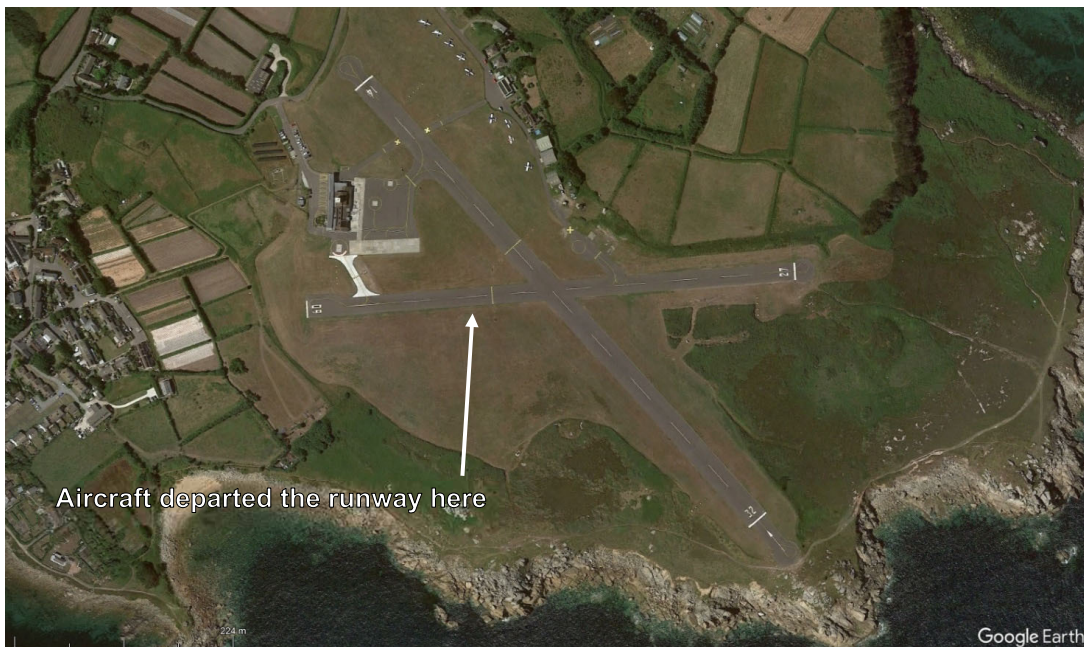
Figure 2

Aerial view of St Mary's Airport showing where the aircraft departed the runway (for orientation the yellow markings seen in Figure 1 can be seen in this view to the right of the point the aircraft left the paved surface)

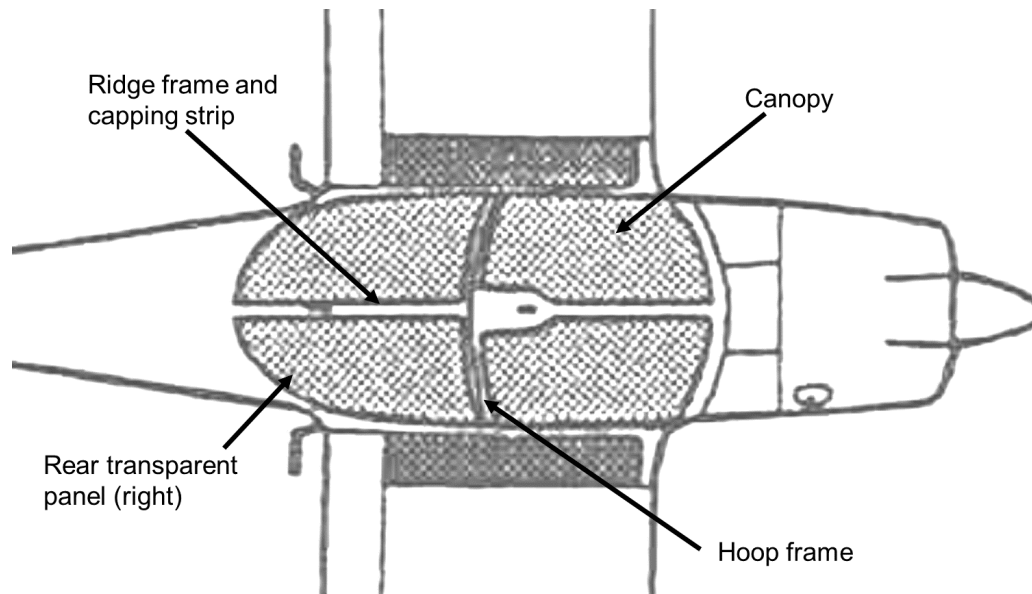
Figure 1

There are two (left and right) transparent panels over the rear area of the cockpit which extend from the edge of the fuselage to a central ridge frame (Figure 1).

Cockpit transparent panels and associated structure

The panel had broken away leaving jagged edged pieces of the panel attached to the side, rear and ridge frames; the screws and adhesive bond were still in place. The leading edge of the panel, where it attaches to a hoop frame just behind the seats (Figure 2) appears to have dis-bonded completely from the frame. It also appears to have taken parts of the canopy weather seal with it. A narrow bead of the adhesive sealant remained on the hoop frame. Examination of the left transparent panel found the bond along the hoop frame had started to come apart and could be lifted under finger pressure.

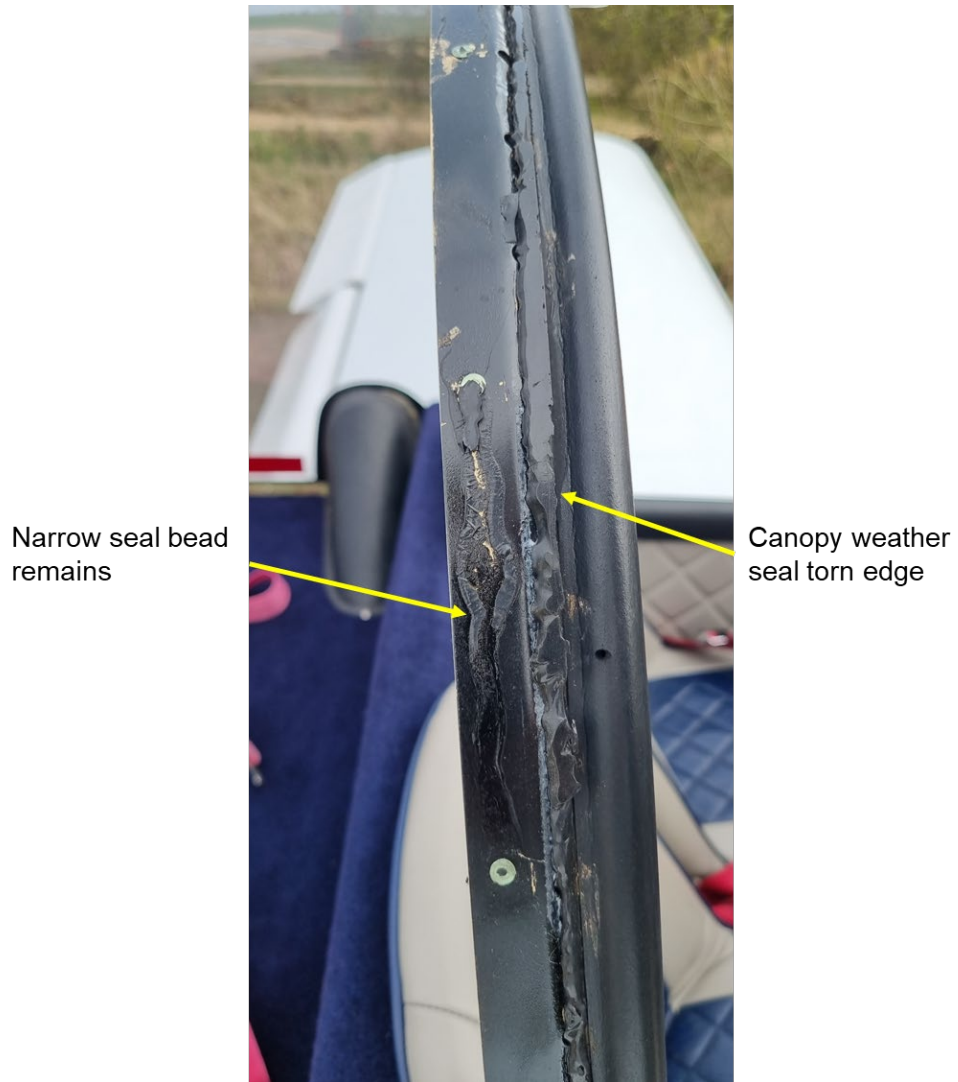
Although it is not fully clear what initiated the detachment of the panel, it is likely that the bond on part of the leading edge, where it attaches to the hoop frame, had failed. The upward force on the panel in flight was sufficient to open a gap and allow the airflow to pass between the frame and panel causing it to break.

It is known that polymethyl methacrylate¹ (PMMA) materials such as used in the panel do not tolerate adverse loads which can induce flexing or distortion from their preformed shape. This often results in the material rapidly cracking along rigidly held edges and breaking apart, which in this event can be seen by the remaining jagged panel pieces trapped under the screws.

Figure 2
Dis-bonded area and canopy seal on the hoop frame

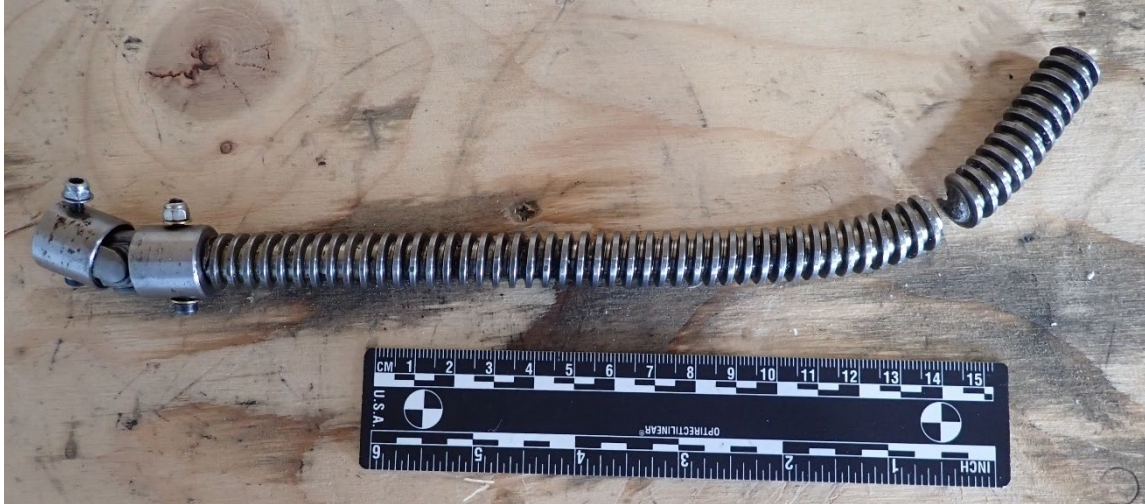
Figure 2

The left main landing gear threaded bar had buckled, fracturing towards its outboard/extended end (Figure 2).

Buckled and fractured G-OBWA left main gear jack screw

With the damage to the components, it was not possible to establish why the mechanism was not locked down; however, it is considered possible that the landing gear had not been correctly set up when the new components had been installed. As the jack screw had failed whilst in the extended position, it is considered unlikely that the issue identified with the incorrect tyre being fitted was linked to the landing gear failure.

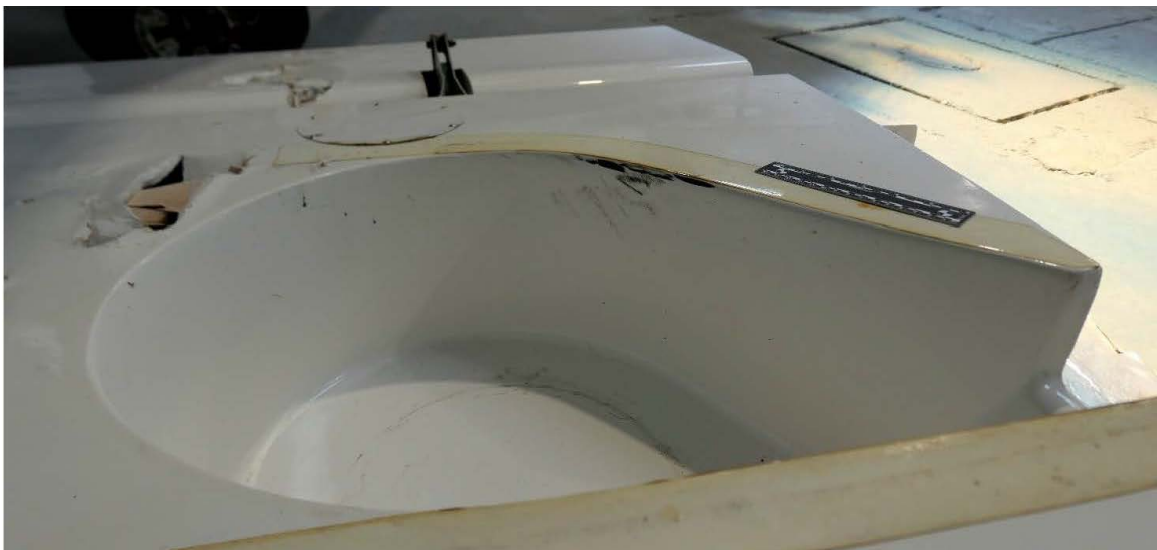
Figure 3

A scuff mark was identified in the wheel well (Figure 3), which indicated that the tyre had contacted the wheel well wall. Assessment of the wheel identified that the tyre fitted was not specified in the maintenance manual and was 2 inches wider than the specified tyre.

G-OBWA left wheel well (underside of wing) showing scuffing

The installation of the incorrect tyre, although unrelated to the landing gear failure, also serves as a reminder to ensure that only components included in the defined parts list should be fitted to an aircraft.
