B. J. UNWIN FORESTRY CONSULTANCY Ltd.

Site: **Land west of Robin Hood Road, Elsenham, Essex,
CM22 6EB.**

Subject: **BS5837 Tree Constraints, Tree Impacts and draft Tree Protection
Method Statement for OUTLINE Residential Development.**

Surveyor: Owen Hutchison.
Report:: Owen Hutchison. (professional-CV in Appendix VI).
Dates: Inspection 2018, updated 25th May 2023. Report: Stage 1: 14th June **Stage 2: 1st Sept & 9th Oct 2023.**

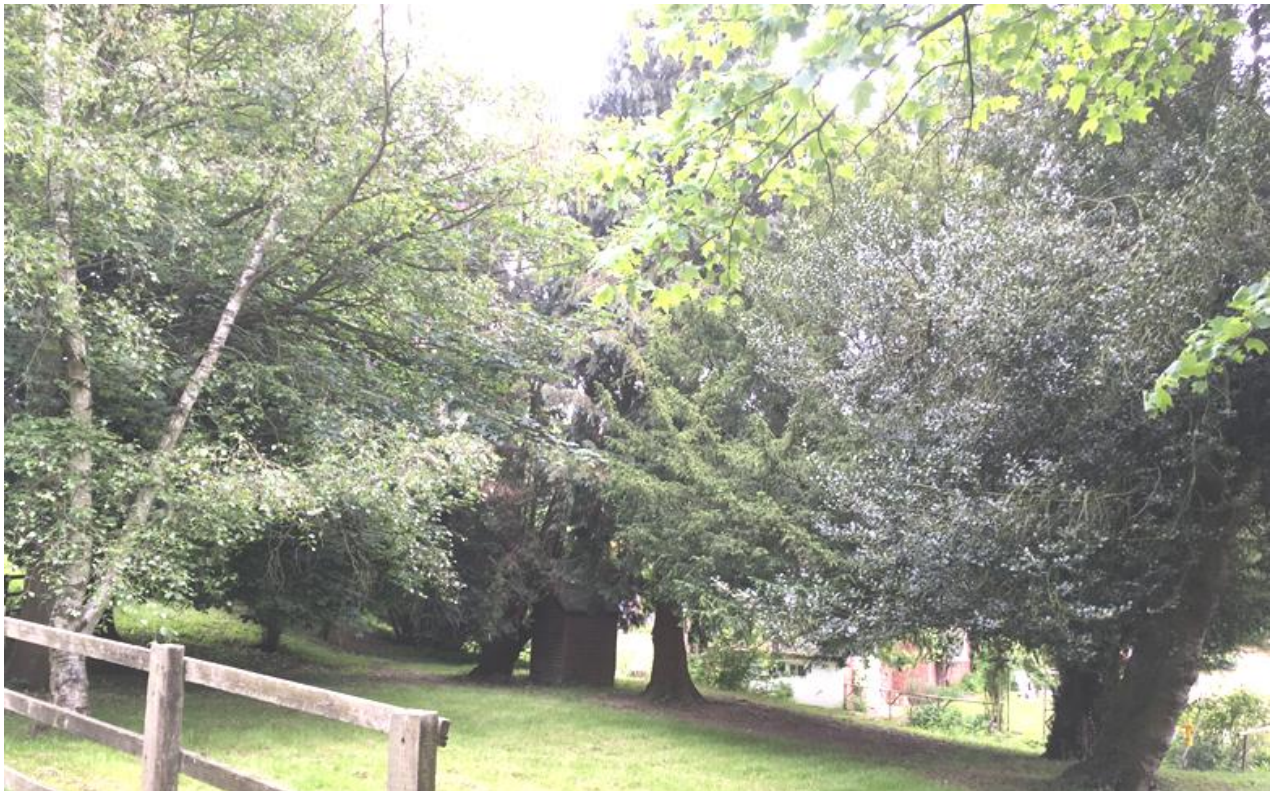
4.4.1 View east through garden trees T11 to T24.

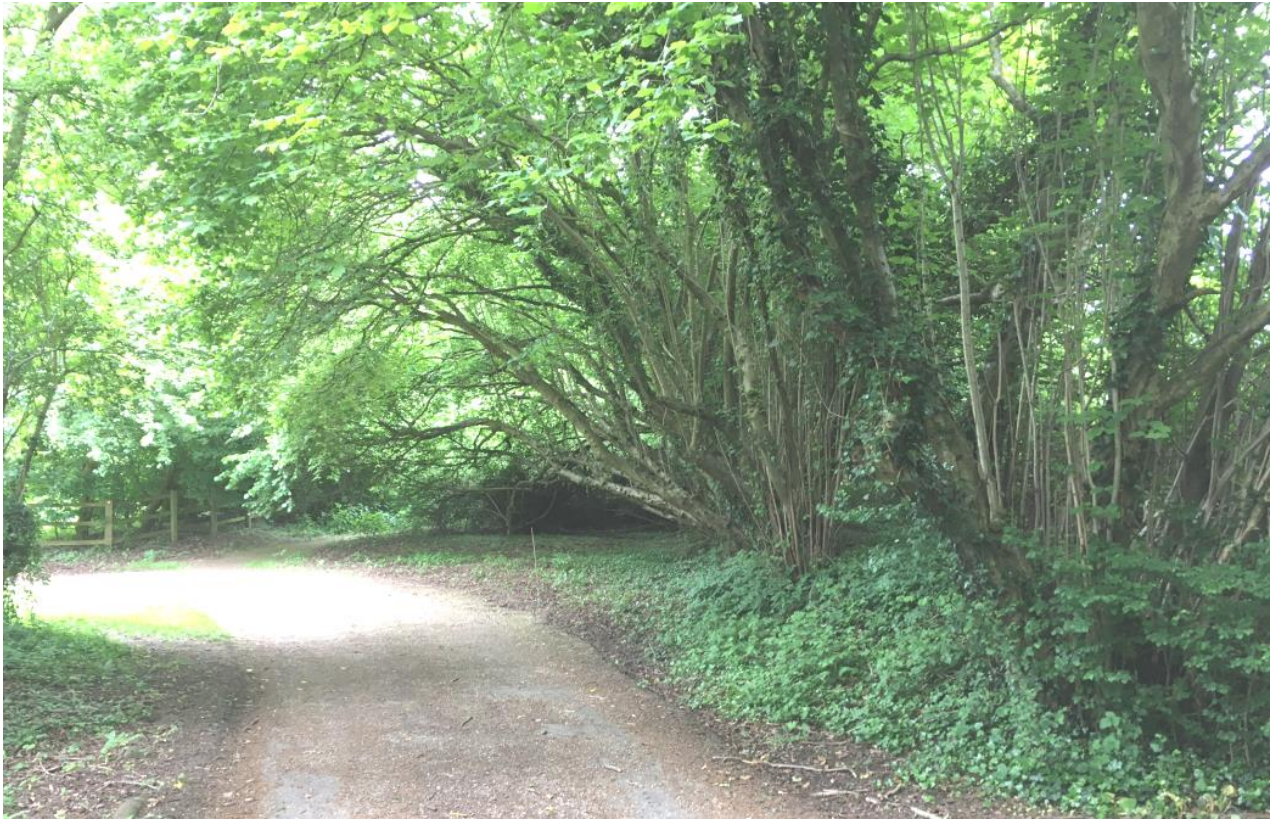
4.4.2 View south-west along access road old hazel coppices G26 to the right.

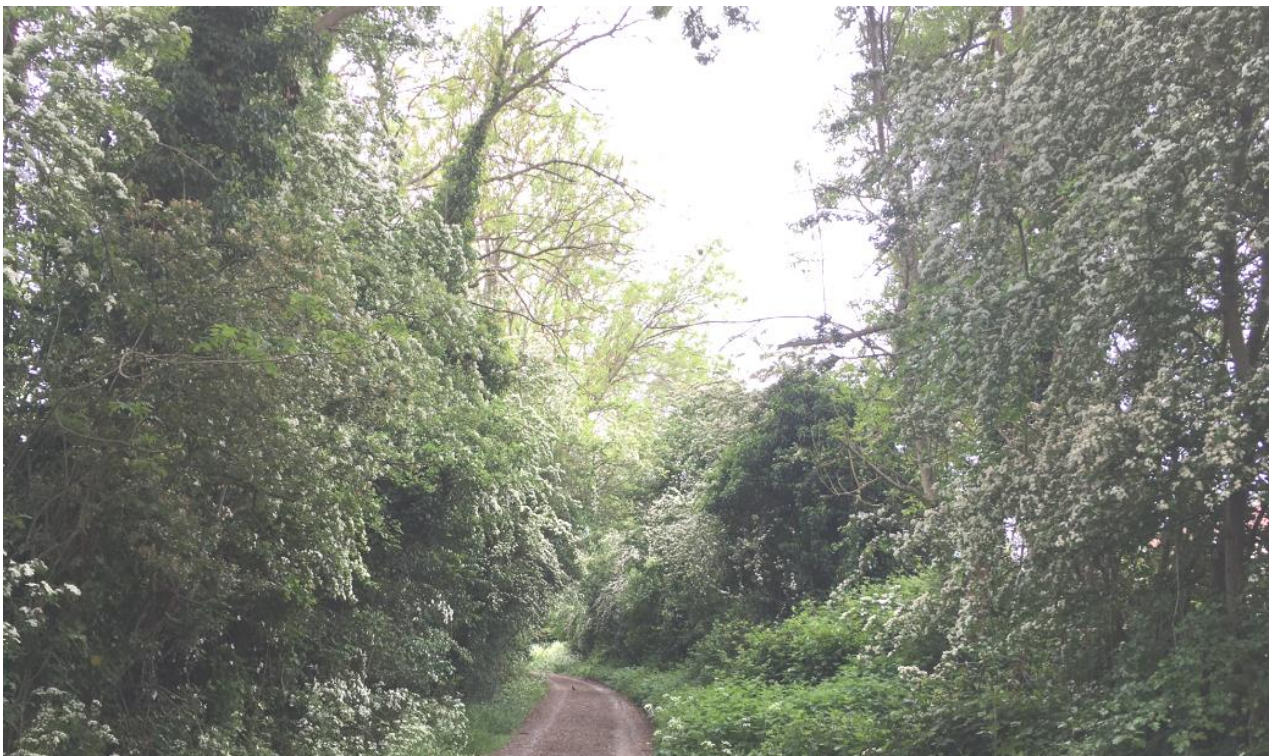
4.4.3 View south-west along the access road. Many ash exhibiting various stages of ash dieback, particularly along the south-eastern edge.

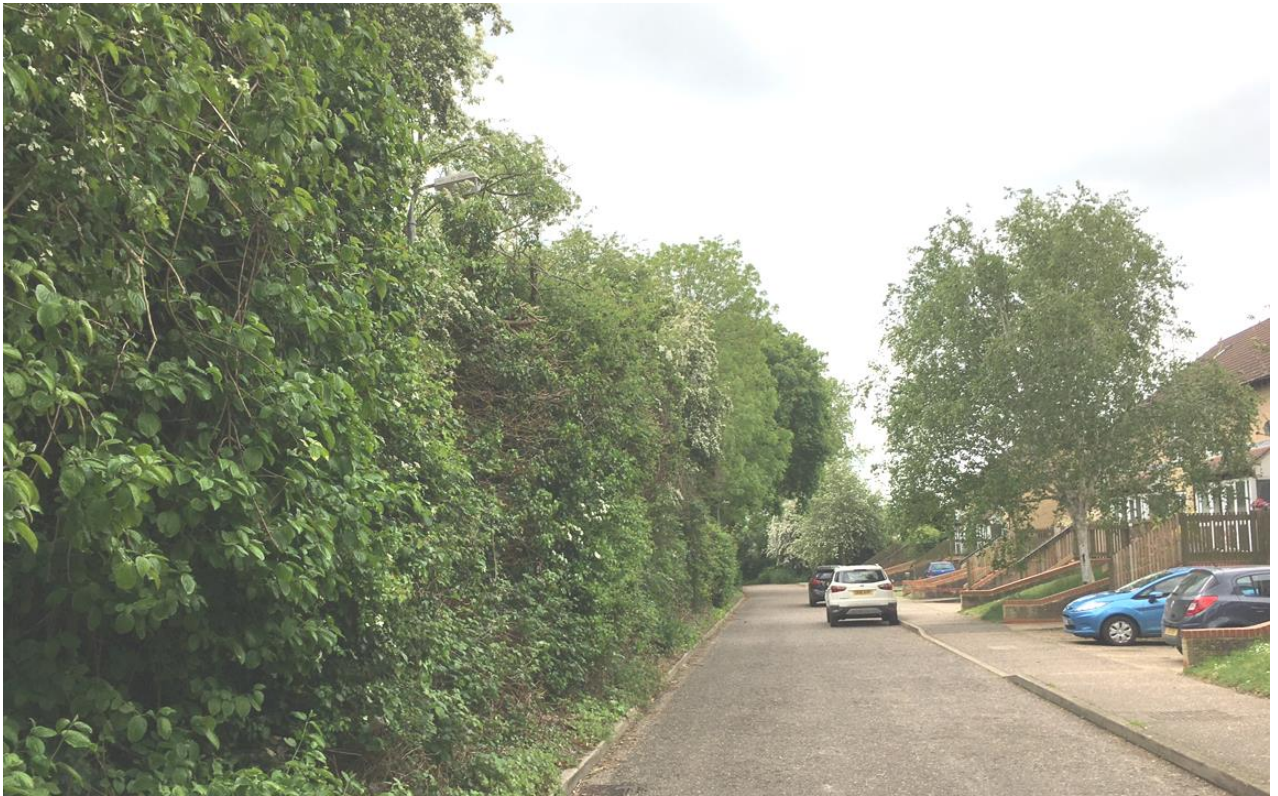
4.4.4 View south-west along Rush Lane. Hedge H56 to the left and off-site birch T55 to the right.

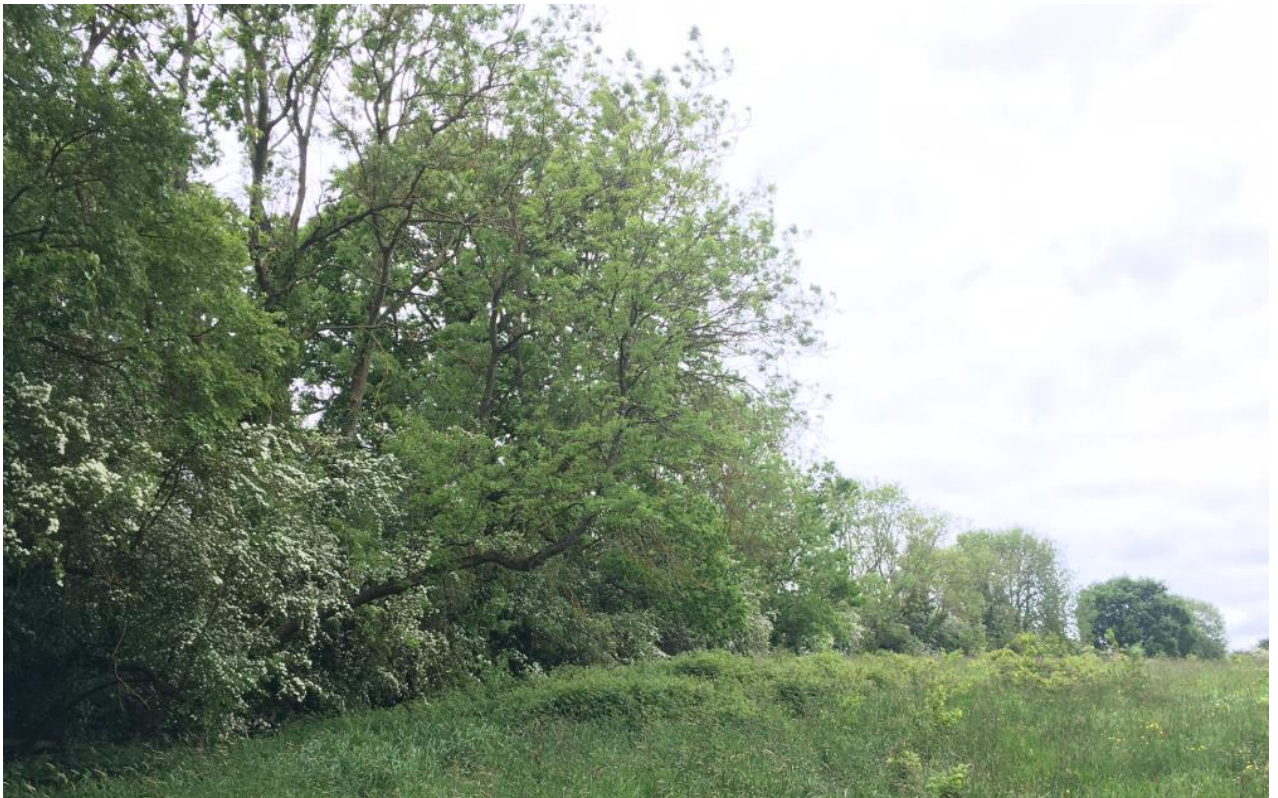
4.4.5 View north from inside the site, showing trees along the south-eastern edge of the access track.

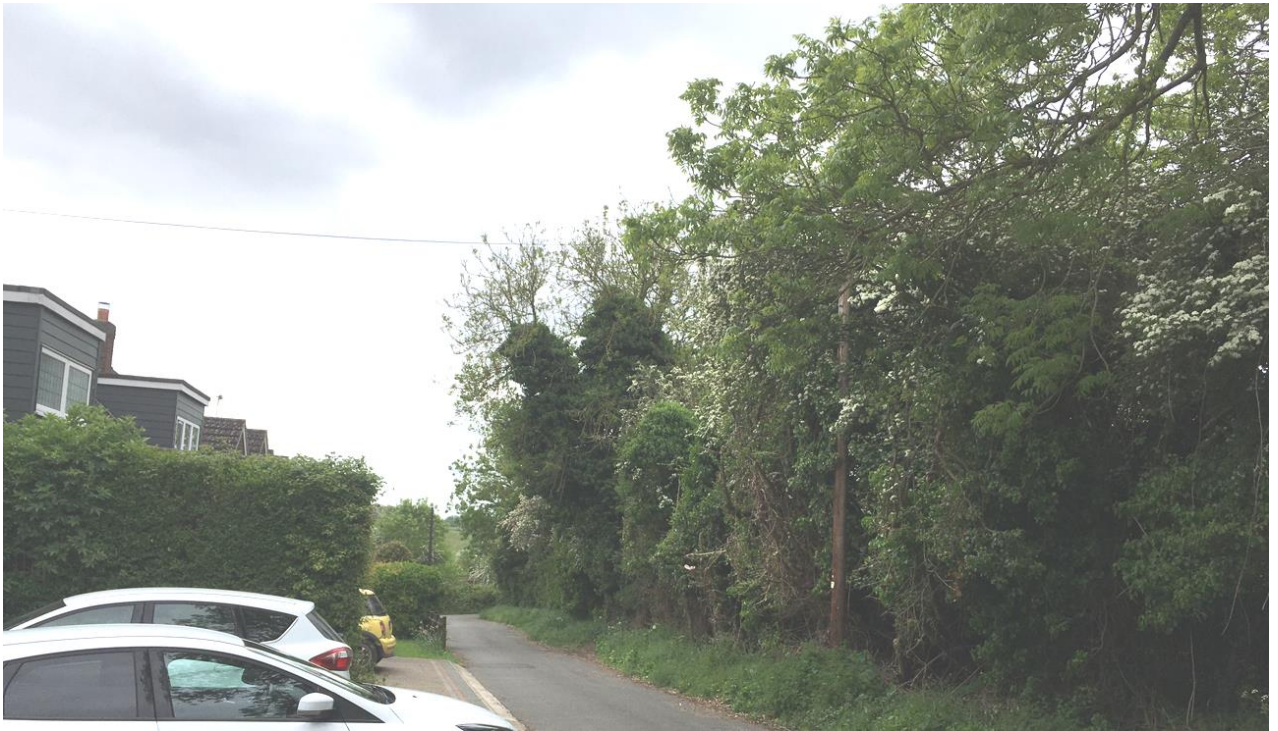
4.4.6 View south along Robinhood Lane. Smaller ash trees exhibiting symptoms of ash dieback.

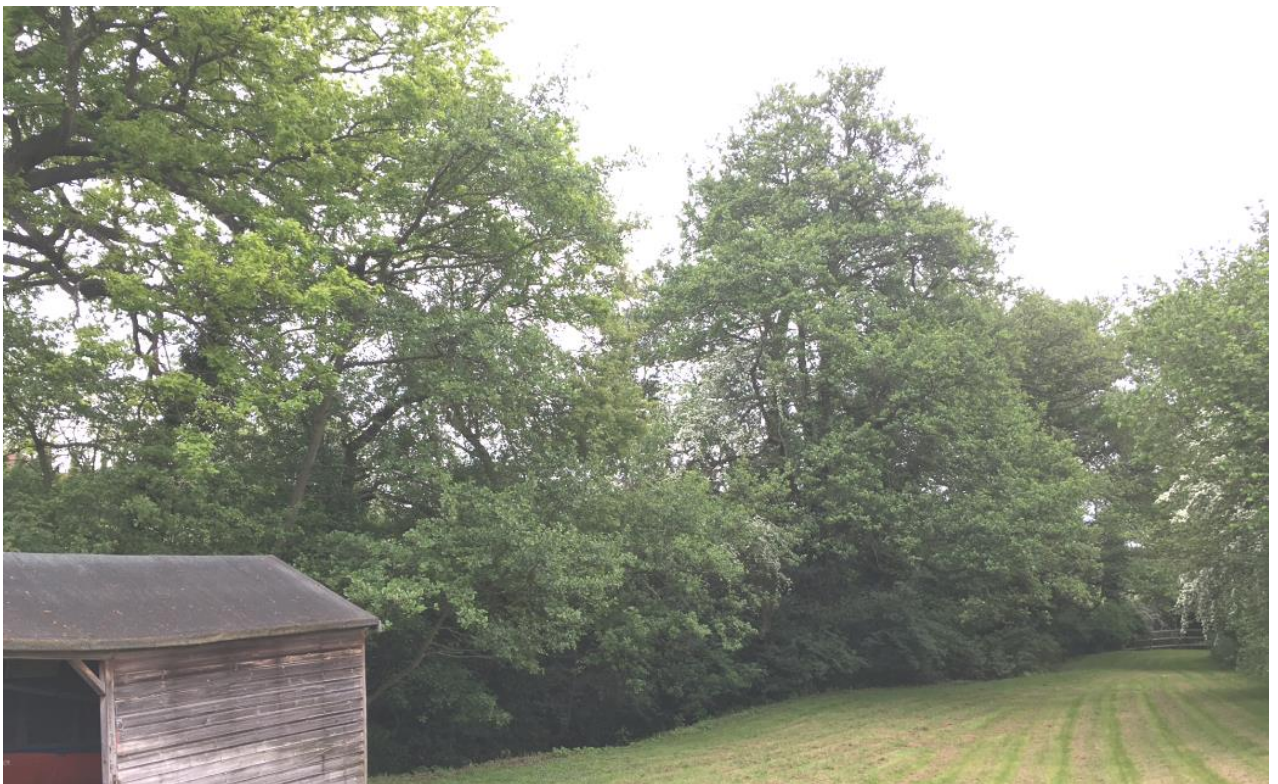
4.4.7 View north-east along the rear garden of Mill House. Trees T68 to G87 located on both sides of the stream.
