Rail Accident Investigation Branch

Rail Accident Report

Collision between passenger trains at Salisbury Tunnel Junction, Wiltshire 31 October 2021

Report 12/2023
October 2023

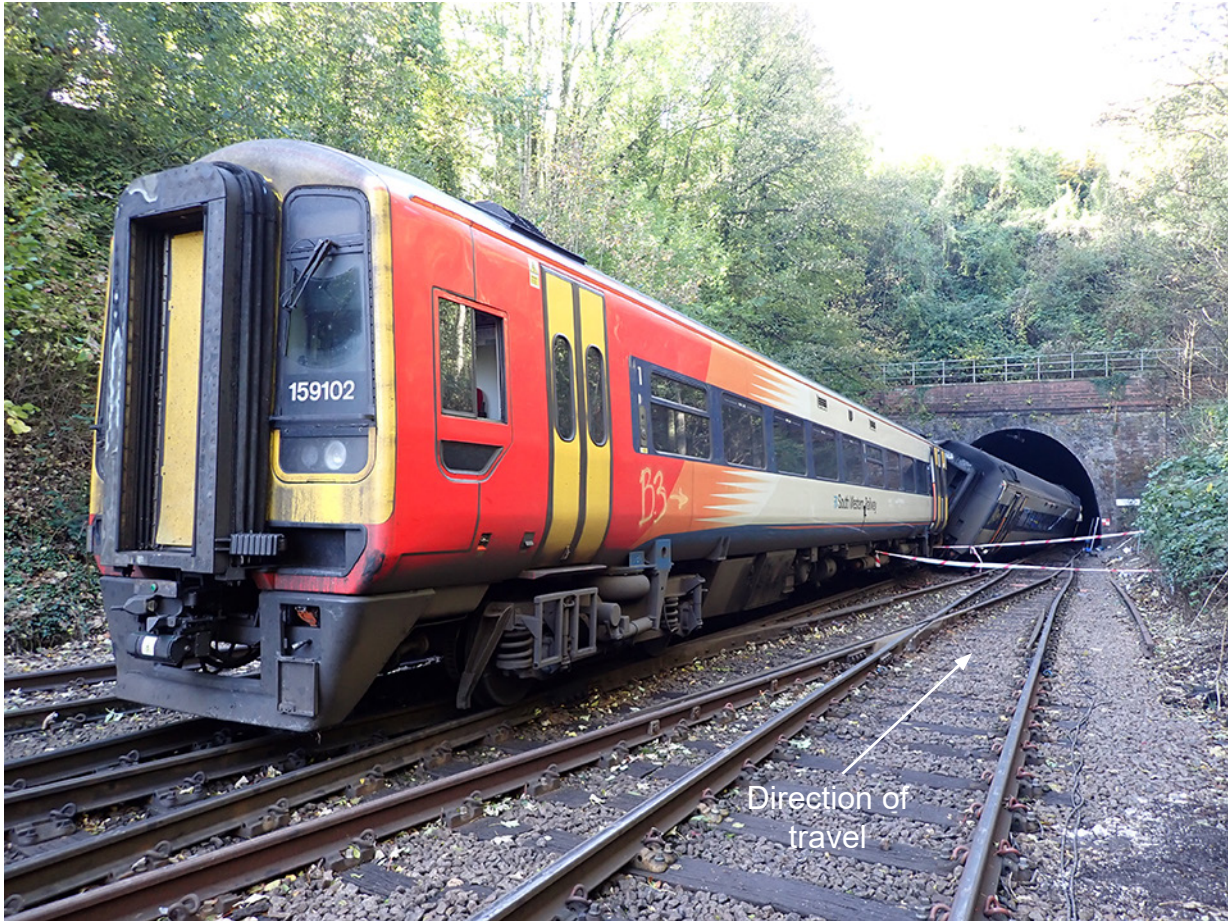
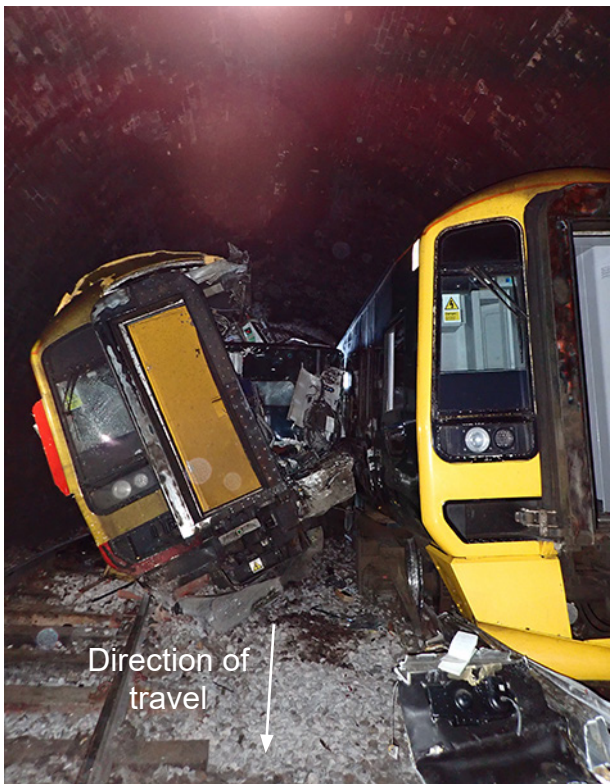
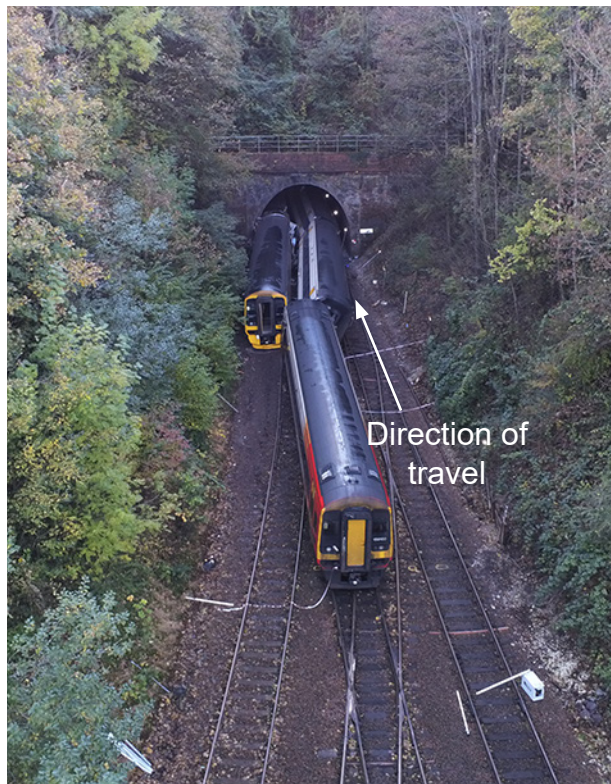
Figure 4: The aftermath of the accident.

- 7 The accident caused substantial damage to the track, the tunnel and the surrounding railway infrastructure. The leading carriage of train 1L53 and the rear two carriages of train 1F30 were damaged beyond economic repair. The rear two carriages of train 1L53 were less seriously damaged and the leading two carriages of train 1F30 were undamaged.
- 8 The driver of train 1L53 was seriously injured in the accident and spent three weeks in hospital. Thirteen passengers were also taken to hospital, with one suffering serious injuries. A further ten passengers were treated at the scene for cuts and bruises.
- 9 In total, there were 197 passengers and five members of staff on the two trains. Each train had a driver and a guard on board. There was also an on-duty driver travelling as a passenger on train 1F30 when the accident occurred.

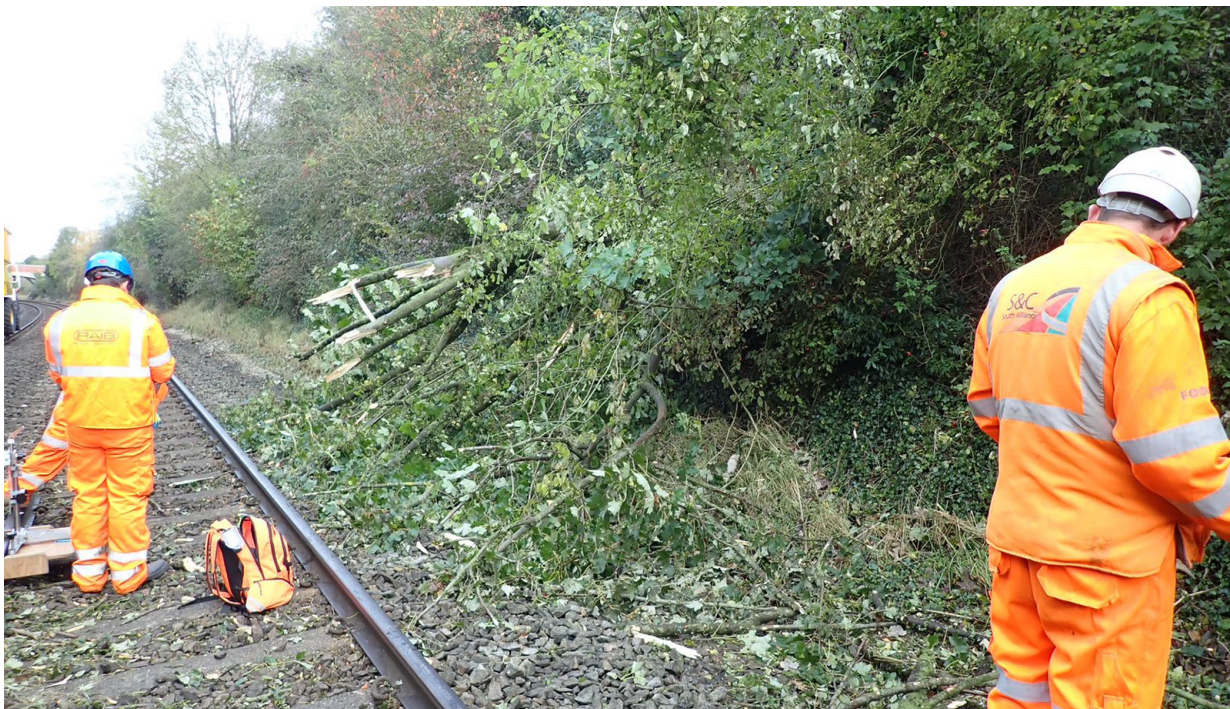
- 47 At 08:44 hrs on 31 October 2021, a train not involved in the accident, train 1L13, struck a tree⁴ that had fallen onto the Down Main line at 80 miles 70 chains, around 250 metres west of Broken Cross bridge (80 miles 58 chains) (figure 5). The collision damaged the cab of the train, but no injuries were reported. The driver of 1L13 reported that they came to a stop in the vicinity of the AWS magnet for signal SY29, which was approximately 1350 metres beyond the fallen tree. On reporting this incident to the signaller, the driver stated that the train's braking was affected by "slipping" before colliding with the tree, but the conversation did not identify railhead contamination as a factor. There was no mobile operations manager (MOM)⁵ available from Network Rail to attend the incident, so the train's driver and guard cut back the branches that were foul of the railway line, leaving the tree in the cress of the Down Main line (figure 7). The line was reopened at 10:44 hrs.

Figure 7: The tree struck by train 1L13 (post-collision) on the Down Main line looking east towards London with Broken Cross bridge in the background.

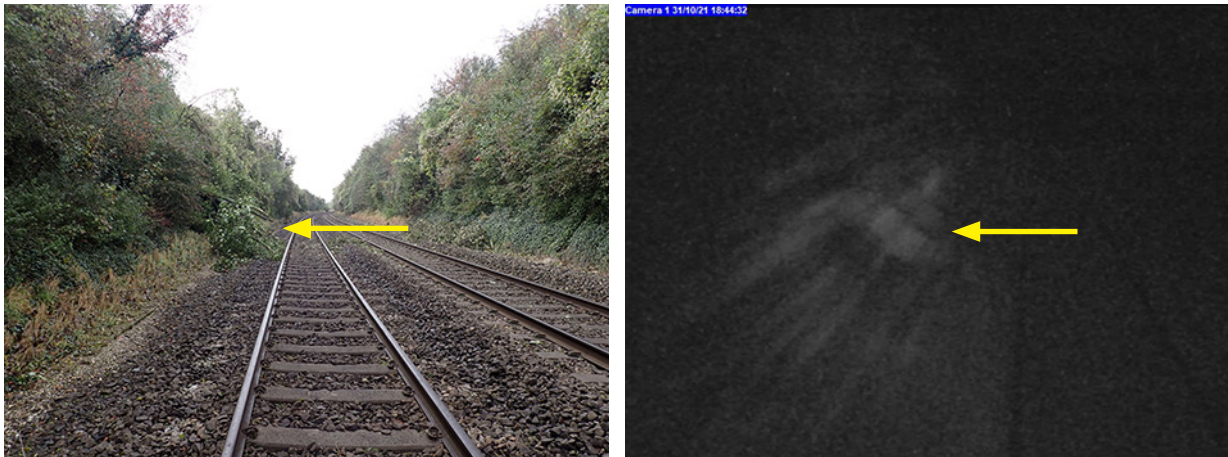
Figure 8: (left) Tree that was struck by train 1L13 (branches had been cut back by the train driver and guard) and later observed by the driver of train 1L53 (when driving train 1L52 on the Up line to London Waterloo) and (right) enhanced image taken from train 1L53 FFCCTV system.

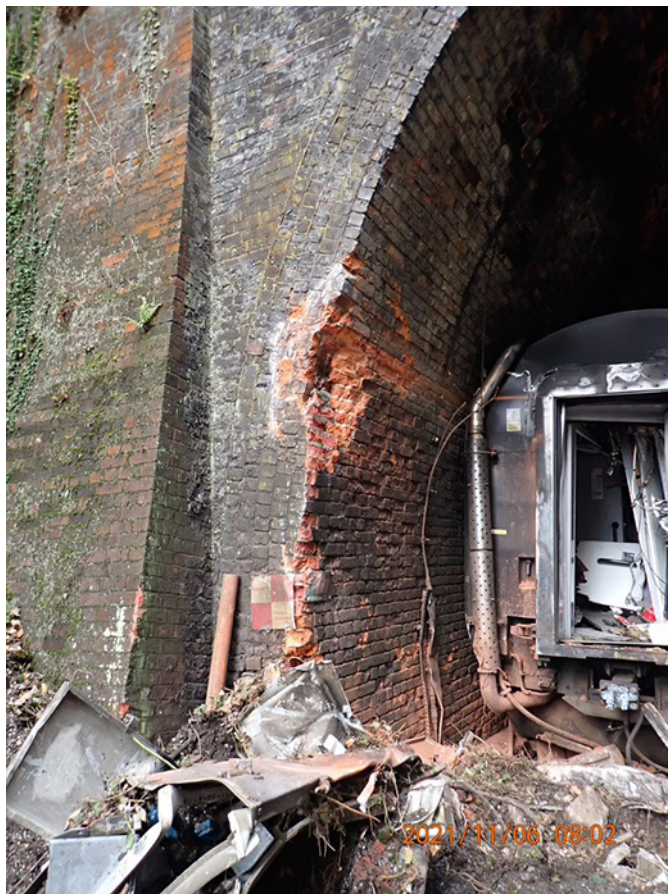
- 71 The fourth carriage of train 1F30 was displaced to the left by the impact, resulting in its leading left corner coming into heavy contact with the facing portal wall of Fisherton Tunnel (figure 12). This caused a failure of the coupling between the second and third carriages of train 1F30, opening a gap of 23.8 metres between the two halves of the train. At this time, passengers intending to leave train 1F30 at Salisbury station were still seated, and no passengers were standing in the vestibule area where the train parted.

Figure 12: Impact mark from carriage A4 on facing portal wall of Fisherton Tunnel. Vestibule of A3 is visible and carriage A4 has been removed.

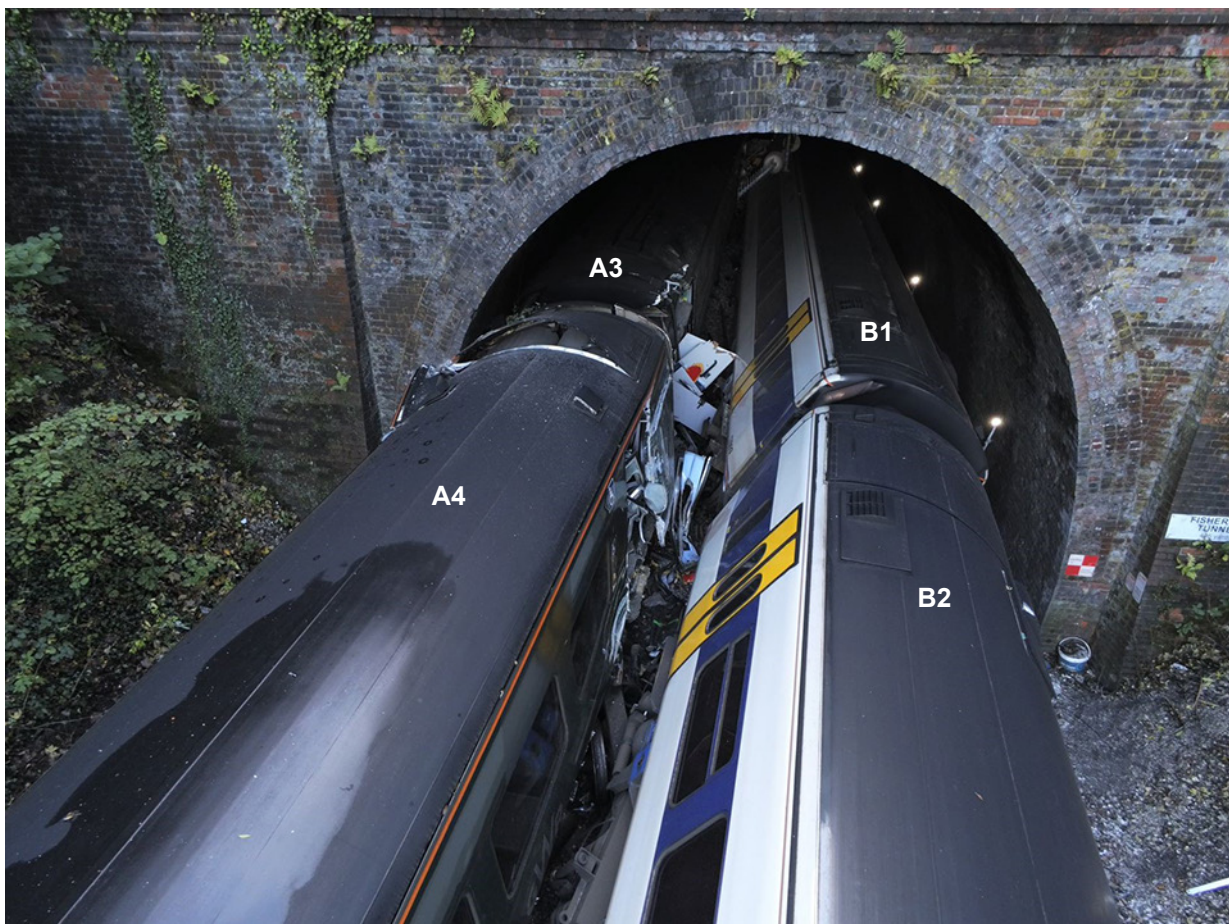
- 72 Both trains travelled into Fisherton Tunnel, with the tunnel walls acting to keep the carriages upright. The rear two carriages of train 1F30 and all carriages of train 1L53 derailed, with the cab of train 1L53 being severely damaged. The front carriage of train 1L53 came to rest adjacent to the leading end cab of the third carriage of train 1F30 (figures 13 and 14).

Figure 14: View from London portal of Fisherton Tunnel showing the rear carriages of train 1F30 (A3 and A4) and front carriages of train 1L53 (B1 and B2).

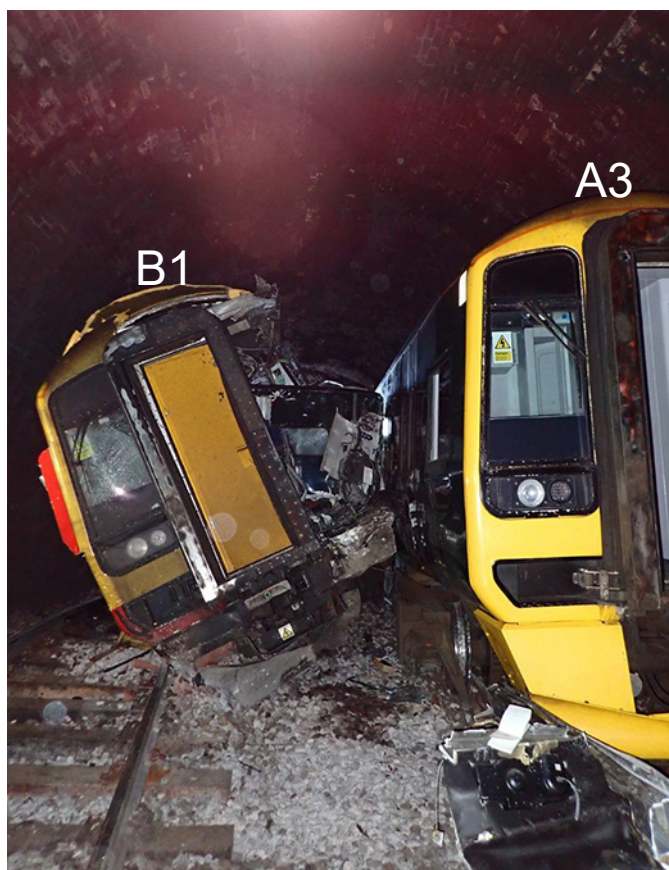
- 73 The driver of train 1L53 was injured in the collision and was trapped in the heavily damaged cab (figure 15). At around 18:46 hrs, the guard on train 1L53 attempted to contact the driver but was unsuccessful in doing so. The guard then tried to make a railway emergency call to the signaller using the GSM-R⁸ train radio in the rear cab, but this again was unsuccessful. They then used their mobile phone to contact the emergency services and provided information from 18:45 until 19:15 hrs when they were met by responding fire and rescue personnel.

Figure 15: View from within Fisherton Tunnel showing the front cab of train 1L53 (B1) and carriage A3, having separated from carriage A2, of train 1F30. Parts of the driving cab of train 1L53 have been cut away by the emergency services to release the trapped driver.

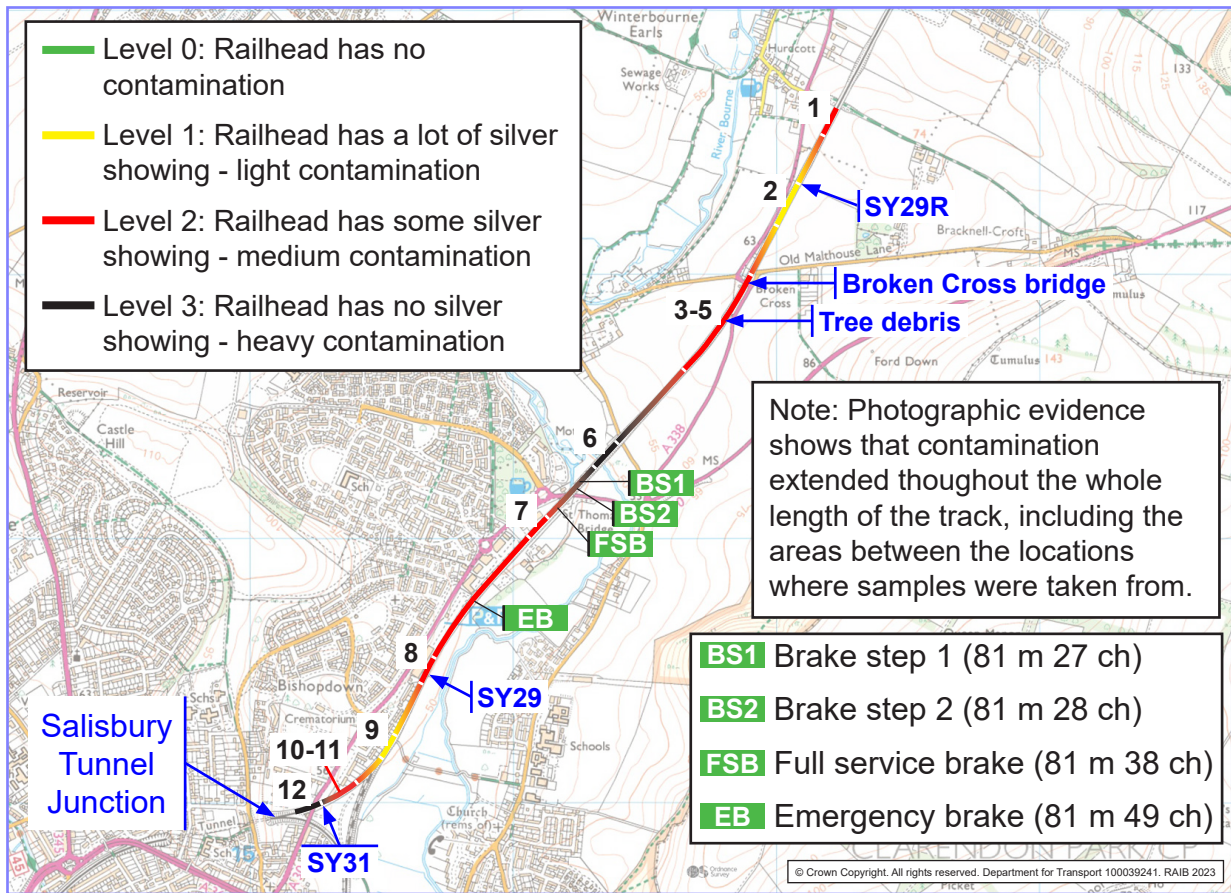
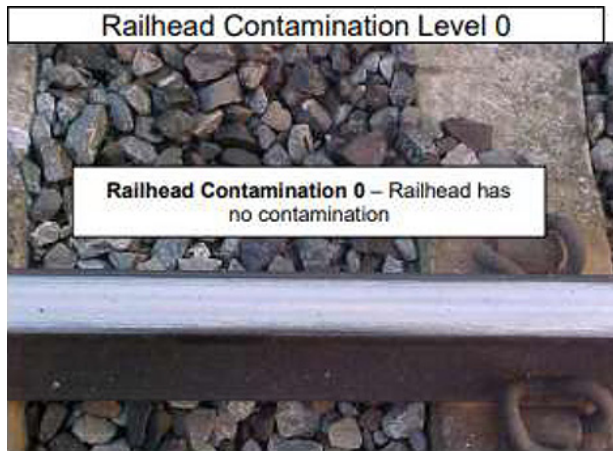
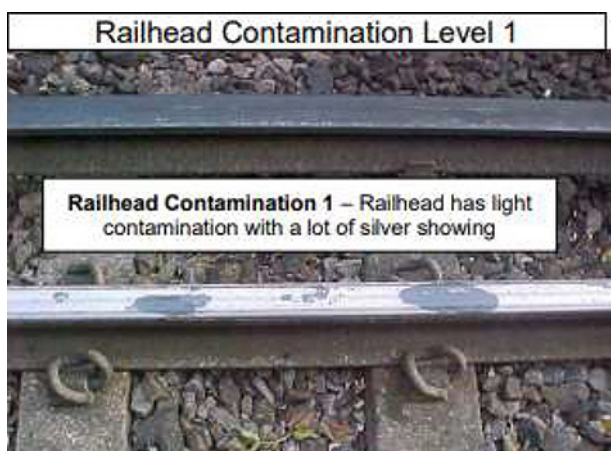
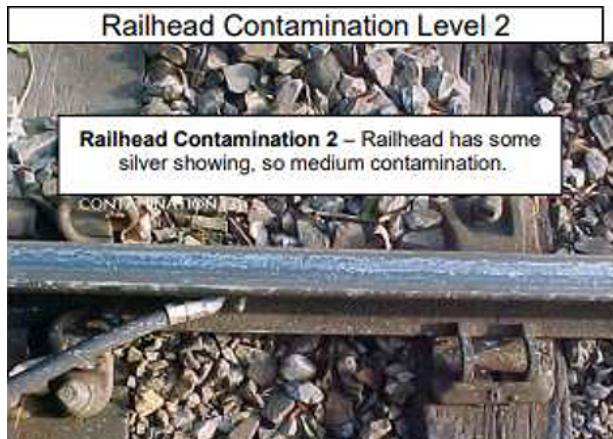
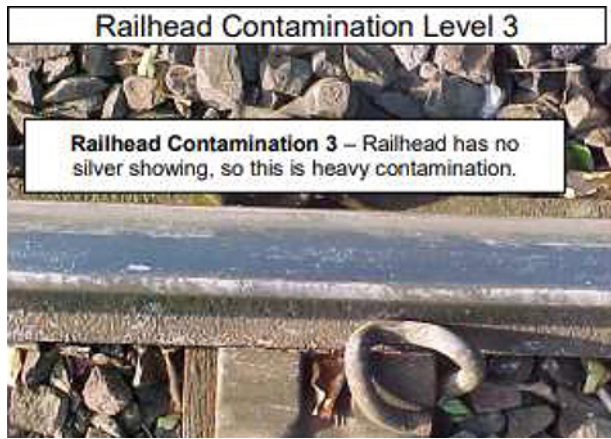
Figure 24: Post-accident sample locations and (below) Network Rail classification of contamination levels (NR/L3/OPS/045/4.07).

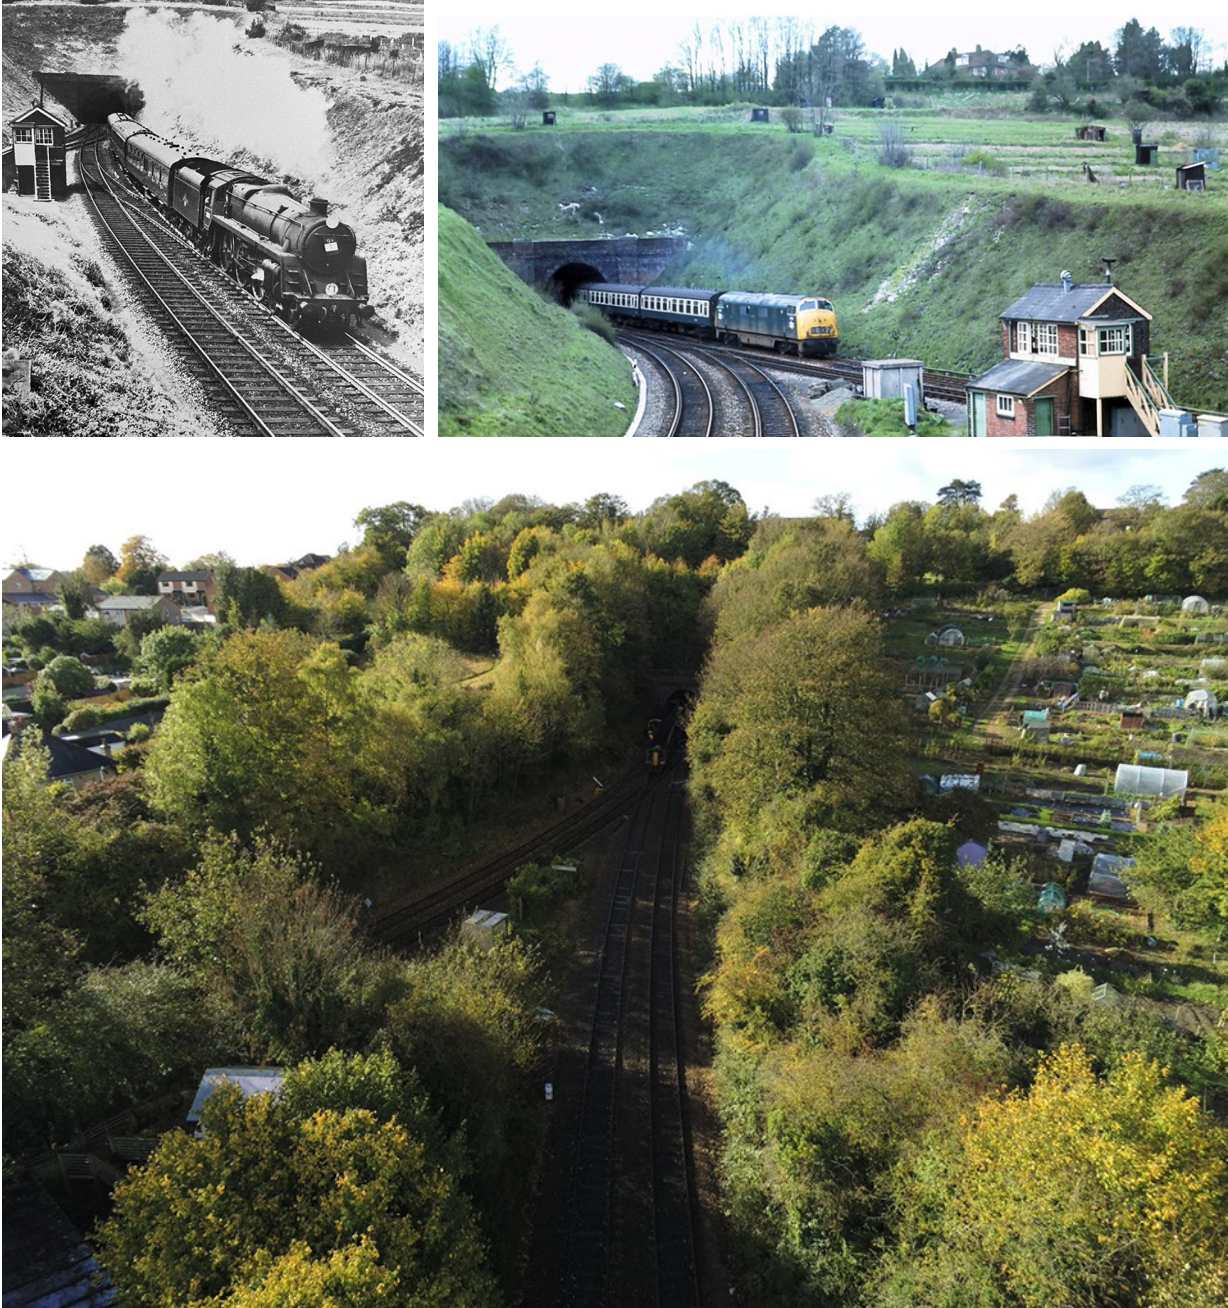
- 147 No action to manage the vegetation had been taken between 2018 and 2021 and video footage shows that vegetation continued to grow on the main lines approaching Salisbury Tunnel Junction between 2019 and 2021. A comparison between the 2021 scores and those from earlier inspections therefore brings into question the robustness of the process. It is also unclear whether classification of sites with an assessment score of between 21 and 26 as *'high risk during peak leaf fall period and wet conditions'* in NR/L2/OTK/5201/F3076 may have affected the contractors' scoring. As explained in paragraph 139, operational standard NR/L2/OPS/095 did not require any action to be taken for such sites, but the contractors were unlikely to have been aware of this. Figure 32 shows the change in the management of vegetation at Salisbury Tunnel Junction over the previous decades.

Figure 32: The Up and Down Dean and Main lines looking towards Fisherton Tunnel in 1963 (top left, courtesy of Crecy publishing), in the 1970s (top right, courtesy of Crecy publishing), and on 1 November 2021 (main image).

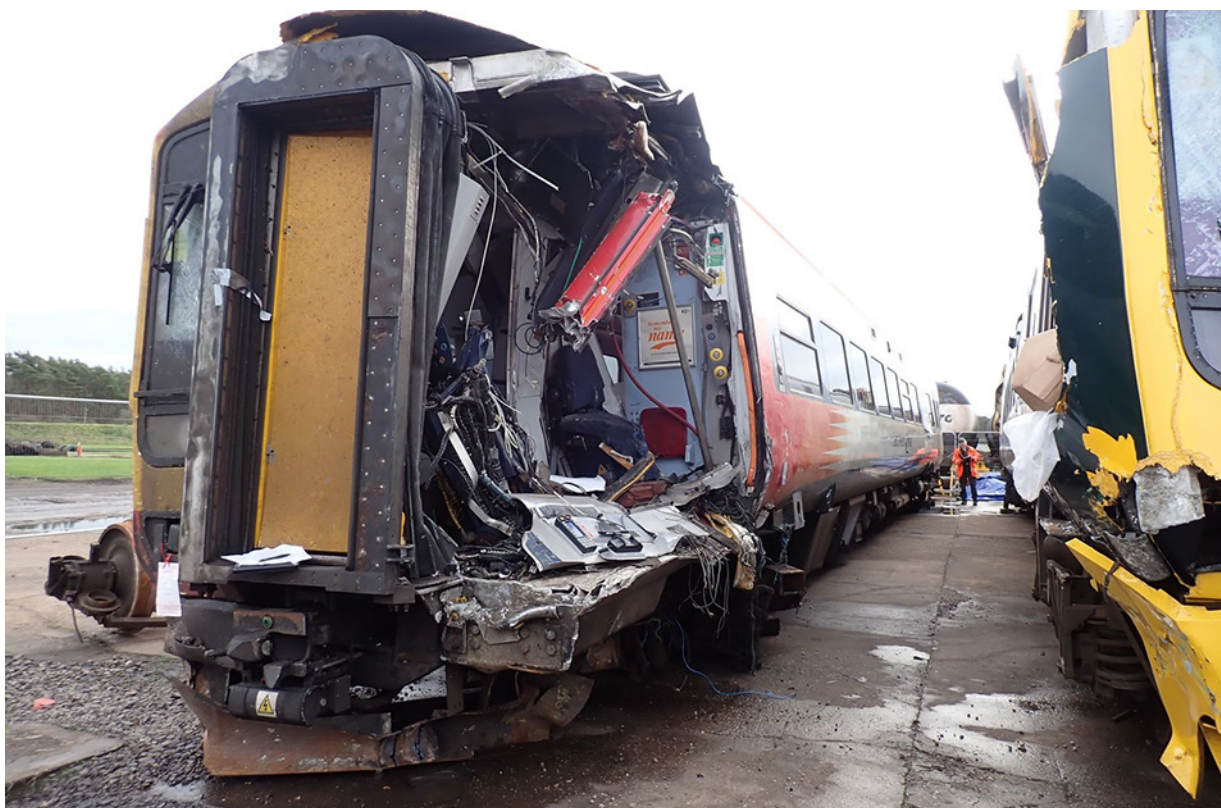
Figure 45: Cab of train 1L53 (additional damage was caused by the fire and rescue service during the extraction of the injured train driver).

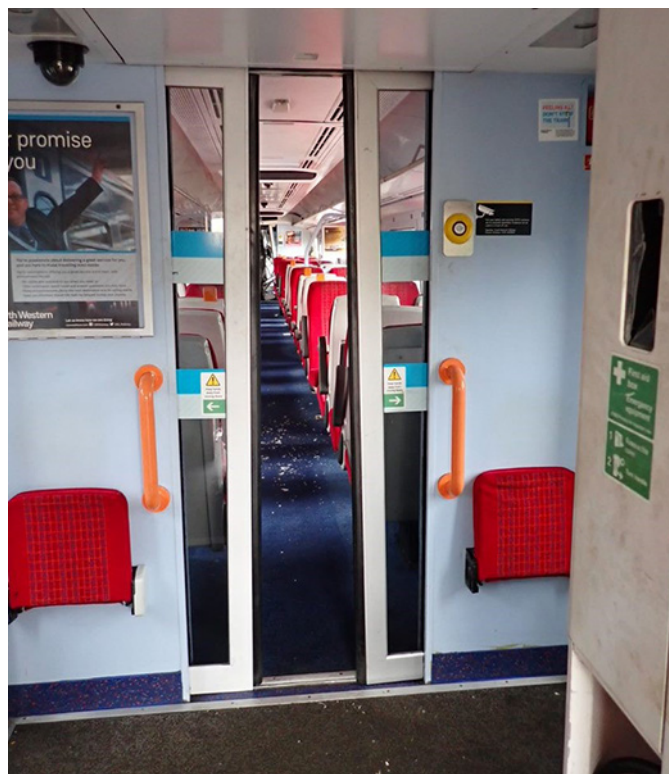
Figure 46: Image showing jammed vestibule door of the leading carriage of train 1L53.

One recommendation is made to Porterbrook, Eversholt and Angel Trains regarding the design of the internal sliding doors on class 158 and 159 carriages.
