# Rail Accident Report

## **Serious injury to a passenger alighting from a train at Loughborough Central station 14 January 2023**

Report 13/2023  
October 2023

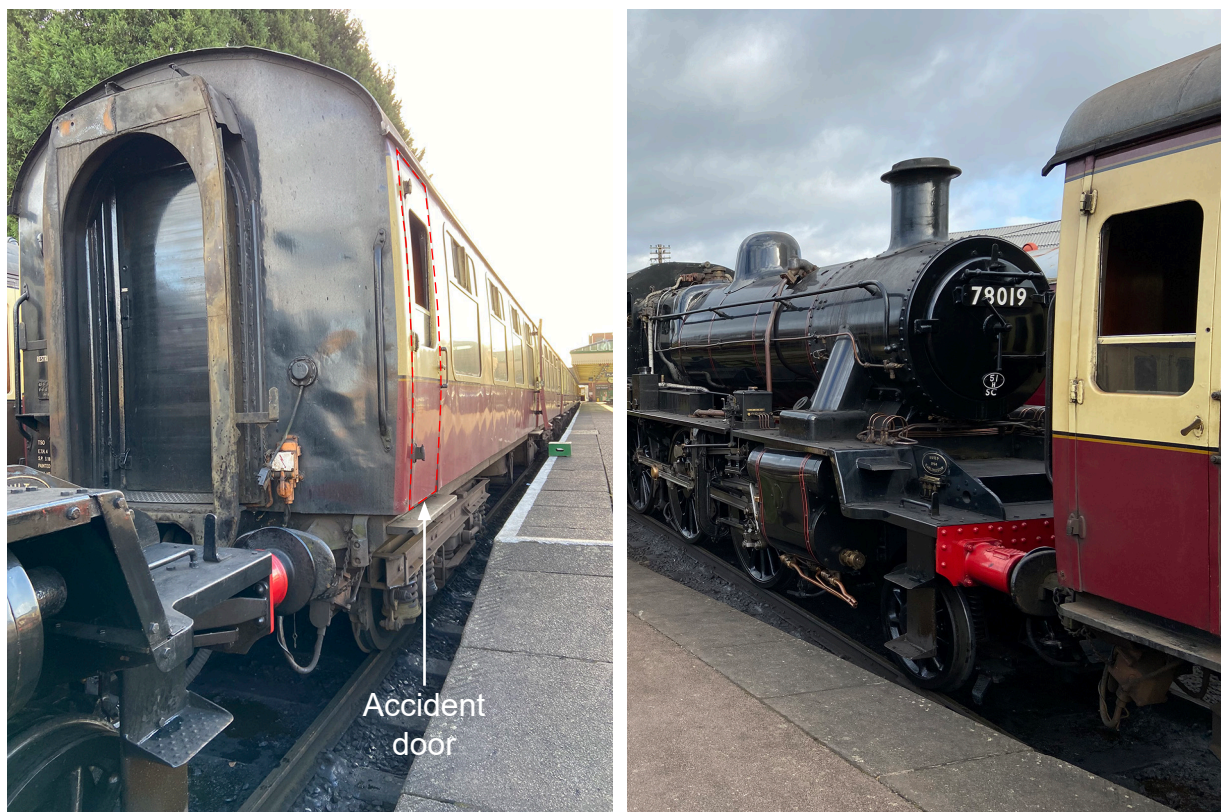
Figure 6: The north end platform ramp.

- 55 Loughborough Central station has two platforms, numbers 1 and 2, located between the Up and Down Main lines (a configuration referred to as an 'island platform' (figure 3)). Platform 1 runs along the east side of the station. The horizontal length of each platform, between the ramps at each end, is 122 metres.
- 56 At the north end of the island, a ramp is provided which slopes from platform height to ground level. This ramp runs across the whole width of the platform island. Visitors can use a path down the middle of the ramp to access a walkway that leads to the Locomotive Shed and a picnic area. The level part of the platform is marked out by white lines painted on the platform edge. At each end, where the platform end ramp starts, there is a short white line perpendicular to the platform edge (figures 6 and 11).

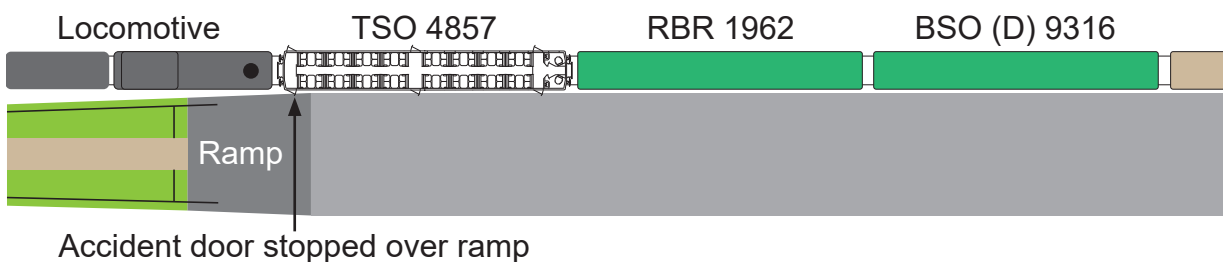
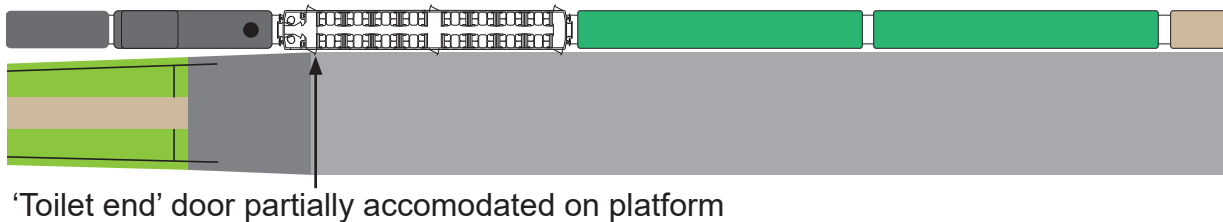
Figure 8: Stopping positions of the train involved in the accident.

51 Witness accounts, corroborated by photographs taken after the accident, show that the train stopped with the front edge of the leading door on coach 4857 approximately 1.6 metres beyond the end of the level part of the platform.

57 The train involved was formed of a locomotive, tender and six coaches (paragraph 12 and figure 7). The distance between the rear edge of the trailing end door of the trailing coach and the front edge of the leading door of the leading coach was 119.9 metres. This means that platform 1 was just over 2 metres longer than the distance between the extreme end doors of the train involved. If the train had stopped centrally along the available level platform length, then there would have been just over 1 metre of level platform beyond each door at both ends (figure 8).

58 Coach 4857 had a pair of toilets at one end with the vestibule inboard of them (paragraph 14, figure 5). Consequently, the passenger doors at that end are around 1.36 metres further inboard than the leading end doors. When the train travelled north from Leicester North station, the toilets were at the trailing end of coach 4857. If the coach had been orientated with the ‘toilet end’ leading, the external door at that end would have been adjacent to the start of the platform end ramp.

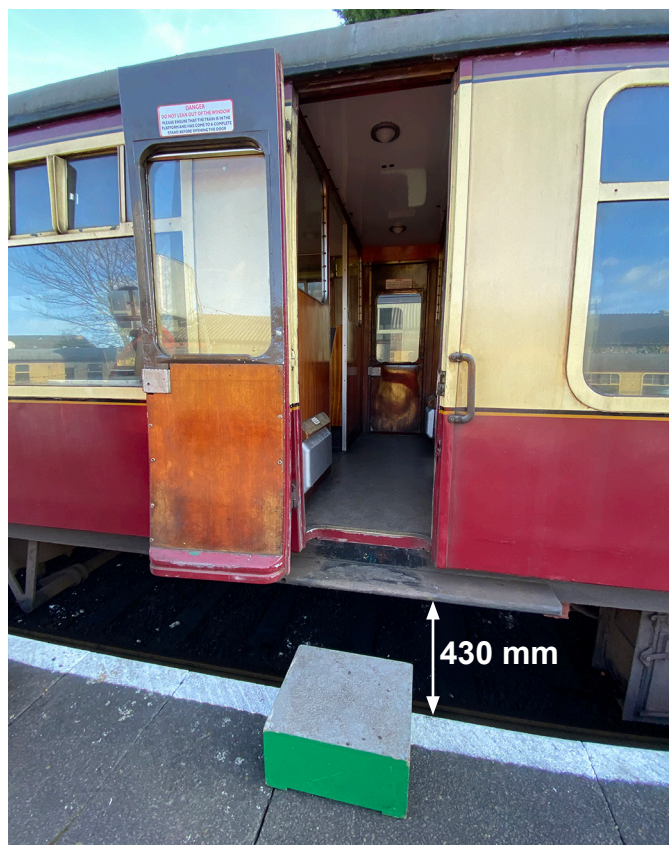
Figure 9: A stepping box and standard stepping height.

- 73 A consequence of the elevated track bed was an increased vertical stepping height for passengers. For example, on the coach involved in the accident, correctly platformed doors at the north end of platform 1 were approximately 430 mm (17 inches) vertically above the platform. GCR was managing this stepping height by providing wooden stepping boxes (figure 9). Such stepping boxes are carried on passenger coaches and provided at platforms for use by on-train or platform staff if required.

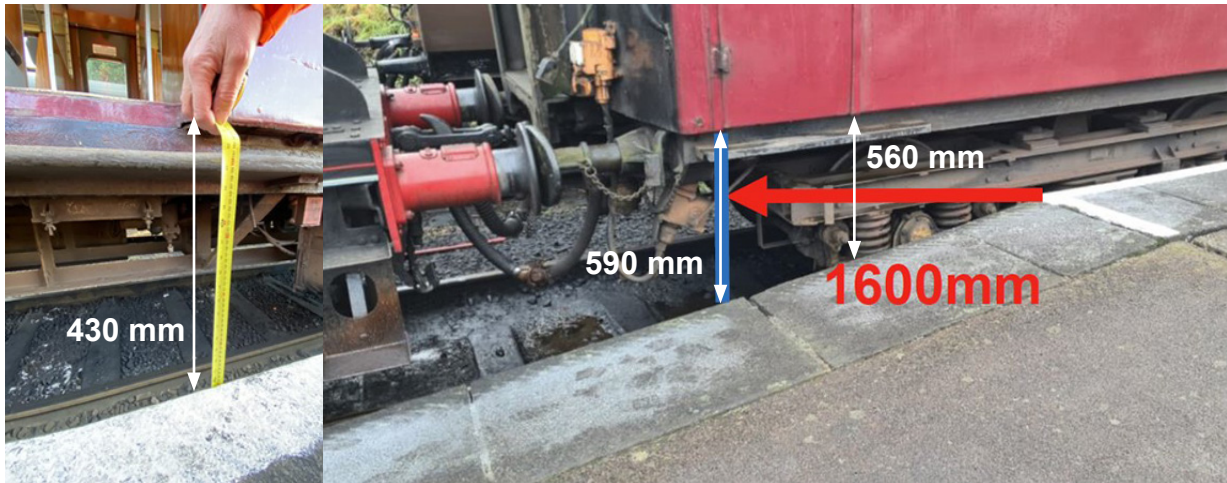
Figure 10: Reconstruction photos showing standard platform stepping height (left) and the increased stepping heights from the train at its stopped position (right).

- 76 The stopping position of the train with the leading door of coach 4857 adjacent to the ramp meant that this normal stepping height of around 430 mm was further increased across the width of the door to between 560 mm and 590 mm (figure 10). While witness evidence indicates that the passenger had identified the larger-than-normal vertical drop at Loughborough Central, and that he had attempted to descend carefully, the increased distance nevertheless would increase the chance of an accident exiting the train.

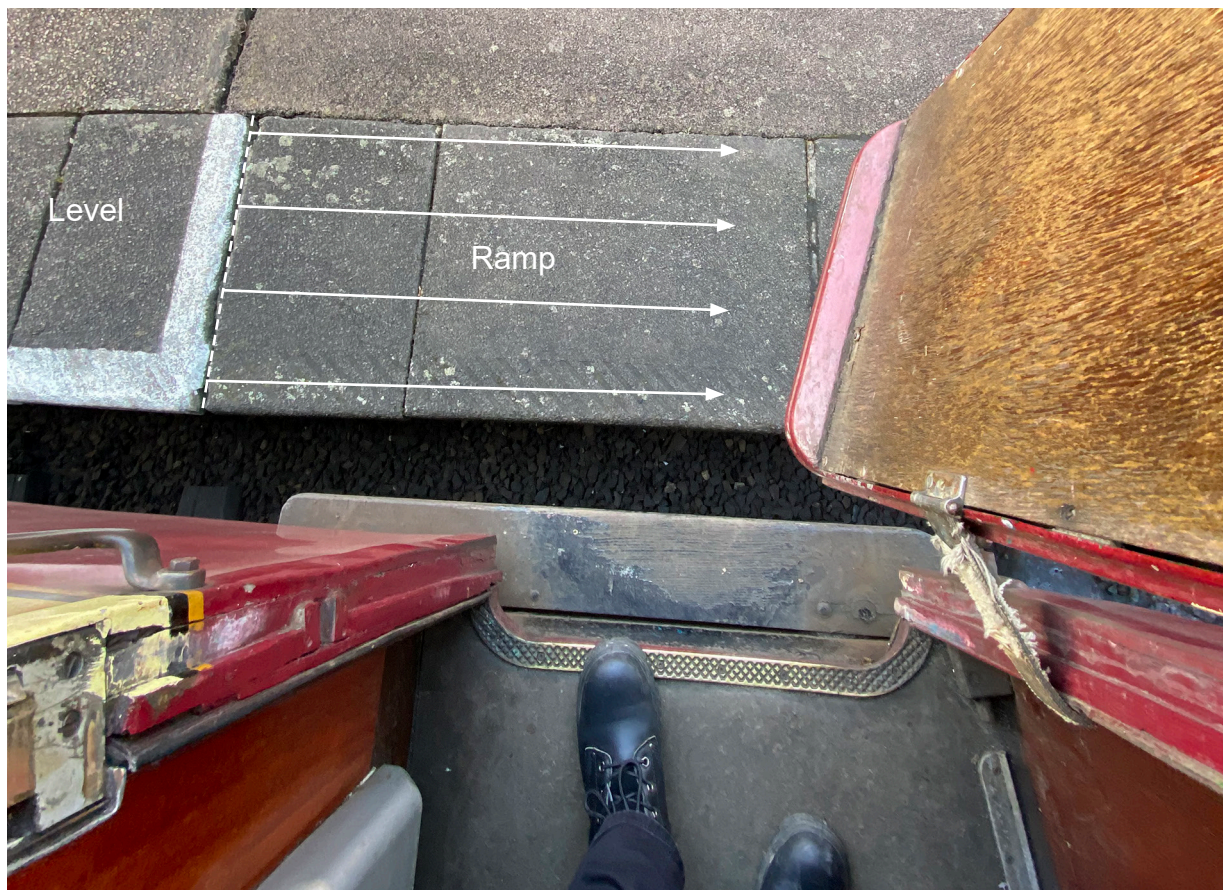
Figure 11: Photo of ramp viewed from coach doorway.

81 RAIB inspectors took a series of photographs to document the reconstruction. It was observed during the reconstruction that the slope along the platform end ramp was not easy to distinguish. As such, it is likely that a visually impaired person would not be able to distinguish the slope. Figure 11 shows the view of the platform end ramp taken from the position of a person preparing to alight from the leading door of coach 4857.
