Rail Accident Investigation Branch

Rail Accident Report

Collision between two freight trains at Loversall Carr Junction, Doncaster 5 July 2022

Report 08/2023
August 2023

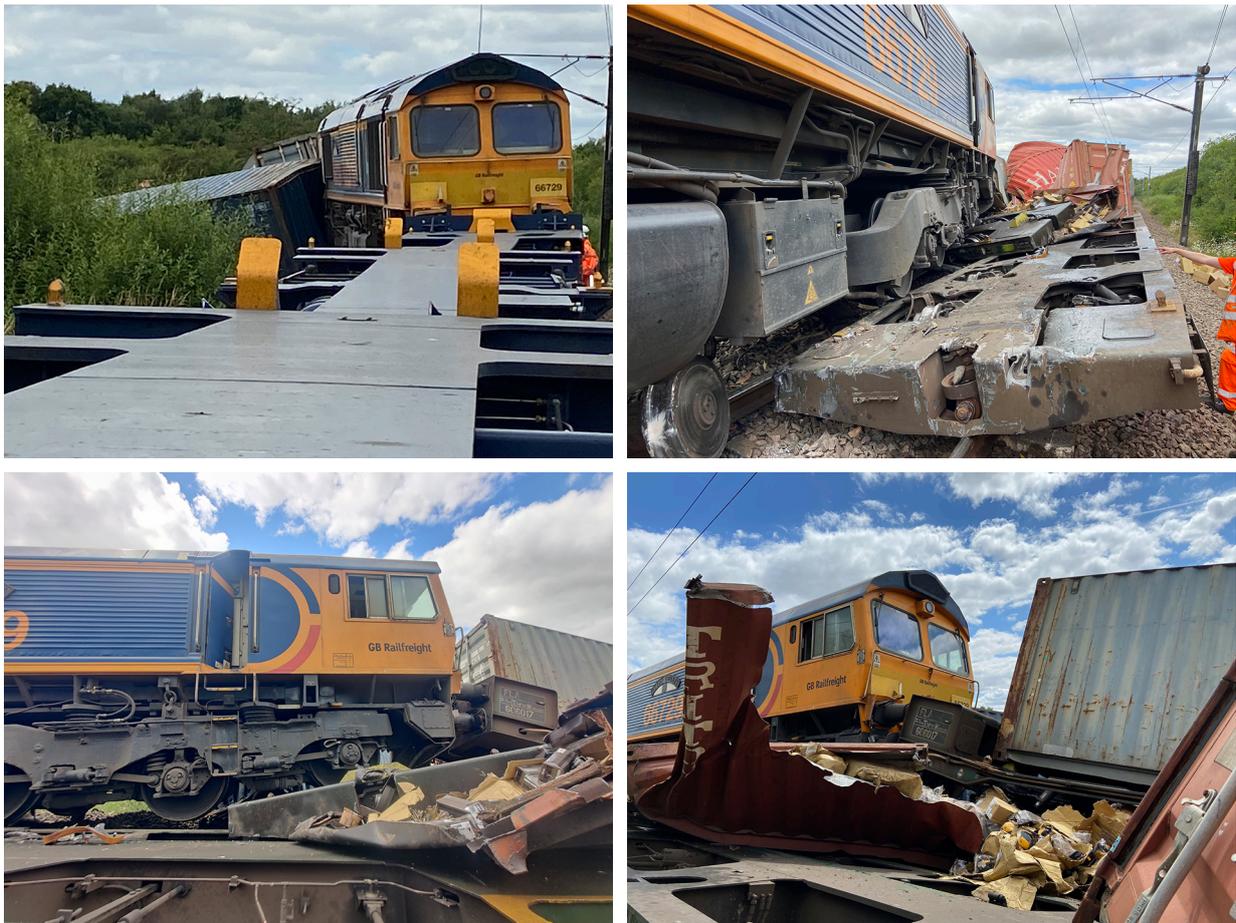
- 4 The rear of train 4E82 was approximately 231 metres beyond signal D197. The driver of 4E11 applied the train's emergency brakes 82 metres beyond signal D197 but there was insufficient distance remaining to prevent the collision. Train 4E11 collided with the rear of 4E82 while travelling at 28 mph (45 km/h) (figure 2).
- 5 The driver of 4E11 was taken to hospital as a precaution and was discharged later that same day. The driver of 4E82 did not sustain any injuries. The collision caused significant damage to the infrastructure, the leading locomotive and wagons of 4E11 and the rear wagons of 4E82. The route remained closed for recovery and repair work until 31 July 2022.

Figure 2: The final position of train 4E11 after the collision with train 4E82.

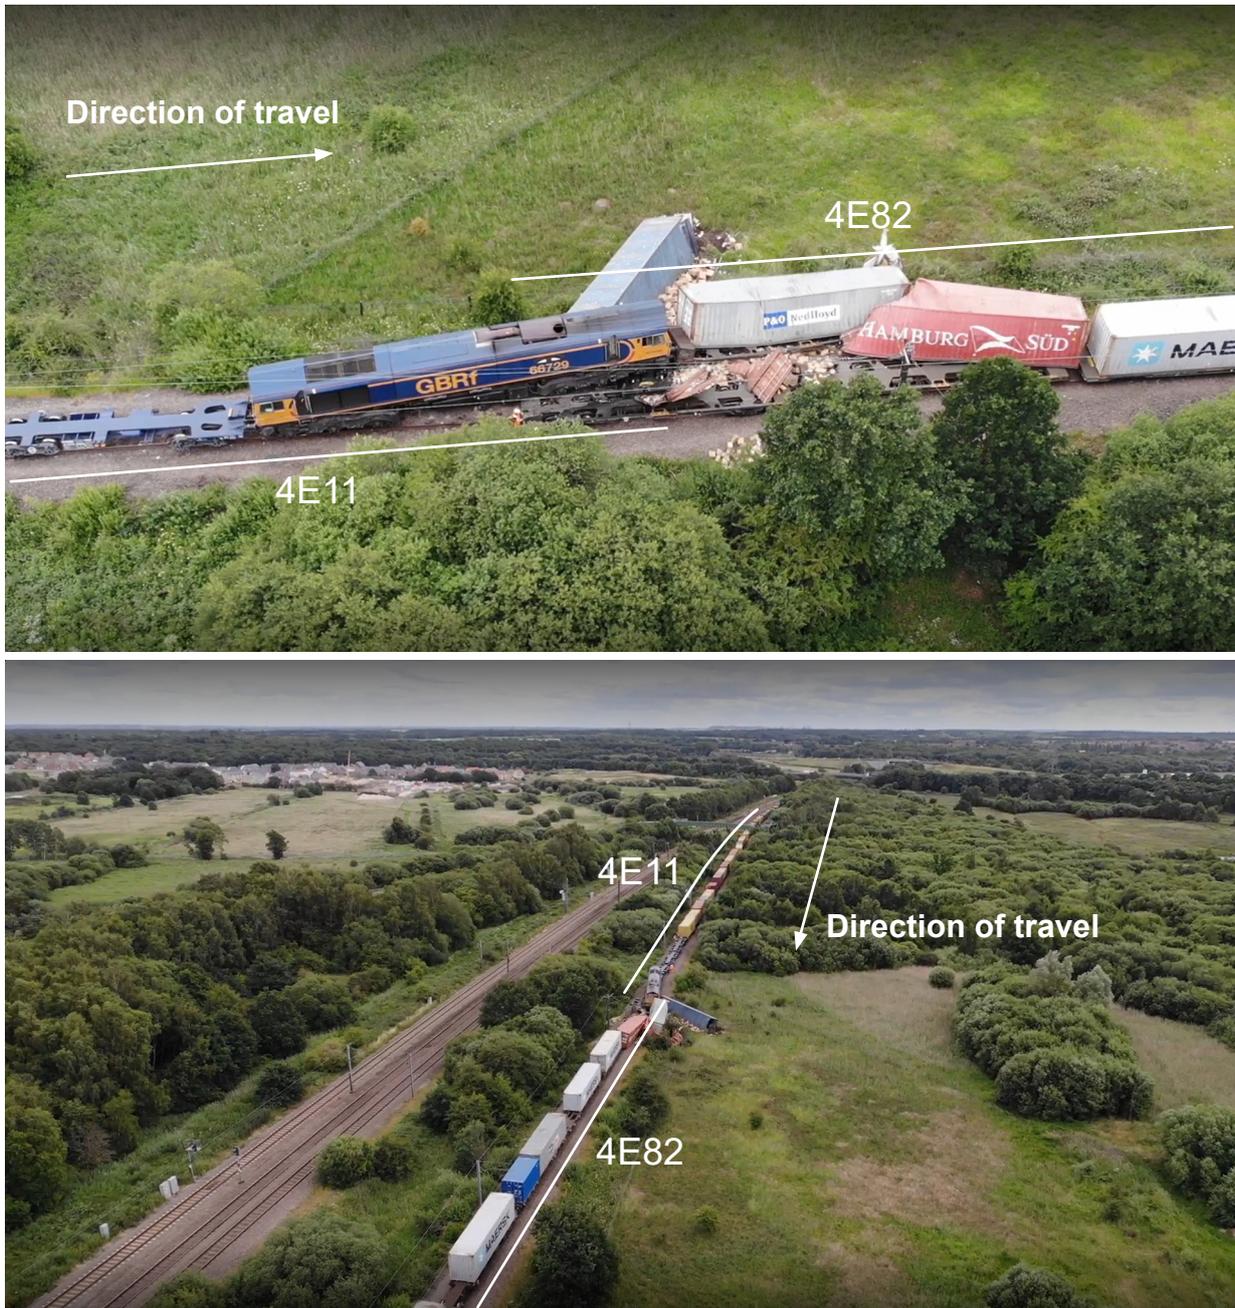
42 The impact from train 4E11 moved train 4E82 forwards, with the front of 4E82 almost passing signal D207. OTDR fitted to the locomotive of 4E82 recorded a forward movement of approximately 10 metres during the collision. Damage was caused to the locomotive of 4E11 and to multiple wagons in the train (figure 6). The wagon damage was mainly related to compression and overriding at the couplers. Train 4E82 also sustained damage to the rear four wagons and their containers. A total of nine wagons and one locomotive were derailed. Railway infrastructure was also damaged in the collision.

Figure 6: Aerial view of the accident site (courtesy of British Transport Police ECML South Disruption Tasking Team).

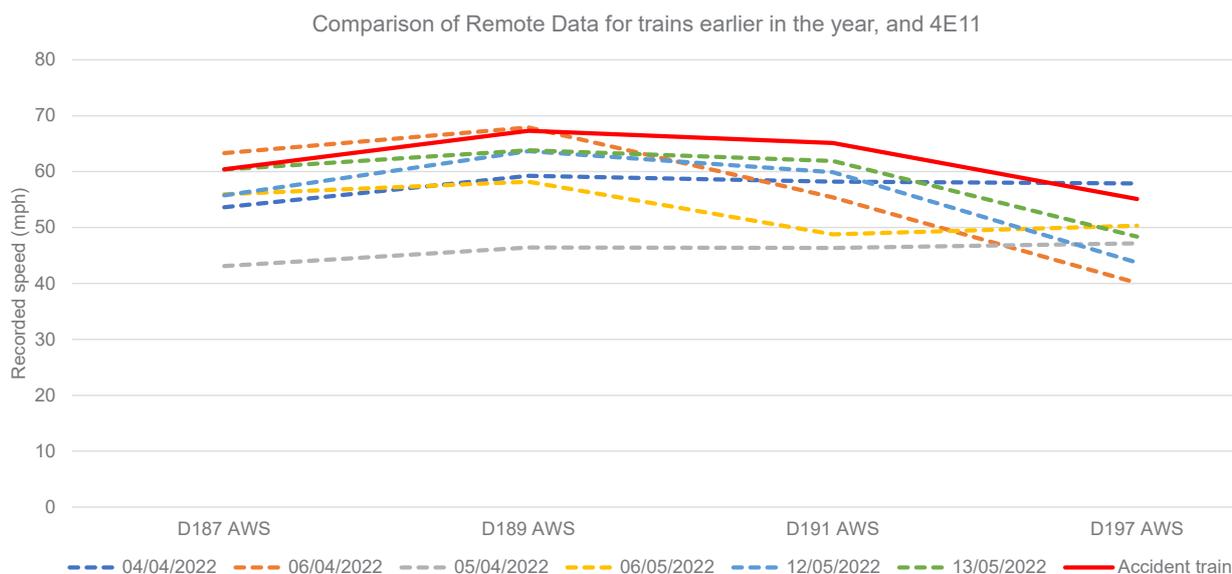
53 GBRf was unable to provide RAIB with OTDR records for any other GBRf trains which had approached D197 while it was showing a red aspect (the reasons for this are discussed at paragraph 107). RAIB analysed OTDR records from other GBRf trains which were approaching signal D197 displaying a green (proceed) or double yellow or yellow (preliminary caution and caution) aspect. This analysis showed that the speed of approach of train 4E11 to D197 was comparable to other trains approaching this signal when it was displaying a proceed or cautionary aspect (figure 7).

Figure 7: Comparison of speed of approach to signal D197 between train 4E11 and other freight services.

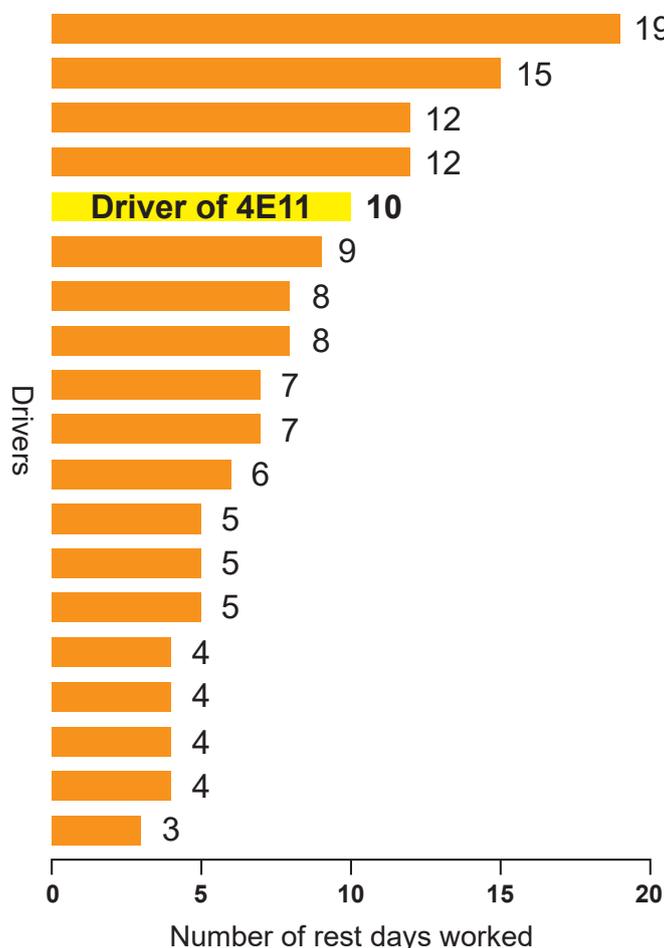
134 RAIB analysed the number of rest days worked by GBRf drivers based at Doncaster depot where they have three rest days per week in their base roster as a requirement of their contractual terms and conditions. This analysis reviewed the eight weeks leading up to the accident (figure 11). The driver of 4E11 was in the top 25% of drivers in terms of the number of rest days worked, having worked 10 rest days within the period.

Figure 11: Doncaster depot rest day working for the 8 weeks before the accident showing the driver of 4E11 compared to the other drivers in the depot.
