AAIB Bulletin S2/2023

SPECIAL

Accident

Aircraft Type and Registration:	Airbus A321-253NX, G-OATW
No & Type of Engines:	2 CFM International SA LEAP-1A33 turbofan engines
Year of Manufacture:	2020 (Serial no: 10238)
Date & Time (UTC):	4 October 2023 at 1151 hrs
Location:	London Stansted Airport
Type of Flight:	Commercial Air Transport (Passenger)
Persons on Board:	Crew - 11 Passengers - 9
Injuries:	Crew - None Passengers - None
Nature of Damage:	Damage to several cabin windows and impact damage to the left horizontal stabiliser
Commander's Licence:	Airline Transport Pilot's Licence
Commander's Age:	54 years
Commander's Flying Experience:	4,905 hours (of which 2,300 were on type) Last 90 days - 128 hours Last 28 days - 27 hours
Information Source:	AAIB Field Investigation

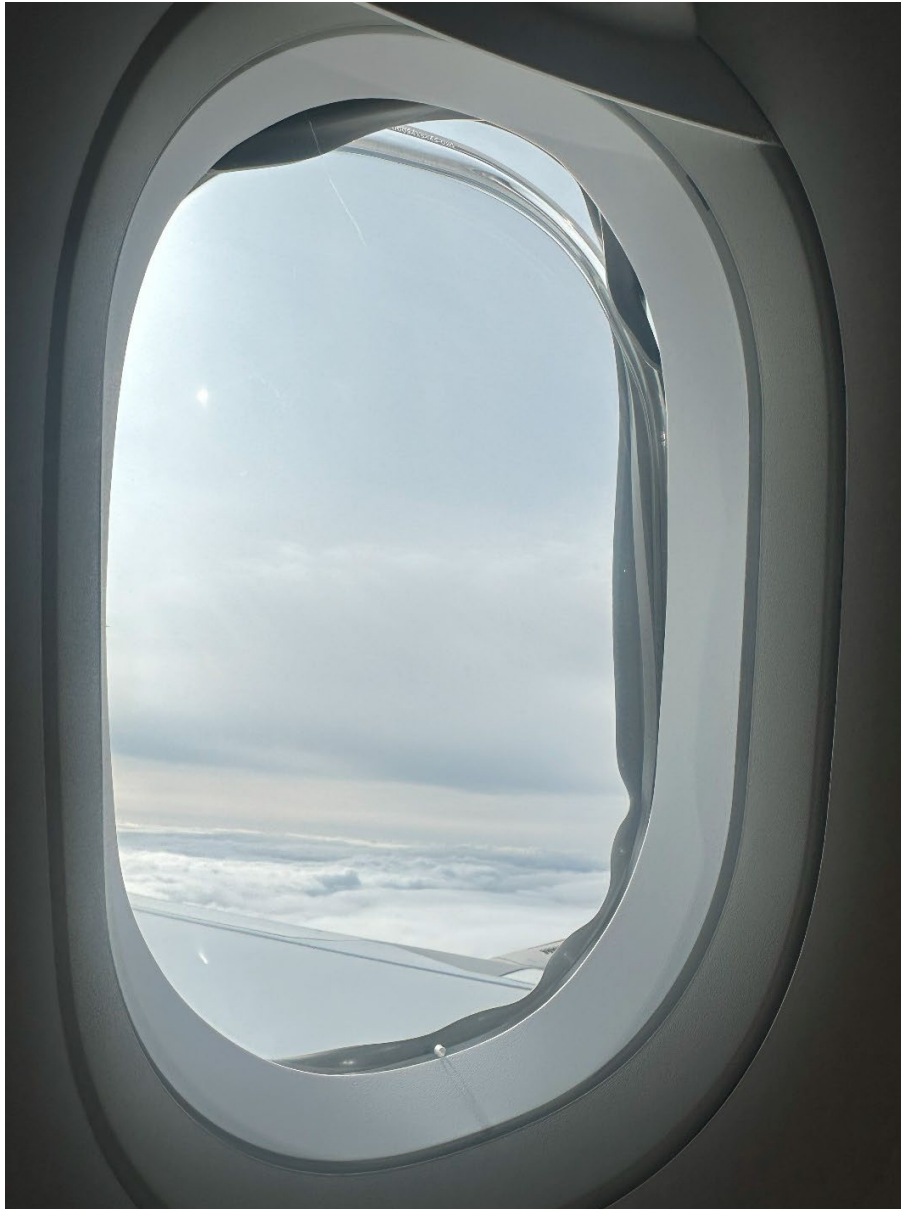
The aircraft departed a few minutes ahead of schedule and took off from Runway 22. Several passengers recalled that after takeoff the aircraft cabin seemed noisier and colder than they were used to. As the aircraft climbed through FL100 and the seatbelt signs were switched off, the loadmaster, who had been seated just in front of the other passengers, walked towards the back of the aircraft. He noticed the increased cabin noise as he approached the overwing exits and his attention was drawn to a cabin window on the left side of the aircraft. He observed that the window seal was flapping in the airflow and the windowpane appeared to have slipped down¹. He described the cabin noise as 'loud enough to damage your hearing'. Figure 1 shows the window in flight.

Having parked and shut down, the crew inspected the aircraft from the outside and saw that two cabin windowpanes were missing and a third was dislodged. During the flight the crew had only been aware of an issue with a single windowpane. The cabin had remained pressurised normally throughout the flight.

View of the left side cabin window aft of the overwing exit

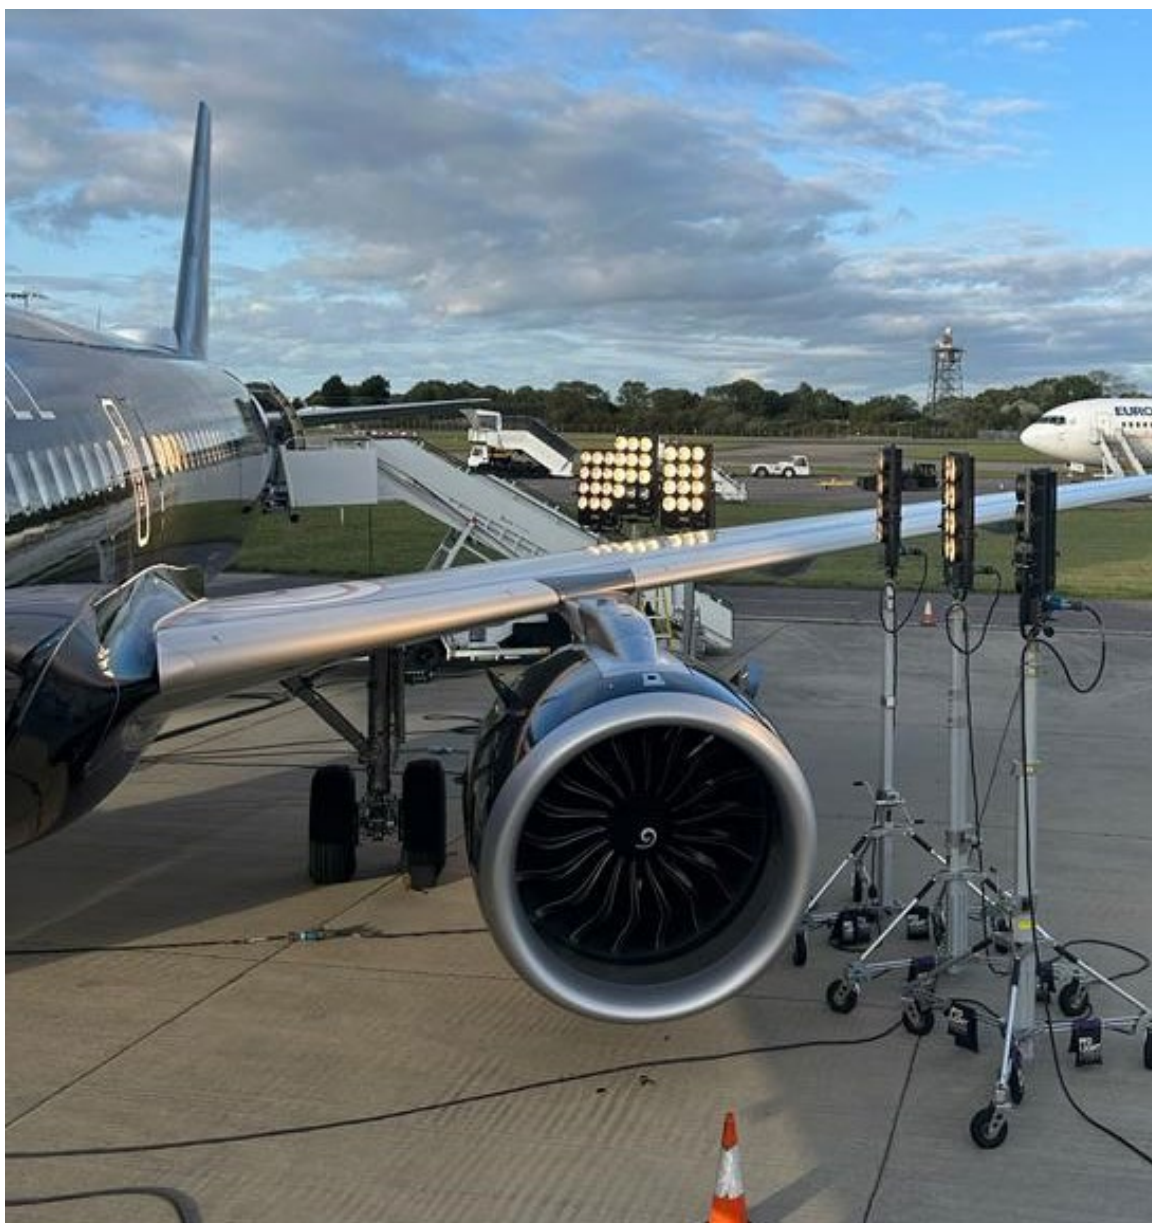
The day before the occurrence flight the aircraft had been used for filming on the ground, during which external lights had been shone through the cabin windows to give the illusion of a sunrise. The lights were first shone on the right side of the aircraft for approximately five and a half hours, with the light focused on the cabin windows just aft of the overwing exits. The lights were then moved to the left side of the aircraft where they illuminated a similar area on the left side for approximately four hours. Photographs taken during filming showed six sets of flood lights on both sides of the aircraft. Figure 2 shows the lights positioned on the left of the aircraft.

Flood lighting on the left side of the aircraft

The windows appear to have sustained thermal damage and distortion because of elevated temperatures while illuminated for approximately four to five and a half hours during filming activity the day before the flight. It is likely that the flood lights were positioned closer than 10 m. Whereas in this case the damage became apparent at around FL100 and the flight was concluded uneventfully, a different level of damage by the same means might have resulted in more serious consequences, especially if window integrity was lost at higher differential pressure.

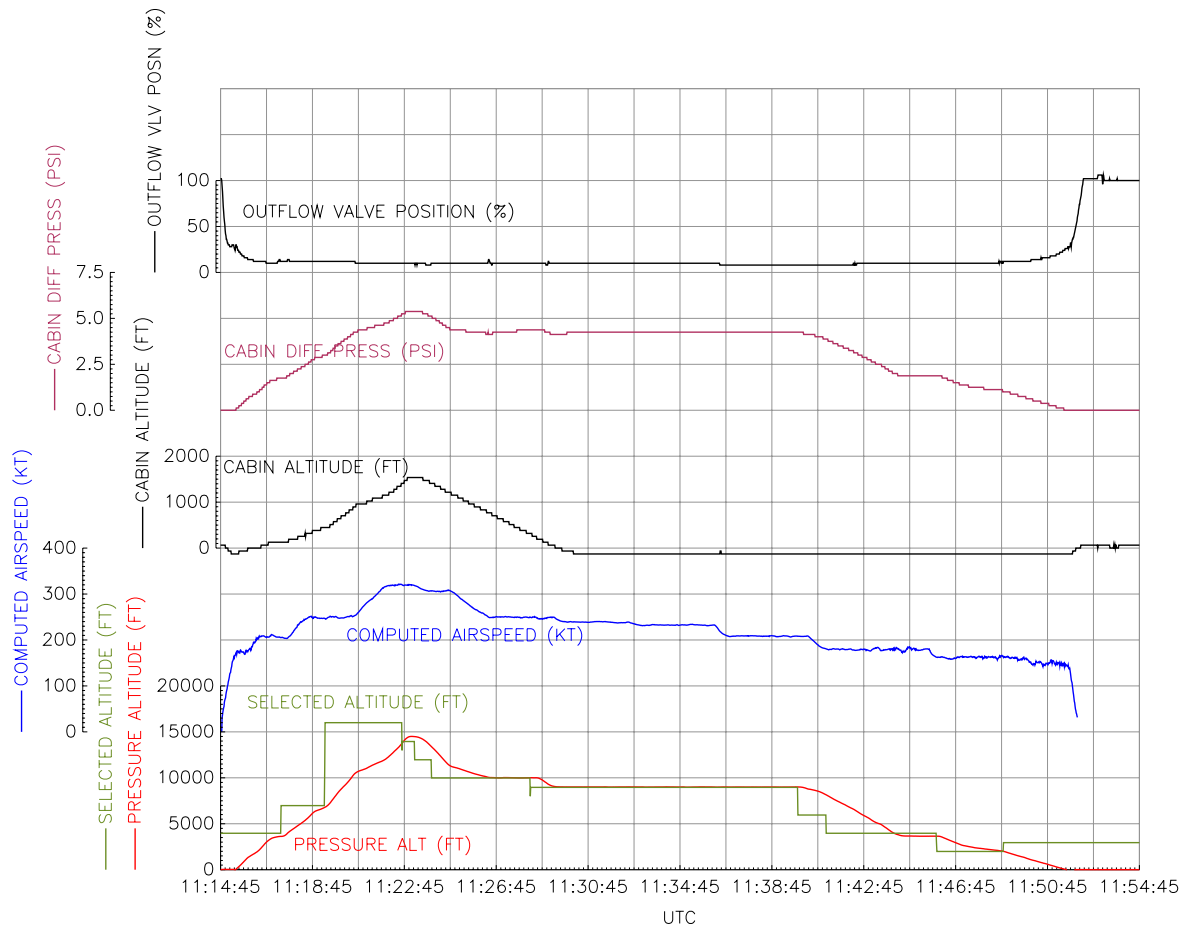
Figure 3
G-OATW FDR data

The aircraft took off from Stansted at 1115 hrs, climbing progressively to a maximum of 14,504 ft² at 1123 hrs (Figure 3). The cabin altitude increased during this time, reaching a

recorded maximum of 1,536 ft. The aircraft then descended to 10,000 ft initially, followed by a further descent to 9,000 ft while circling to the north-west of the airport. No pressurisation warnings were recorded during the flight, which landed back at Stansted Airport at 1151 hrs.

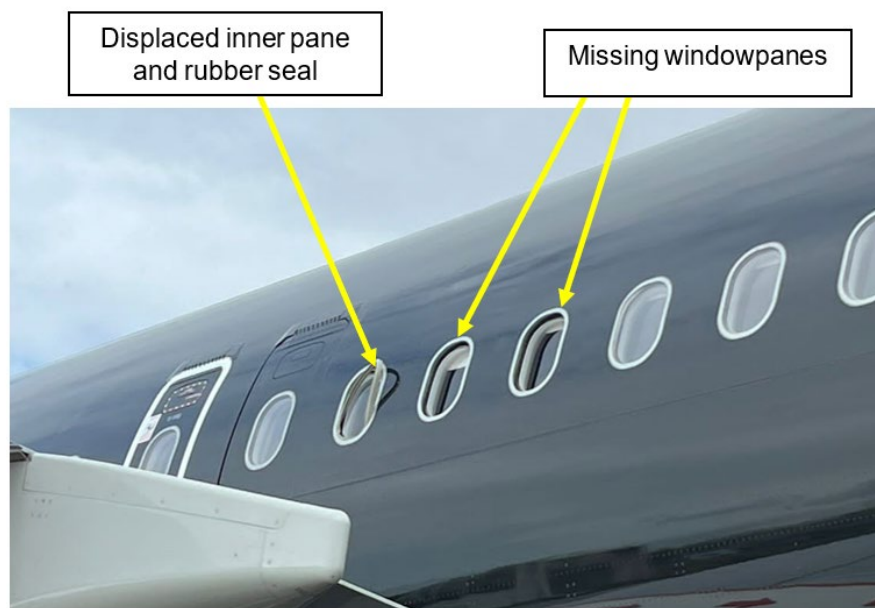
Figure 4

Two window assemblies³ were missing, and the inner pane and seal from a third window were displaced but partially retained in the airframe (Figure 4). A shattered outer pane was recovered from the entrance to a rapid-exit taxiway during a routine runway inspection after the aircraft landed.

Displaced and missing windowpanes on the left side of the aircraft

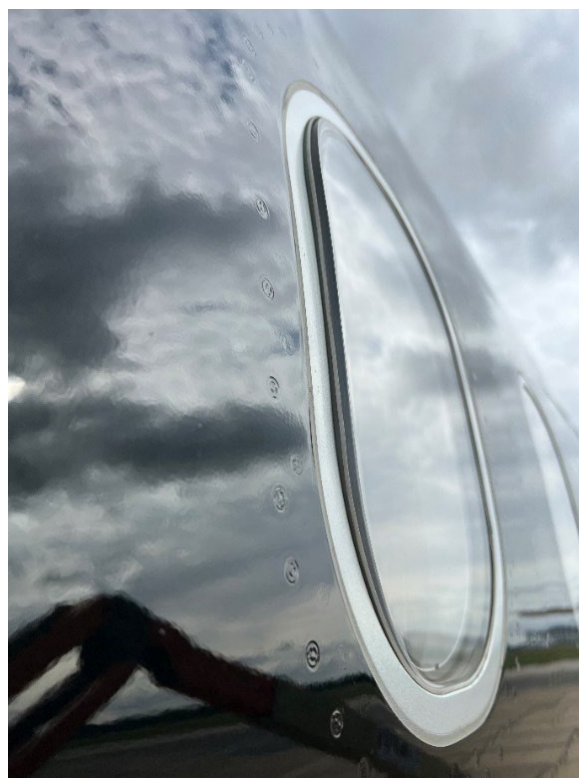
Figure 5

A fourth window protruded from the left side of the fuselage (Figure 5). The four affected windows were adjacent to each other, just aft of the left overwing exit.

Protruding window on the left side of the aircraft

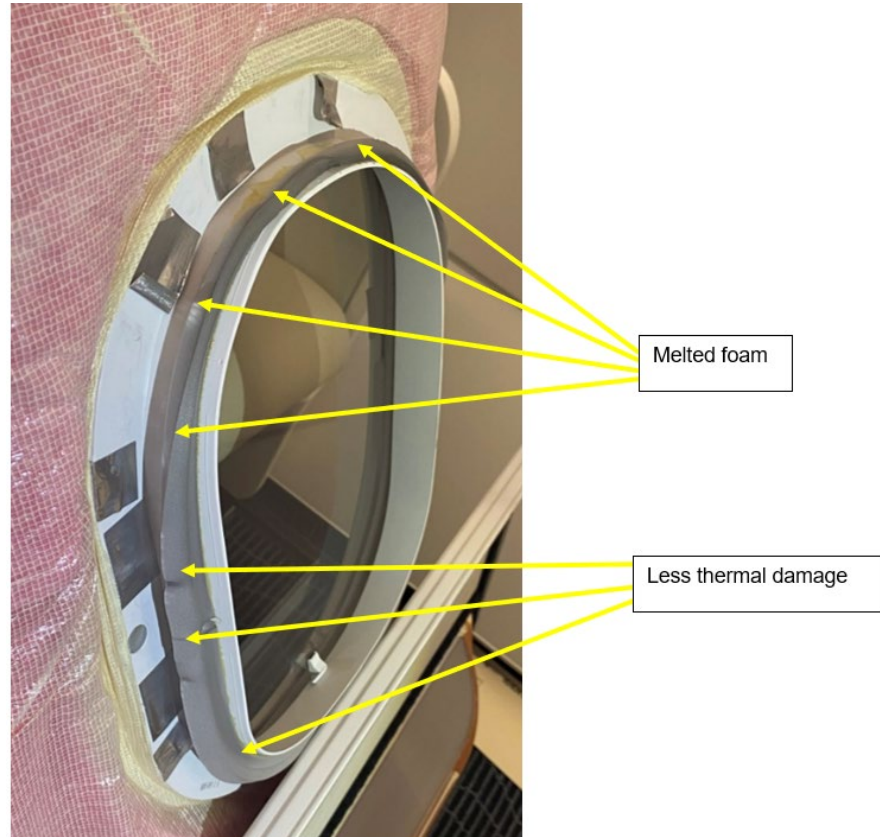
Figure 6

Removal of the cabin lining inside the passenger cabin revealed that the window retainers were in good condition and correctly installed. The foam ring material on the back of the cabin liners was found to be melted in the areas adjacent to the windows that were damaged or missing (Figure 6).

Foam ring material affected by elevated temperatures

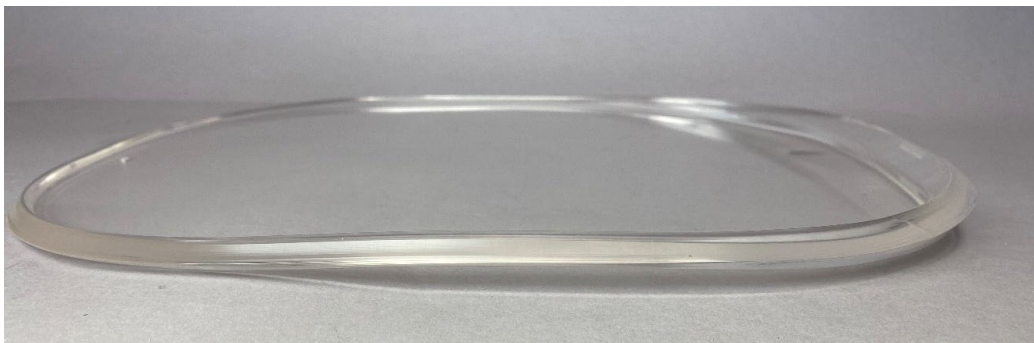
Figure 7

Visual examination of the damaged windowpanes revealed that they were deformed and shrunk (Figure 7). The deformed panes no longer formed an effective interface with the rubber seals.

Inner pane showing plastic deformation around the entire perimeter

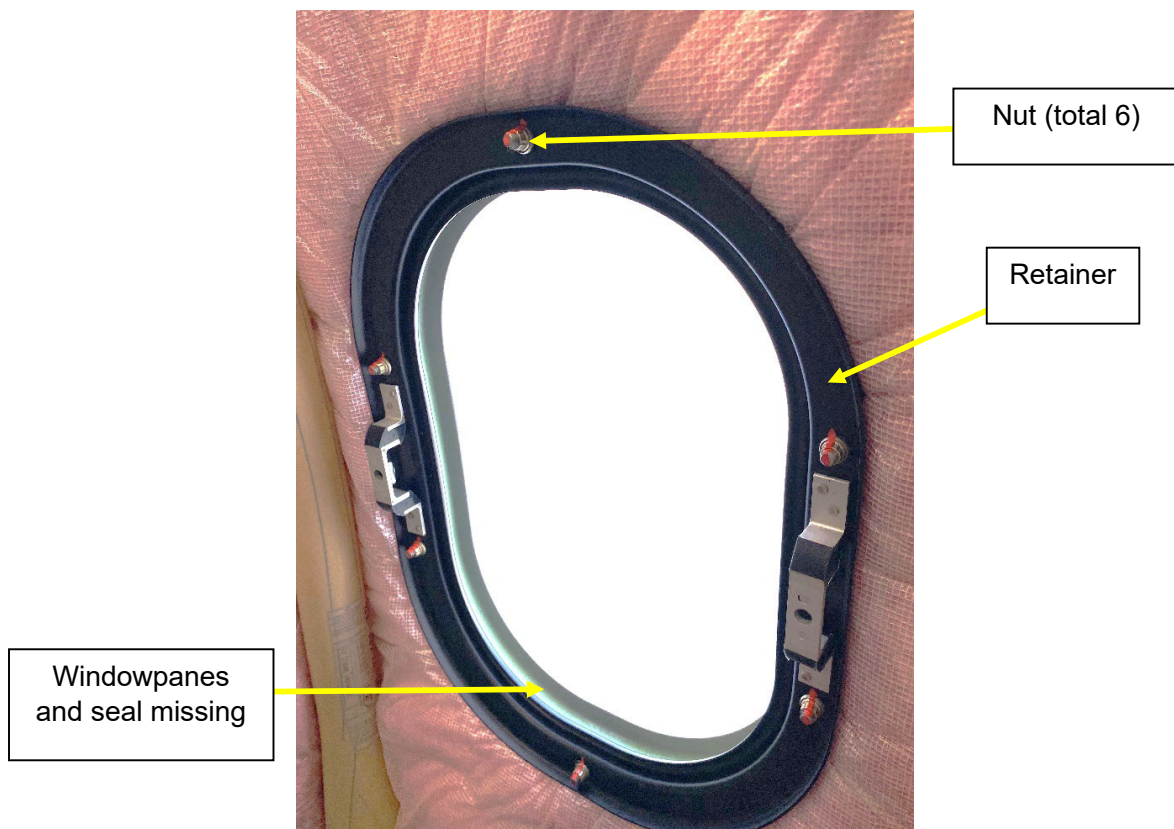
Figure 8

Correct installation of the retainer but the window assembly is missing

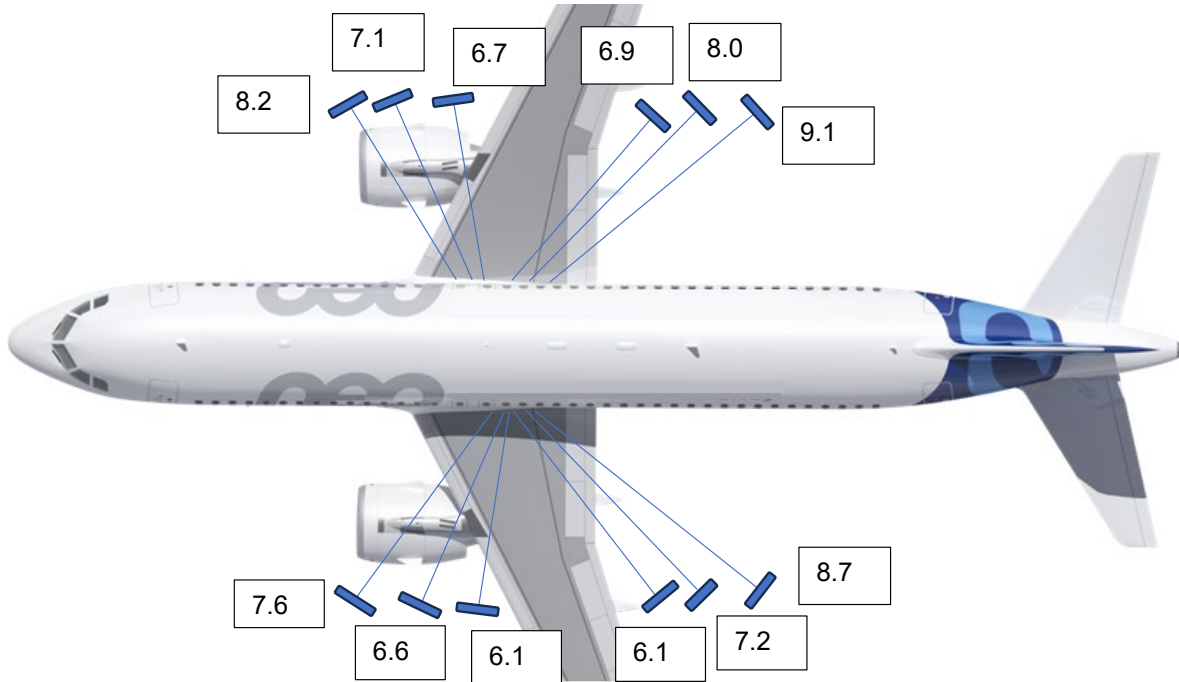
Figure 9

Photographs of the filming showed that the lights were between approximately 6 and 9 m from the window areas where damage was apparent (Figure 9).

Approximate distance of the flood lights from the fuselage during the filming activity
