# Carmont Derailment – Investigation of the Geotechnical Elements

Neil Esslemont

Head of Systems – Geotechnical and Drainage, East West Railway Company,  
formerly Senior Engineer, Technical Authority, Network Rail

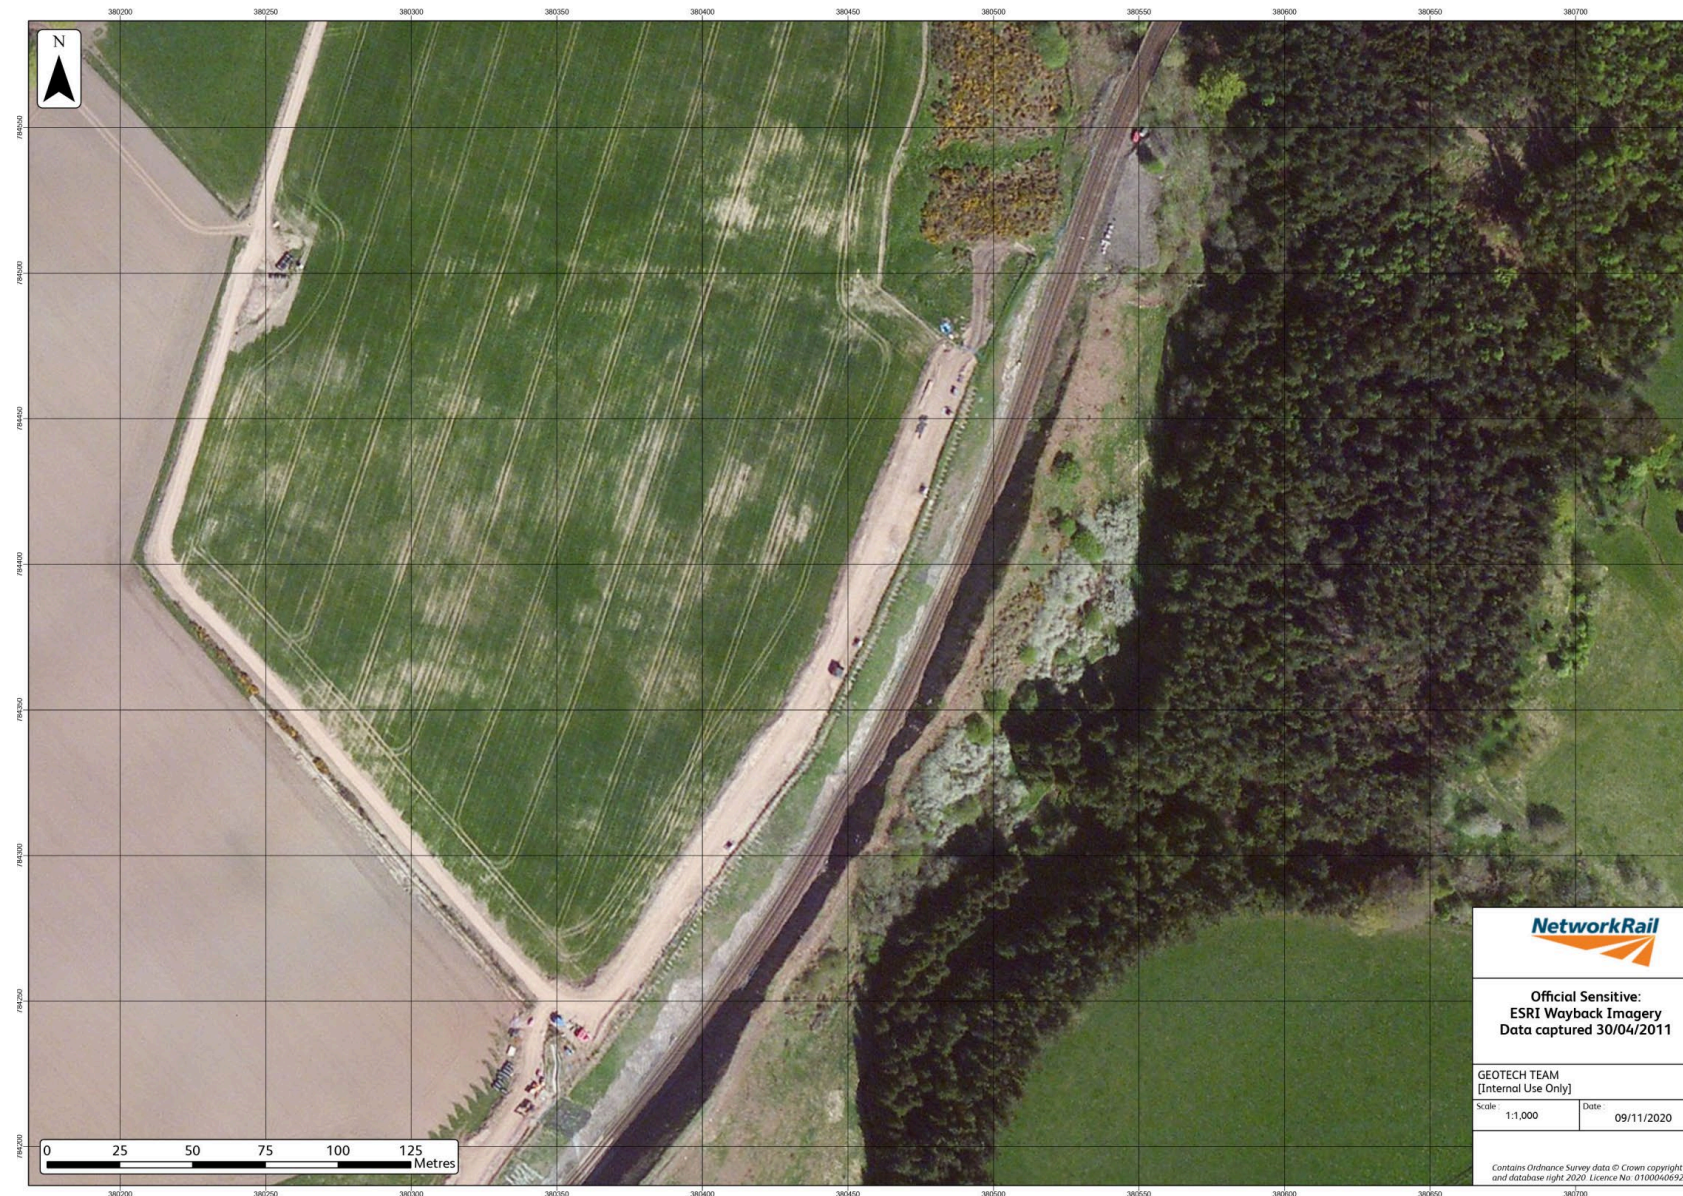
Aerial photographs indicate:

- Field boundary removed mid 2000's
- Construction work on cutting visible April 2011

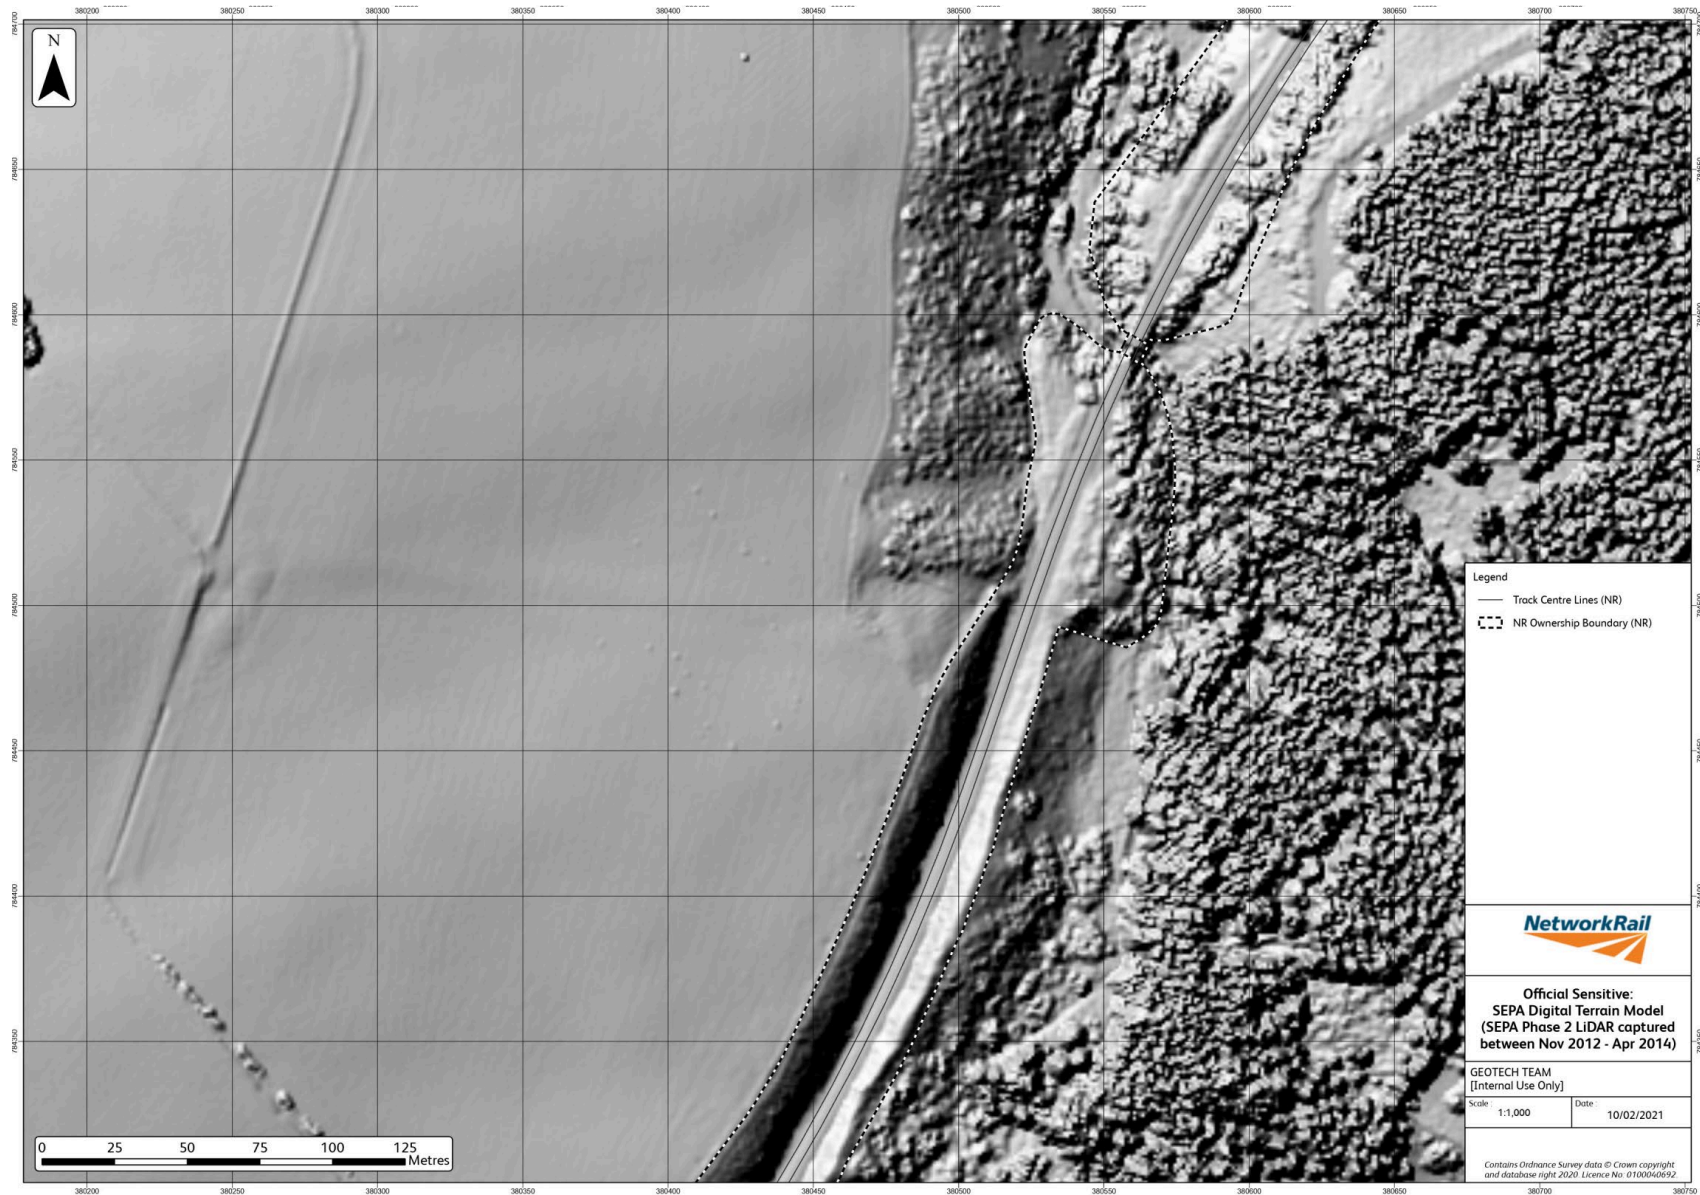
LiDAR shows:

- The bund was present from the time of the first survey (2012-2014)
- Comparison of SEPA LiDAR with subsequent NR surveys shows no significant *detectable* change in profile
