Rail Accident Investigation Branch

Derailment Mechanism

Rail Accident Investigator's Seminar

Carmont derailment site

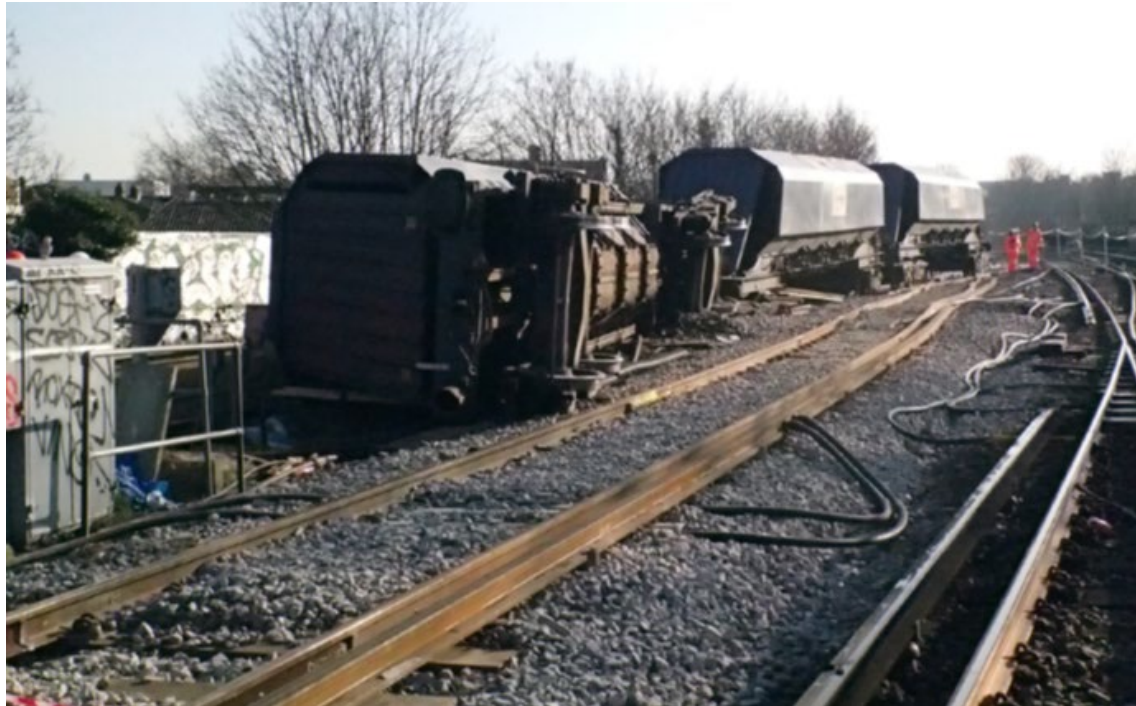
Lewisham - 24 January 2017

Combination of track twist and probable offset load resulted in significant wheel unloading on a bogie hopper wagon when traversing newly-laid S&C

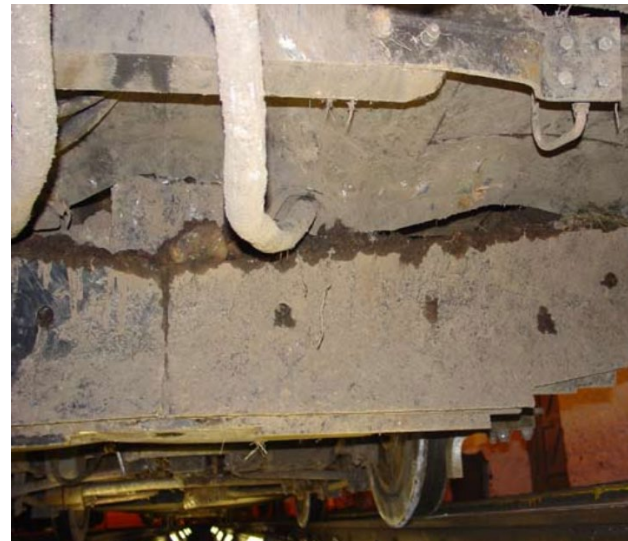
Moy 26 November 2005

Landslide debris accumulated under cab lifting the wheels, resulting in leading vehicle immediately deviating from the track

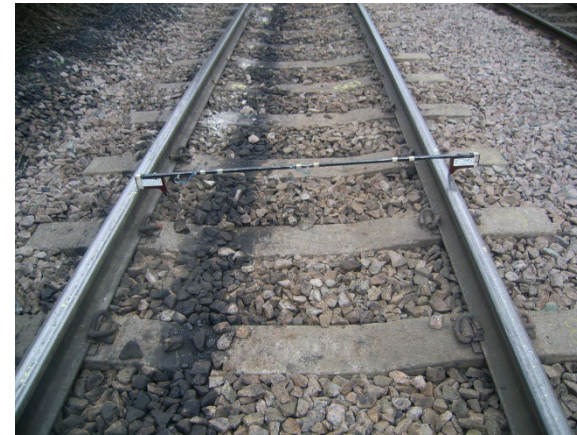
- RH flange drops down field face
- LH tread corner drops into four-foot

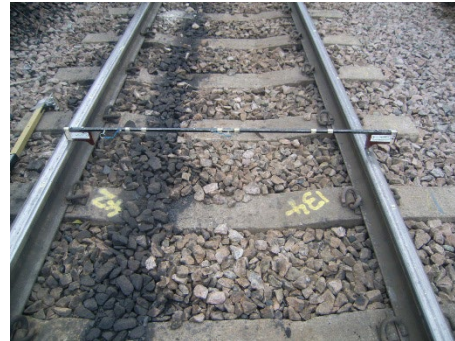
- RH flange runs on rail head

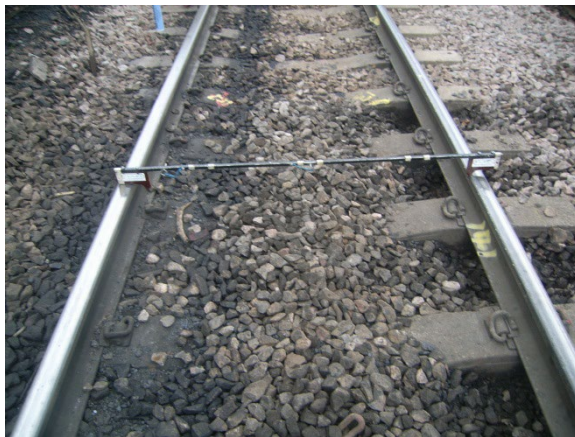
- RH flange climbs gauge face

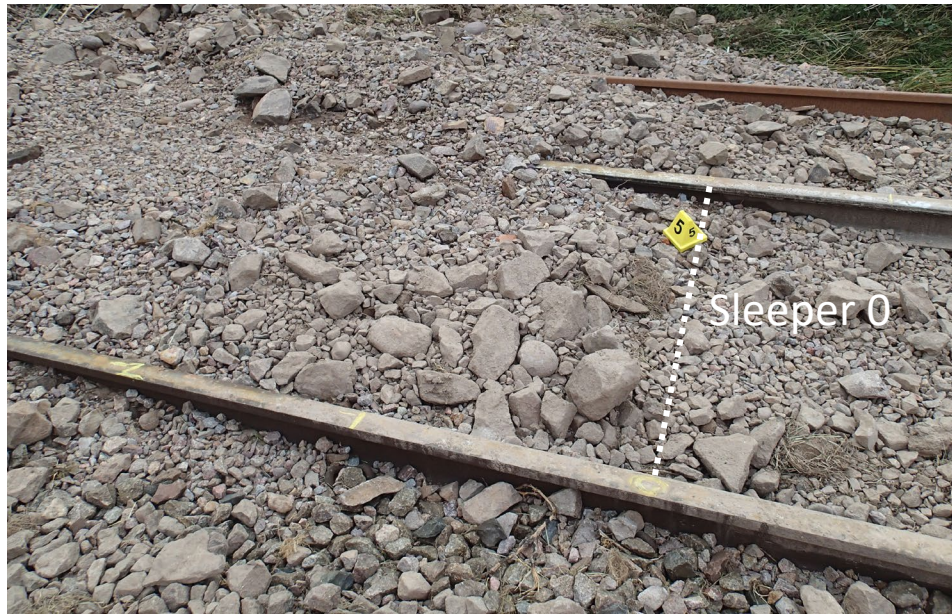
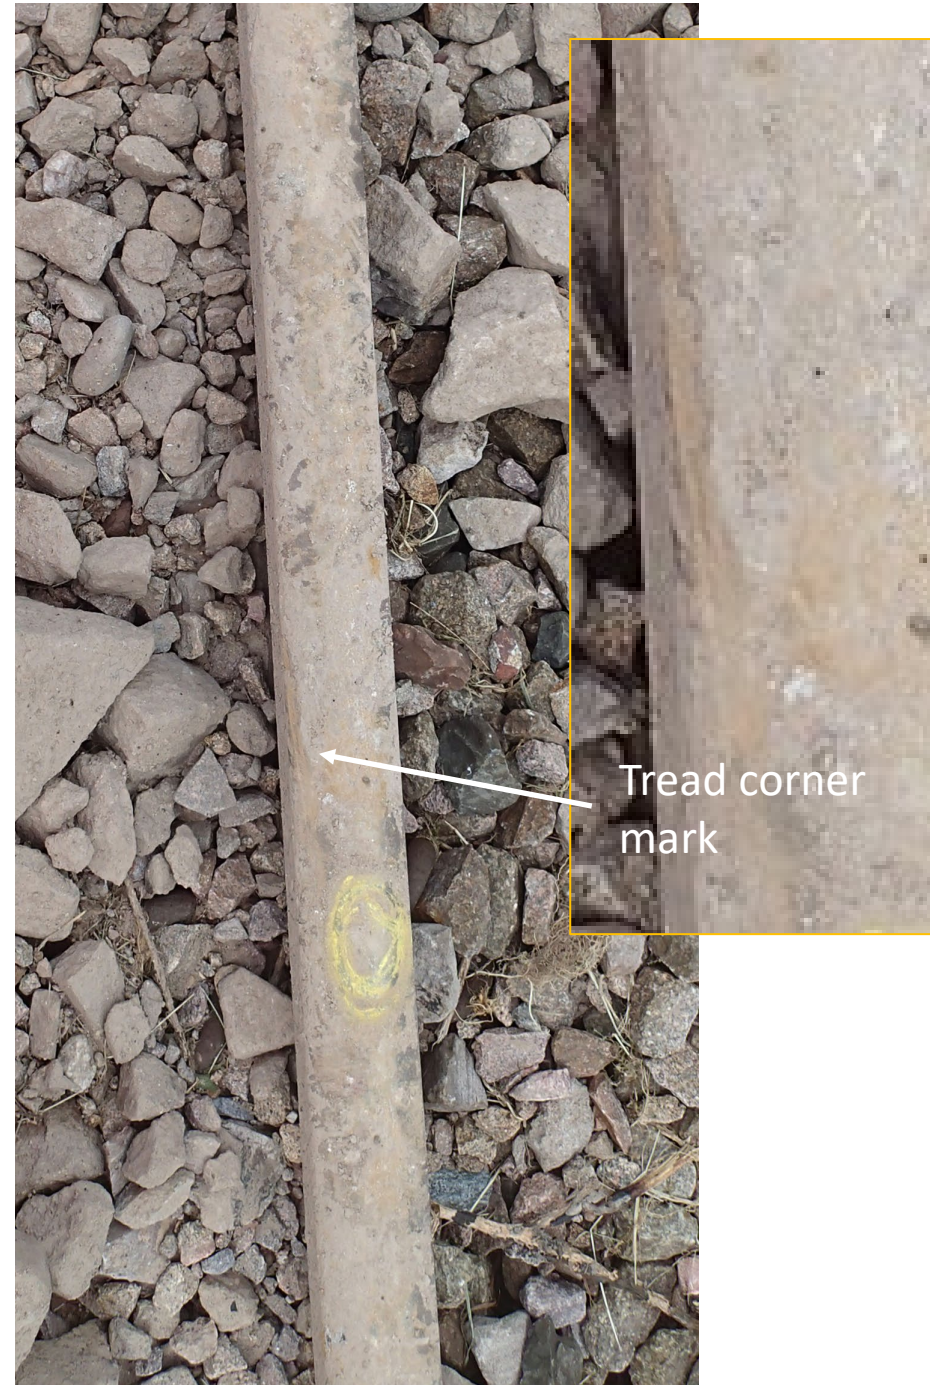
Carmont – initial site reconnaissance

- Pattern of track damage and witness marks: Zones B to D
- First wheel mark (tread corner) on RH rail:
 - immediately north of washout material
- PoD nominated: Sleeper 0
- Sleepers numbered:
 - Approach to PoD = -ve
 - Leaving PoD = +ve

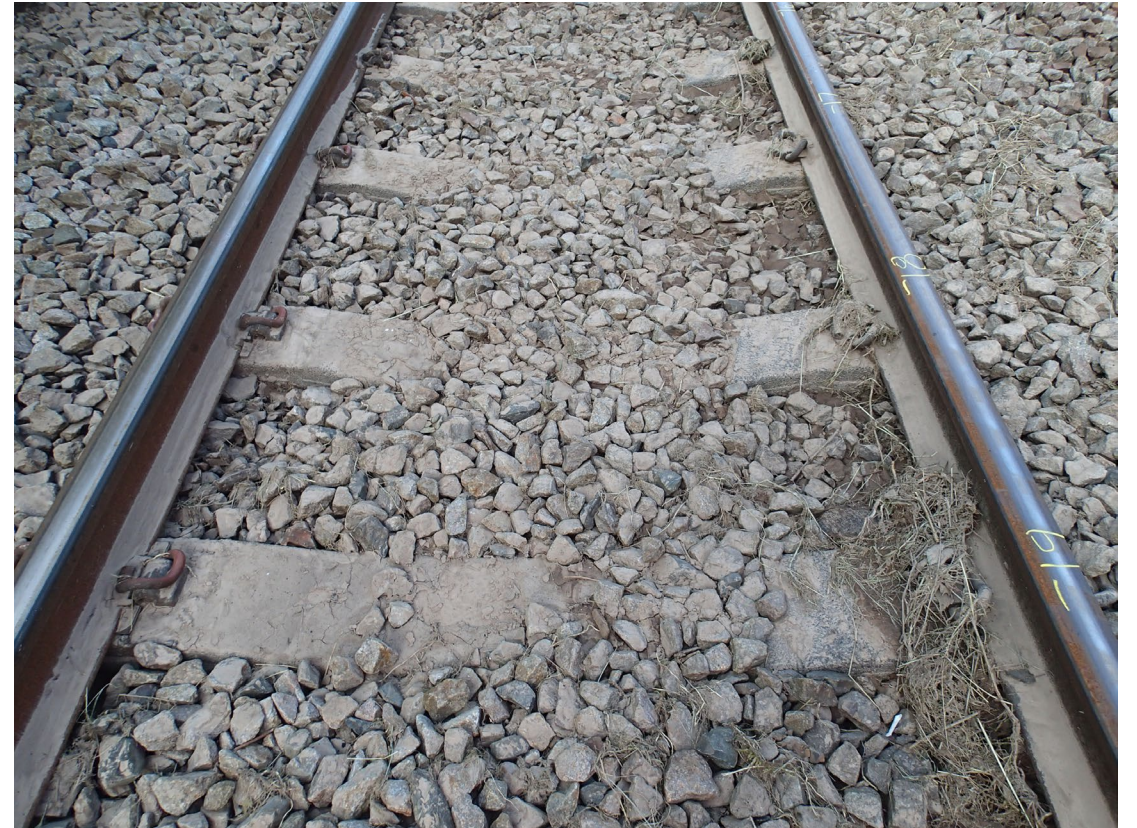
Carmont – Zone B observations

- Track walk (from beyond 200 sleepers) on the approach to PoD
- Systematic photographic record
- No wheel marks on rail head

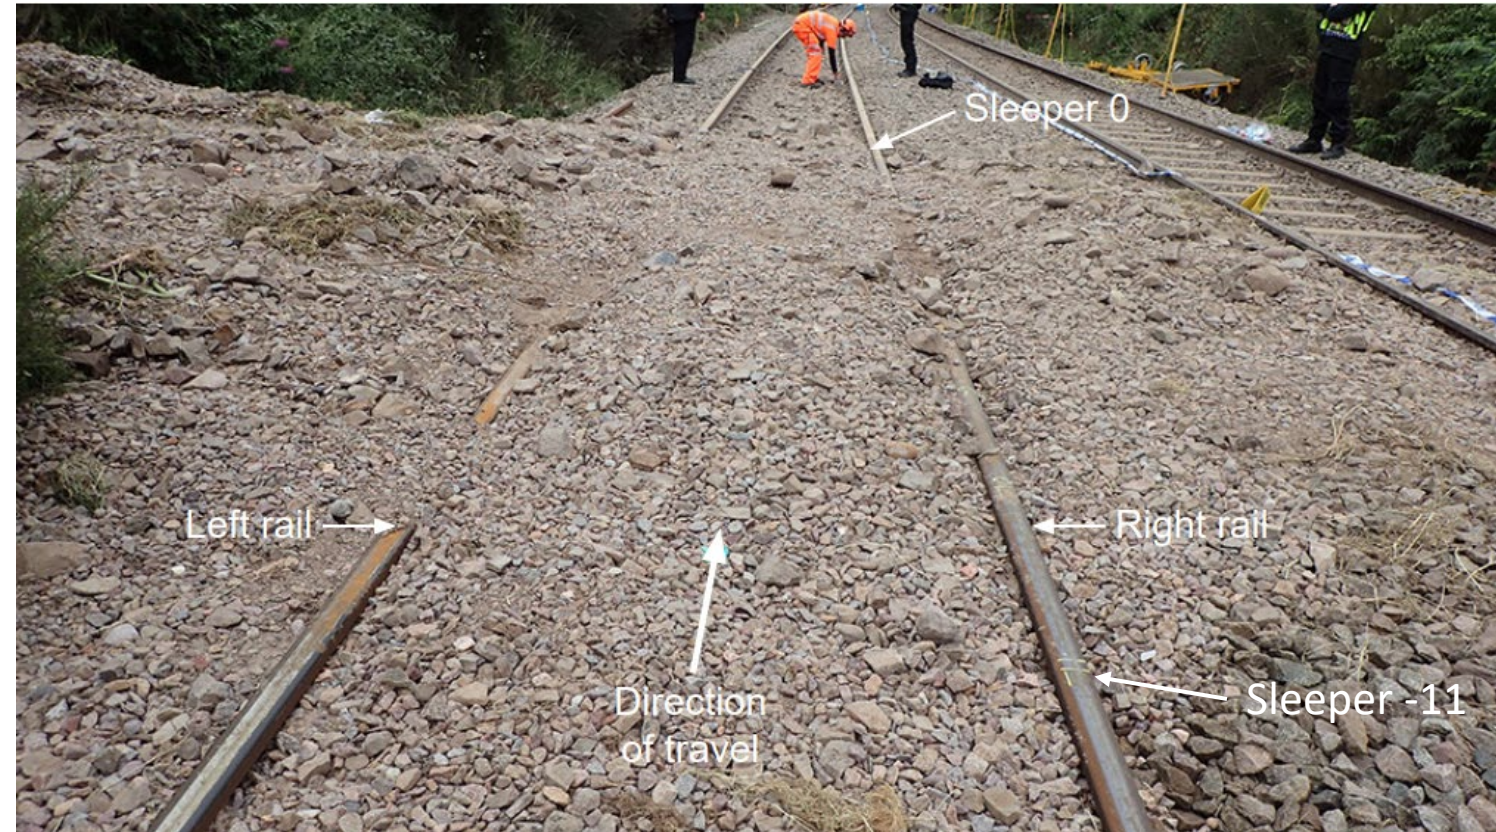
Carmont – Zone C observations

- systematic photography
- Washout debris covering the track – relatively low height
- Grooves cut by the passage of the train wheels

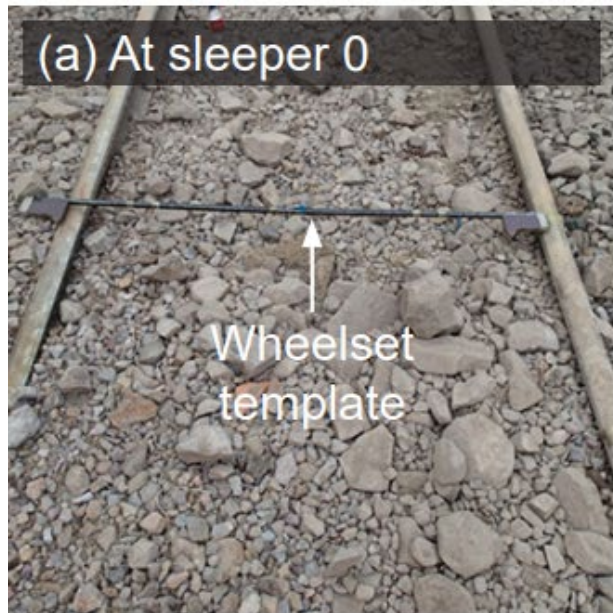
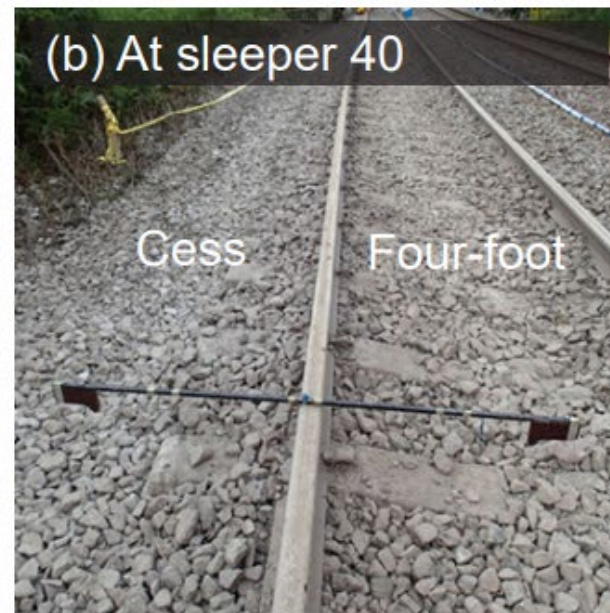
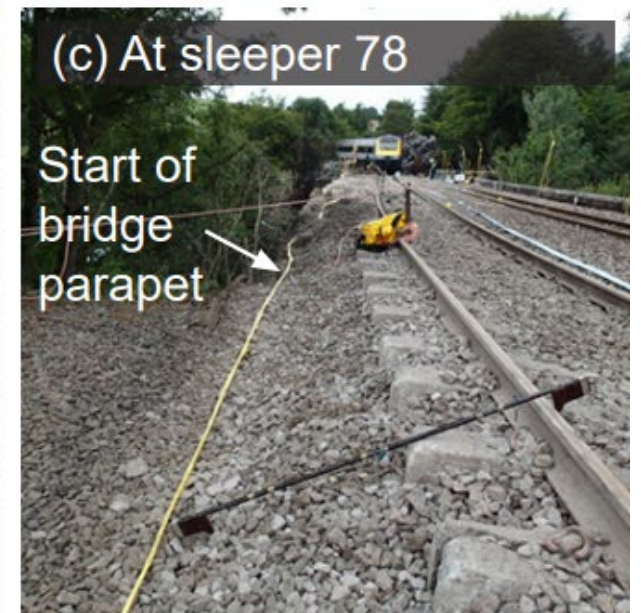
Carmont – Zone D observations

- Systematic photography using wheelset template
- Identified wheel marks consistent with LH wheels of four wheelsets climbing outside rail on the curve approaching bridge 325
- Sleeper damage and displaced ballast consistent with derailed wheelsets migrating to left

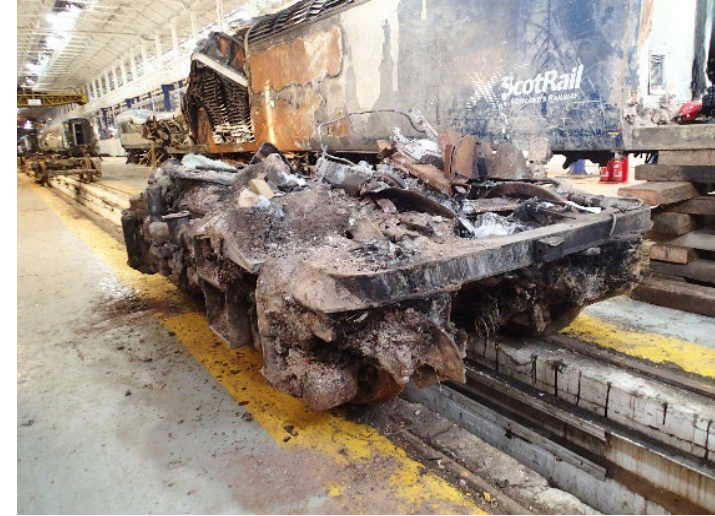
Leading bogie

- Post-site examination of wheels and bogies on train
- Complex and extensive pattern of damage
- Evidence of leading bogie running through washout debris
- Evidence of wheels on leading power running over rail clips
