ACCIDENT

Aircraft Type and Registration:	Bombardier Challenger 350, LN-JHH
No & Type of Engines:	2 Honeywell HTF7350 turbofan engines
Year of Manufacture:	2017 (Serial no: 20702)
Date & Time (UTC):	30 May 2023 at 0850 hrs
Location:	Dundee Airport
Type of Flight:	Commercial Air Transport (Passenger)
Persons on Board:	Crew - 3 Passengers - None
Injuries:	Crew - None Passengers - N/A
Nature of Damage:	Damage to left winglet
Commander's Licence:	Airline Transport Pilot's Licence
Commander's Age:	55 years
Commander's Flying Experience:	8,100 hours (of which 700 were on type) Last 90 days - 51 hours Last 28 days - 39 hours
Information Source:	Aircraft Accident Report Form submitted by the commander and further enquiries by the AAIB

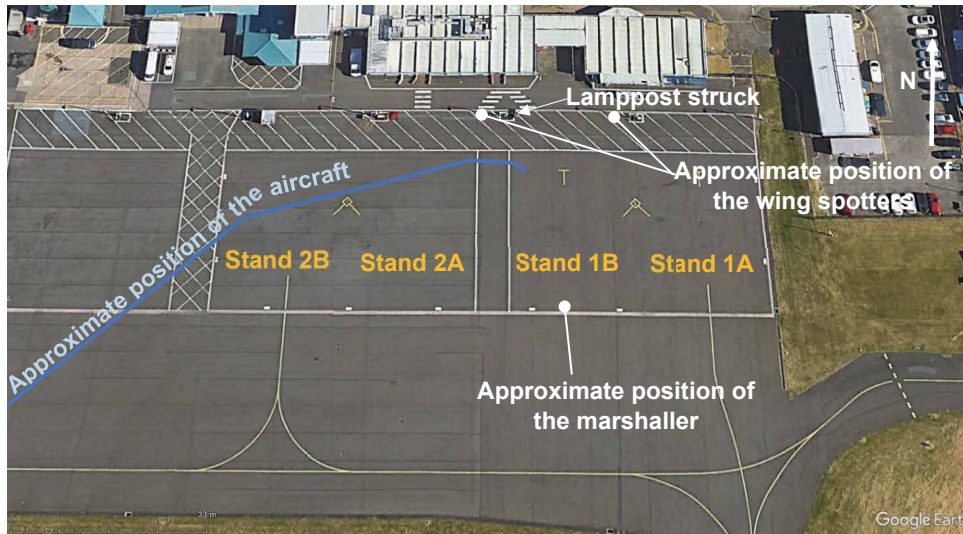
Figure 1

A marshaller was positioned at the head of the stand and two 'wing spotters' were positioned on the end of the apron (Figure 1). Another aircraft was already parked on the adjacent stand (Stand 1A).

Apron at Dundee Airport showing approximate path of the aircraft and position of the marshaller and wing spotters

Following the airport operator's investigation into this occurrence it commented that the white hatched area at the top of the apron is intended as a safety buffer zone. No part of the aircraft should enter this area whilst manoeuvring. It intends to instruct wing spotters to stand on the outer edge of the buffer zone rather than inline with the lampposts, to ensure the buffer is maintained. It also intends to:

- Conduct a review of its marshalling training package.
- Consider the introduction of direct headset communications between marshaller and wing spotters.
- Consider a two-stage marshalling process with two marshallers for circumstances similar to the accident.

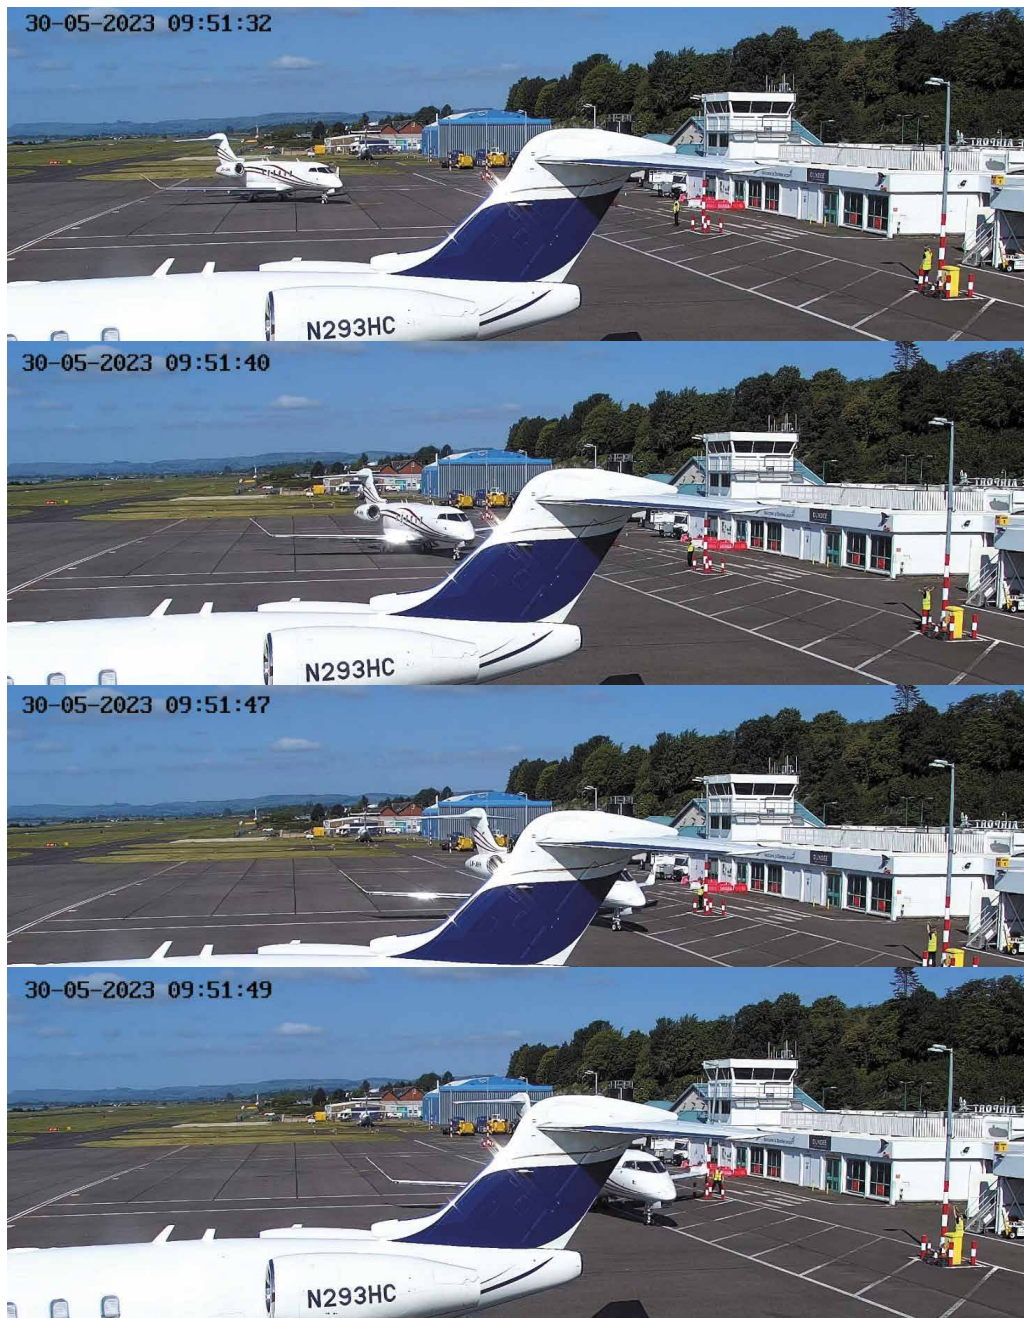
CCTV evidence showed the wing spotters started to signal the aircraft to stop 4 seconds before the collision.

The occurrence was captured on CCTV. Figure 4 shows the sequence of events. The marshaller is out of shot on the left of the images.

CCTV footage of the occurrence (time stamps are local time)
