**ACCIDENT**

| <b>Aircraft Type and Registration:</b> | Scintex CP301-C1, G-CKCF | |
| <b>Date &amp; Time (UTC):</b> | 31 October 2022 at 1058 hrs | |
| <b>Location:</b> | Blue Bell Hill, Kent | |

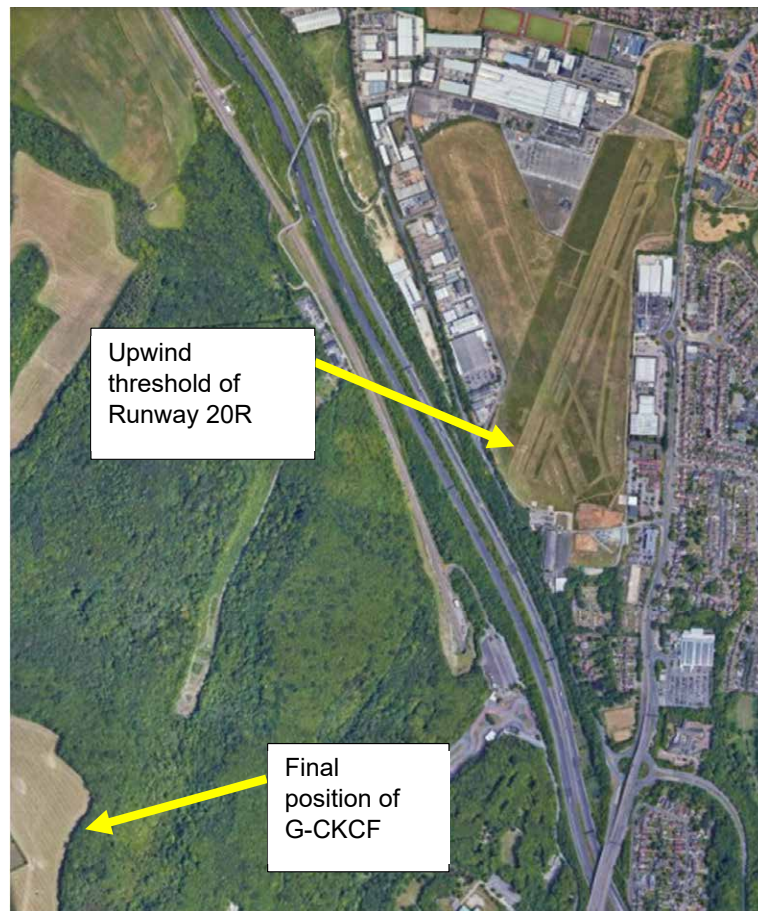
**Figure 1**

The area of wood into which the aircraft descended rises to the same elevation as the aerodrome approximately 400 m to the south of the upwind runway threshold, then rises steadily to 130 ft above the aerodrome elevation at the accident site, a further 1,000 m to the south-south-west. The relative locations are shown in Figure 1. The average gradient from the runway end to the accident site is therefore approximately 3%.

The relative locations of the upwind threshold of Runway 20R and the final position of G-CKCF
