Rail Accident Investigation Branch

# Rail Accident Report

## **Freight train derailment at Petteril Bridge Junction, Carlisle 19 October 2022**

Report 10/2023  
October 2023

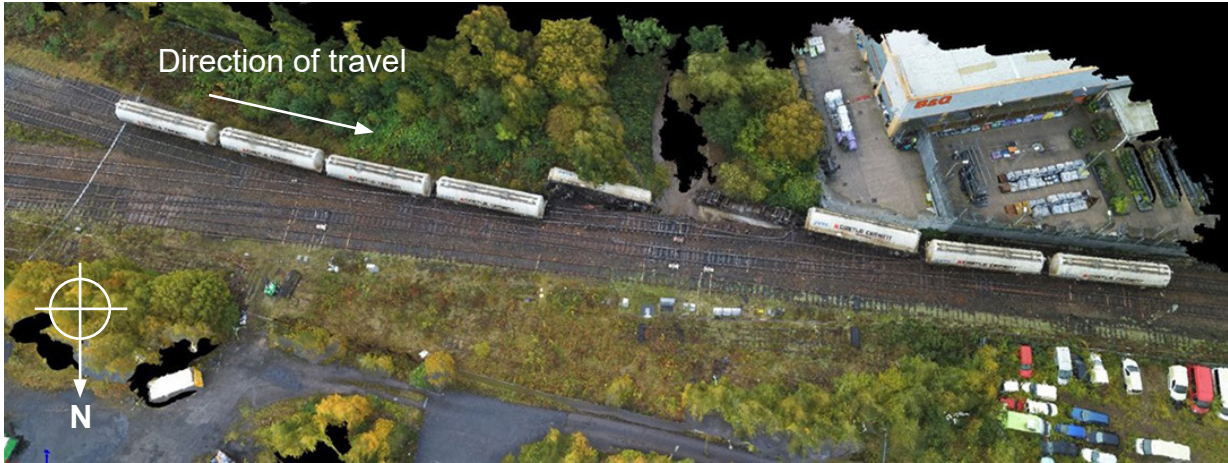
Figure 2: Overview of derailed wagons at Petteril Bridge Junction.

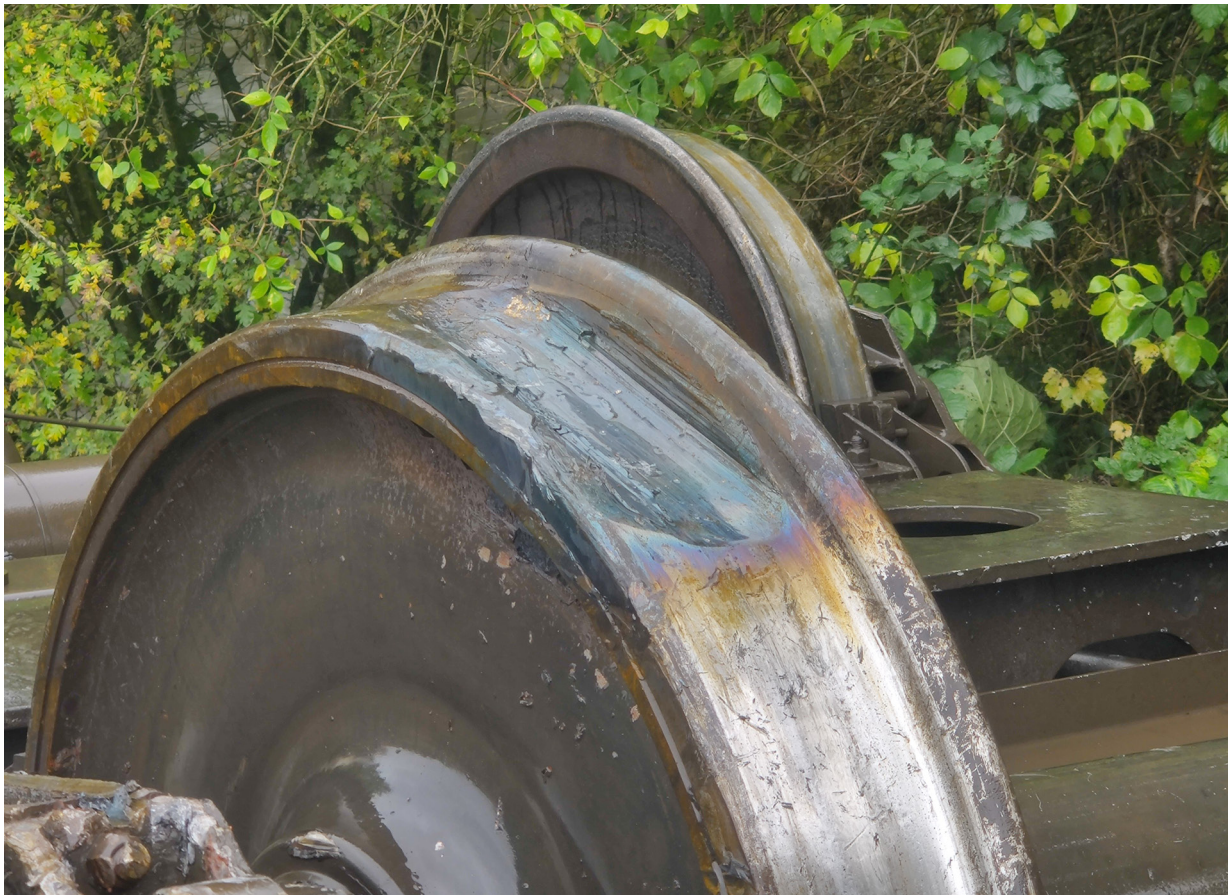
Figure 3: Wheel flat observed on the leading wheelset of the ninth wagon immediately after derailment.

**68** Immediately after the derailment, the leading wheelset of the ninth wagon was found to have a large wheel flat on each of its wheels (figure 3). These wheel flats had worn approximately 25 mm into the tread surface of the wheels, resulting in a large false flange on the outside edge (figure 21). The wheel flats were approximately 290 mm long (figure 22).

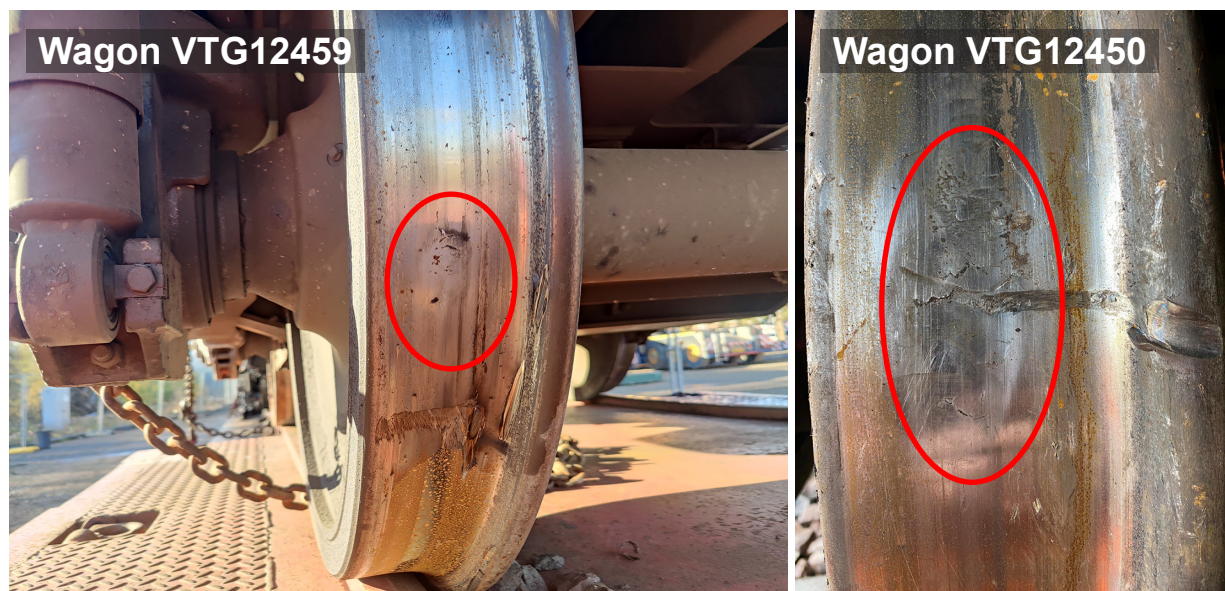
- 32 These flats were recorded on the fourth (rear) wheelset of wagon VTG12459 (the eighth wagon from the front of train 6C00) and the third wheelset of wagon VTG12450 (the eleventh wagon from the front). No wheel flats were recorded in the 13 October data for wagon VTG12455 (the ninth wagon from the front).
- 33 Examination of the eighth and eleventh wagons after the derailment showed that these pre-existing wheel flats were still visible (figure 10). RAIB has no evidence to suggest that the existence of either of these wheel flats contributed to the derailment on 19 October 2022.

Figure 10: Pre-existing wheel flats on wagons in train 6C00.

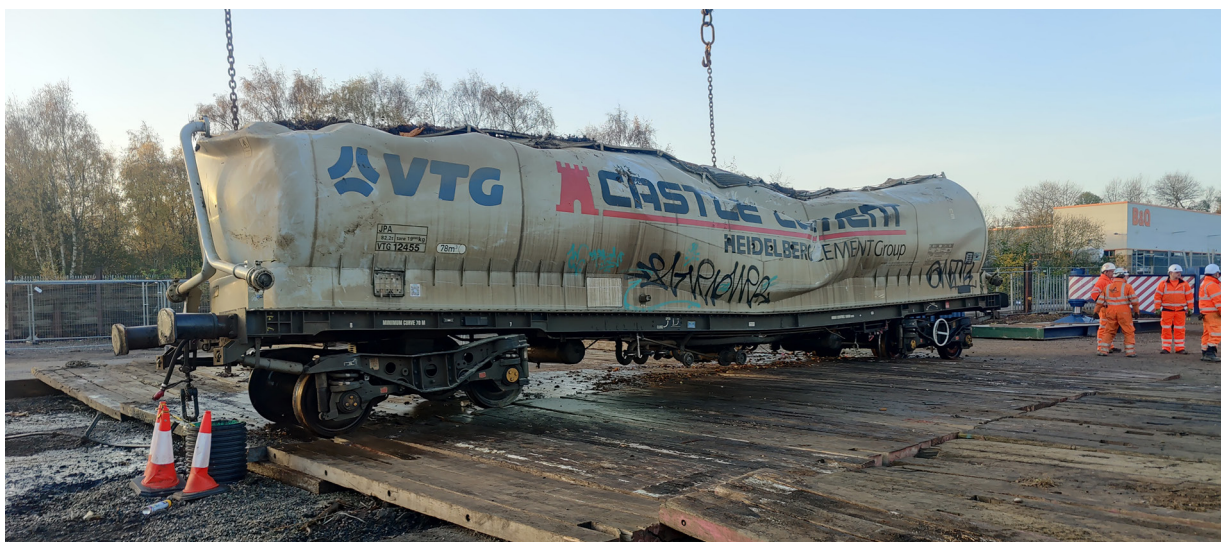
- 35 Following the accident, the ninth wagon was recovered from the River Petteril and transported to a secure storage site (figure 11). Examination of the braking system showed that all the main components were still intact, although several air pipes had become dislodged due to the distortion in the wagon's underframe caused by the accident and the wagon's recovery. Reconnection of the dislodged pipework made the brake system airtight, and able to be pressurised and tested. A series of functional tests was then undertaken on the wagon's braking system in conjunction with VTG and DB Cargo.

Figure 11: The ninth wagon (VTG12455) after recovery.

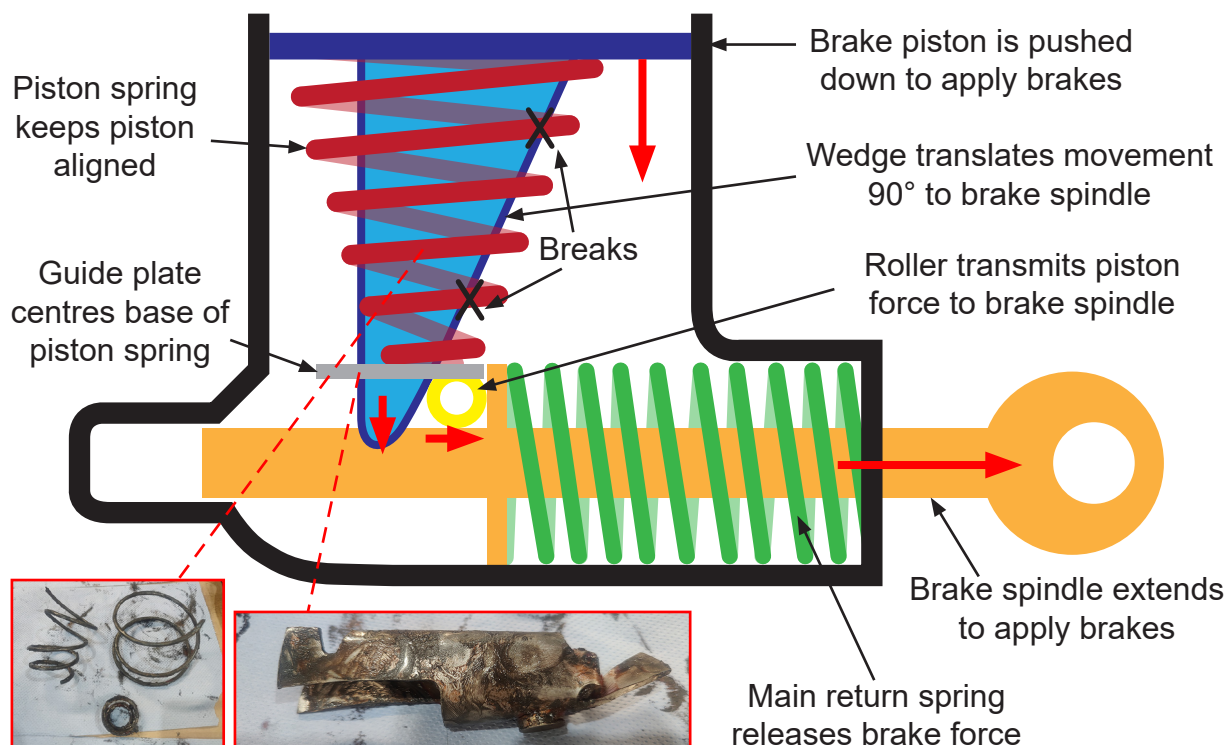
Figure 12: Internal arrangement of the brake cylinders.

- 45 The piston spring had broken in two locations and RAIB commissioned a metallurgical examination of it to determine the nature of the breaks. This found that the first break showed signs of fatigue cracking that would have developed over many cycles of operation in normal service. The second of the breaks was due to the dislodged spring being trapped in the brake cylinder mechanism and being crushed. The conclusion of the examination was that fatigue had initially led to the spring failing and becoming dislodged, resulting in the spring and its guide plate becoming loose in the mechanism and subsequently becoming crushed during service operations. The metallurgical report concluded that it was likely that the cracking, and both the resulting breaks, had occurred during normal service, before the derailment.

- 46 If the dislodged spring and guide plate had become wedged in the brake cylinder mechanism, it is possible that it could have resulted in the brake force on that bogie not being fully released after a brake application. The maximum force that could have been applied would have been a normal full service brake application. However, this would have resulted in the brakes being applied to both wheelsets in the bogie, and not just to the wheelset that slid, which would also cause additional brake wear on the brake blocks for both wheelsets. Examination of the wagon after the derailment did not show any significant difference in the brake block wear between the two bogies on the ninth wagon, nor any evidence of excess heat having been generated, suggesting that any possible abnormal brake force from this brake cylinder had a minimal effect.

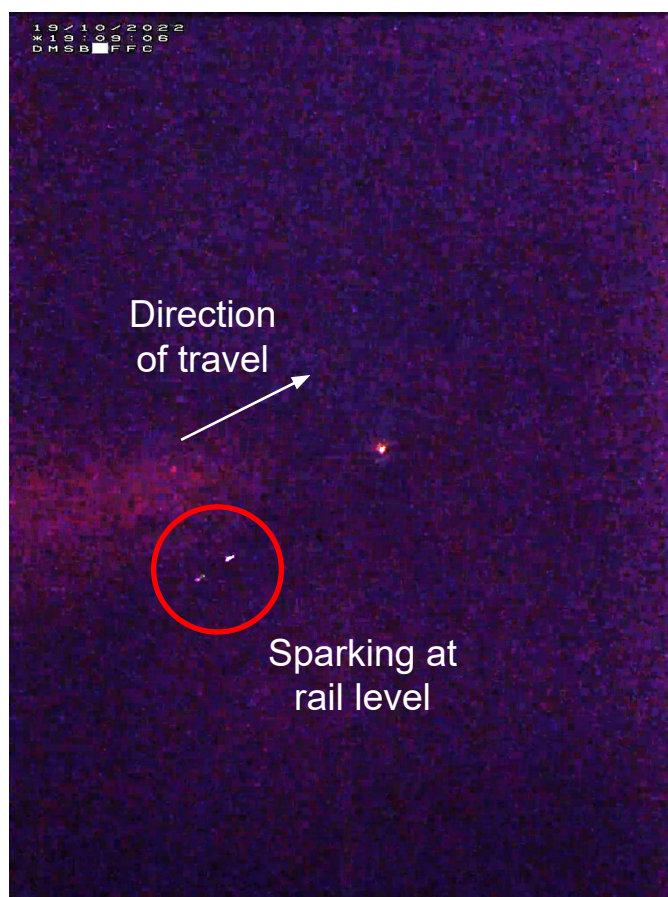
- 57 At 19:09 hrs, train 6C00 passed a southbound passenger service on the opposite line (train 2H97, the 18:24 Northern service from Carlisle to Leeds). Rear-facing closed-circuit television (CCTV) footage from this service (figure 17) momentarily showed a small amount of sparking at the wheel/rail interface on one wheelset of train 6C00. This sparking was only visible once the contrast of these CCTV images had been altered and it is unlikely that the driver, or any other railway staff, on train 2H97 would have been able to see it as train 6C00 passed.

Figure 17: Rear-facing CCTV image from train 2H97 showing sparking at a wheelset on train 6C00 (courtesy of Northern Trains).

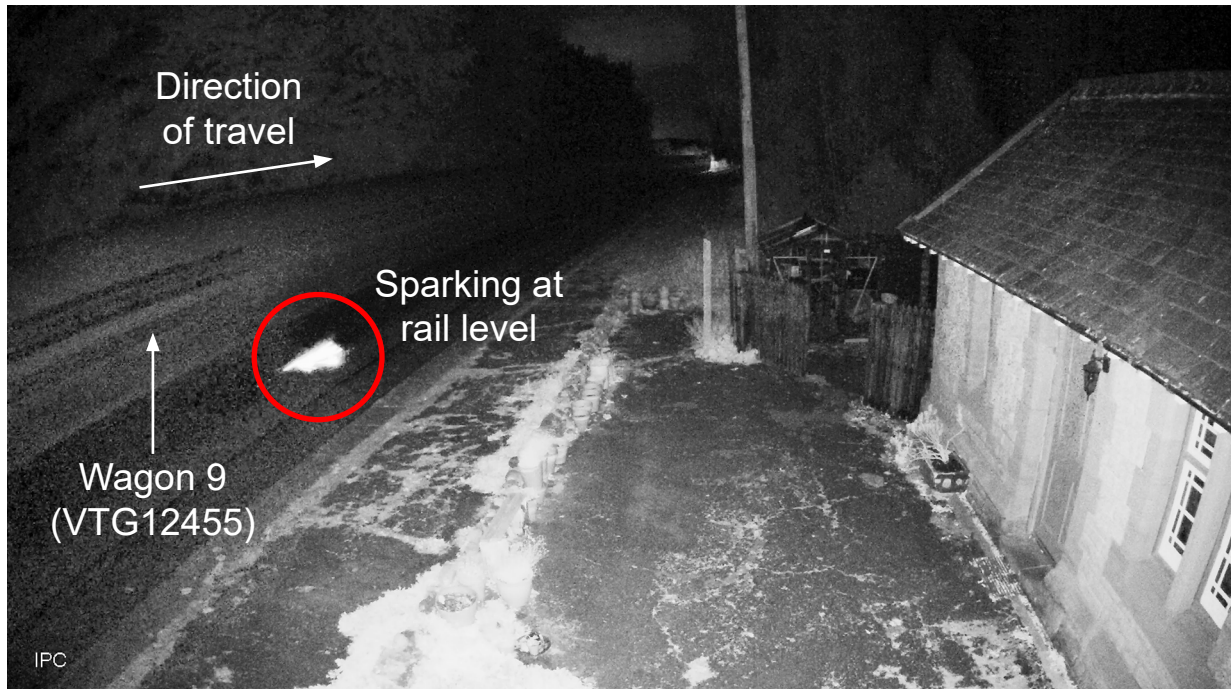
- 58 At 19:31 hrs, train 6C00 passed a private residence at Little Salkeld. CCTV footage from this residence, which was fitted with a night vision system, showed sparking from the leading wheelset on the ninth wagon (figure 18). This sparking would not have been as visible to the naked eye as it appears in the night vision images.

Figure 18: Sparking from the ninth wagon in train 6C00 at Little Salkeld (courtesy of Mike England).

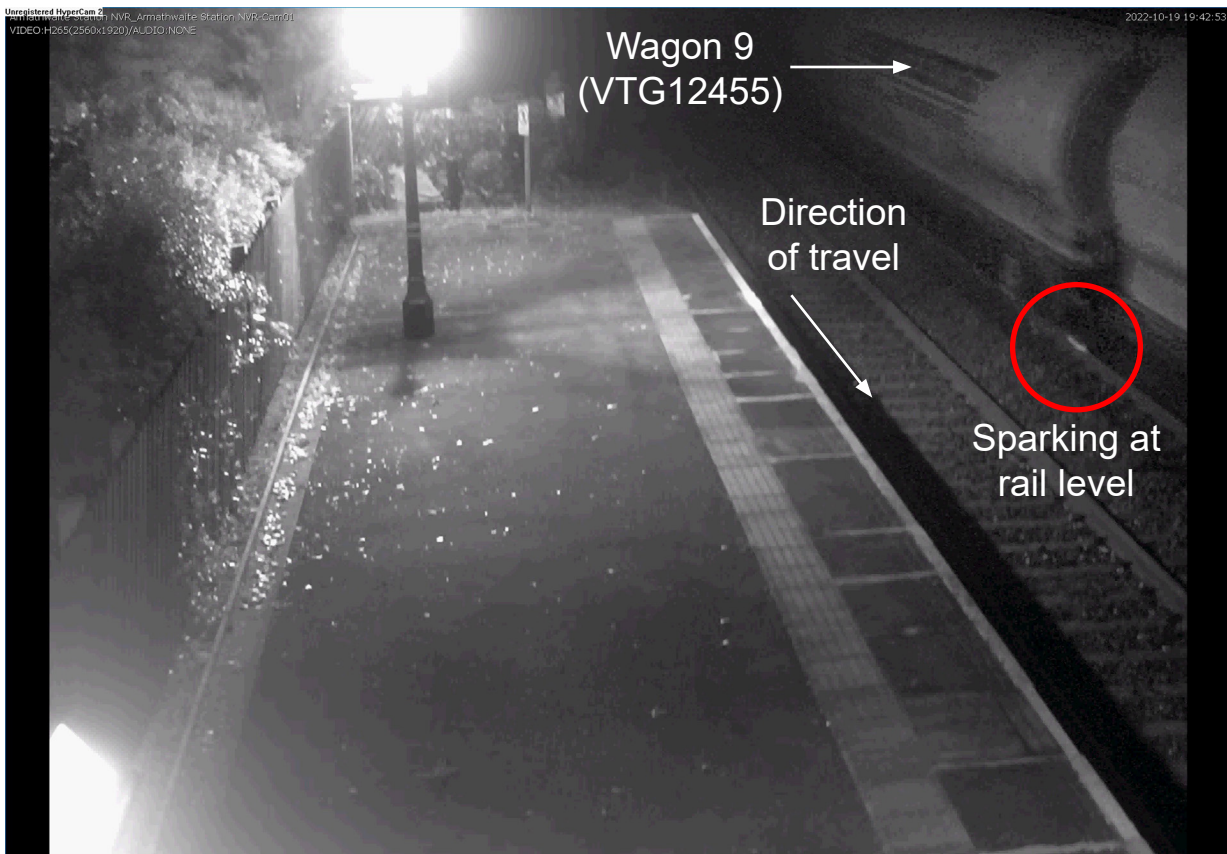
- 60 At 19:42 hrs, train 6C00 passed Armathwaite station, where the station CCTV footage showed a small amount of sparking at the leading wheelset on the ninth wagon (figure 19). One minute later it passed Low House signal box. The signaller watched the train pass to check that it was complete after the contact from Culgaith signal box. The signaller at Low House did not see or hear anything wrong with the train as it passed by (see paragraph 142).

Figure 19: Sparking from the ninth wagon in train 6C00 at Armathwaite station (courtesy of Northern Trains).

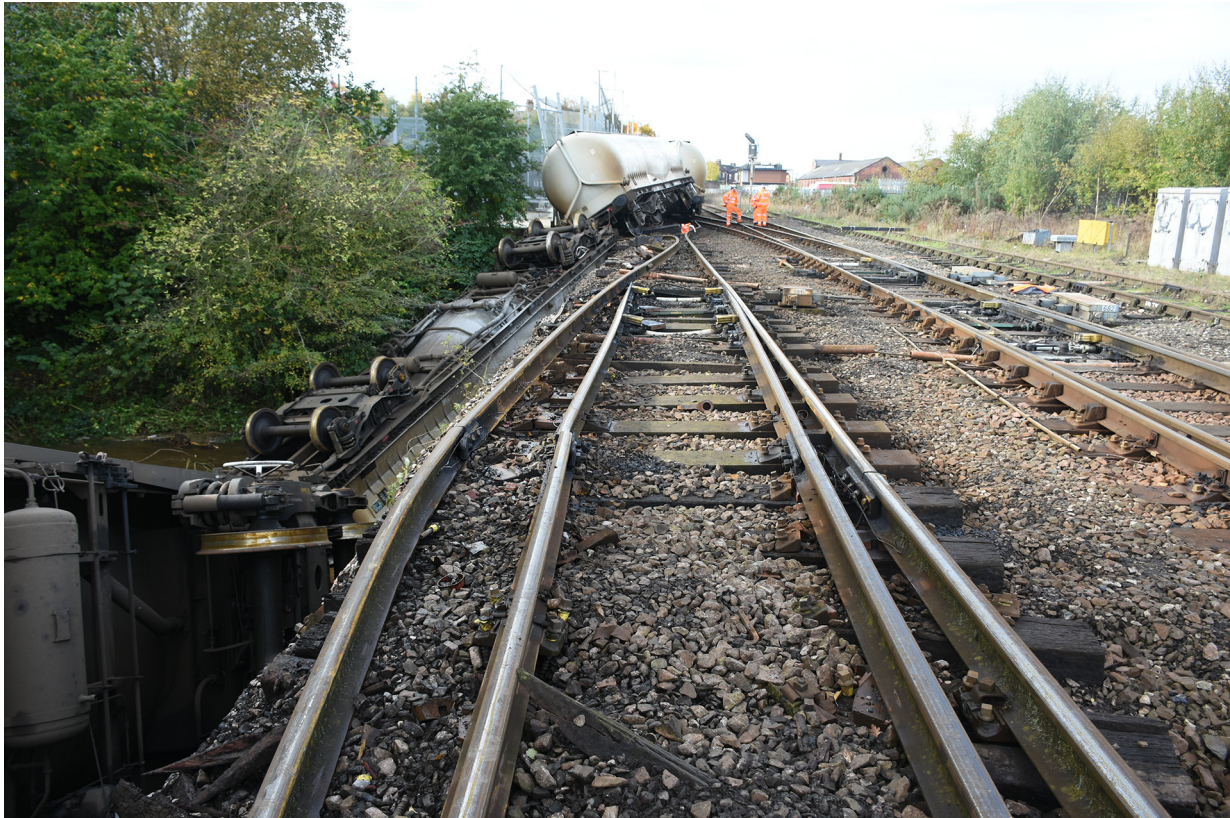
- 62 The derailed wagons destroyed the set of points at Petteril Bridge Junction, which was located on top of the bridge over the river. The derailed wagons, which were running to the left of the track, ran against the side of the bridge parapet wall, resulting in the wall and part of the railway formation falling into the river. This led to the ninth and tenth wagons falling off the left side of the bridge, coming to a rest with the ninth wagon upside down in the river and the tenth wagon on its side on the riverbank (figure 20). The rear of the eighth wagon also derailed to the left as it was dragged sideways by the front of the ninth wagon.

Figure 20: Damage to the track and bridge at Petteril Bridge Junction.

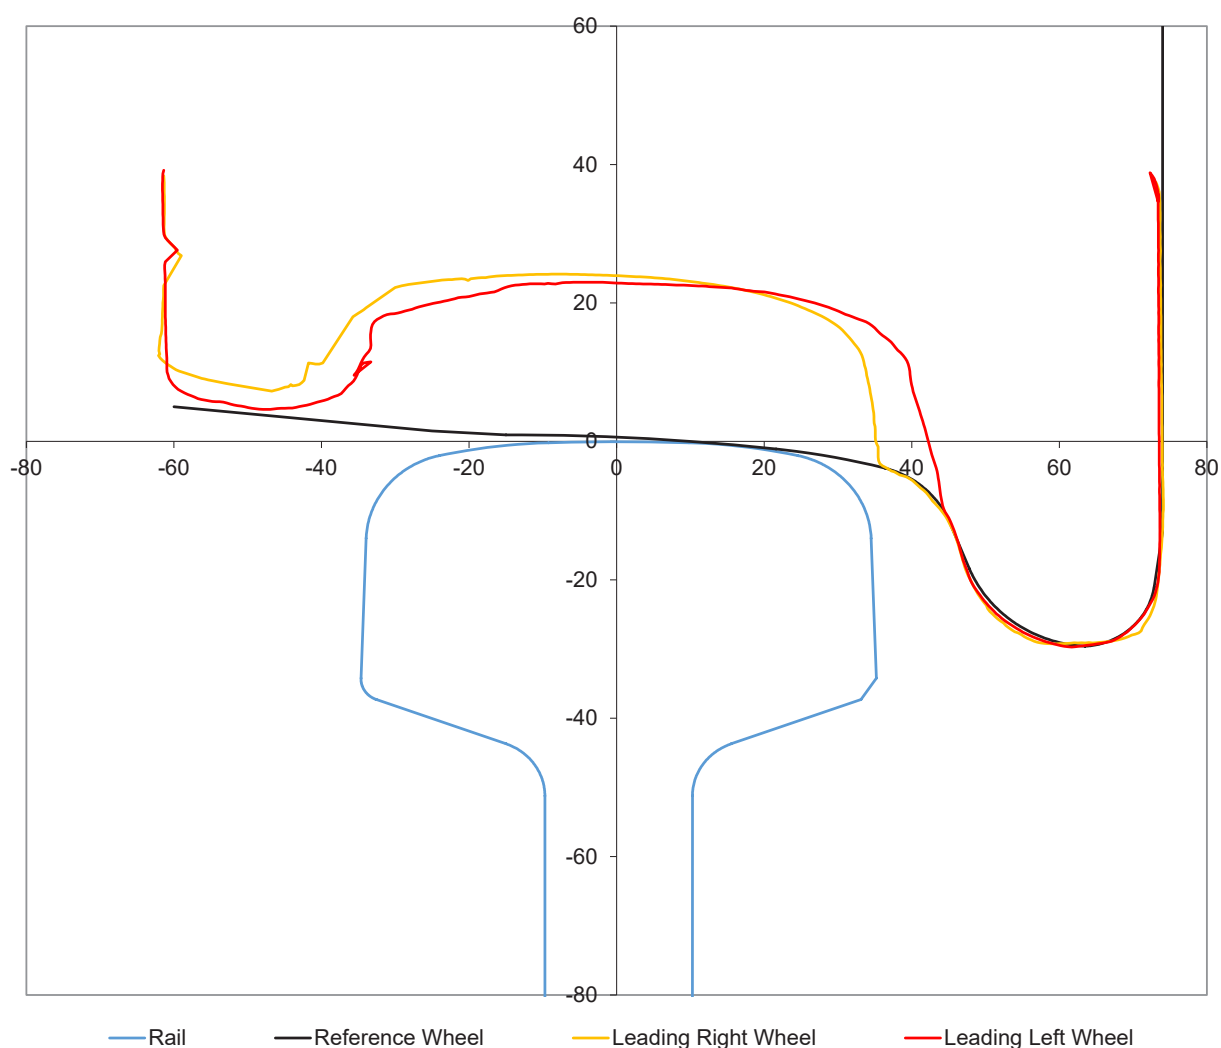
Figure 21: Wheel profile of the worn wheels, compared to the reference wheel profile.

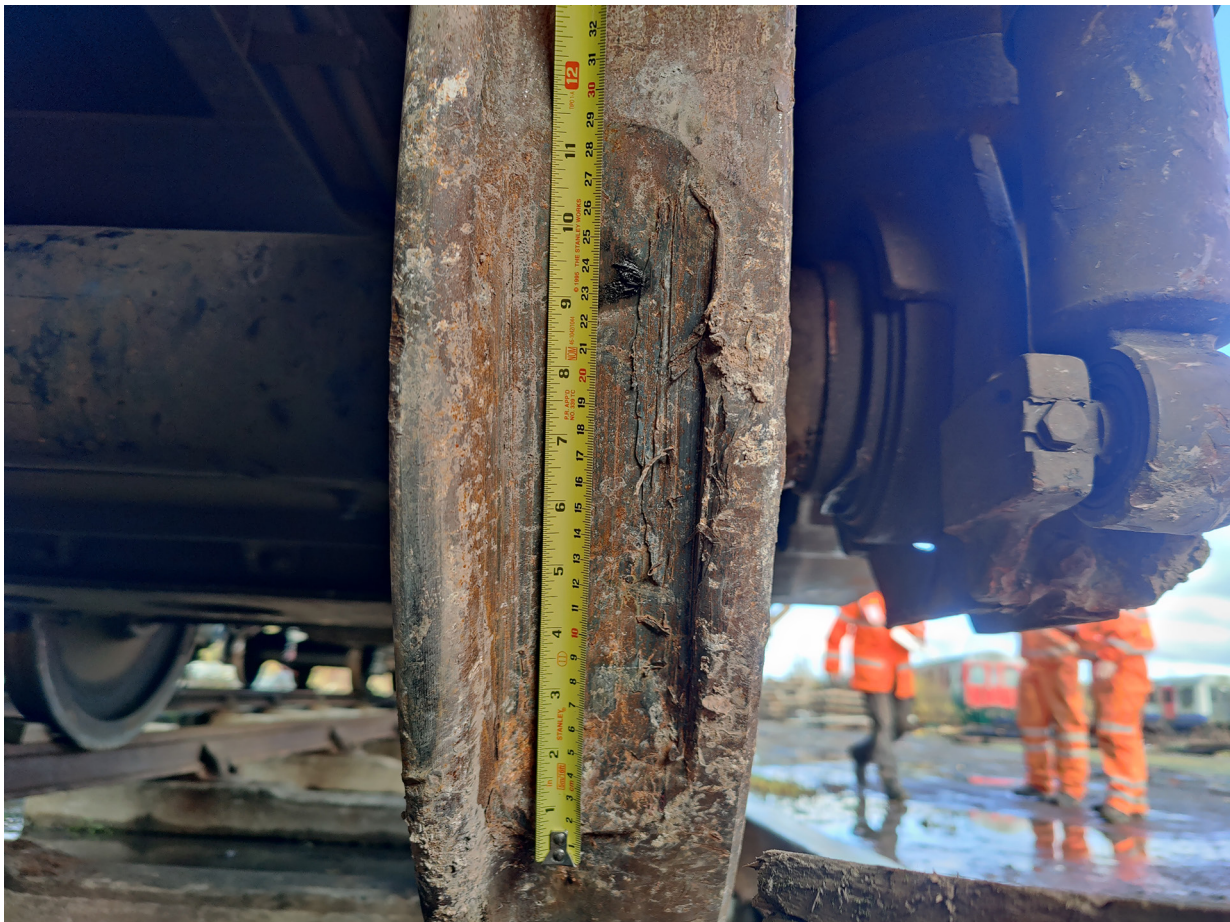
Figure 22: The length of the wheel flats.

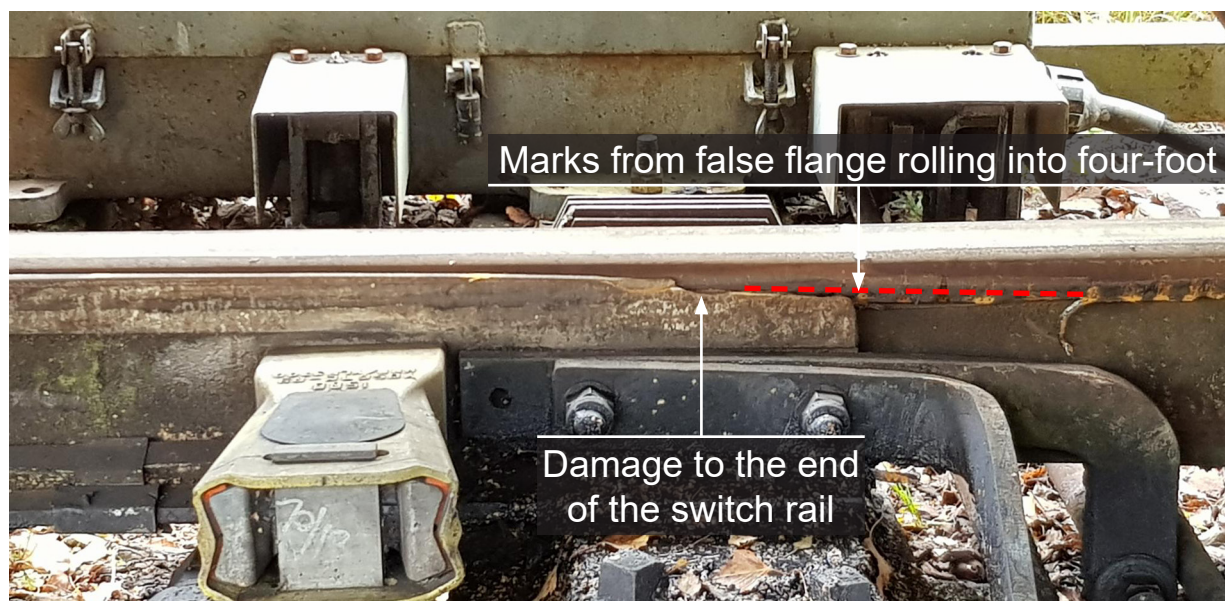
Figure 24: Switch rail at 679A points.

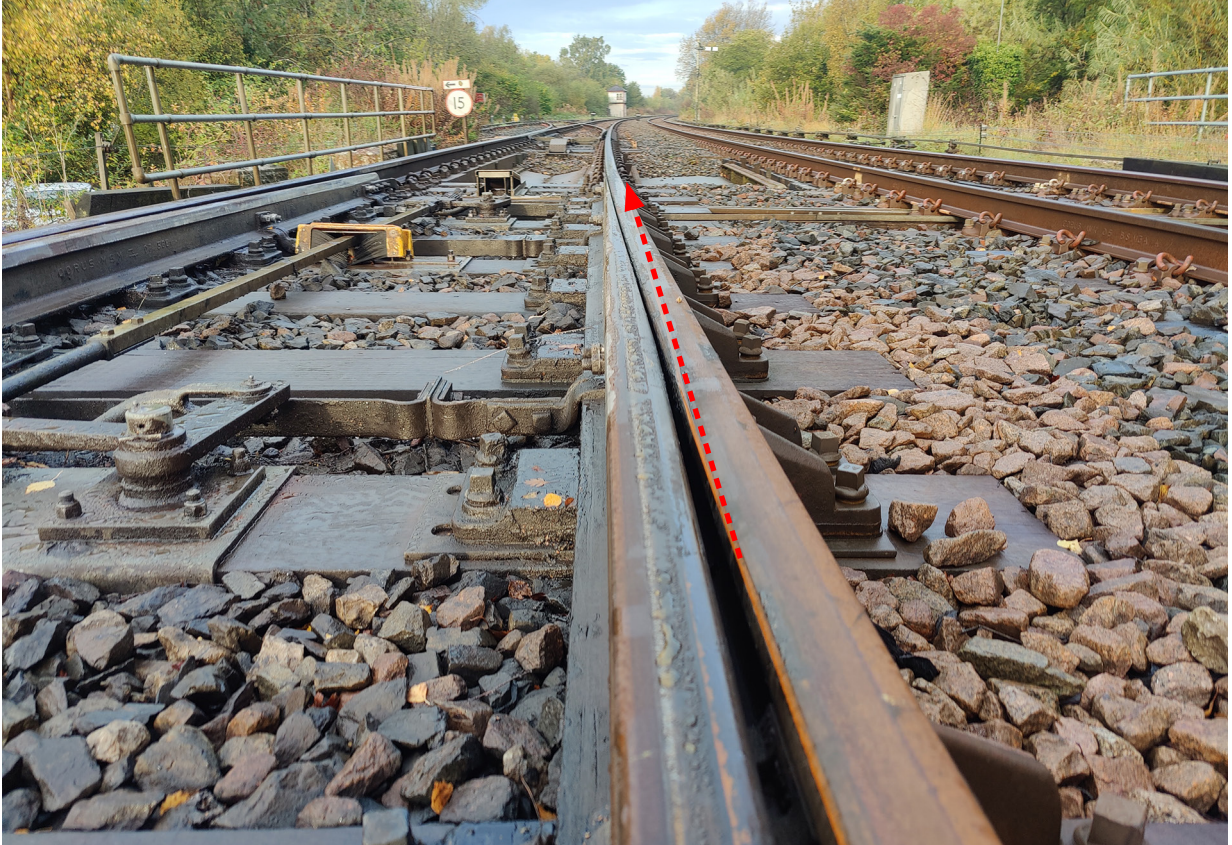
Figure 29: False flange marks at Howe & Co's Siding.

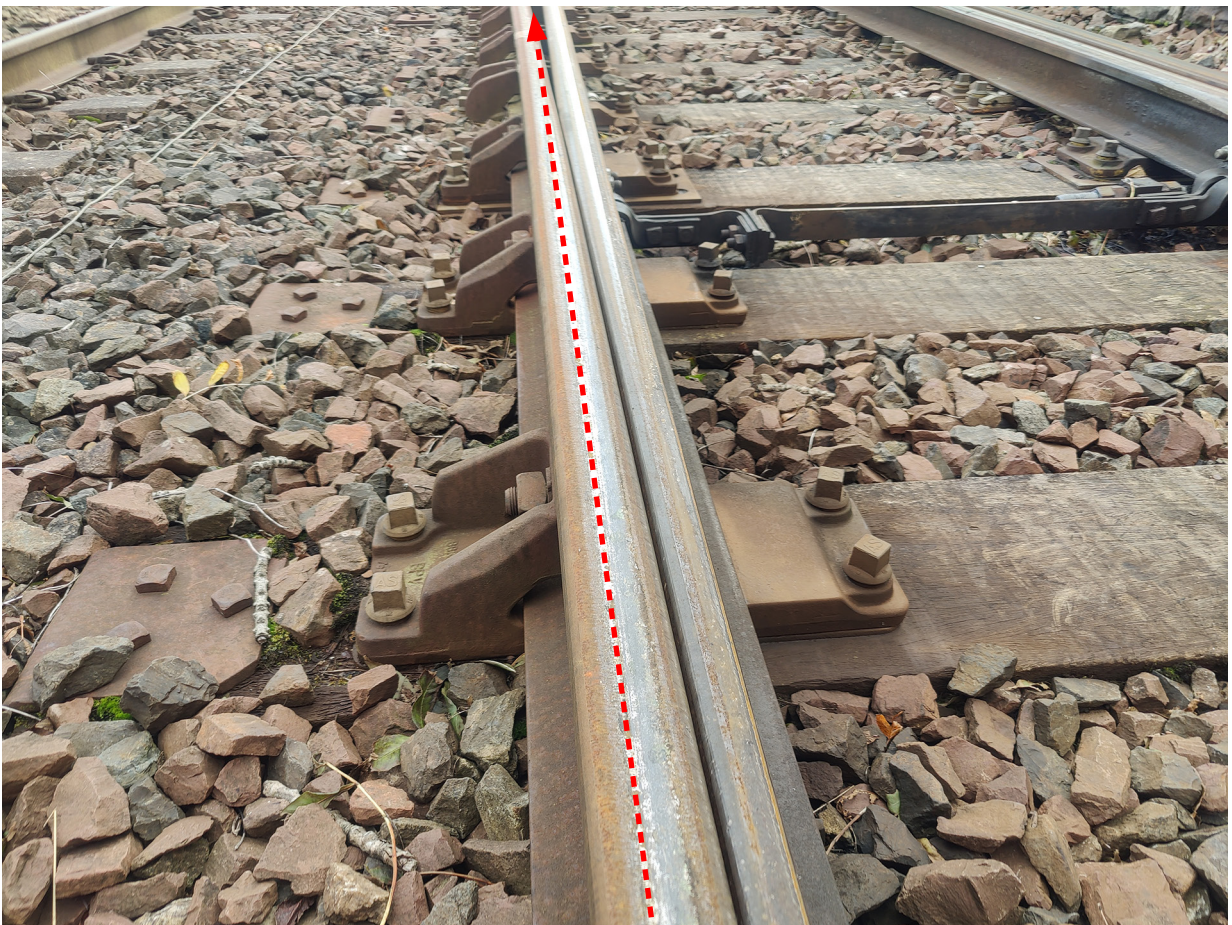
- 79 After the derailment, RAIB surveyed each set of points from Petheril Bridge Junction back along the route of the train, in turn, until no false flange marks were visible. Marks were clearly visible at the last set of points that train 6C00 passed, at Howe & Co's Siding, as shown in figure 29. False flange marks were then found at every set of points that the train had previously passed over, all the way back to Kirkby Stephen (figure 30). No easily recognisable false flange marks were found at the previous set of points from Kirkby Stephen, which were at Garsdale. That meant that the first location where there was clear evidence of the leading wheelset on the ninth wagon sliding with a large enough false flange to leave marks on the railhead was at Kirkby Stephen.

Figure 30: False flange marks at Kirkby Stephen.
