ACCIDENT

Aircraft Type and Registration:	Schleicher AS-K 13, G-DCMK	
No & Type of Engines:	None	
Year of Manufacture:	1975 (Serial no: 13305)	
Date & Time (UTC):	12 August 2022 at 1054 hrs	
Location:	Troed yr Harn, Talgarth, Powys	
Type of Flight:	Training	
Persons on Board:	Crew - 2	Passengers - None
Injuries:	Crew - 2 (Serious)	Passengers - N/A
Nature of Damage:	Destroyed	
Commander's Licence:	BGA Instructor rating (Full)	
Commander's Age:	71 years	
Commander's Flying Experience:	7,099 hours (of which approximately 2,500 were on type) Last 90 days - 42 hours Last 28 days - 6 hours	
Information Source:	AAIB Field Investigation

Synopsis

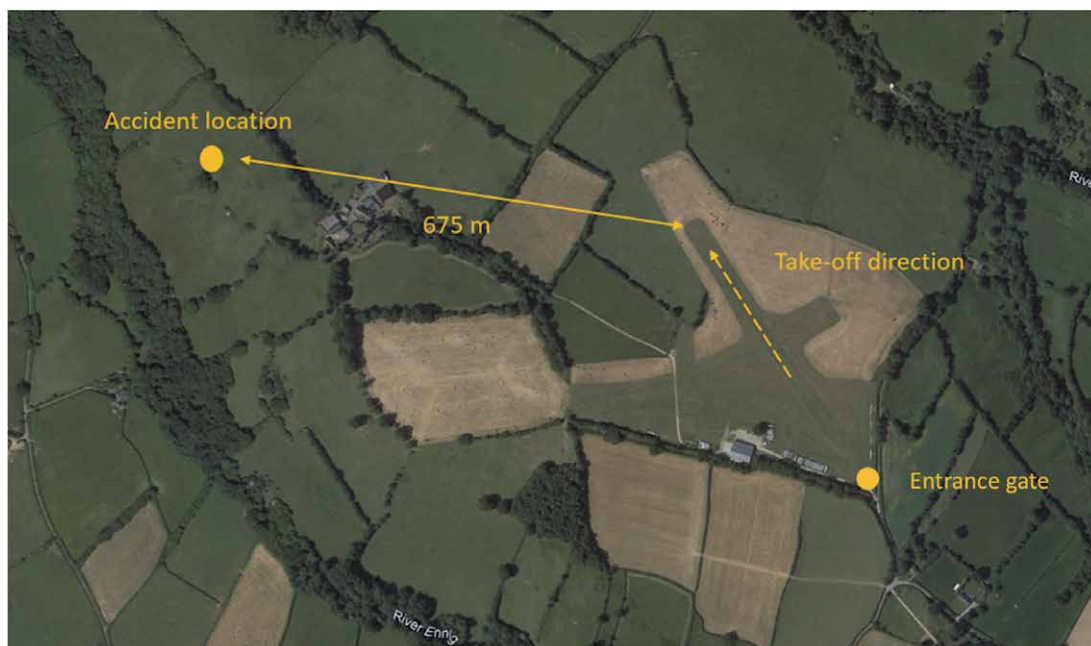
Figure 1

Takeoff run and accident location

The student was the handling pilot and the intention was to depart in a north-westerly direction (Figure 1), remain connected to the aerotow until 1,500 ft agl before tow release, then rejoin a left hand circuit to land in a north-easterly direction. The pilot intended to make minimal inputs and the student was expected to make all radio calls. The pilot noted the student was close to solo standard but needed to focus on his use of the airbrake during the approach.

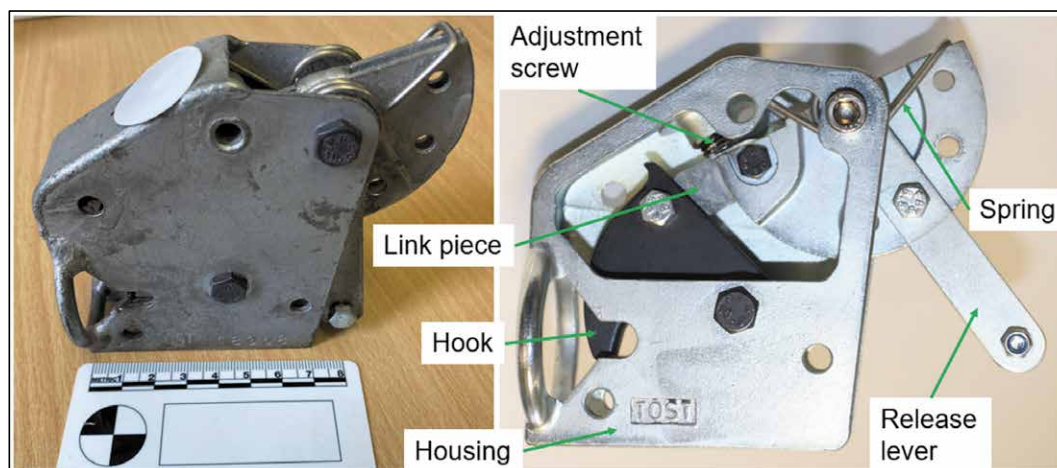
**Figure 3**

The nose tow release fitted to G-DCMK at the time of the accident was a Tost E72, serial number 18058 (Figure 3 left). Figure 3 right shows a sectioned E85 tow release, which differs from an E72 in having a cast instead of welded housing. The tow release comprises the housing, adjustment screw, hook, link piece, release lever and a spring.

Left – Tost E72 tow release fitted to G-DCMK

Right – Example E85 tow release. Internal mechanism similar

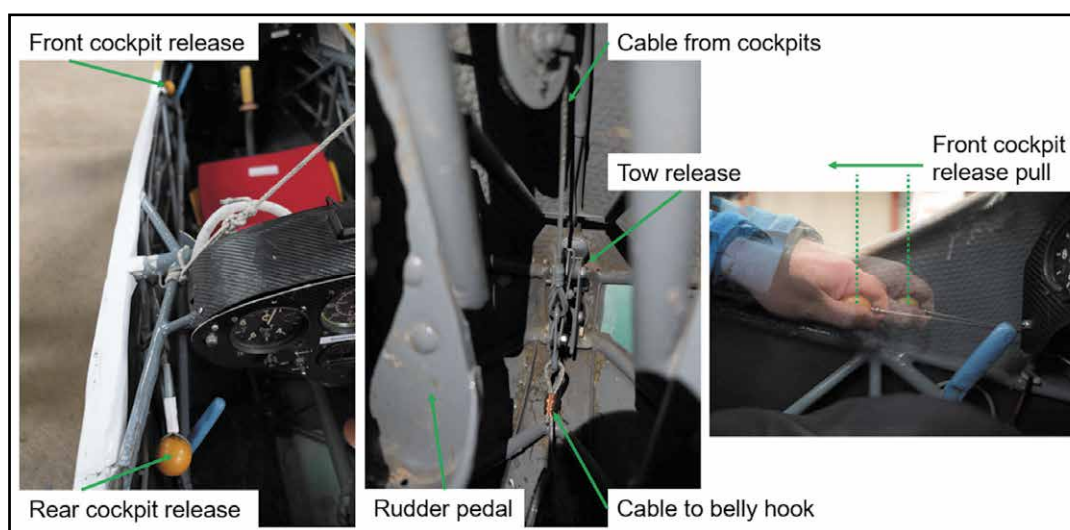
**Figure 4²**

It was operated by either pilot pulling on a plastic release knob attached to a steel cable in the cockpit (Figure 4 left and right). The steel cable passed through a series of guides and was attached to the release lever (Figure 4 centre), and another cable attached to the release lever continued under the cockpit area to the belly hook.

Left – Cockpit releases

Centre – Cable attachments to the tow release

Right – Front cockpit showing the movement of the knob to release the tow cable

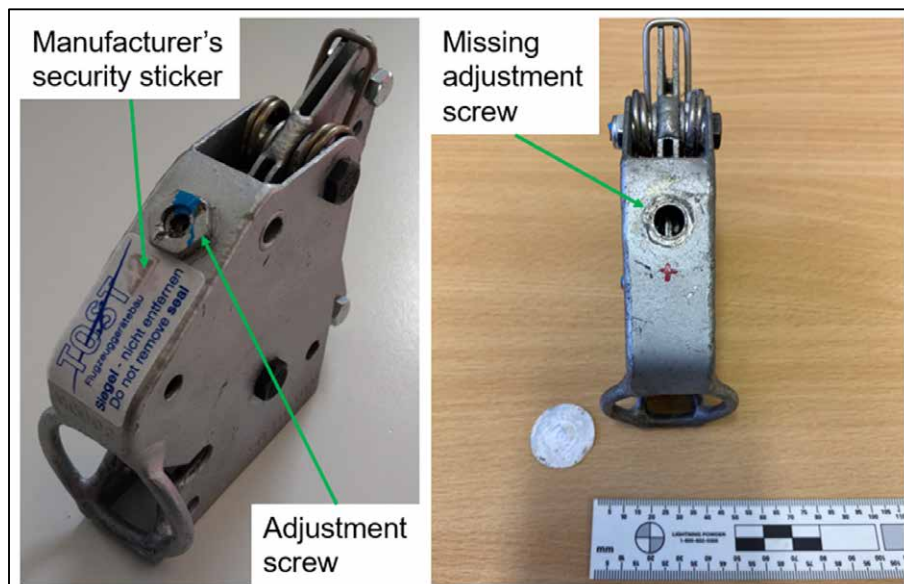
Figure 5

The tow release was examined by the manufacturer, which noted that the white round sticker on the housing was not the security sticker applied by the factory (Figure 5 left). The sticker was removed and it was found that the over-centre adjustment screw had been removed (Figure 5 right).

Left – Example of an E72 tow release as supplied from the manufacturer
Right – White round sticker removed showing missing adjustment screw

It was stated to the investigation that while installing it following the June 2022 incident, the replacement tow release would not fit because the adjustment screw fouled against the structure. To enable the release to be fitted the adjustment screw was removed. The tow release that was removed was an E85 which has a recessed adjustment screw as shown in Figure 3 right.

The examination of the tow release revealed that the over-centre adjustment screw had been removed from the housing. The adjustment screw is set by the manufacturer and sealed before delivery. The tow release is a certified, safety critical part and is supplied with an EASA Form 1. No modification or adjustment of this component is permitted except by qualified persons. No one at the gliding club was qualified to modify the tow release.

The adjustment screw on the E72 tow release was proud of the housing and prevented it from being fitted when the tow release was changed on 17 June 2022 following a previous uncommanded release. The adjustment screw of the E85 tow release which was removed from the glider during that change was recessed into the housing, so the problem only arose when the E72 was fitted. The removal of the adjustment screw would have increased the loads required to open the tow release hook and need a longer pull on the tow release cable, so would not have caused inadvertent release. The tow release manufacturer informed the AAIB that a special version of the E72 with a recessed adjustment screw is available.
