ACCIDENT

Aircraft Type and Registration:	Bombardier CL-600-2B16 Challenger 604, N999PX	
No & Type of Engines:	2 GE CF34 turbofan engines	
Year of Manufacture:	1998 (Serial no: 5387)	
Date & Time (UTC):	31 January 2022 at 0018 hrs	
Location:	London Stansted Airport	
Type of Flight:	Private	
Persons on Board:	Crew - 2	Passengers - 2
Injuries:	Crew - None	Passengers - None
Nature of Damage:	Damaged beyond economical repair	
Commander's Licence:	Airline Transport Pilots Licence	
Commander's Age:	48 years	
Commander's Flying Experience:	4,235 hours (of which 1,320 were on type) Last 90 days - 48 hours Last 28 days - 36 hours	
Information Source:	AAIB Field Investigation

Synopsis

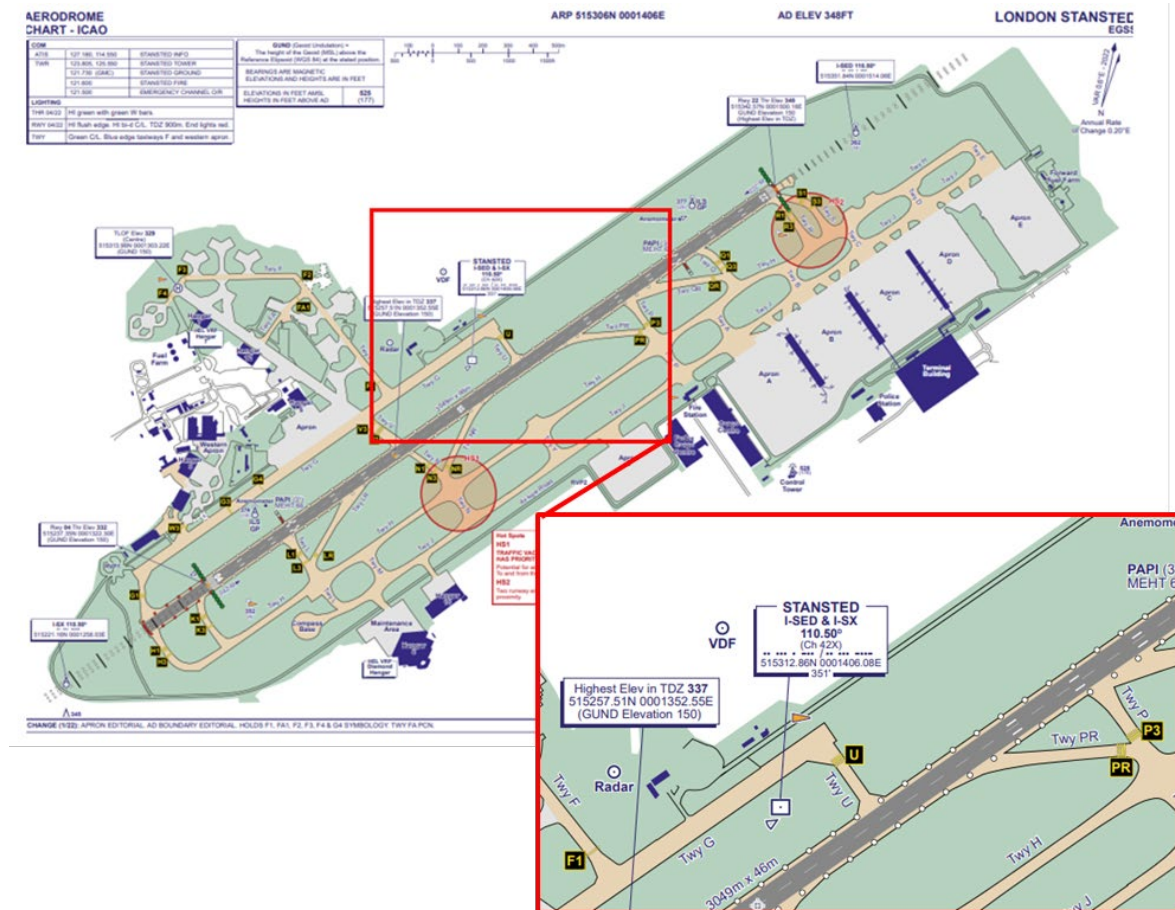
Figure 2

Examination of Runway 22 at London Stansted Airport showed three separate wing strike marks on the paved surface between the intersections of Taxiways Papa, Romeo and Uniform, each approximately 20 m long (Figure 2). Paint transfer from N999PX's wing was evident in the strike marks on the runway (Figure 3), becoming a furrow in the grass. As it continued to travel through the grass, the wingtip struck a concrete pad. Several pieces of debris were found in this area, including fragments of wingtip skin panel and wingtip light transparency.

Tracks corresponding to all three landing gear wheels were also evident in the grass.

London Stansted Aerodrome Chart, inset showing area where N999PX left wing struck the ground

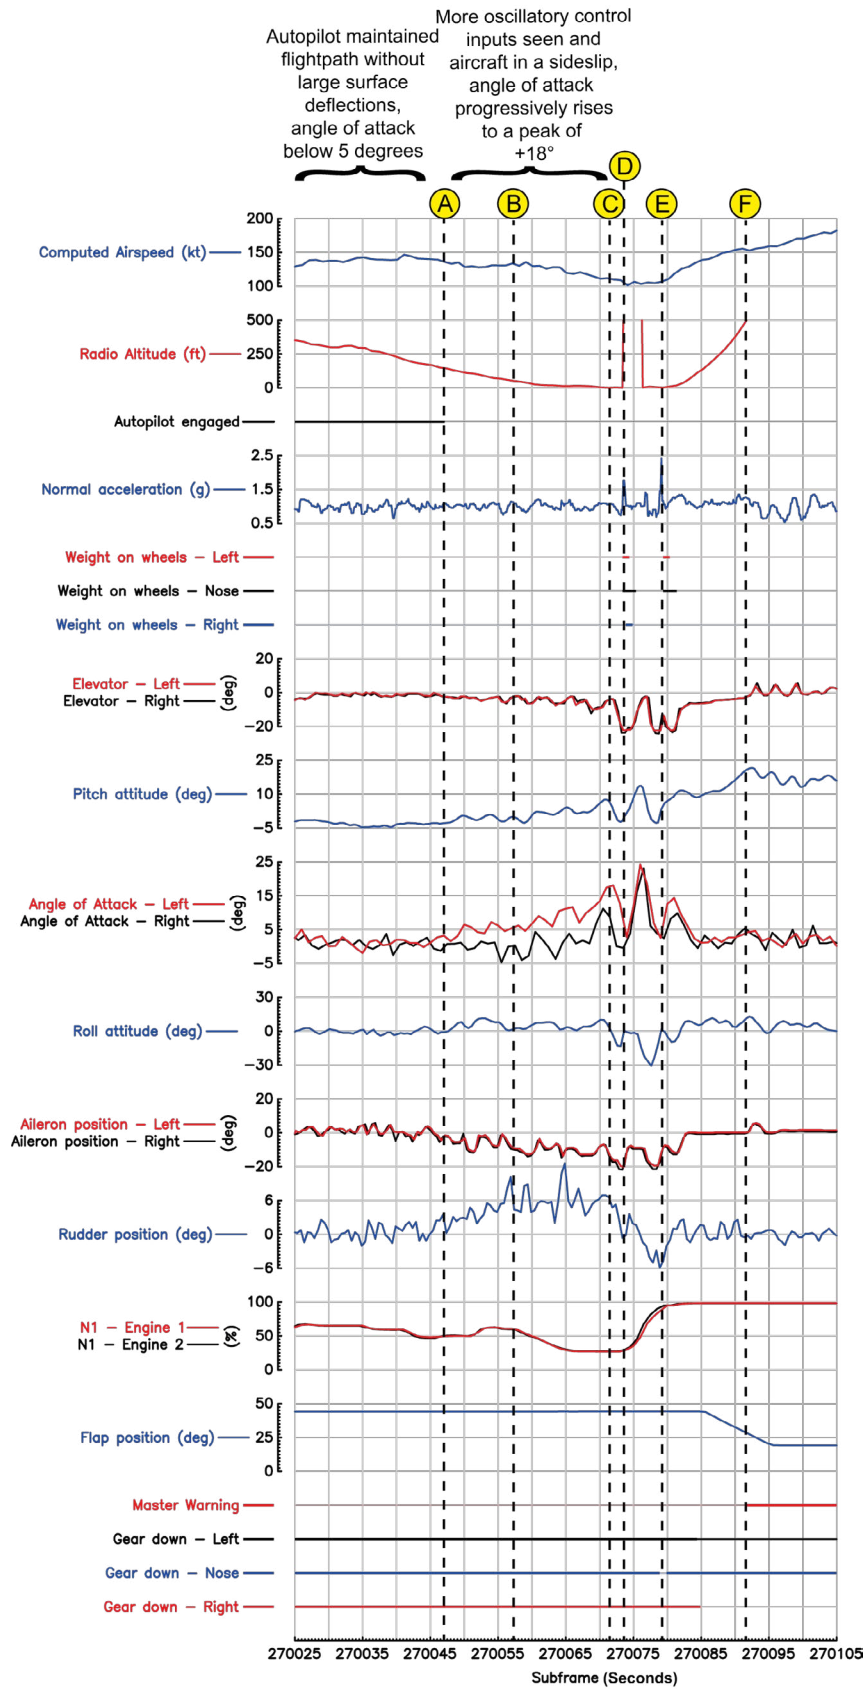
Figure 4

Data from the FDR is shown in Figure 4, each square on the x-axis representing five seconds. This shows that N999PX's autopilot was disconnected at 150 ft agl at an IAS of 136 kt, the landing gear was down and FLAPS 45 selected. Both engines were set at approximately 50% N_1 (Point A on Figure 4). Before this there are mostly only minor modulations in control surface deflections, with slightly larger rudder deflections. The autopilot maintained the aircraft's flightpath without the application of large surface deflections. The angle of attack (AOA) vanes agreed and remained below $+5^\circ$.

The aircraft went around and the flightpath stabilised in the climb, but the position of the individual landing gear disagreed and, subsequently, a master warning was triggered (Point F). At about 550 ft agl during the GA the aircraft's pitch reached a maximum of 21.6° nose-up.

Data from the FDR showing N999PX's approach and GA at London Stansted

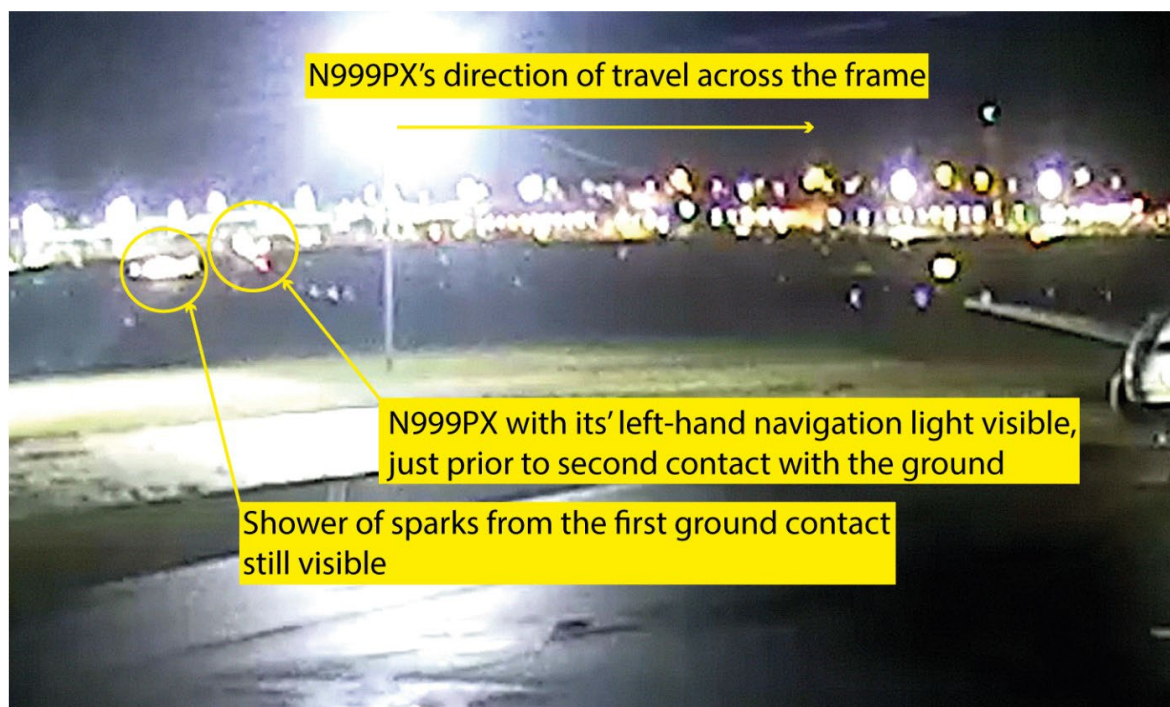
Figure 5

Closed-circuit television (CCTV) recordings from London Stansted captured the aircraft's approach and GA, showing that N999PX struck the ground at least twice. An image from one of these recordings is shown below (Figure 5).

CCTV from London Stansted showing N999PX striking the ground

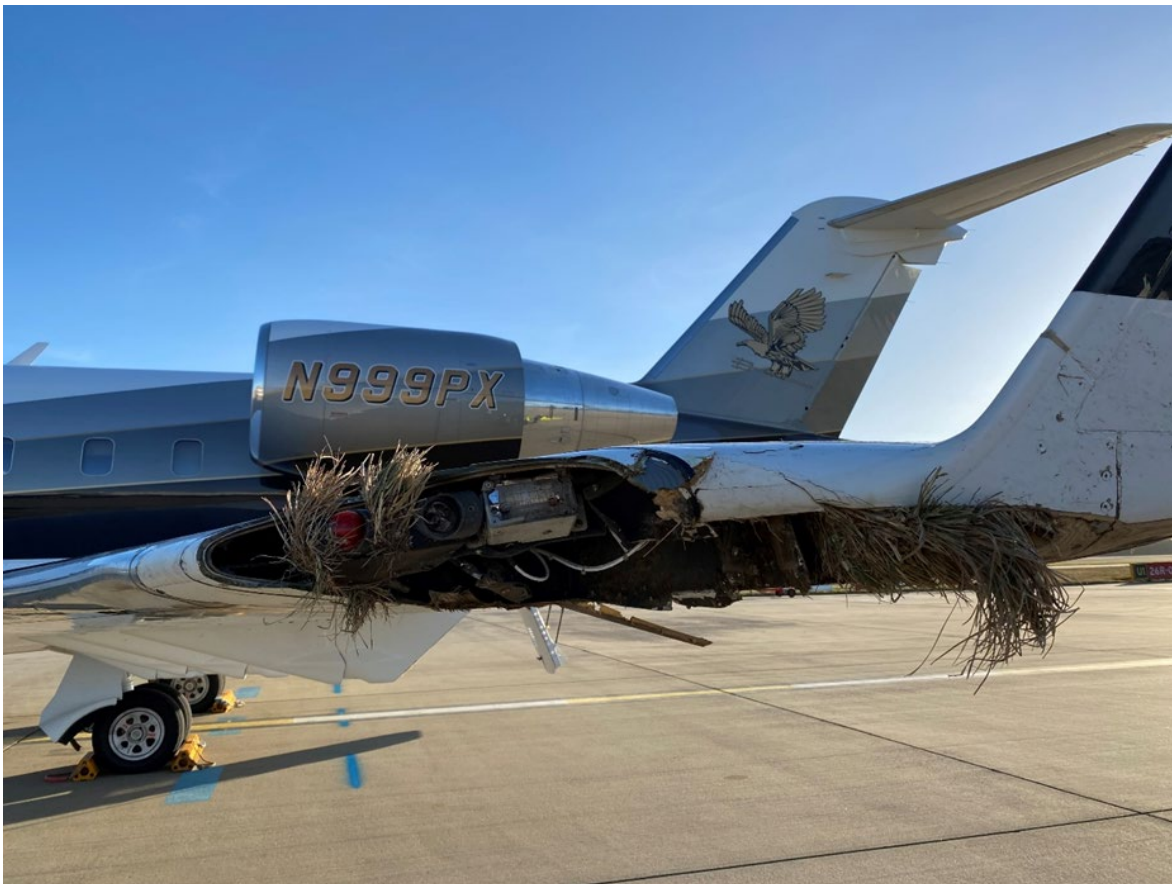
Figure 6

The aircraft was examined on Taxiway Juliet at London Gatwick the morning after the accident. The outboard portion of the left wing and winglet had suffered considerable damage (Figure 6). There was a dent on the lower surface of the outboard leading edge.

The landing light glazing at the wingtip and several fairings and skin panels were missing. The wingtip lower skin was abraded, in some locations through its entire thickness, and there was damage to the sub-structure. Grass and earth were lodged in the landing light housing and in the exposed structure at the base of the winglet. The winglet and wingtip trailing edge skin showed evidence of ground contact, including the mounting plate for the wingtip static discharge wick which was abraded flat. There was also evidence of ground contact on the outboard rear corner of the left aileron, a small section of which was missing, and on the aileron's outboard static discharge wick. The aileron upper skin was buckled. The trailing edge of the outboard flap fairing also showed evidence of ground contact.

Damage to N999PX left wing

A wing symmetry/alignment check identified that the degree of twist to the left wing was out of allowable limits. The aircraft manufacturer considered that this indicated permanent plastic deformation of the wing attachment point, meaning that ultimate strength of the materials had been exceeded. In order to return to service, the aircraft would have required a complete wing set replacement. The aircraft insurers considered that the damage to the aircraft was beyond economical repair.

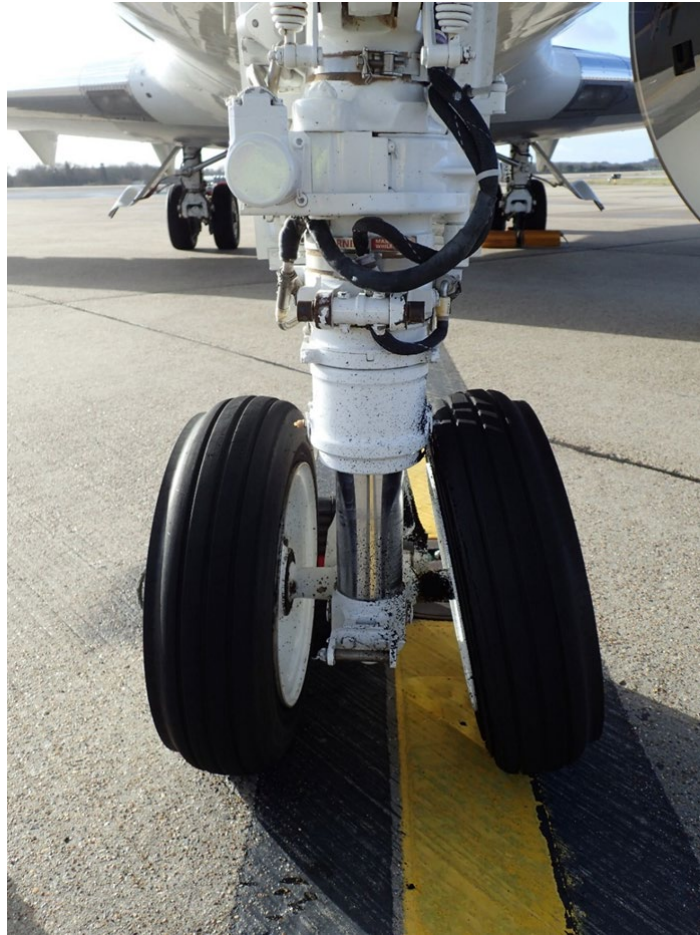
Figure 7

The nose landing gear left wheel axle had failed such that the top of the left wheel was angled towards the landing gear leg (Figure 7). Severe scoring and abrasion on the inboard sidewall of the left tyre had been caused by the tyre rotating against a grease nipple at the bottom of the oleo. Some localised buckling was evident on the lower fuselage skin immediately aft of the nosewheel bay.

Damage to N999PX nose landing gear (view looking aft)

The damage to the nose landing gear axle probably occurred during the second touchdown on the nose and left landing gears, when the normal acceleration reached the maximum recorded value of almost 2.5g. It is likely that activation of the stick pusher contributed to the landing attitude and therefore the damage sustained by the nose landing gear axle.
