ACCIDENT

| Aircraft Type and Registration: | Pegasus Quik, G-CCPC | |
| Location: | East Fortune Airfield, East Lothian | |

Synopsis

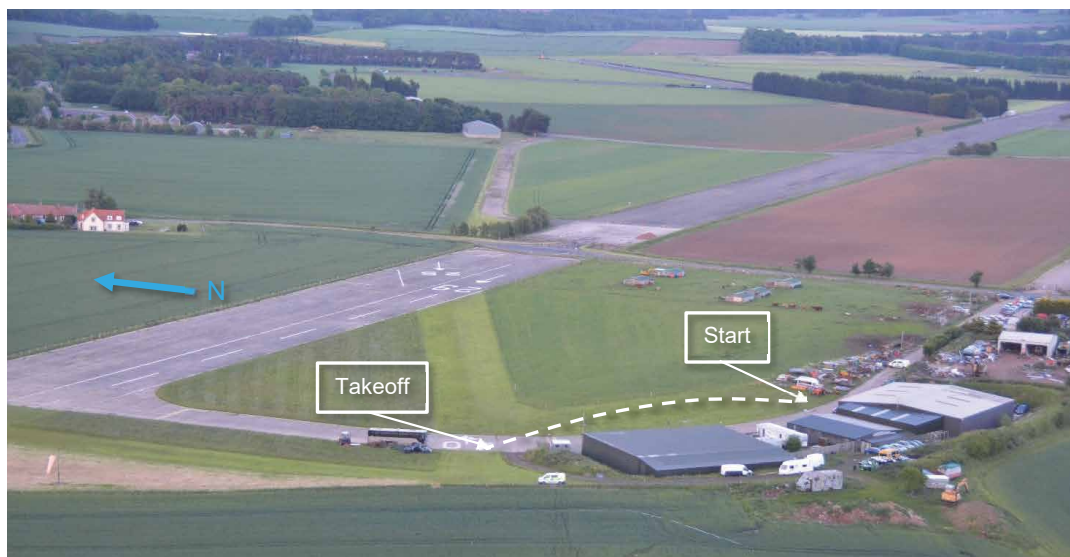
Figure 1

The flying club has multiple CCTV cameras from which recordings show the pilot putting on a helmet and entering the aircraft, which was parked on a grass area immediately in front of the club hangar. The recordings, one of which included audio, showed four engine start cycles and on the fifth cycle the engine started and immediately accelerated to a high rpm. This was at approximately 0940 hrs. Club staff, who were alerted by the sudden “abnormal” sound of the engine, ran out of the hangar and saw the aircraft accelerating rapidly over the grass and collide with a runway marker sign. The collision caused the aircraft to bounce as it crossed the taxiway and become airborne (Figure 1).

Approximate path of aircraft across the grass area (image used with permission)

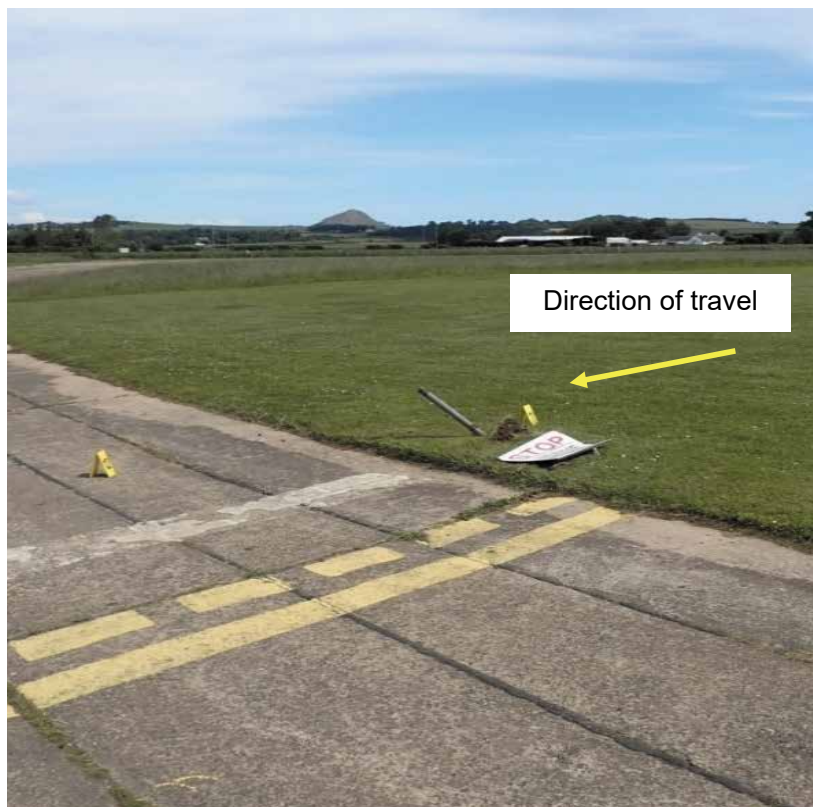
Figure 2

Marks made by the aircraft's wheels as they travelled across the grass stretched from where the aircraft was parked on the grass in front of the hangar to the edge of the concrete taxiway. The marks indicate that the aircraft travelled in a left arc, missing a wire fence approximately 30 m in front and perpendicular to the direction the aircraft was parked. As the aircraft travelled towards the concrete taxiway, its right main landing gear struck a runway stop sign concreted into the ground at the edge of the taxiway (Figure 2) before becoming airborne.

Runway stop sign struck by aircraft

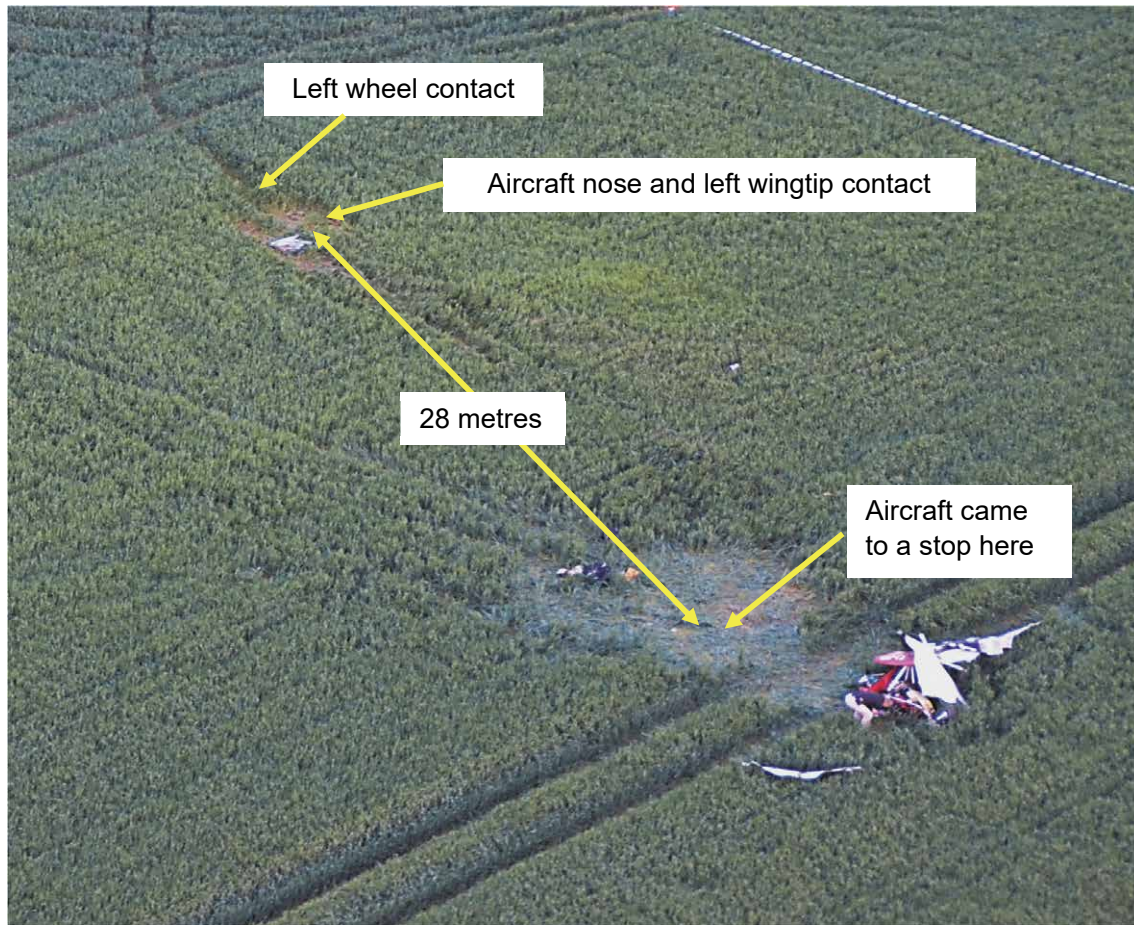
Figure 3
Accident site

The aircraft came to rest in a field to the west of the airfield. Ground impact marks show that the aircraft's left wheel struck the ground first followed by the left-wing tip and the front of the trike. The aircraft cartwheeled and bounced before stopping approximately 28 m from the initial impact point. The trike came to rest on its right side with the pylon still attached to the wing (Figure 3).

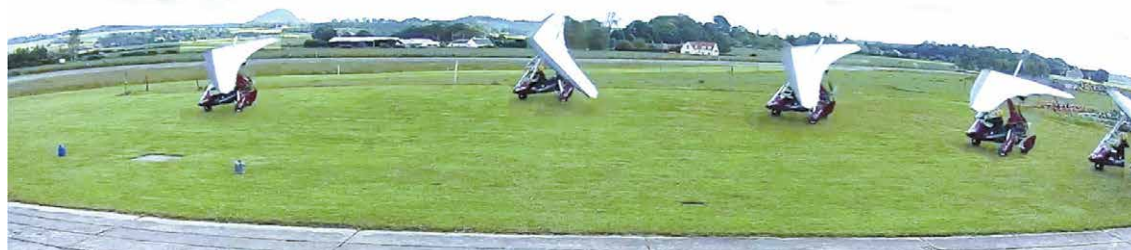
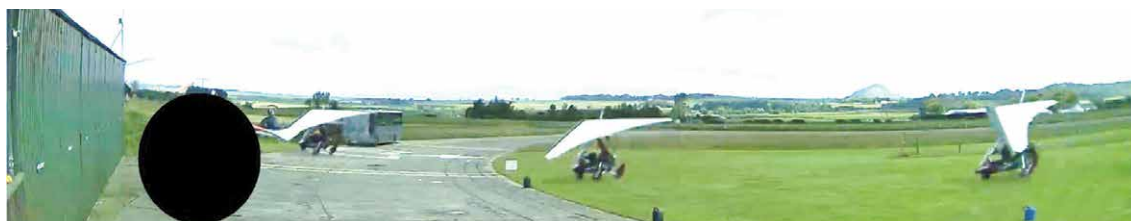
Figure 6

which corroborated the maximum engine speed recorded by the engine monitoring unit. The peak was reached on startup and dropped to approximately 4,630 rpm over the next few seconds.

Cropped CCTV snapshots, overlaid to show the aircraft position at one second intervals in each camera view. There is overlap between the period covered by image b) and the other two sequences.

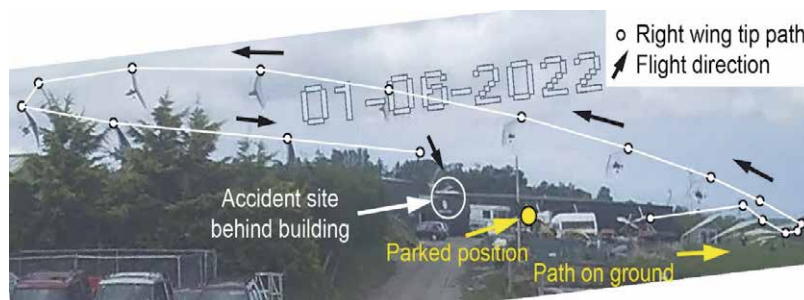
Figure 7

After taking off, the microlight flew in a low-level, tight, left turn (Figure 7). The images are not clear enough to determine whether the base bar was against the front strut after takeoff.

Cropped CCTV snapshots, rotated to horizontal, and overlaid to show the aircraft position at one second intervals

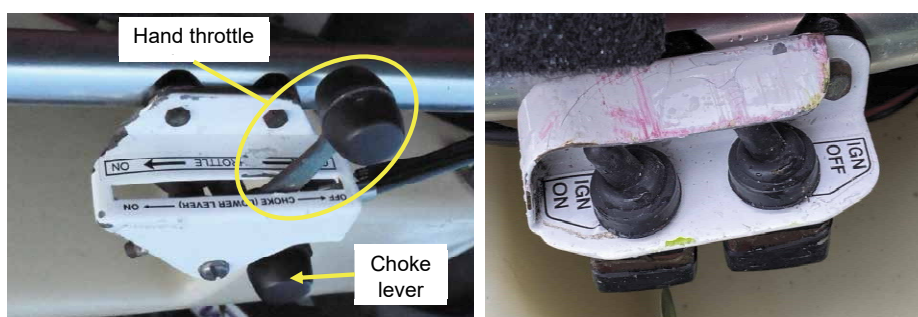
Figure 8

Both ignition switches located on the right side of the seat frame were found in the ON position with the switch guard bent over the switches preventing them from being moved. The friction-damped hand throttle lever located on the left side of the seat frame was positioned slightly forward of OFF. Located directly below the hand throttle was the choke lever which was selected to OFF (Figure 8).

Hand throttle and choke levers (left), ignition switches (right)

It is recommended that the UK Civil Aviation Authority issue a Mandatory Permit Directive to mandate Pegasus Sport Aviation Ltd Service Bulletin 159, to embody a Starter Inhibitor Switch on all electric start, in-service Pegasus Sport Aviation Ltd flexwing aircraft.

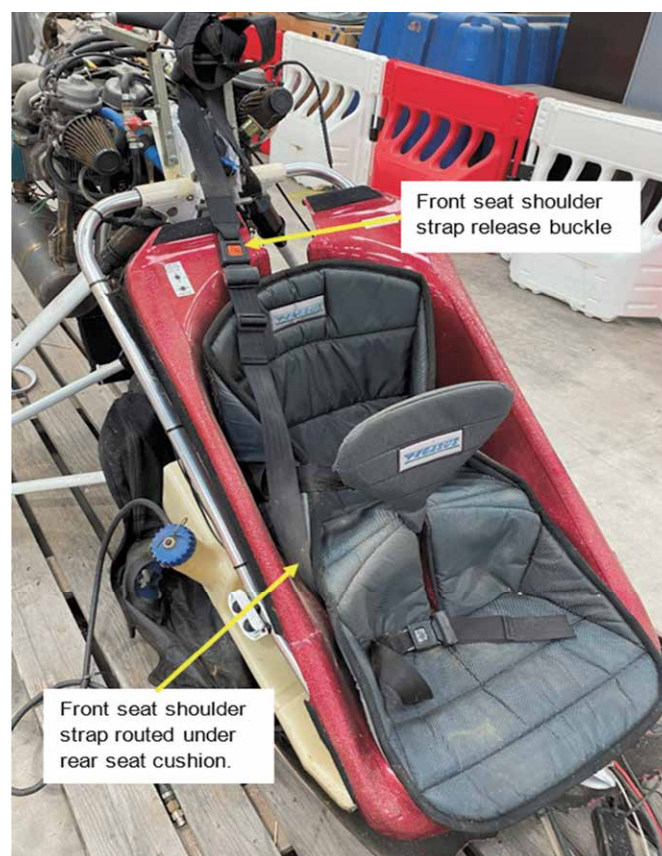
Figure 9

The rear seat shoulder straps were found disconnected from their lap strap and tied around the pylon. The rear seat lap strap had been adjusted so that it was tight against the rear seat cushion. The front seat diagonal shoulder strap had been tightened between the pylon and the base tube and routed under the seat cushion to prevent it from fouling the propeller during flight (Figure 9). In this configuration, the shoulder strap could not have been worn by the pilot during the flight.

Front seat diagonal shoulder strap positioned as found at the accident site

The RAFCAM described excessive flailing of the pilot's upper torso and head during the accident sequence as a consequence of only using the lap strap as a restraint. It was likely that not using the diagonal shoulder strap resulted in the pilot's head striking the ground and cockpit structure with significant force, thereby increasing the severity of his head injury. The RAFCAM assessment postulates that the potential reduction in the impact velocity of the pilot's head when it struck the ground if he had been wearing his shoulder strap, may have made the outcome of the accident survivable.

It is recommended that the UK Civil Aviation Authority review the suitability of the Configuration Specific Provision in British Civil Airworthiness Requirements, Section S 1307 (a) Miscellaneous equipment which states, 'except that only a lap strap need be provided for front seat occupants of a weight-shift controlled aircraft'.

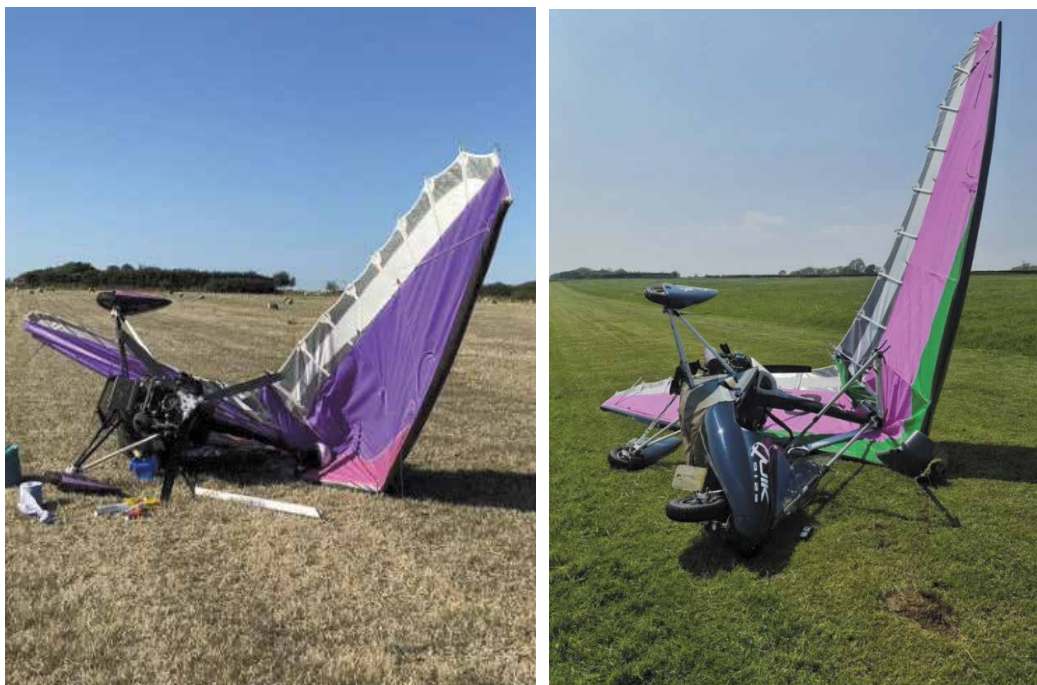
Figure 10

Despite the similarities between the accidents, the injuries sustained by the pilots were substantially different. The pilot of G-CGRR, who was only wearing the lap strap and not

the shoulder strap, received serious facial injuries when his head contacted parts of the structure and the ground. Whereas the pilot of G-CDPD, who was wearing the full three-point harness, received only minor injuries.

Pictorial comparison of G-CGRR (left) and G-CDPD (right)
