AAIB Bulletin

12/2023

S2/2023: Airbus A321-253NX	G-OATW	4-Oct-23	3
----------------------------	--------	----------	---

Aircraft Type and Registration:	Airbus A321-253NX, G-OATW
No & Type of Engines:	2 CFM International SA LEAP-1A33 turbofan engines
Year of Manufacture:	2020 (Serial no: 10238)
Date & Time (UTC):	4 October 2023 at 1151 hrs
Location:	London Stansted Airport
Type of Flight:	Commercial Air Transport (Passenger)
Persons on Board:	Crew - 11 Passengers - 9
Injuries:	Crew - None Passengers - None
Nature of Damage:	Damage to several cabin windows and impact damage to the left horizontal stabiliser
Commander's Licence:	Airline Transport Pilot's Licence
Commander's Age:	54 years
Commander's Flying Experience:	4,905 hours (of which 2,300 were on type) Last 90 days - 128 hours Last 28 days - 27 hours
Information Source:	AAIB Field Investigation

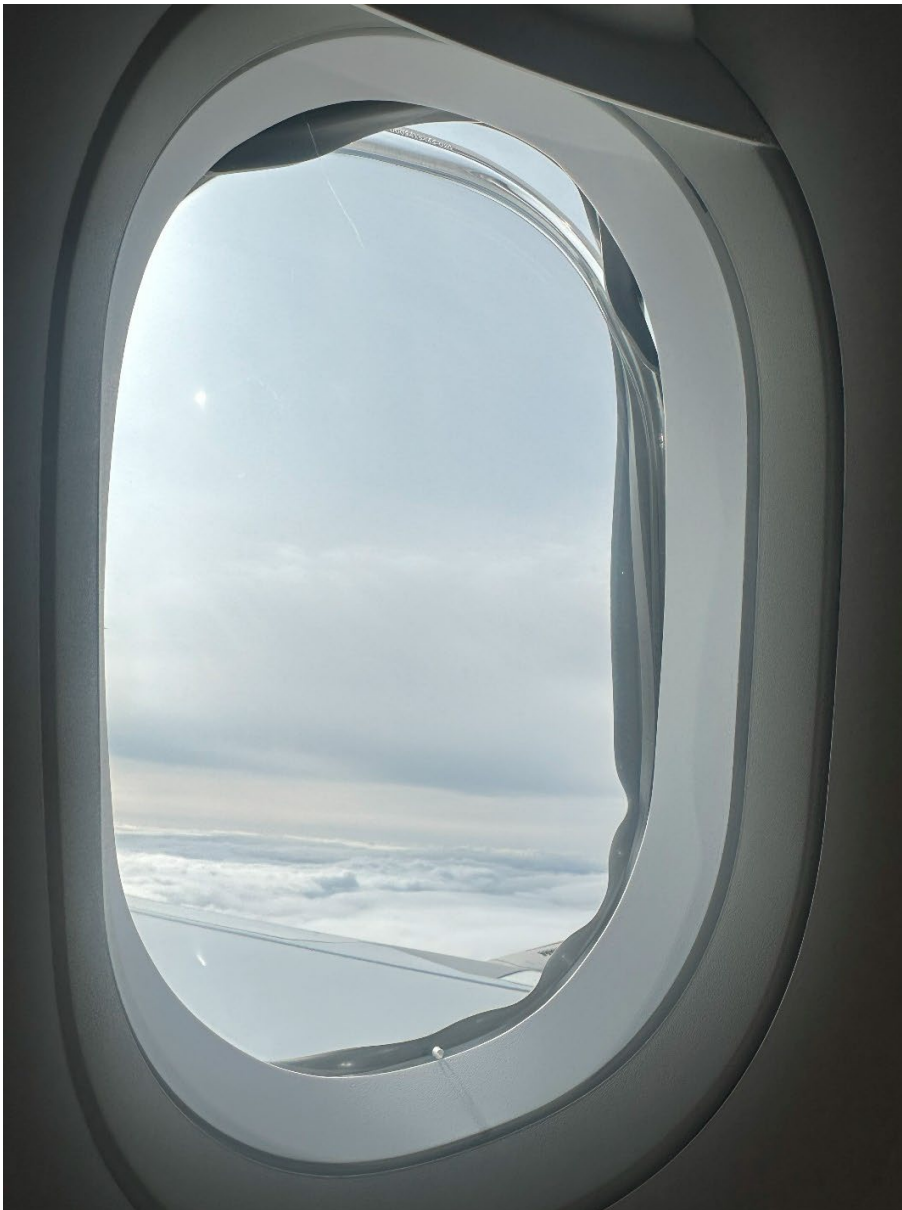
The aircraft departed a few minutes ahead of schedule and took off from Runway 22. Several passengers recalled that after takeoff the aircraft cabin seemed noisier and colder than they were used to. As the aircraft climbed through FL100 and the seatbelt signs were switched off, the loadmaster, who had been seated just in front of the other passengers, walked towards the back of the aircraft. He noticed the increased cabin noise as he approached the overwing exits and his attention was drawn to a cabin window on the left side of the aircraft. He observed that the window seal was flapping in the airflow and the windowpane appeared to have slipped down¹. He described the cabin noise as 'loud enough to damage your hearing'. Figure 1 shows the window in flight.

View of the left side cabin window aft of the overwing exit

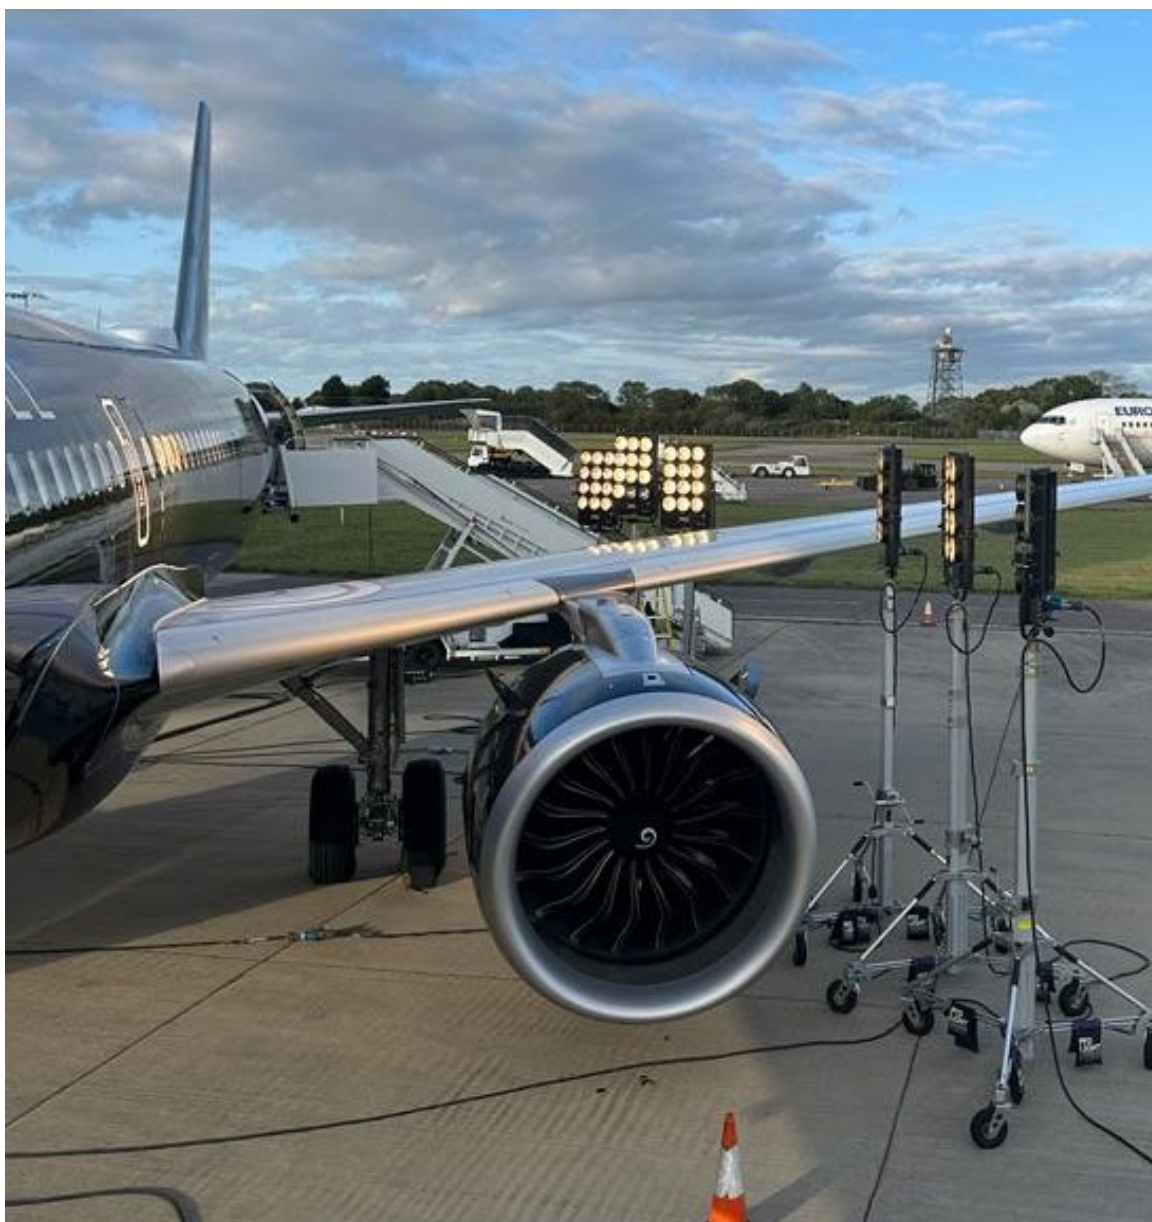
The day before the occurrence flight the aircraft had been used for filming on the ground, during which external lights had been shone through the cabin windows to give the illusion of a sunrise. The lights were first shone on the right side of the aircraft for approximately five and a half hours, with the light focused on the cabin windows just aft of the overwing exits. The lights were then moved to the left side of the aircraft where they illuminated a similar area on the left side for approximately four hours. Photographs taken during filming showed six sets of flood lights on both sides of the aircraft. Figure 2 shows the lights positioned on the left of the aircraft.

Flood lighting on the left side of the aircraft

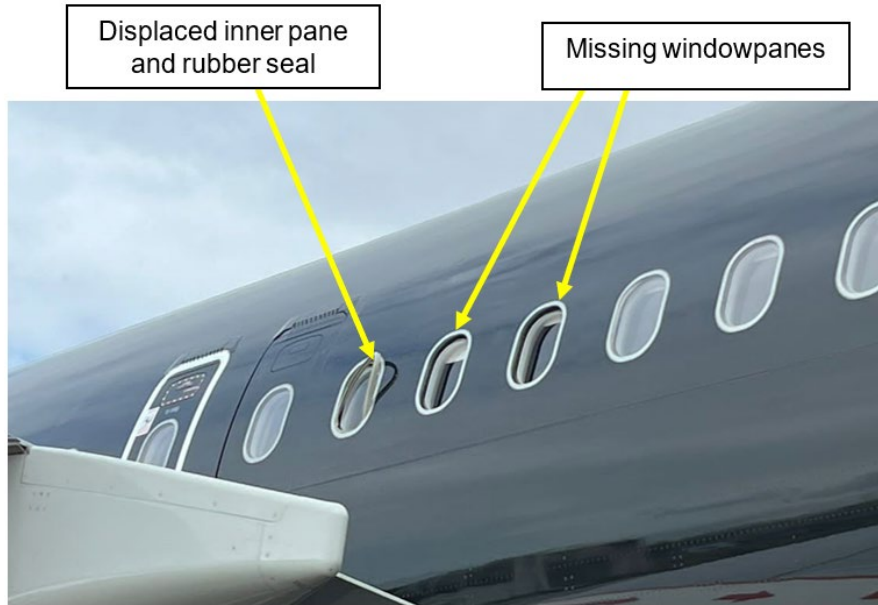
Figure 4

Two window assemblies³ were missing, and the inner pane and seal from a third window were displaced but partially retained in the airframe (Figure 4). A shattered outer pane was recovered from the entrance to a rapid-exit taxiway during a routine runway inspection after the aircraft landed.

Displaced and missing windowpanes on the left side of the aircraft

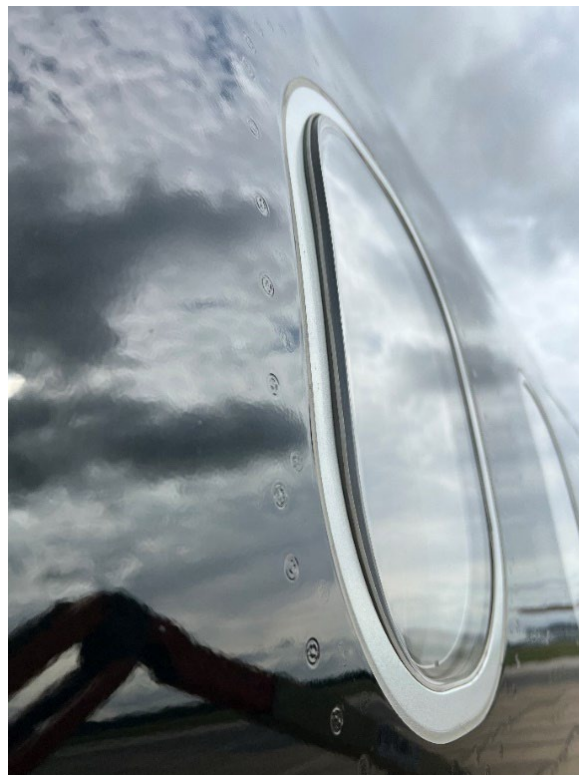
Figure 5

A fourth window protruded from the left side of the fuselage (Figure 5). The four affected windows were adjacent to each other, just aft of the left overwing exit.

Protruding window on the left side of the aircraft

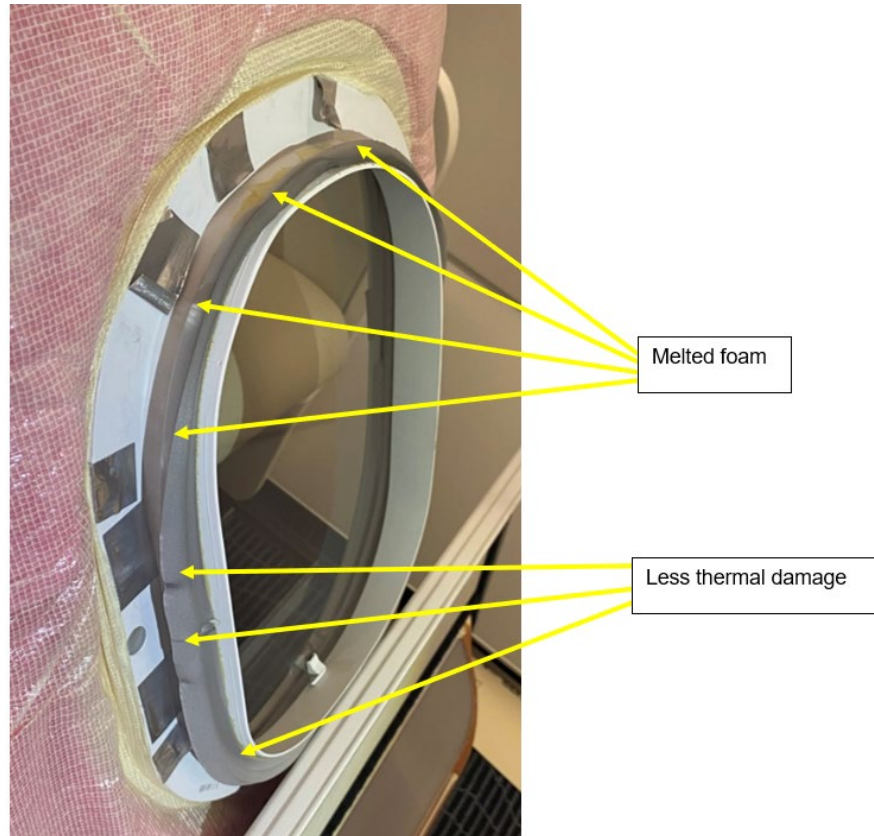
Figure 6

Removal of the cabin lining inside the passenger cabin revealed that the window retainers were in good condition and correctly installed. The foam ring material on the back of the cabin liners was found to be melted in the areas adjacent to the windows that were damaged or missing (Figure 6).

Foam ring material affected by elevated temperatures

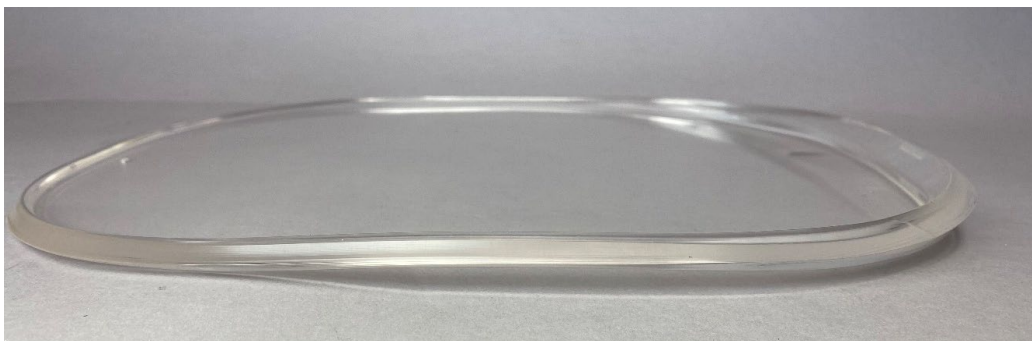
Figure 7

Visual examination of the damaged windowpanes revealed that they were deformed and shrunk (Figure 7). The deformed panes no longer formed an effective interface with the rubber seals.

Inner pane showing plastic deformation around the entire perimeter

The windows appear to have sustained thermal damage and distortion because of elevated temperatures while illuminated for approximately four to five and a half hours during filming activity the day before the flight. It is likely that the flood lights were positioned closer than 10 m. Whereas in this case the damage became apparent at around FL100 and the flight was concluded uneventfully, a different level of damage by the same means might have resulted in more serious consequences, especially if window integrity was lost at higher differential pressure.

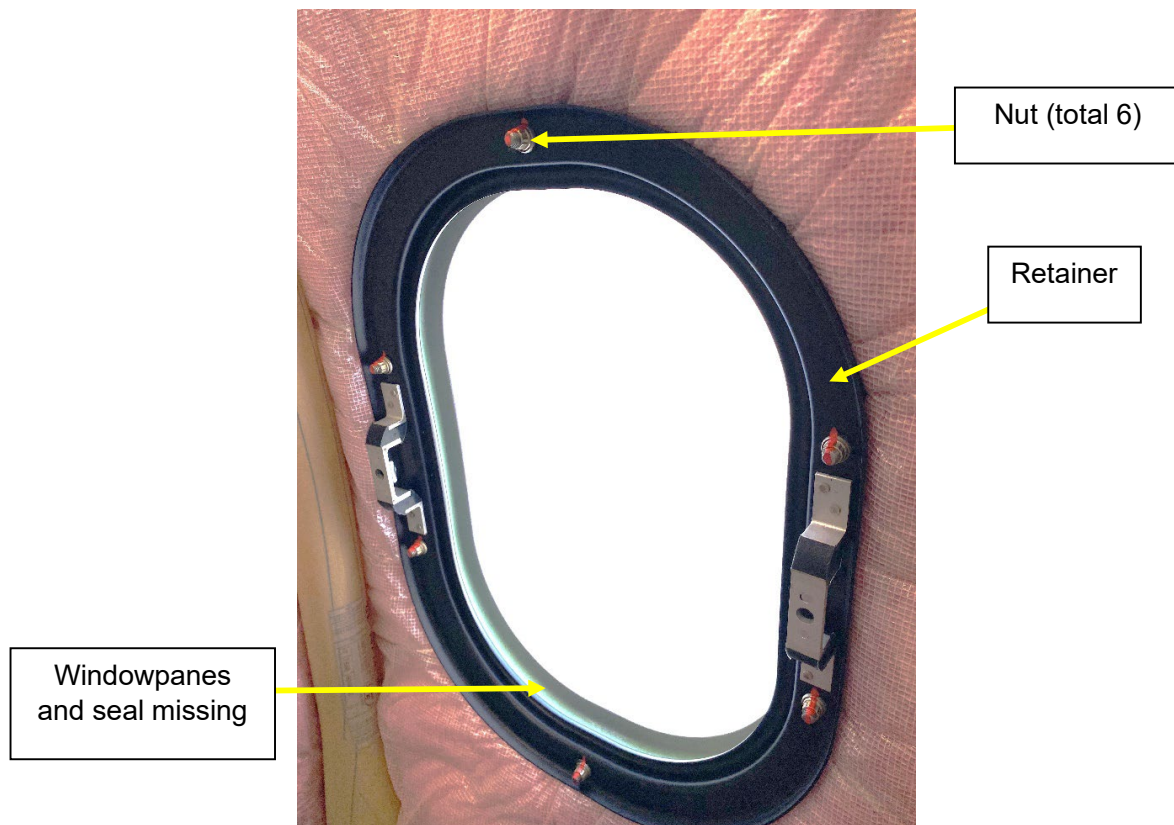
Figure 8

Correct installation of the retainer but the window assembly is missing

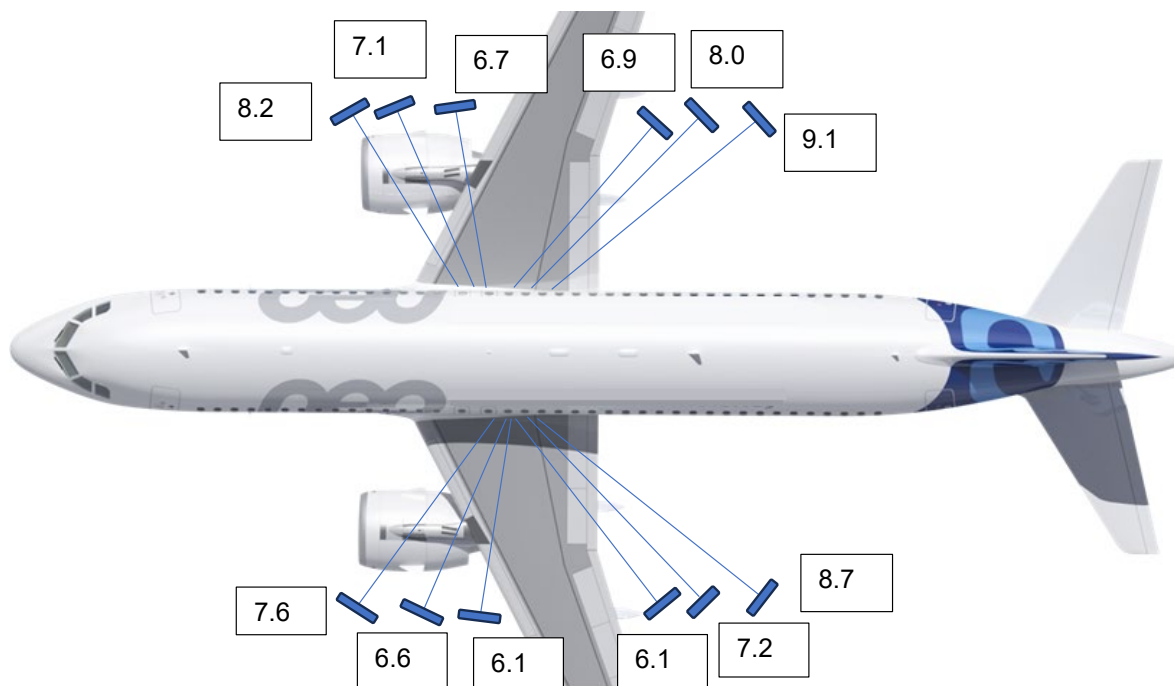
Figure 9

Photographs of the filming showed that the lights were between approximately 6 and 9 m from the window areas where damage was apparent (Figure 9).

Approximate distance of the flood lights from the fuselage during the filming activity

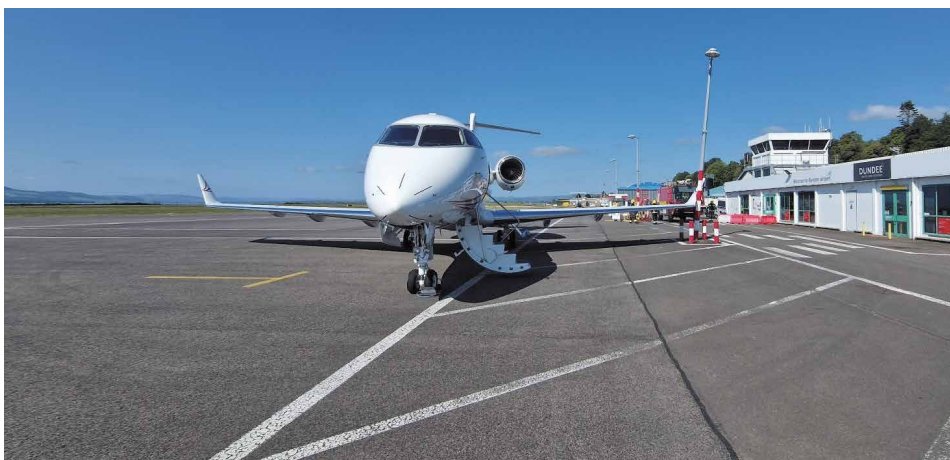
Figure 2

Aircraft after the collision

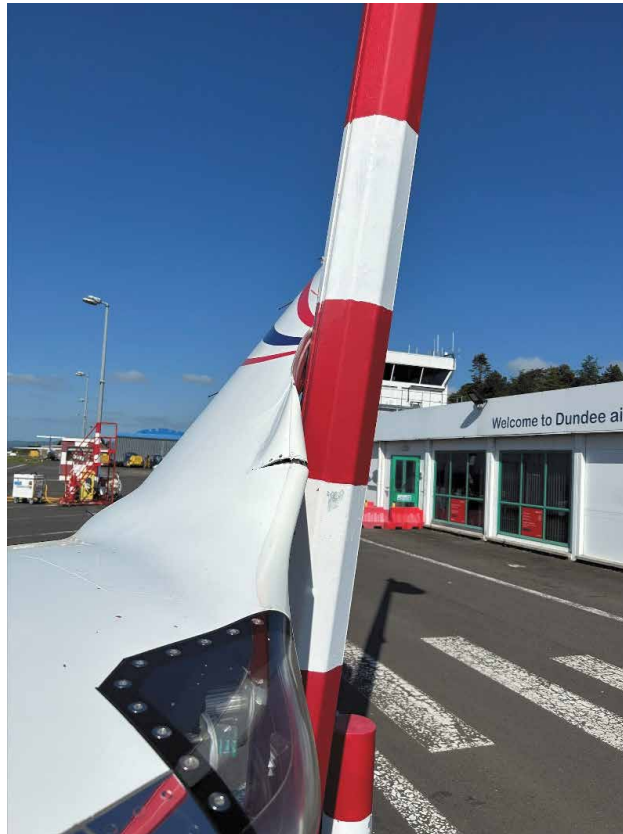
Figure 3

Damage to the left winglet and lamppost

- Conduct a review of its marshalling training package.
- Consider the introduction of direct headset communications between marshaller and wing spotters.
- Consider a two-stage marshalling process with two marshallers for circumstances similar to the accident.

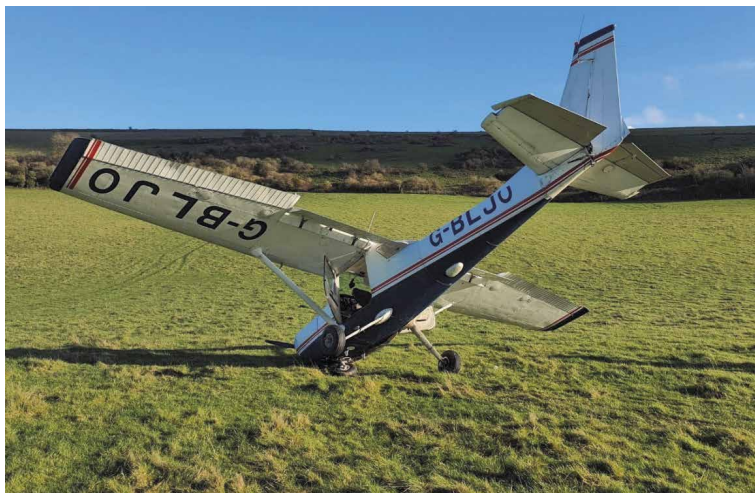
Figure 1
Accident site

The pilot stated that he did not know what had caused the power loss and that he had done the same thing on each of the previous four circuits, such as his downwind checks which included checking that the mixture was rich and selecting the carburettor heat on for 10 seconds. He said he had practised forced landings with an instructor the week before, and this enabled him to go into “autopilot mode” with picking a field and setting up an approach. He thinks he flared a bit too early with the downhill slope which contributed to the nosewheel-first touchdown.

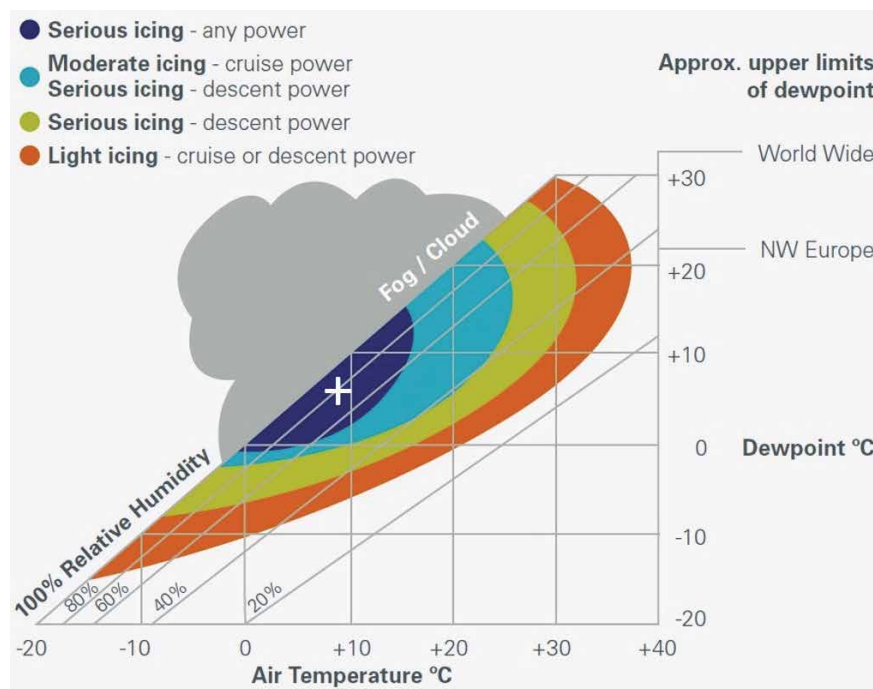
Figure 2

According to the CAA's risk of carburettor icing chart, in the Safety Sense Leaflet on Piston Engine Icing², the temperature and dewpoint spread at the airport elevation indicated that there was a serious risk of carburettor icing at any power setting (Figure 2).

Temperature and dewpoint, at Shoreham Airport near the time of the accident, marked with a white cross on the CAA's risk of carburettor icing chart
