Rail Accident Investigation Branch

Rail Accident Report

Serious injury to a passenger alighting from a train at Loughborough Central station 14 January 2023

Report 13/2023
October 2023

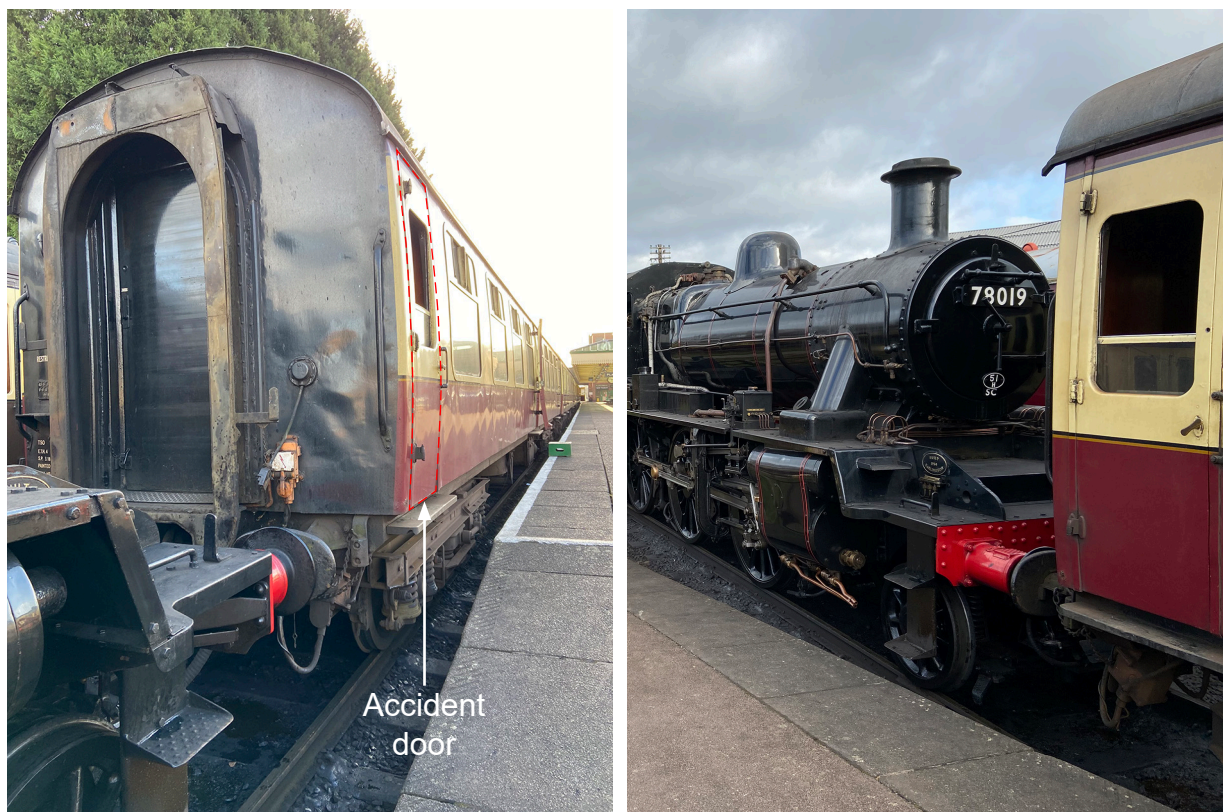
- 55 Loughborough Central station has two platforms, numbers 1 and 2, located between the Up and Down Main lines (a configuration referred to as an 'island platform' (figure 3)). Platform 1 runs along the east side of the station. The horizontal length of each platform, between the ramps at each end, is 122 metres.
- 56 At the north end of the island, a ramp is provided which slopes from platform height to ground level. This ramp runs across the whole width of the platform island. Visitors can use a path down the middle of the ramp to access a walkway that leads to the Locomotive Shed and a picnic area. The level part of the platform is marked out by white lines painted on the platform edge. At each end, where the platform end ramp starts, there is a short white line perpendicular to the platform edge (figures 6 and 11).

Figure 6: The north end platform ramp.

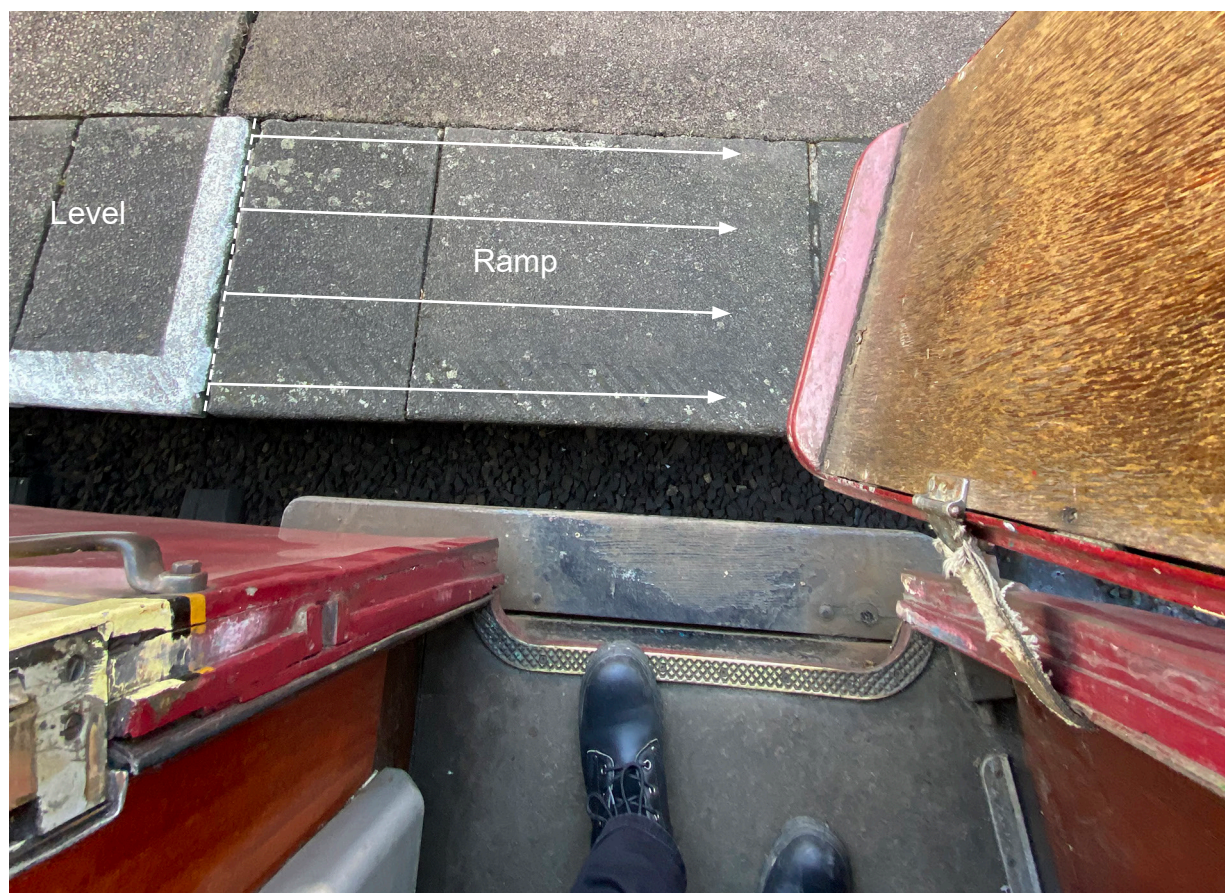
81 RAIB inspectors took a series of photographs to document the reconstruction. It was observed during the reconstruction that the slope along the platform end ramp was not easy to distinguish. As such, it is likely that a visually impaired person would not be able to distinguish the slope. Figure 11 shows the view of the platform end ramp taken from the position of a person preparing to alight from the leading door of coach 4857.

Figure 11: Photo of ramp viewed from coach doorway.
