# Trains overspeeding between Blackford and Gleneagles, Perth and Kinross, 15 July 2023

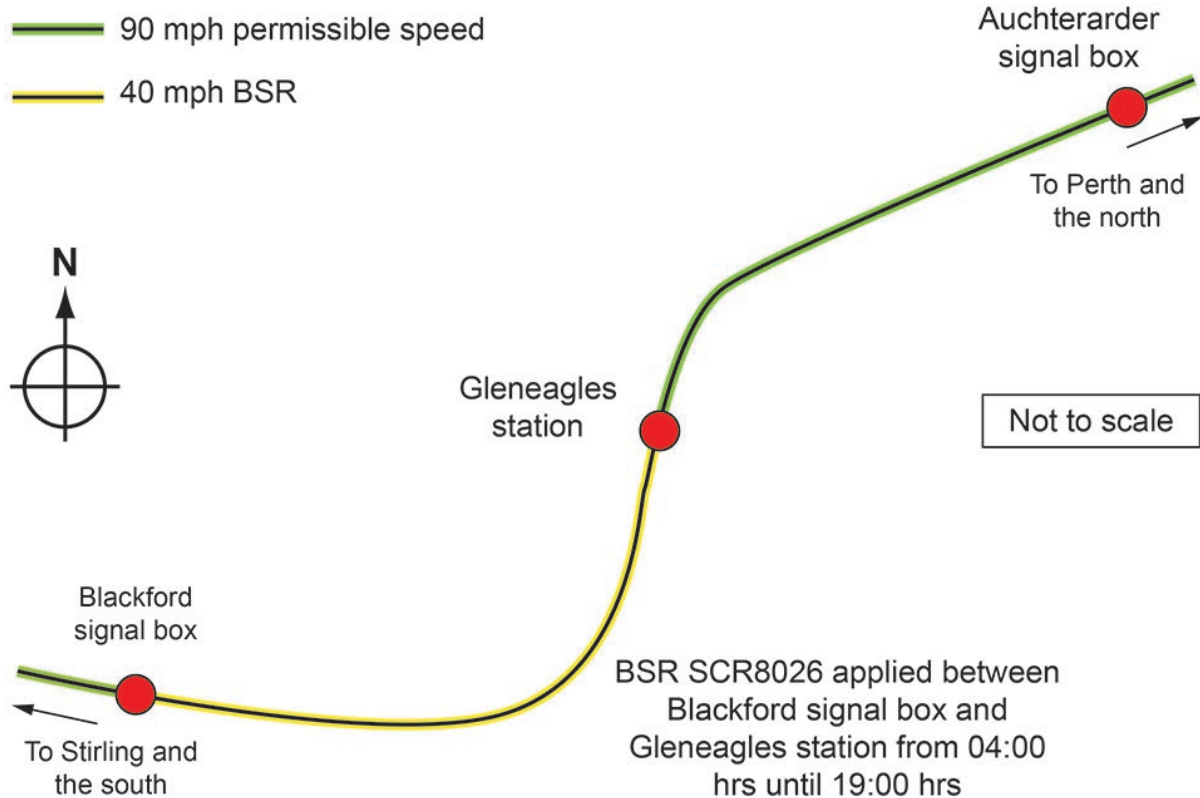
One of the additional BSR notifications, reference SCR8026, applied to a 2.25 mile (3.6 km) section of railway between Blackford signal box (at the south end of the BSR) and Gleneagles station (to the north). This BSR imposed a temporary maximum permitted speed of 40 mph (65 km/h) from 04:00 hrs to 19:00 hrs on 15 July. The normal maximum permitted speed between these locations was 90 mph (145 km/h).

**Simplified diagram showing location of the blanket speed restriction. Not to scale and not all features shown.**
