Report on the investigation of the accidental discharge
of a FirePro condensed aerosol fire-extinguishing system
during its installation on board the fishing vessel

Resurgam (PZ1001)

resulting in one fatality

on 15 November 2019

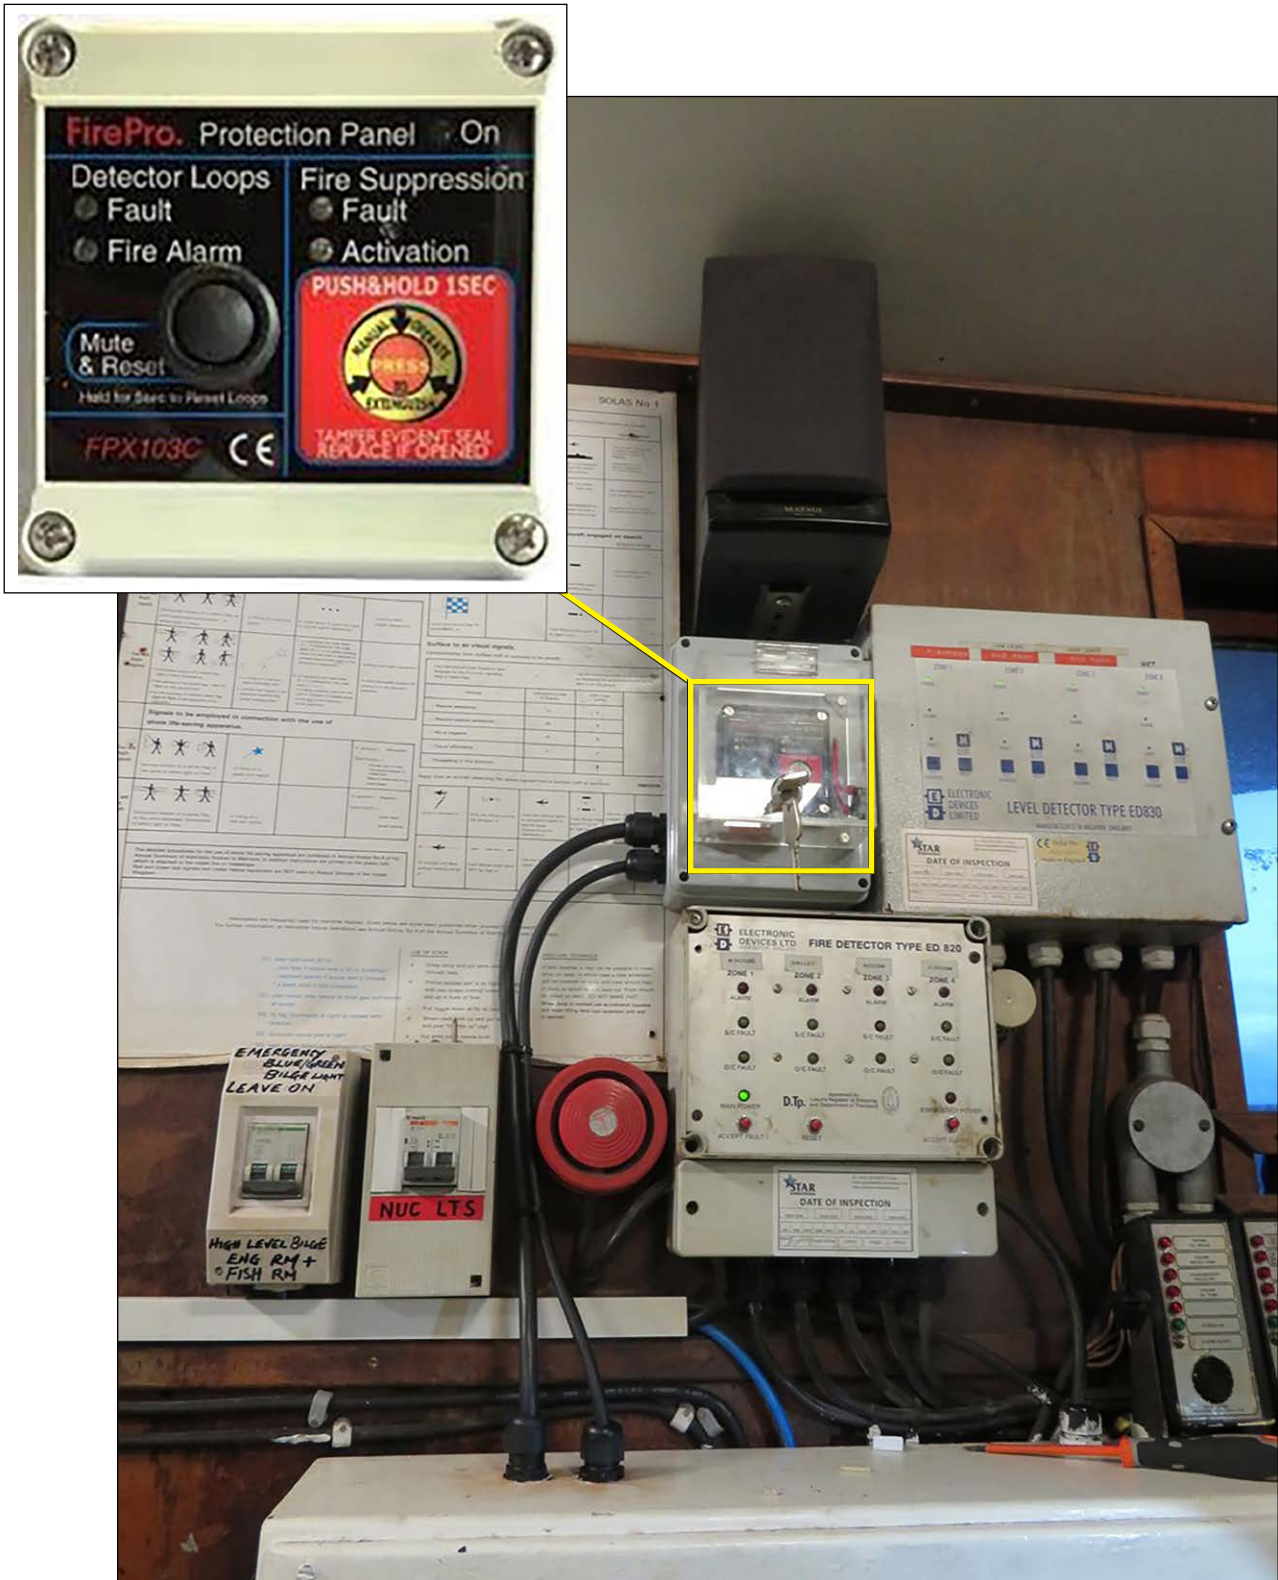
Figure 2: Fire protection control panel mounted in the wheelhouse

Once the installation had been completed, and with the aerosol generators unplugged, a Stevenson electrical engineer, at the request of Ocean Engineering's lead technician, connected the vessel's 24V power supply to the FirePro system's PSU. At about 1530, the lead technician powered up the PSU and checked the control panel display. The control panel fault alarm activated. The trainee technician entered the engine room and told the Stevenson engineers that they were about to test the extinguishing system's pre-activation alarm. The lead technician then

opened the control panel's protective cover, which released a microswitch and initiated the pre-activation alarm. The trainee technician went into the engine room space and confirmed that the alarm warning beacons were flashing and sounding. The lead technician then closed the control panel cover to stop the alarm and then returned to the engine room.

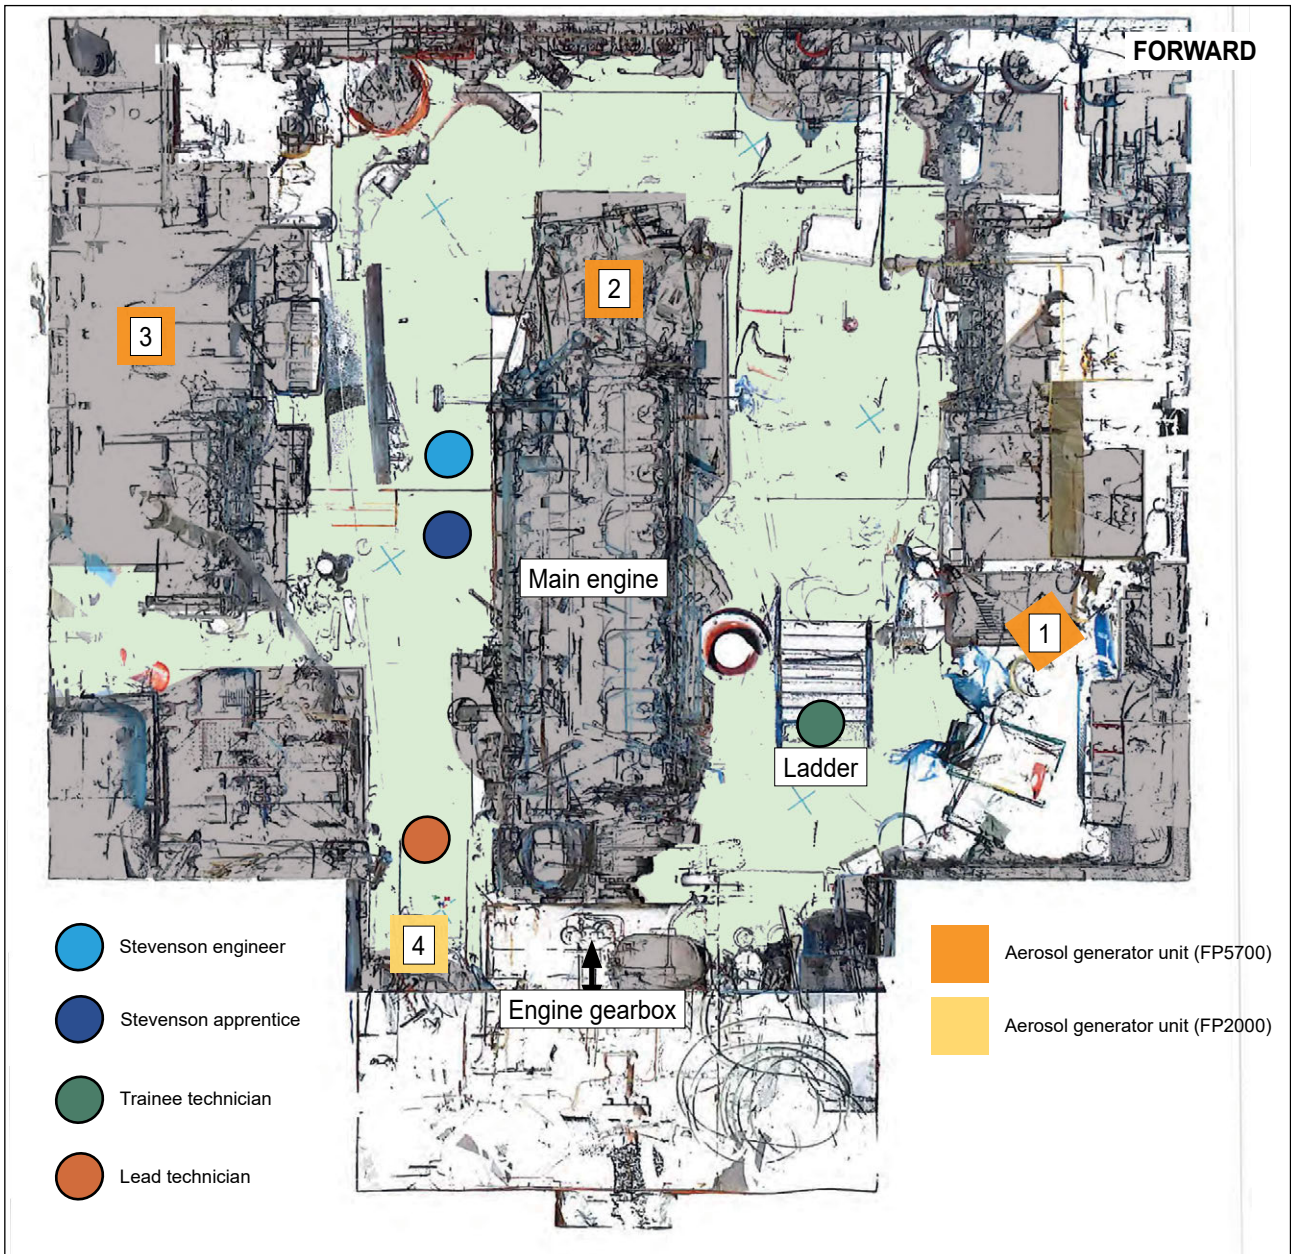
Figure 4: Positions of installation technicians and Stevenson engineers when the fourth aerosol generator was plugged in

While the trainee technician plugged in the aerosol generator adjacent to the access ladder (generator 1³), the lead technician sequentially connected the two forward units (generators 2 and 3) and then squeezed past the Stevenson engineers to get to the last generator (generator 4). By this time, the trainee technician had connected generator 1 and was making his way back to the wheelhouse (**Figure 4**). At 1540, the lead technician plugged in generator 4 and almost immediately heard a loud hissing sound behind him. Realising that the system had activated, he unplugged the generator, jumped over the main engine gearbox and ran to the access ladder, shouting “Get out”.

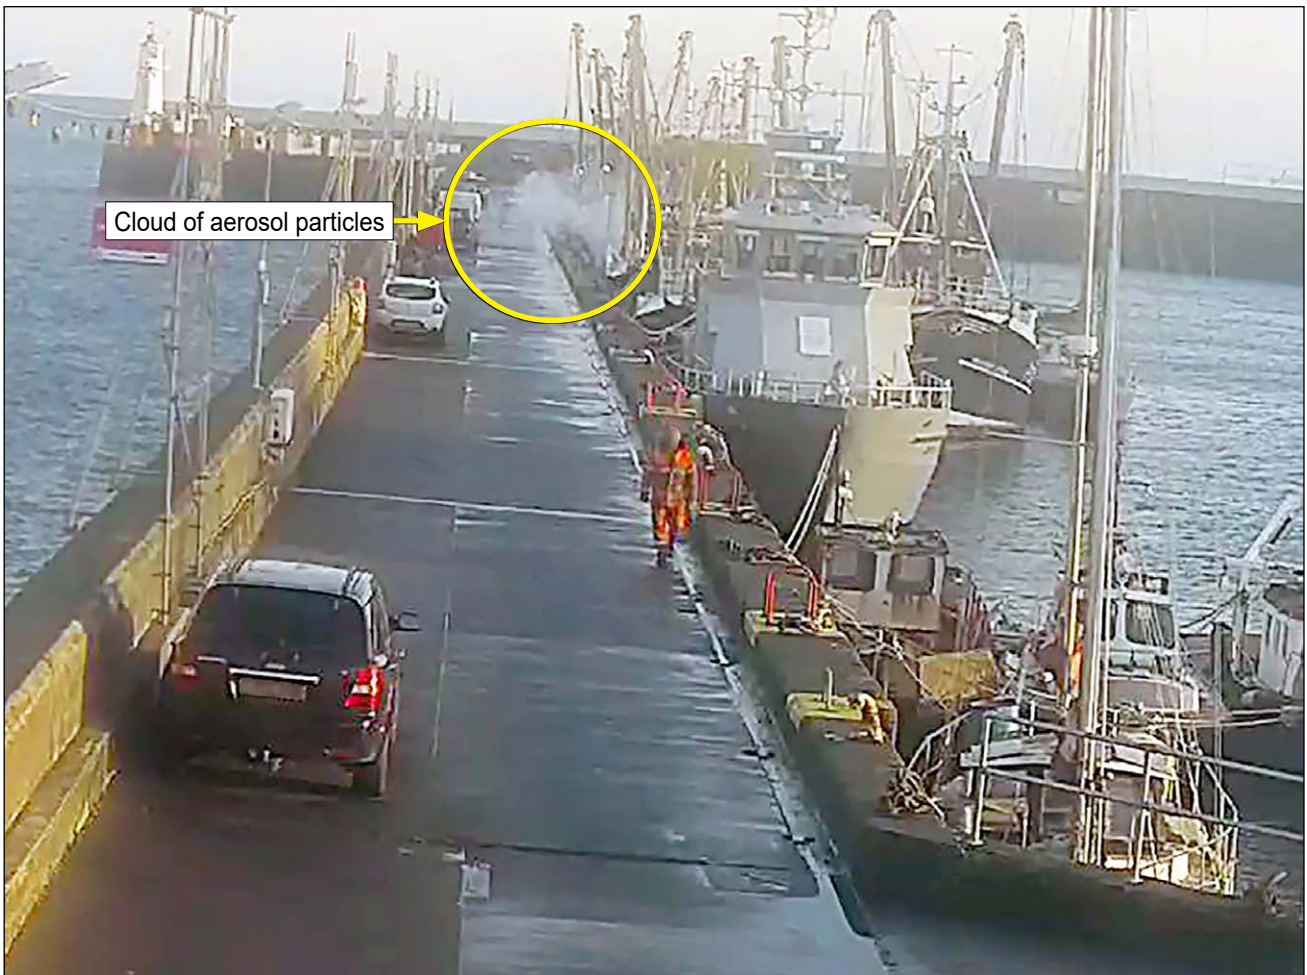
Figure 5: Cloud of aerosol particles seen coming from *Resurgam's* engine room

Two Stevenson engineers and the engineering project manager on board a nearby vessel saw a dense cloud of aerosol particles coming from *Resurgam* (**Figure 5**). Initially thinking that a fire had broken out, they ran to the scene. When they arrived and realised what had happened, they asked the Ocean Engineering technicians if the aerosol was hazardous. The lead technician said he understood it was safe to breathe.

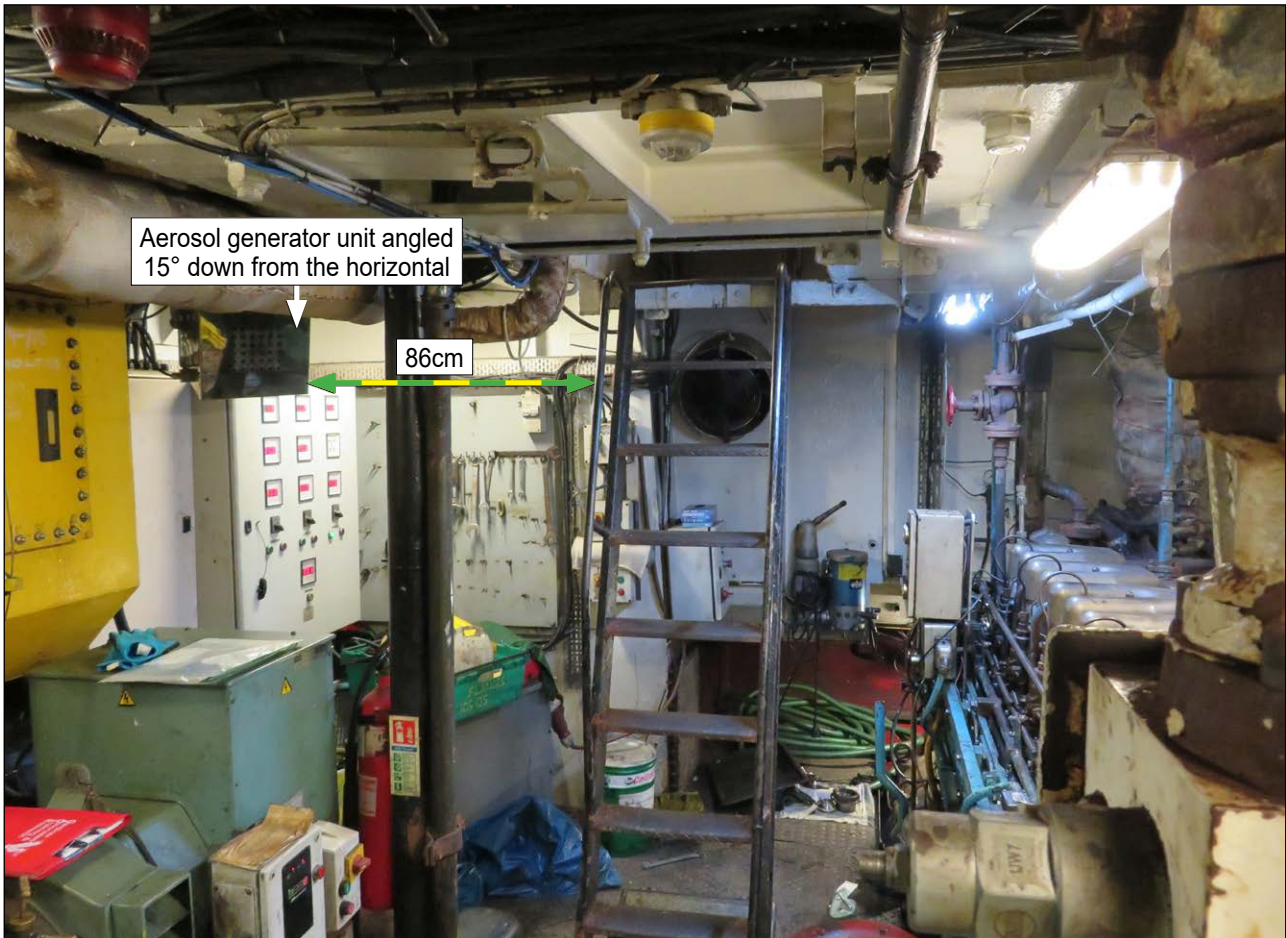
Figure 9: View of engine room looking aft, showing position of aerosol generator unit adjacent to the access ladder

FirePro manufactured various models of aerosol generator units based on aerosol generating capacity. Three FP5700⁷ units and one FP2000 unit were fitted on board *Resurgam* (**Figure 3**) and were mounted with their outlets facing down at a slight angle of approximately 15° to the horizontal. The FP5700 generator positioned next to the engine room access ladder was mounted at head height with its outlet 86cm from the closest edge of the ladder and walkway (**Figure 9**). The other generators were mounted in close vicinity to the engine room's floor plate walkways, just above head height.

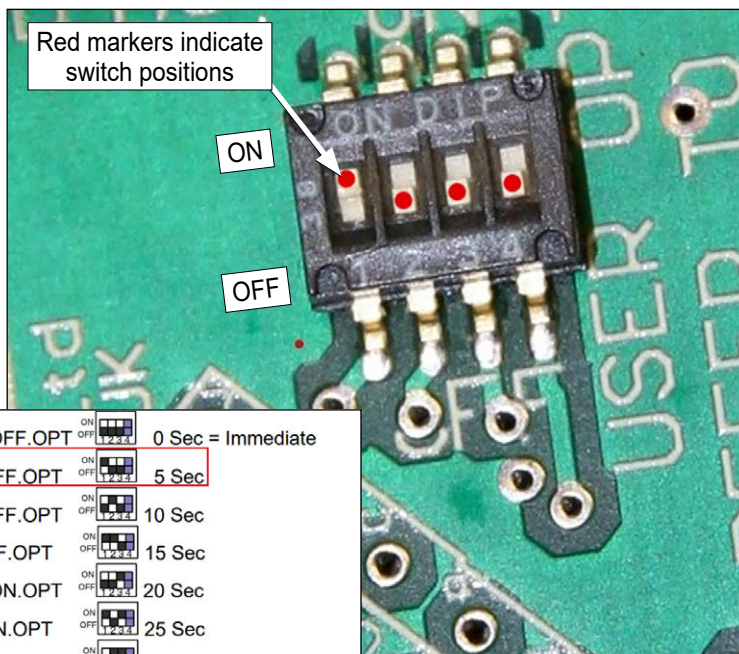
Figure 11: Fire control panel DIP switch settings

Resurgam's system was designed for manual operation only. The vessel had a separate fire detection system and therefore no detectors were connected to the FPX103C panel; instead, 10k ohm¹⁰ resistors were connected across the printed circuit board's dual loop connections. The DIP switches were set to an automatic mode with a 5-second spin-down delay and dual loop activation (**Figure 11**).

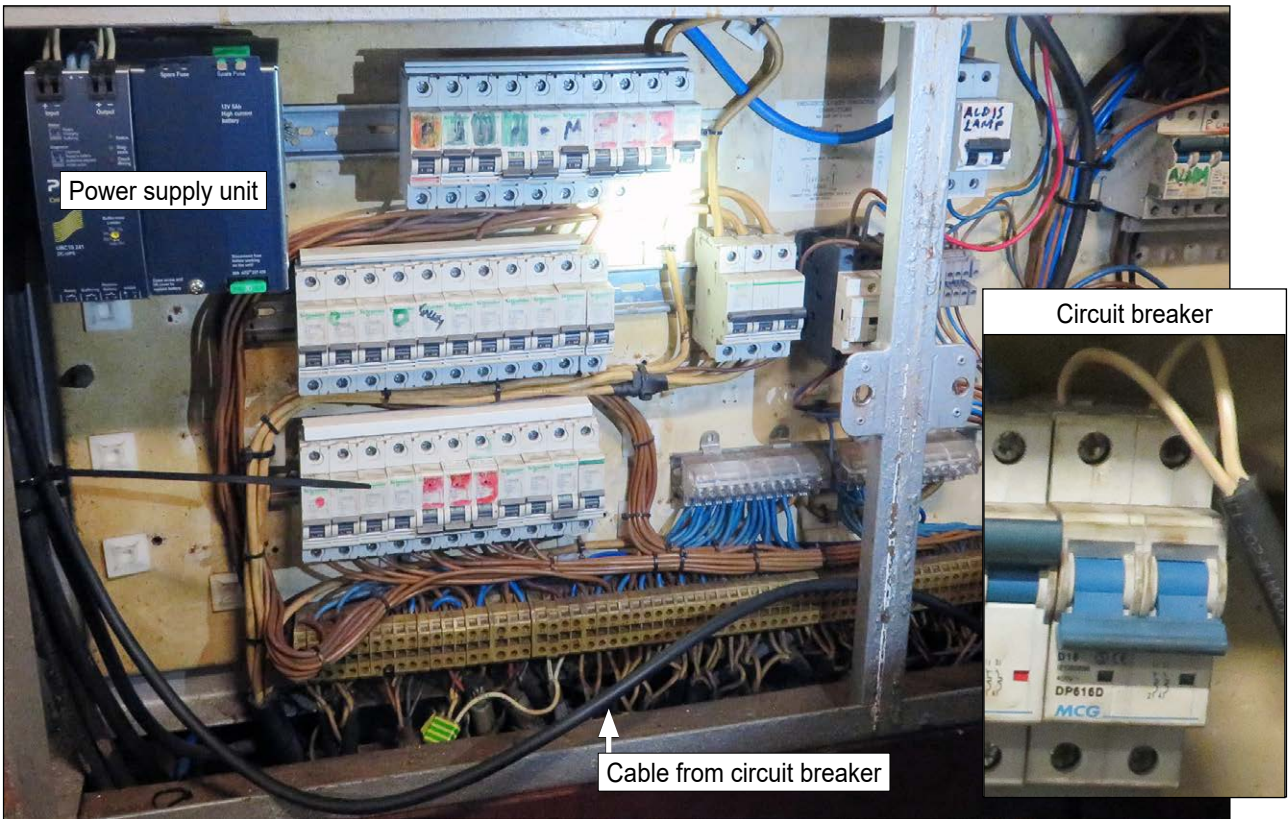
Figure 17: Power supply unit installed in the electrical distribution cabinet in the wheelhouse

- The doors to the electrical distribution cabinet in the wheelhouse that contained the PSU were open (**Figure 17**). A length of cable had loosely been led from a miniature circuit breaker on the mounting rail and connected to the PSU. The circuit breaker was in the off position and the system was depowered.

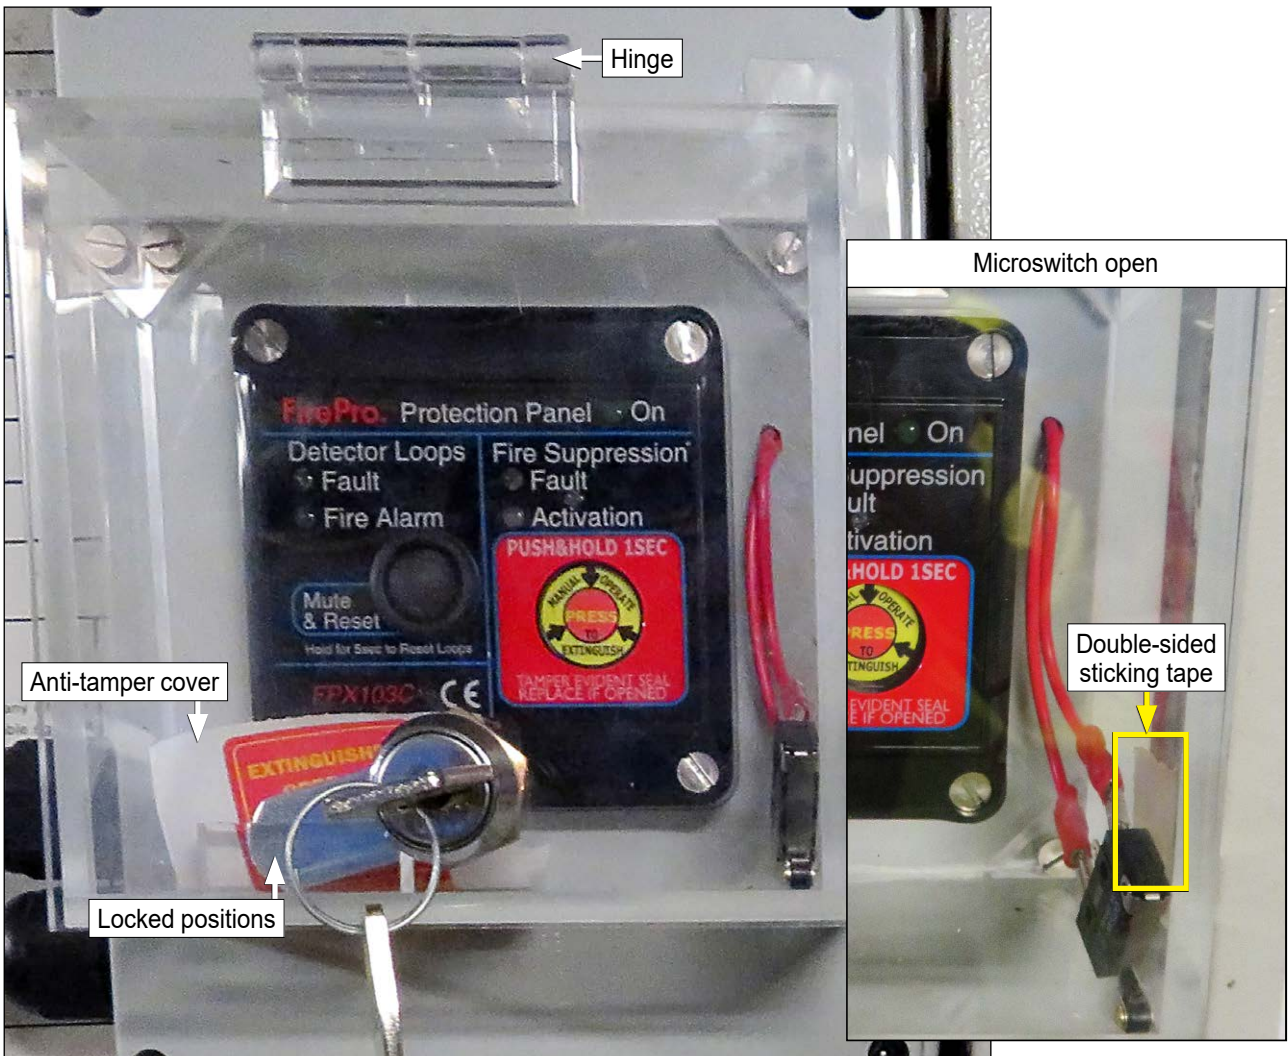
Figure 18: FPX103C control panel on board *Resurgam* following the accident

When power was applied, the green *protection panel on* LED illuminated. The control panel's amber fire suppression fault LED also illuminated and its audible alarm sounded. The pre-activation alarm warning beacon audible alarms sounded in the engine room and their warning lights flashed. The pre-activation alarms had activated because the microswitch had detached from the control panel cover and was in its open position. The alarms stopped when the microswitch was closed.

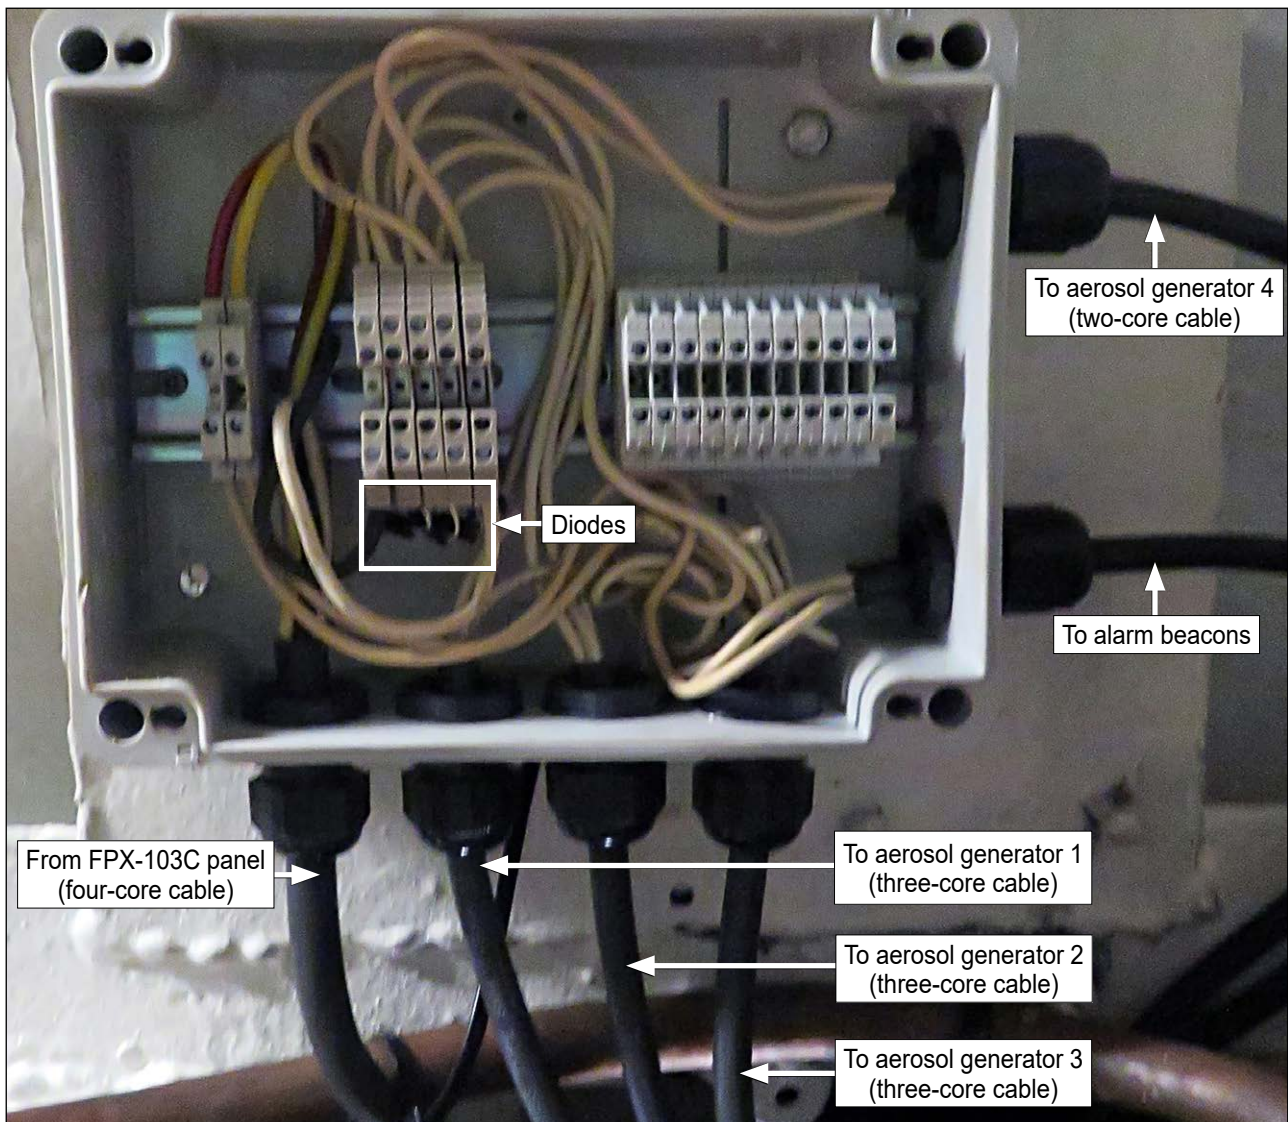
Figure 19: Junction box in engine room lobby on board *Resurgam* following the accident

The fire suppression system voltage in the lobby junction box was measured at 22.4V.

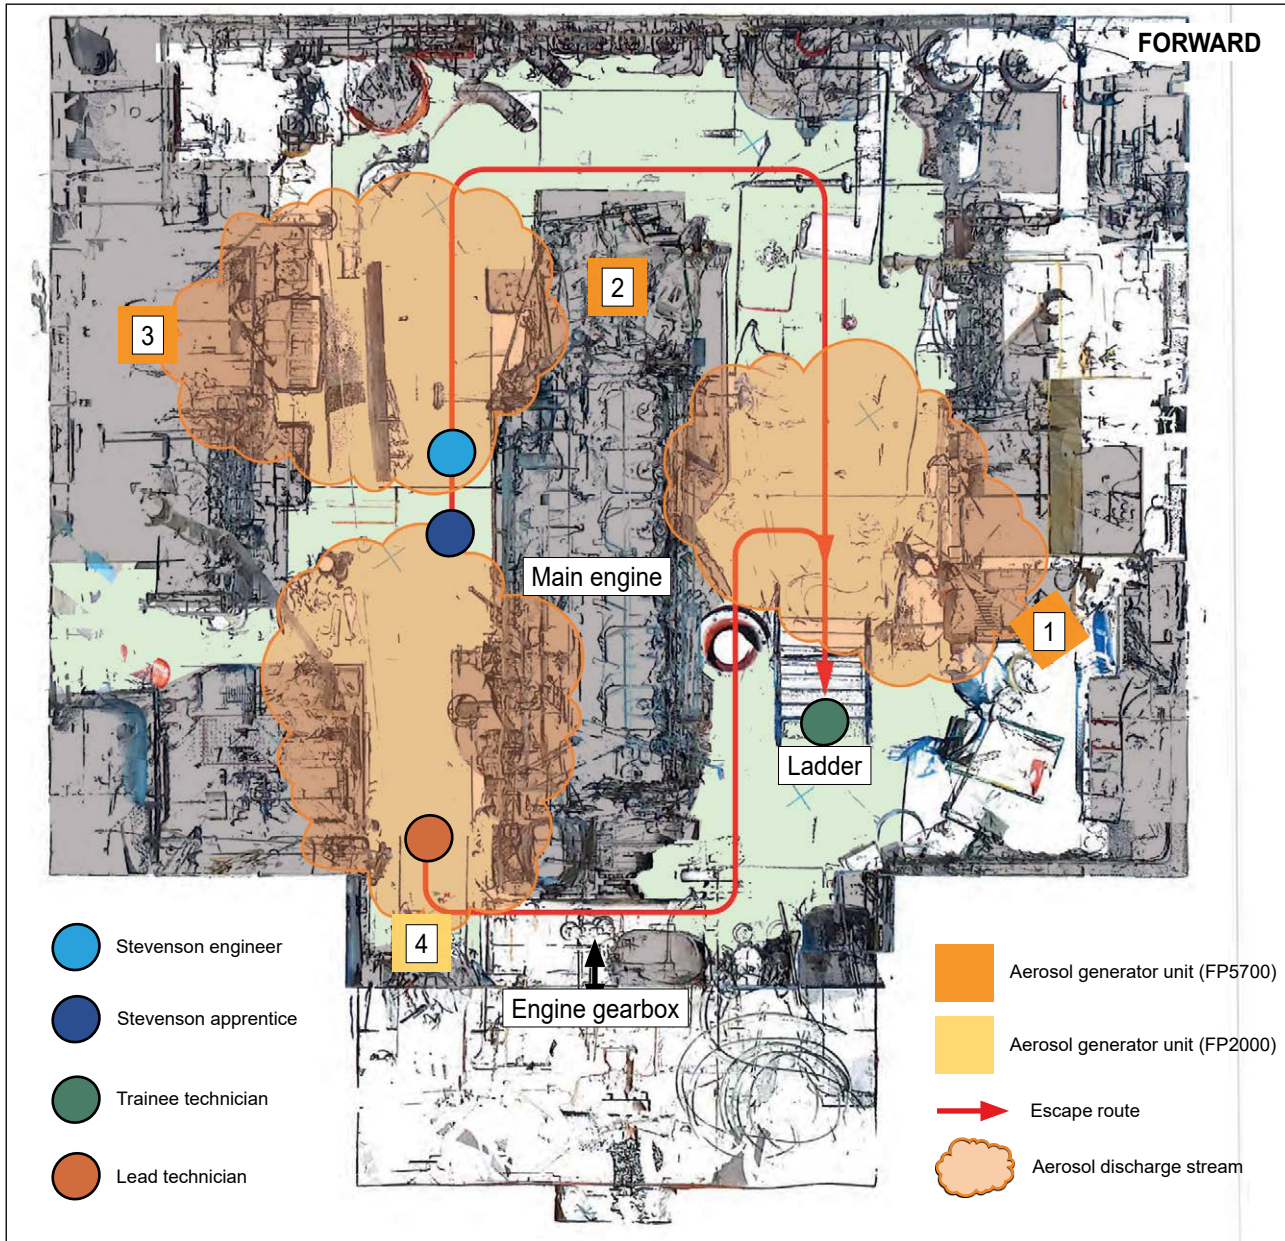
Figure 25: Escape route through aerosol discharge streams

Resurgam had one escape route from its engine room, which was via the compartment's normal access ladder located on the starboard side of the main engine. When the generators started to discharge, the Stevenson engineers were

working on the port side of the engine, the lead installation technician was directly aft of them, and the trainee technician was in the lobby area at the top of the access ladder.
