Report on the investigation of the
contact between the high-speed passenger craft

Seadogz

and a navigation buoy, resulting in one fatality
in Southampton Water, England

on 22 August 2020

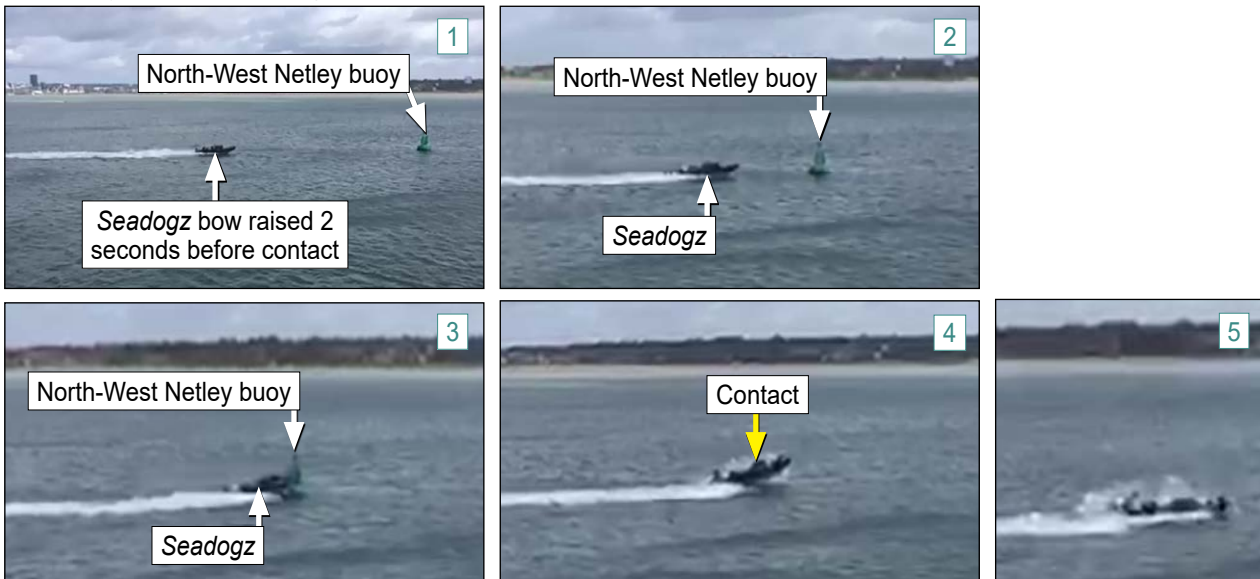
Figure 8: View from port side of *Red Falcon*, showing *Seadogz* running towards and making contact with North-West Netley buoy

The force of the impact momentarily knocked the buoy over to an almost horizontal orientation (see **Figure 8**, stills 4 and 5) and briefly threw the bow of *Seadogz* upwards, while the starboard engine stopped. The deceleration forces caused all the passengers to be thrown violently forward from their seats and the skipper, who was standing, to be thrown forward into the steering console. Two of the passengers seated in the front row of jockey seats were thrown out of the RIB and into the water, where their lifejackets inflated automatically. One of the passengers in the water was a non-swimmer and quickly became distressed when her lifejacket, which had been poorly fitted, lifted over her head. The male passenger in the water went to her assistance.

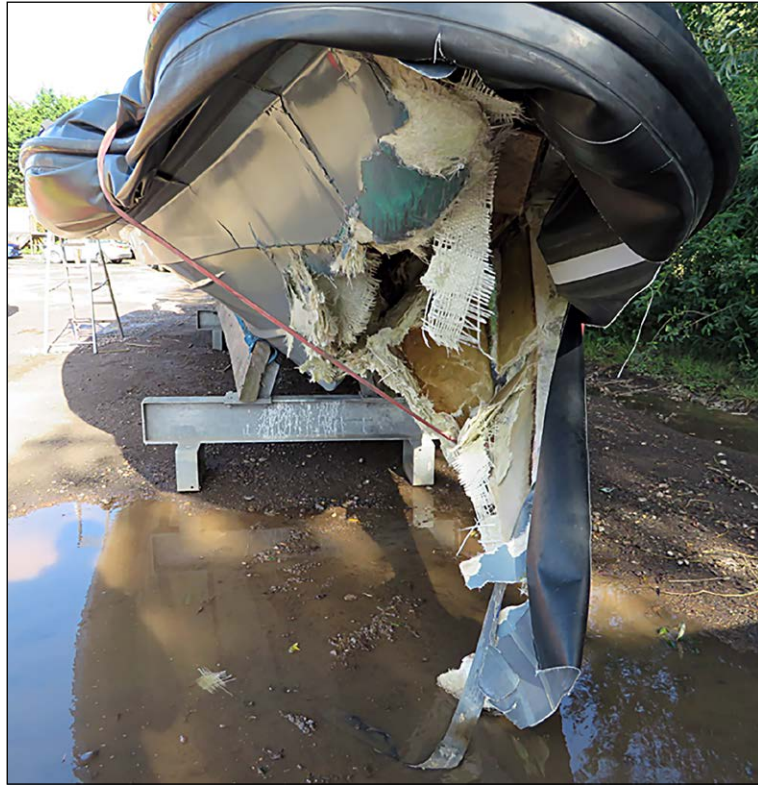
Figure 15: Damage to the bow of *Seadogz*

- the port forward section of the hull had sustained extensive damage, including a significant breach (**Figure 15**);
- three of the seven buoyancy chambers had been breached;
- several of the jockey seat backs had been displaced forward (**Figure 16**);
- the extended handhold in front of the centre of the bench seat (B2) had been displaced slightly to port (**Figures 11 and 13**); and
- the handhold for the forward port jockey seat (J1) had become detached on its starboard side (**Figure 17**).
