# Overspeeding incidents at Wood Green, and Melton Lane level crossing, 11 and 12 June 2023

## Summary of the incidents

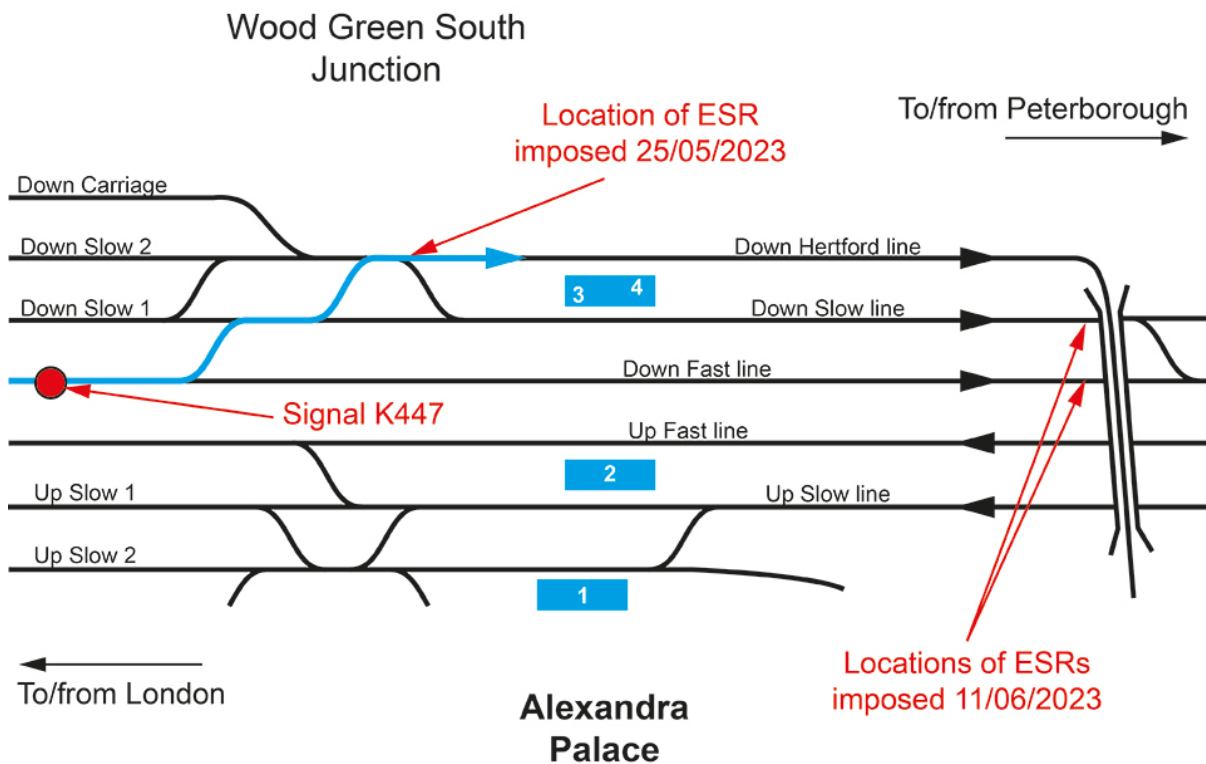
Track layout diagram showing the path of a train (blue arrow) crossing from the Down Fast to the Down Slow 2 line at Wood Green South Junction (note Down Slow 2 line becomes the Down Hertford line beyond the set of points covered by the ESR). Not to scale and not all features shown.

This meant that every train driver travelling along the Down Fast line received an AWS audible warning (a horn tone) and a visual indication (the 'sunflower') from each of the two portable AWS magnets associated with the ESR, as well as passing the EROS indicator and a warning board, which had an arrow indicating that the ESR applied only to the diverging route. In the period between 25 May and the implementation of the ESR relating to the high temperatures on the night of 10 to 11 June, nearly three thousand trains passed the equipment installed on the Down Fast line; only sixteen of these trains were routed across to the Down Slow 2 line.

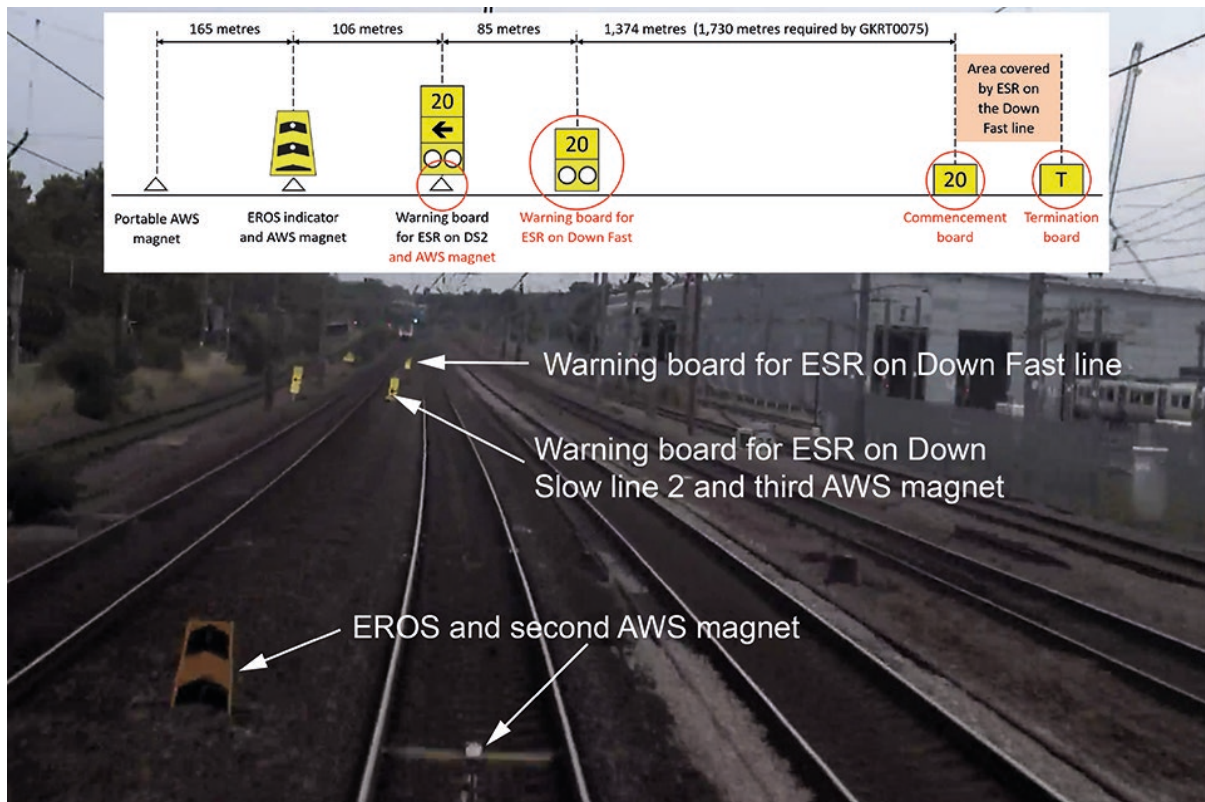
- The newly installed warning board for the ESR on the Down Fast line was only two seconds' running time at 95 mph (153 km/h) from the additional AWS magnet. Consequently, drivers had little time to react to the AWS warning and to identify the reason for it.

- The sequence of warning boards did not sufficiently draw drivers' attention to the new ESR on the Down Fast line. GERT8000-SP specifies that the warning board on the track on which the train is travelling should be installed on the approach to a diverging route warning board if the latter is required. In this case, the required sequence was reversed when the boards were erected.

Image from forward-facing CCTV showing ESR equipment on the Down Fast line on 11 June 2023, and a corresponding diagram. The additional equipment installed for the CRT(20) ESR on the Down Fast line on 10 to 11 June is shown in red on the diagram.

In addition to possibly misleading drivers by the incorrect sequence of warning boards, the position of the second warning board provided an insufficient deceleration distance for the speeds involved. This was because it was installed 1,374 metres from the ESR on the Down Fast line while (a) the design required the warning board to be installed 1,609 metres from the ESR and (b) the minimum deceleration distance from 95 to 20 mph (153 to 32 km/h) given in Railway Group Standard GKRT0075 is 1,730 metres.

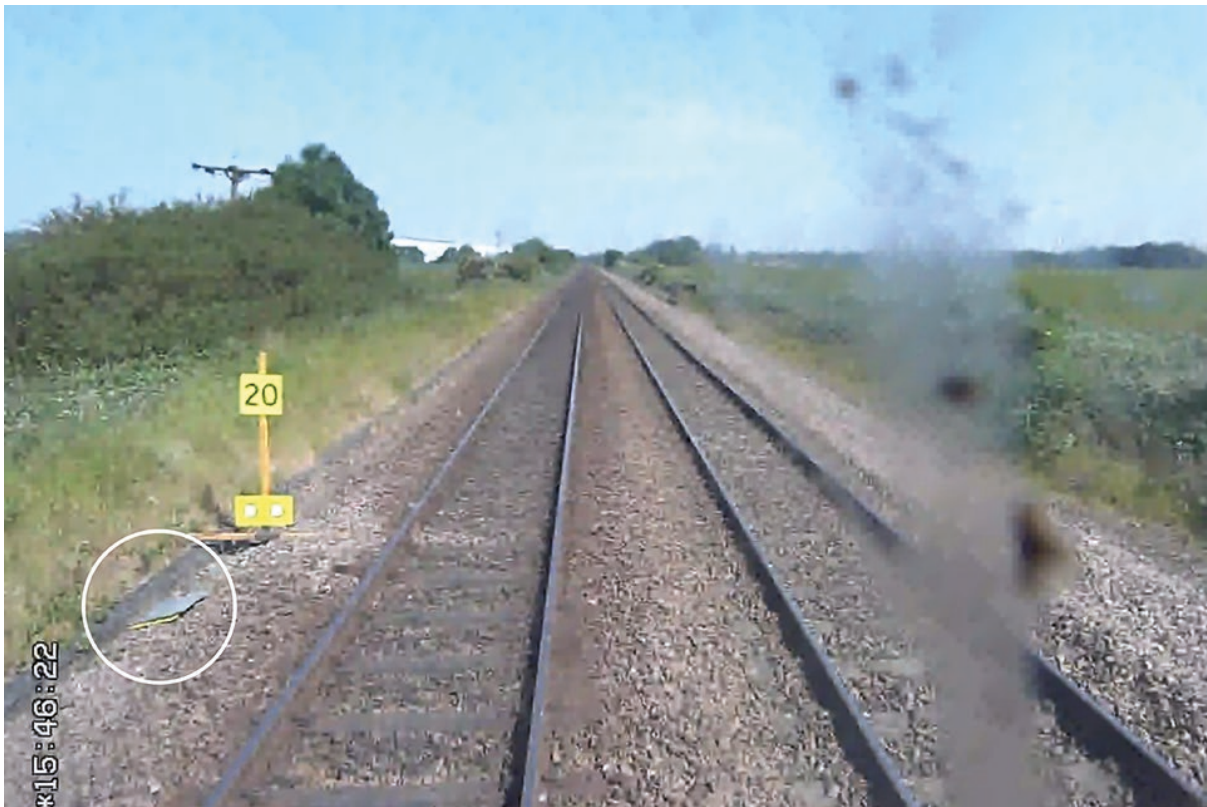
RAIB has seen no evidence that a new design was produced when it became necessary to impose a CRT(20) ESR due to the hot weather on 12 June. Instead, track maintenance staff swapped the 30/75 mph (48 and 121 km/h) warning and commencement boards for 20 mph (32 km/h) boards. Network Rail advised that this was because it had insufficient staff to move the ESR equipment when the critical rail temperature was reached. If the CRT(20) ESR had been implemented in accordance with the requirements of Railway Group Standard GKRT0075 for a reduction in speed from 75 to 20 mph (121 to 32 km/h), it would have been necessary to have moved the warning board and associated equipment 70 metres further from the start of the ESR, as the minimum deceleration distance would have needed to increase to 1,257 metres.

Image from forward-facing CCTV showing the CRT(20) warning board on 12 June 2023 (previous 30/75 warning boards lying on ground, shown in white circle).

The configuration of the ESR warning equipment on the Down Hull line approaching the CRT(20) ESR at Melton Lane level crossing on 12 June 2023 had the potential to mislead drivers. This was because it was installed at the same location as the earlier 30/75 ESR that had not been applicable to passenger trains throughout this period. Repositioning the ESR equipment would have provided drivers with a cue that the ESR speed limit had changed.
