# Near miss at Worlingham user worked crossing, Suffolk, 8 June 2020

## Summary of the incident

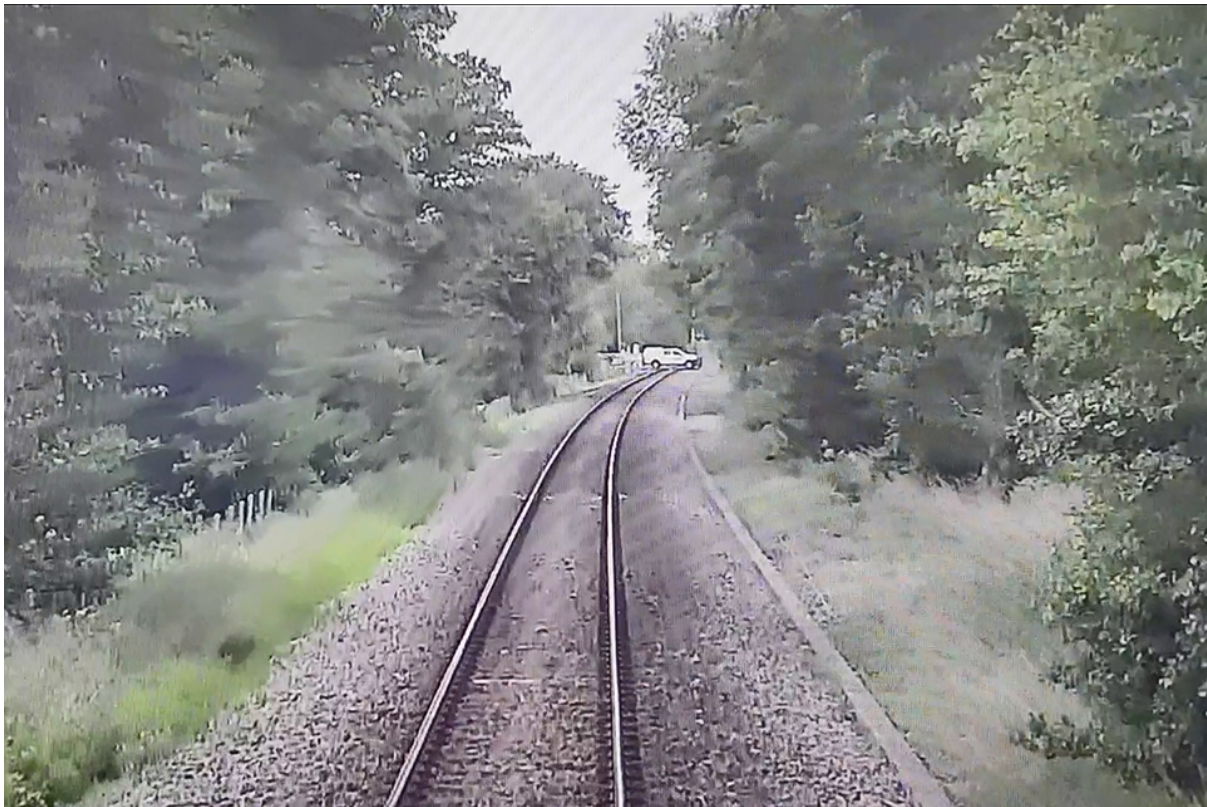
At 13:18 hrs, the driver of train 2D83, the 13:07 hrs Greater Anglia service from Lowestoft to Ipswich, applied the train's emergency brake after observing a vehicle towing a trailer cross Worlingham user worked crossing (UWC) ahead of the train. The crossing is located near Beccles, Suffolk. The train was about 350 metres from the crossing and was travelling at 55 mph (89 km/h), equivalent to 14 seconds running time. A second road vehicle was about to drive across behind the first but reversed away from the railway as the train approached. No collision occurred and there were no injuries.

Forward facing CCTV from train 2D83, showing the first vehicle crossing the railway (courtesy of Greater Anglia)

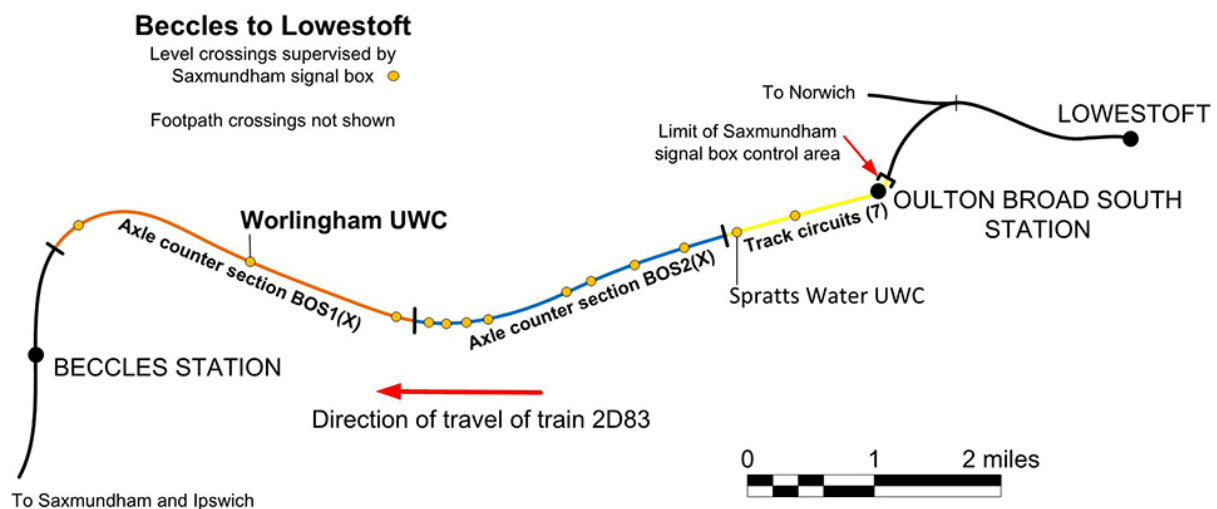
In May 2020, Network Rail introduced additional axle counters to subdivide some of the long signal sections controlled by Saxmundham signal box, in response to the second improvement notice. It had briefed signallers that the aim of the project was to provide them with 'more confidence when telling level crossing users if it is safe to cross'. The changes included subdividing signal section BOS(X) in the vicinity of Worlingham UWC into axle counter sections BOS1(X) and BOS2(X).

**Simplified track diagram showing signal section BOS(X), divided into two axle counter sections: BOS1(X) and BOS2(X)**

A table provided to the signallers as part of the project to introduce additional axle counters indicated that permission should not be given for Worlingham crossing to be used after a train approaching from the direction of Oulton Broad South had occupied axle counter section 'BOS2(X)'. This meant that although additional information on train position was provided on the display of the signaller's workstation, this did not give them any new information about the location of the train in this particular case.

Data from the telephone call management system at Saxmundham signal box and the data recorder on train 2D83, indicate the train had occupied axle counter section BOS2(X) 130 seconds before the driver of the road vehicle telephoned to request permission to cross.
