Rail Accident Investigation Branch

Rail Accident Report

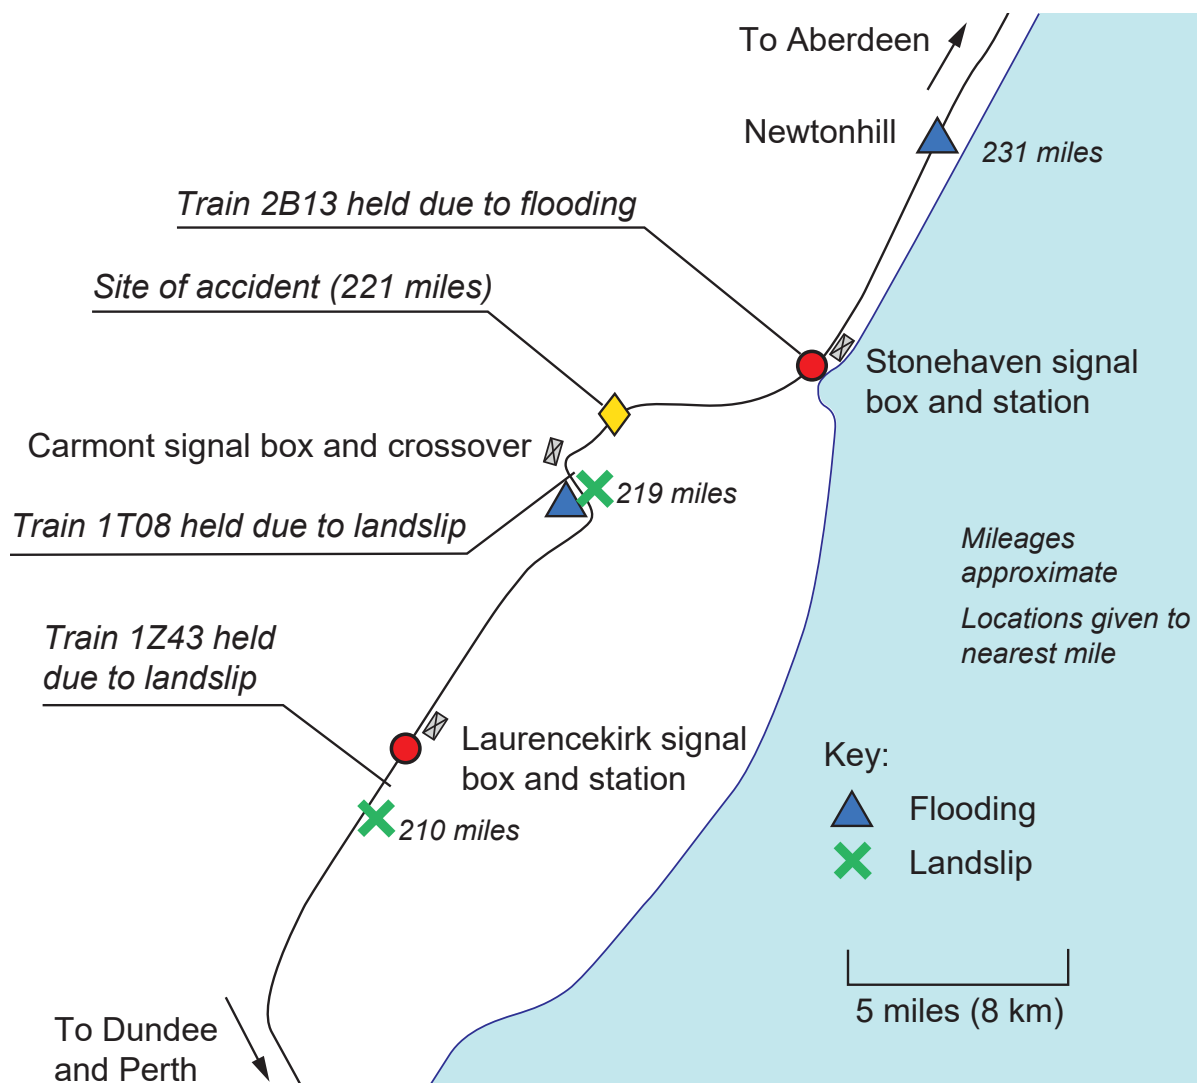
Train positions and known infrastructure failures around Carmont at 09:00 hrs on 12 August 2020

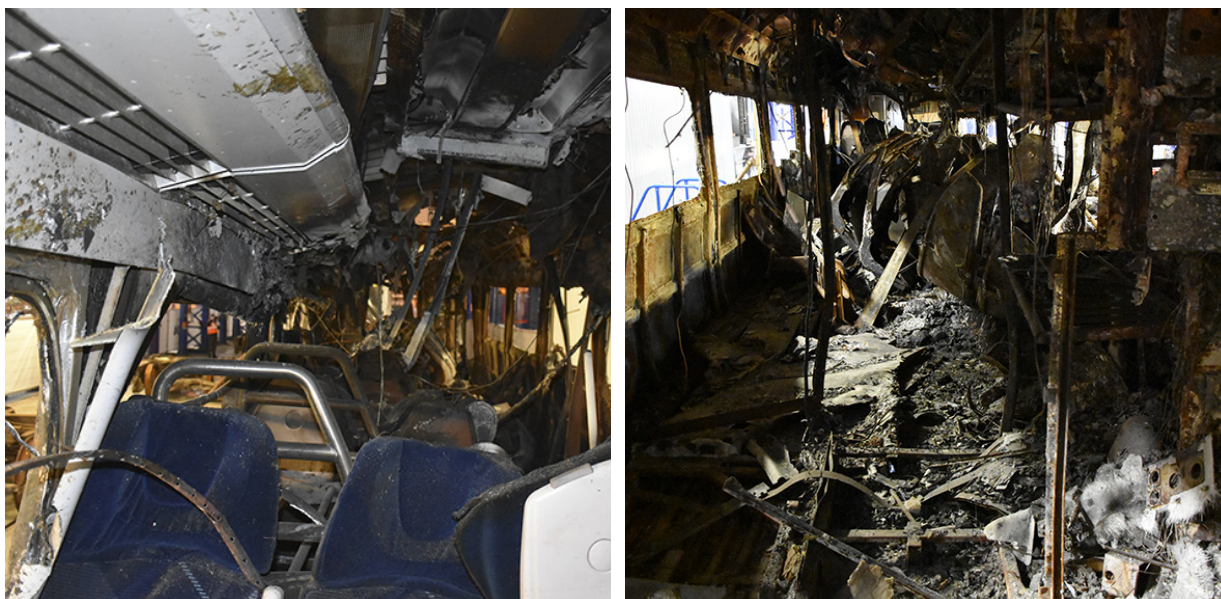
Fire damage in the third coach

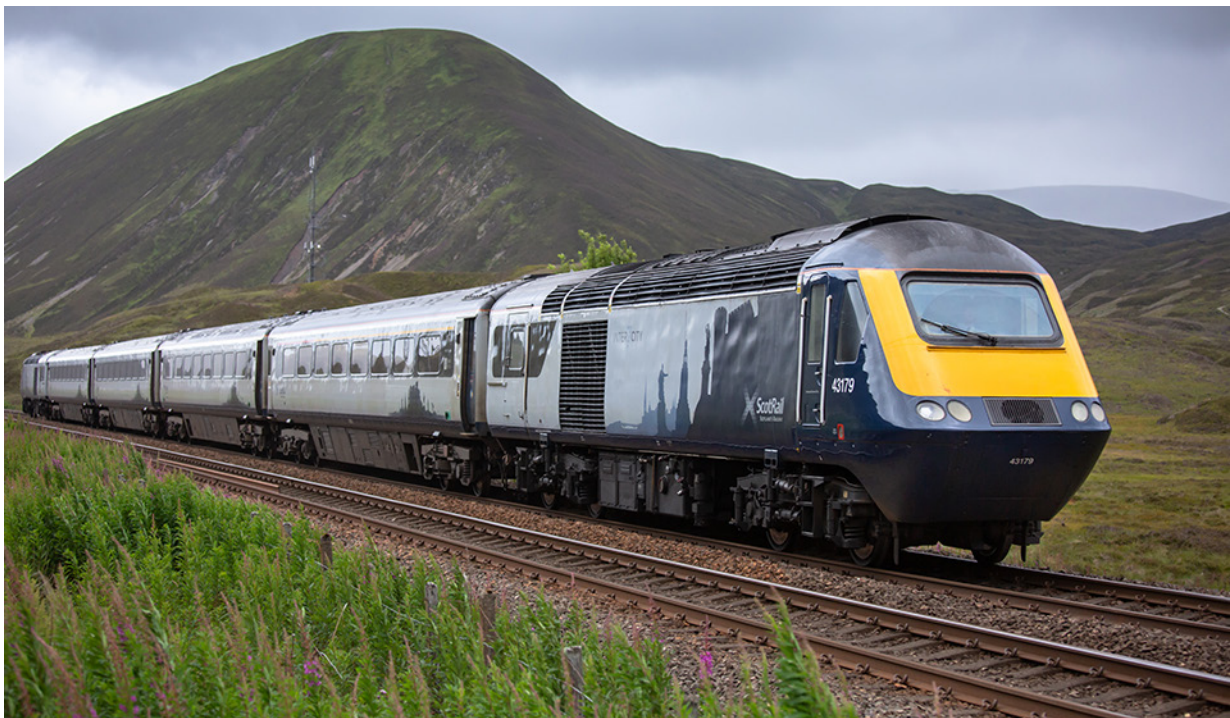
Figure 5: A typical ScotRail HST with power cars and mark 3 coaches (ScotRail)

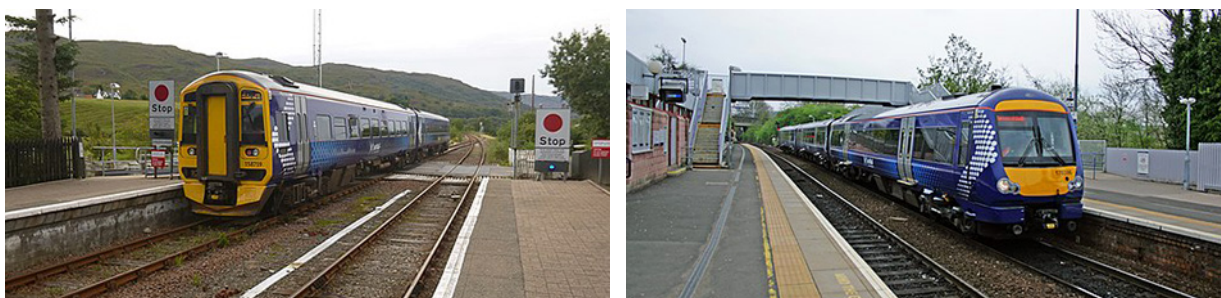
Figure 6: Typical class 158 and class 170 trains (left image Craig Wallace, used under Creative Commons Licence; right image Cal Smith, used under Creative Commons Licence)

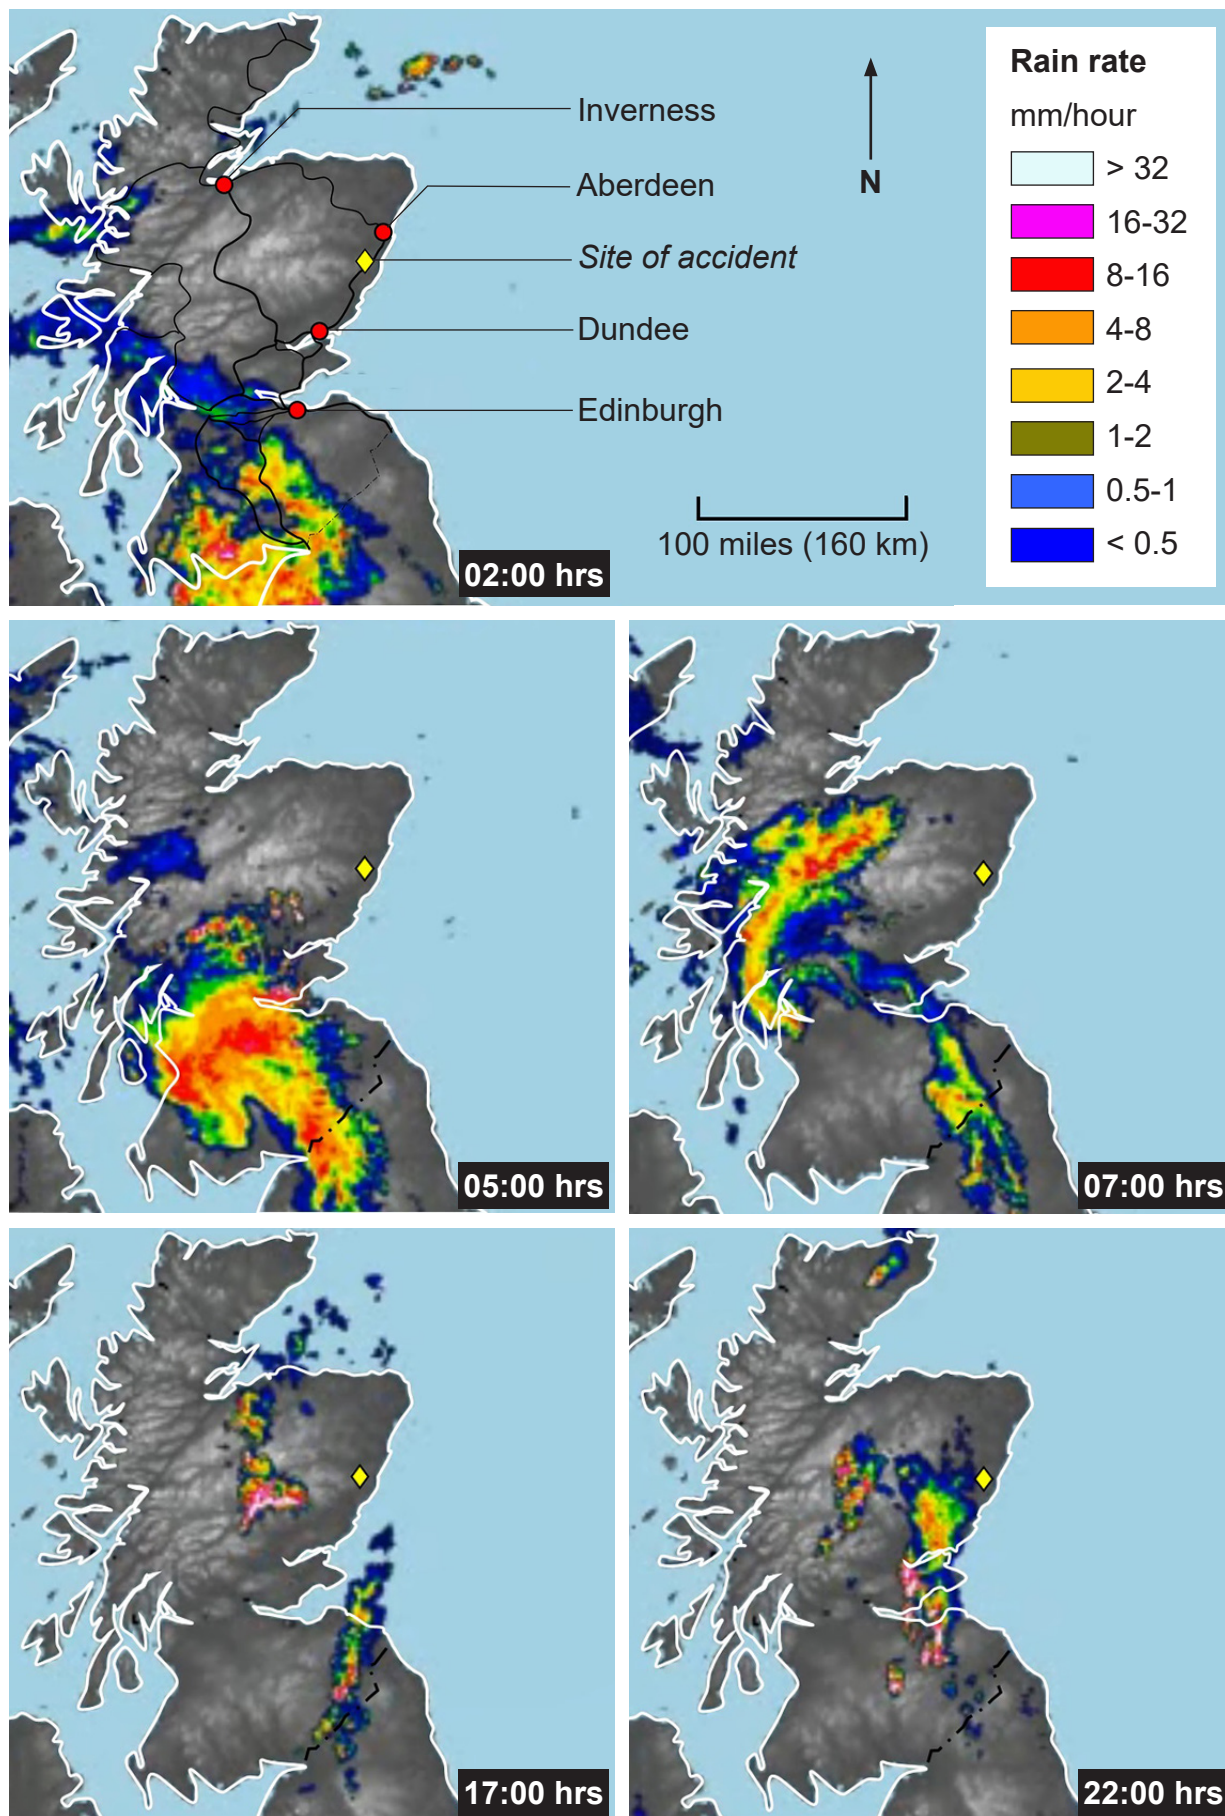
Figure 11: Rainfall - Scotland, 11 August 2020 (Met Office)

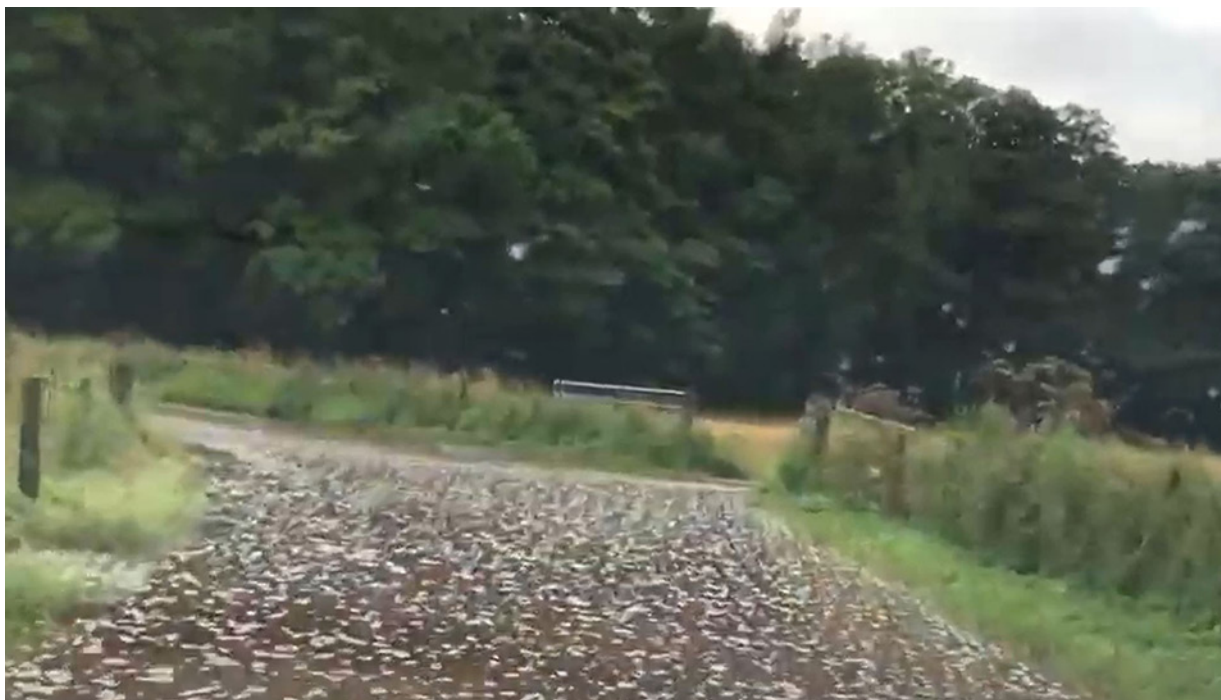
Figure 13: Conditions on a road near Carmont at 08:39 hrs on 12 August 2020 (Chris Harvey)

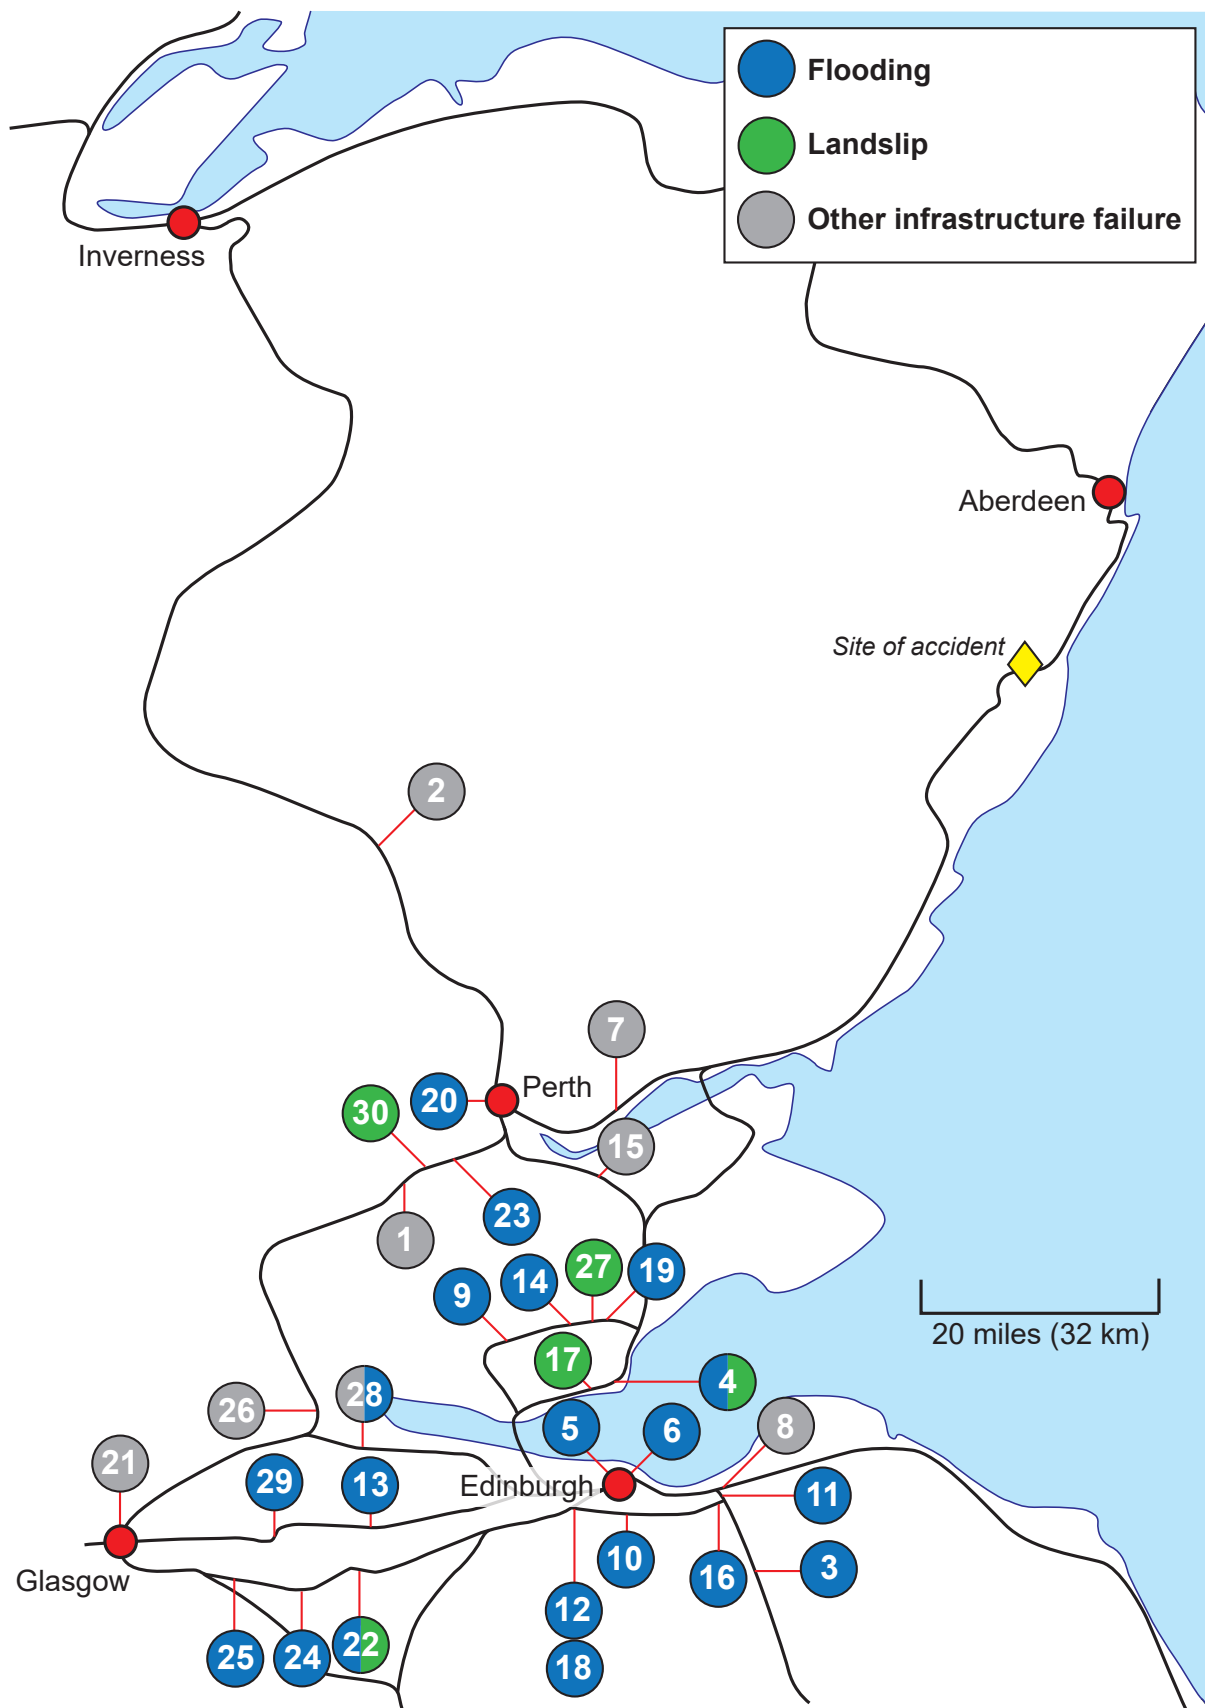
Figure 14: Known infrastructure failures at 06:55 hrs on 12 August 2020. Reference numbers relate to incident details given in appendix D. Incidents in the area around Carmont reported after 06:55 hrs but before 09:00 hrs are shown in figure 16.

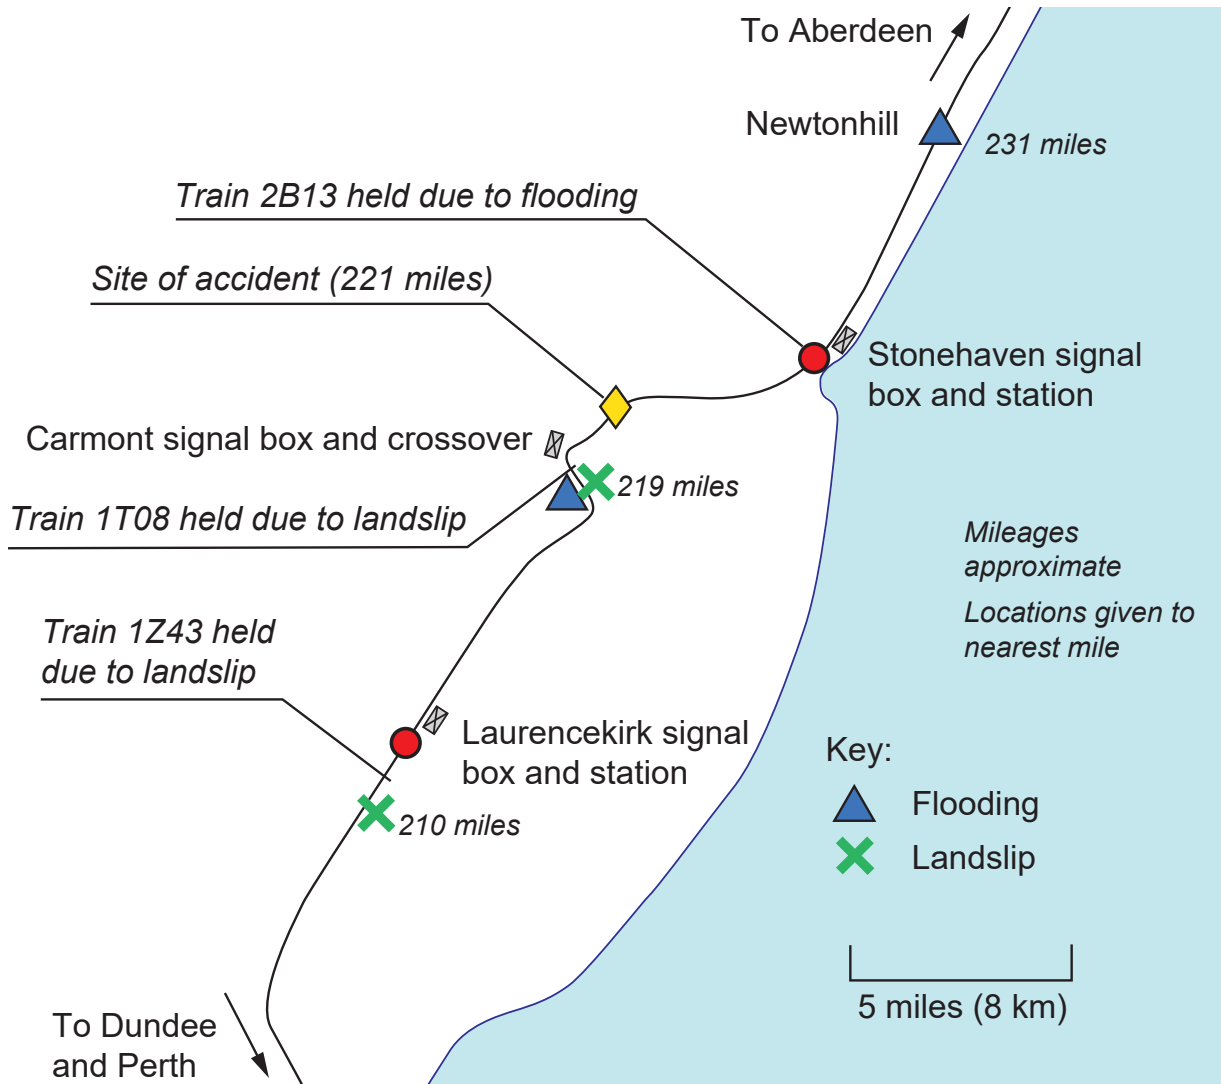
Figure 16: Train positions and known infrastructure failures around Carmont at 09:00 hrs on 12 August 2020

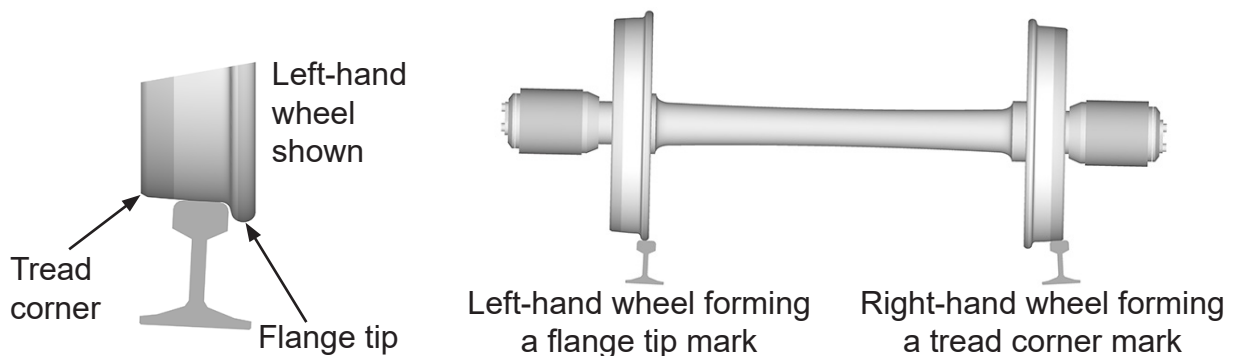
Figure 23: Wheel components and rail marks

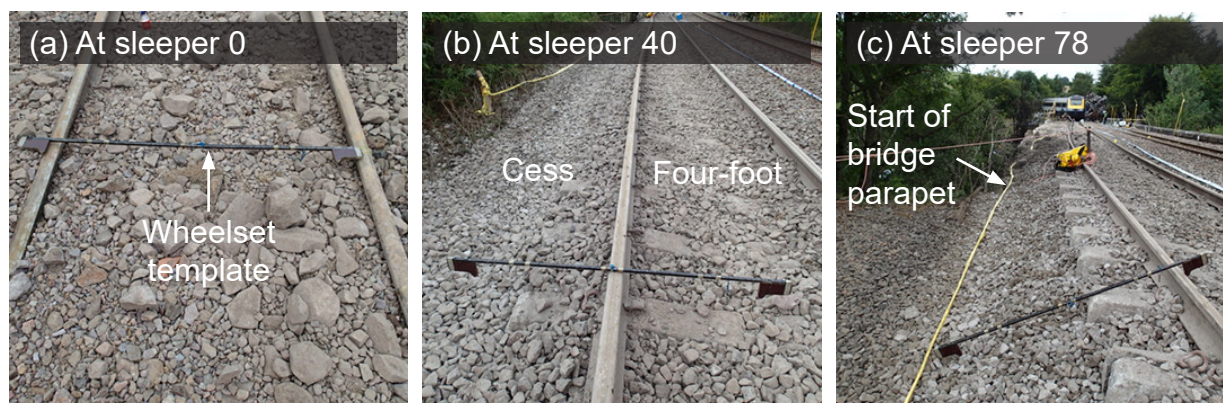
Figure 24: Position of leading wheelset (shown by wheelset template) from washout to bridge 325

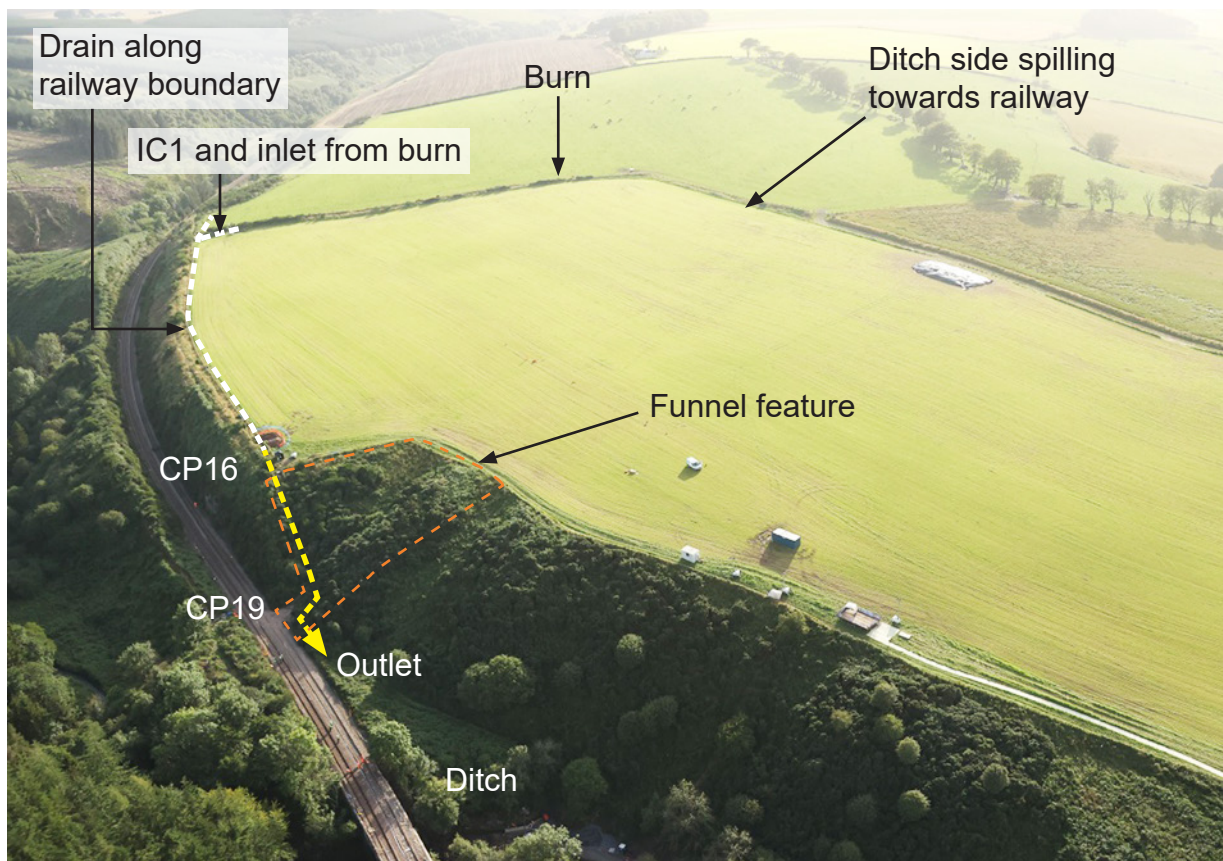
Figure 25: Post-accident aerial image of 2011/12 drainage system's catchment area (Network Rail)

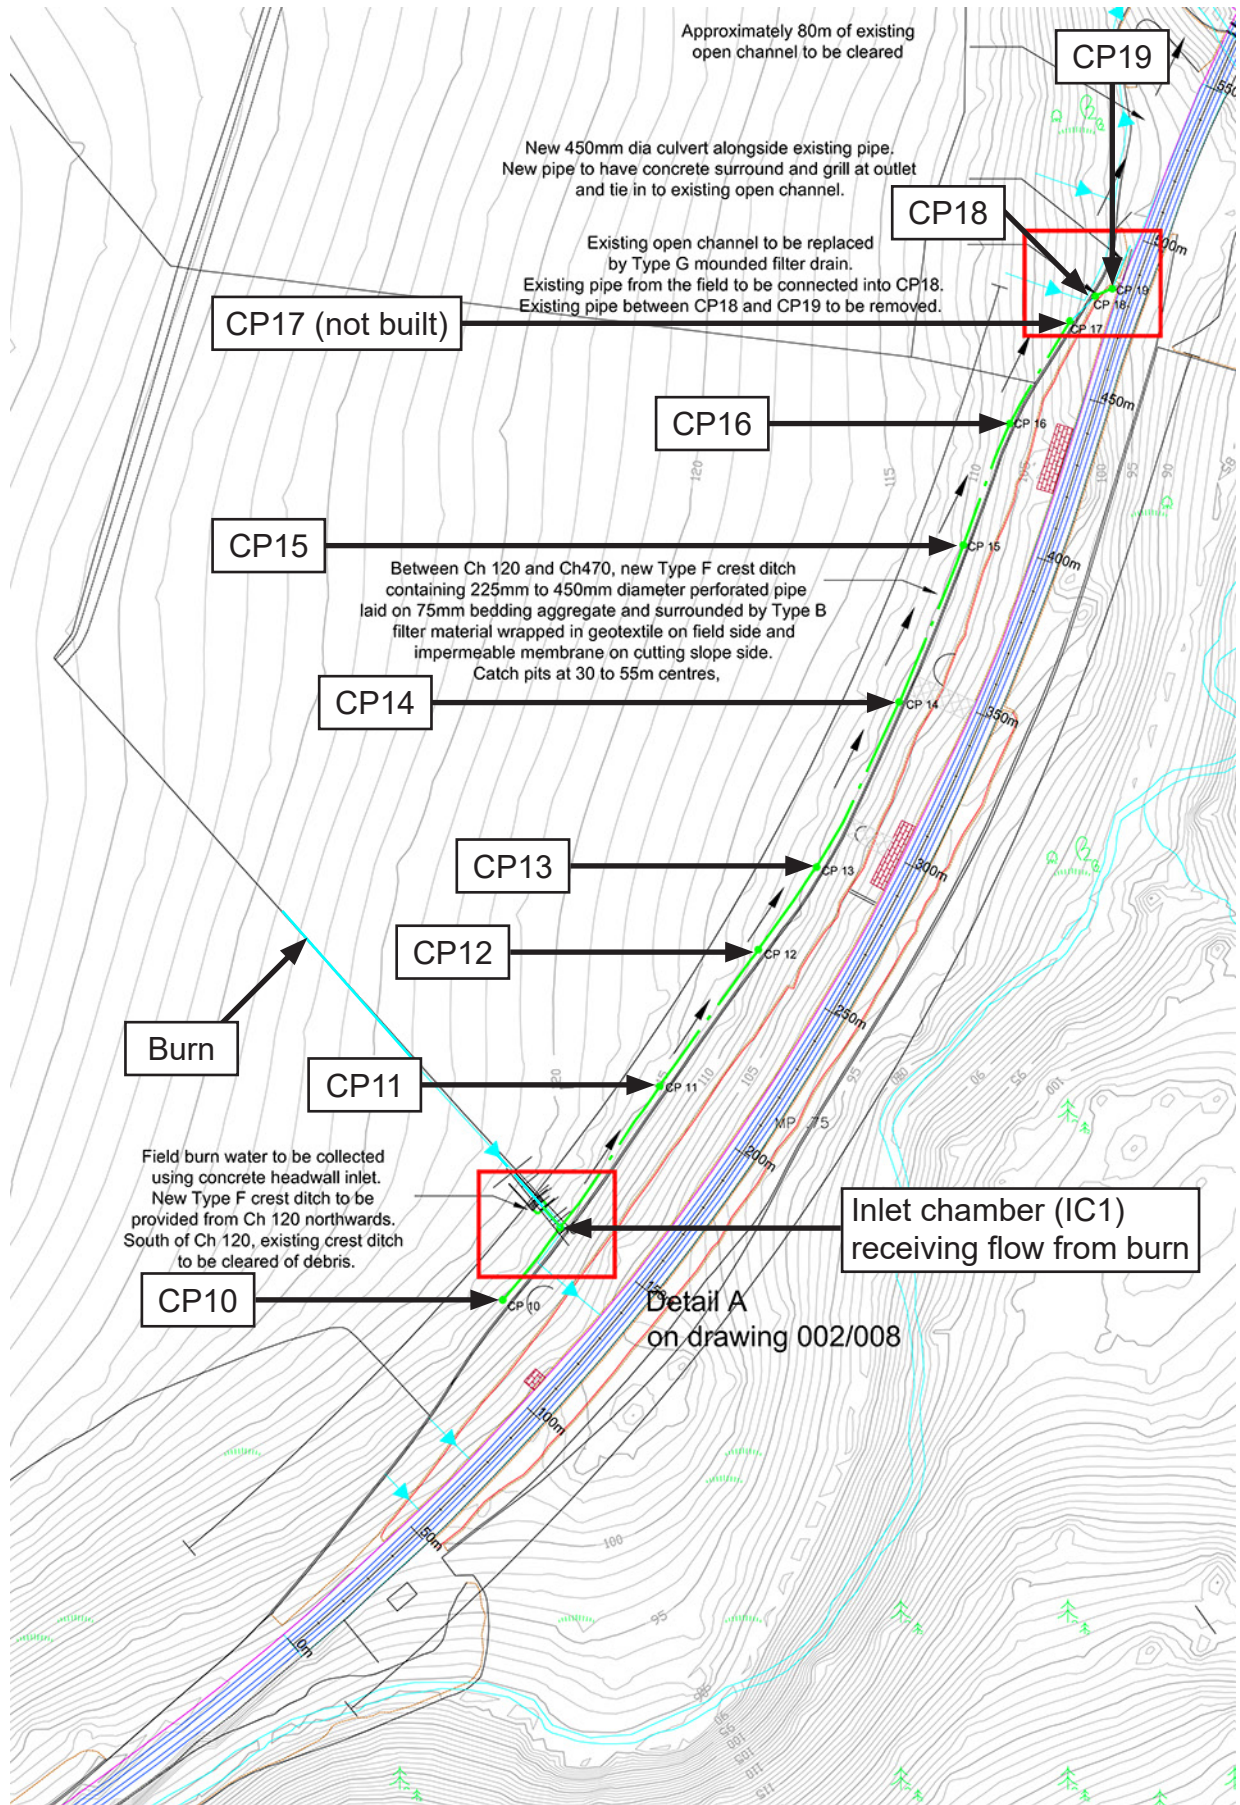
Figure 27: Drain design – plan. Annotated version of Arup drawing 002/001 issue 4. As-built layout differs

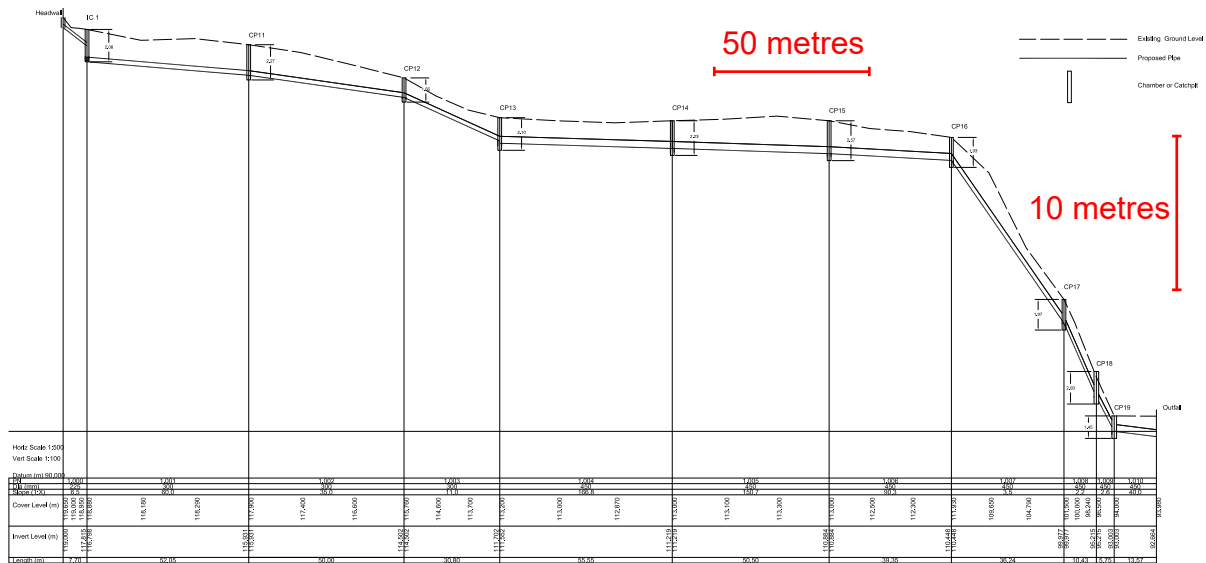
Figure 28: Drain design – elevation with exaggerated vertical scale. Annotated version of Arup drawing 002/005 issue 3. As-built layout differs

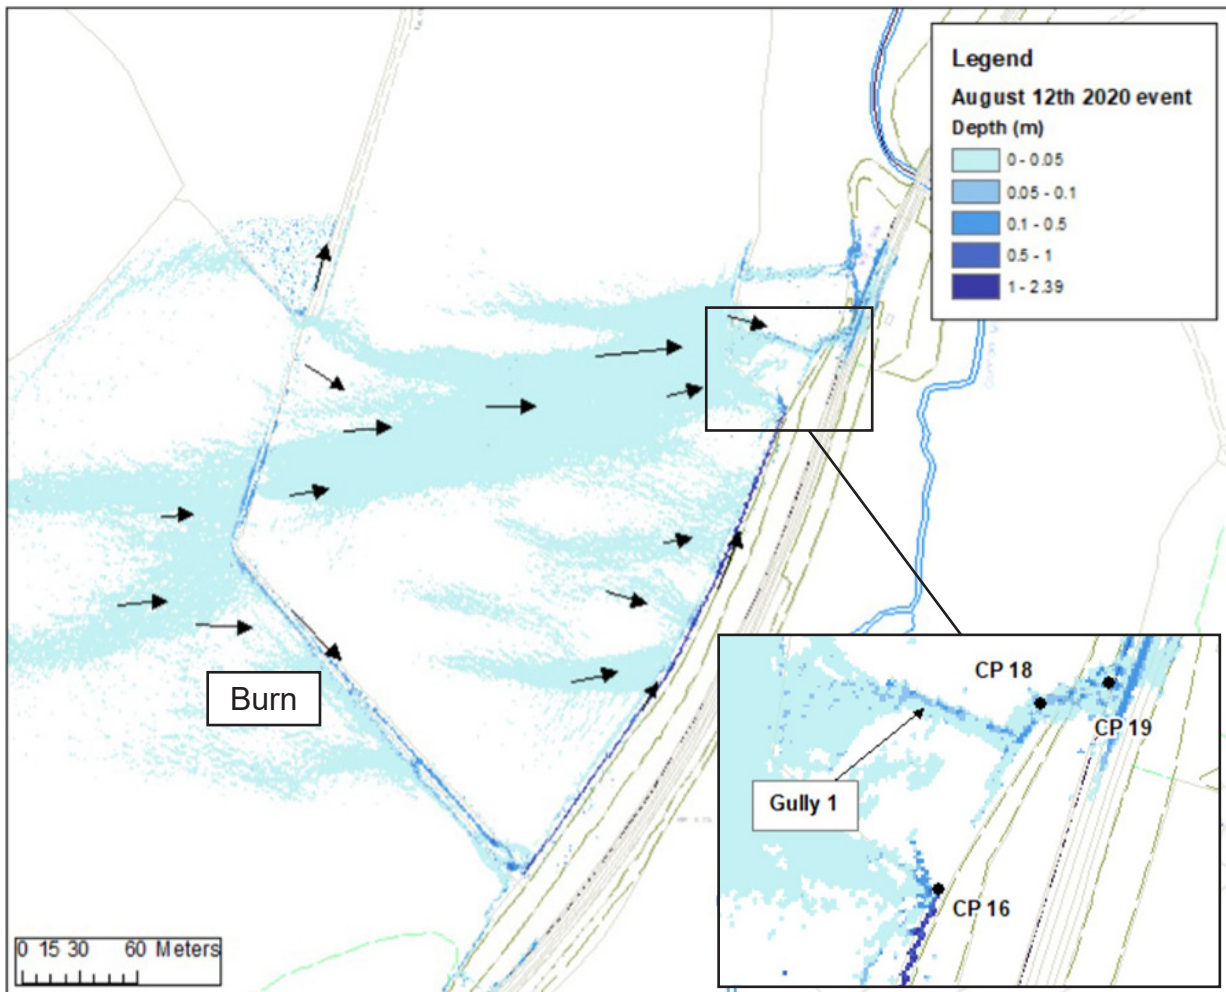
Figure 41: Overland flow maximum depths, best estimate analysis (AECOM)

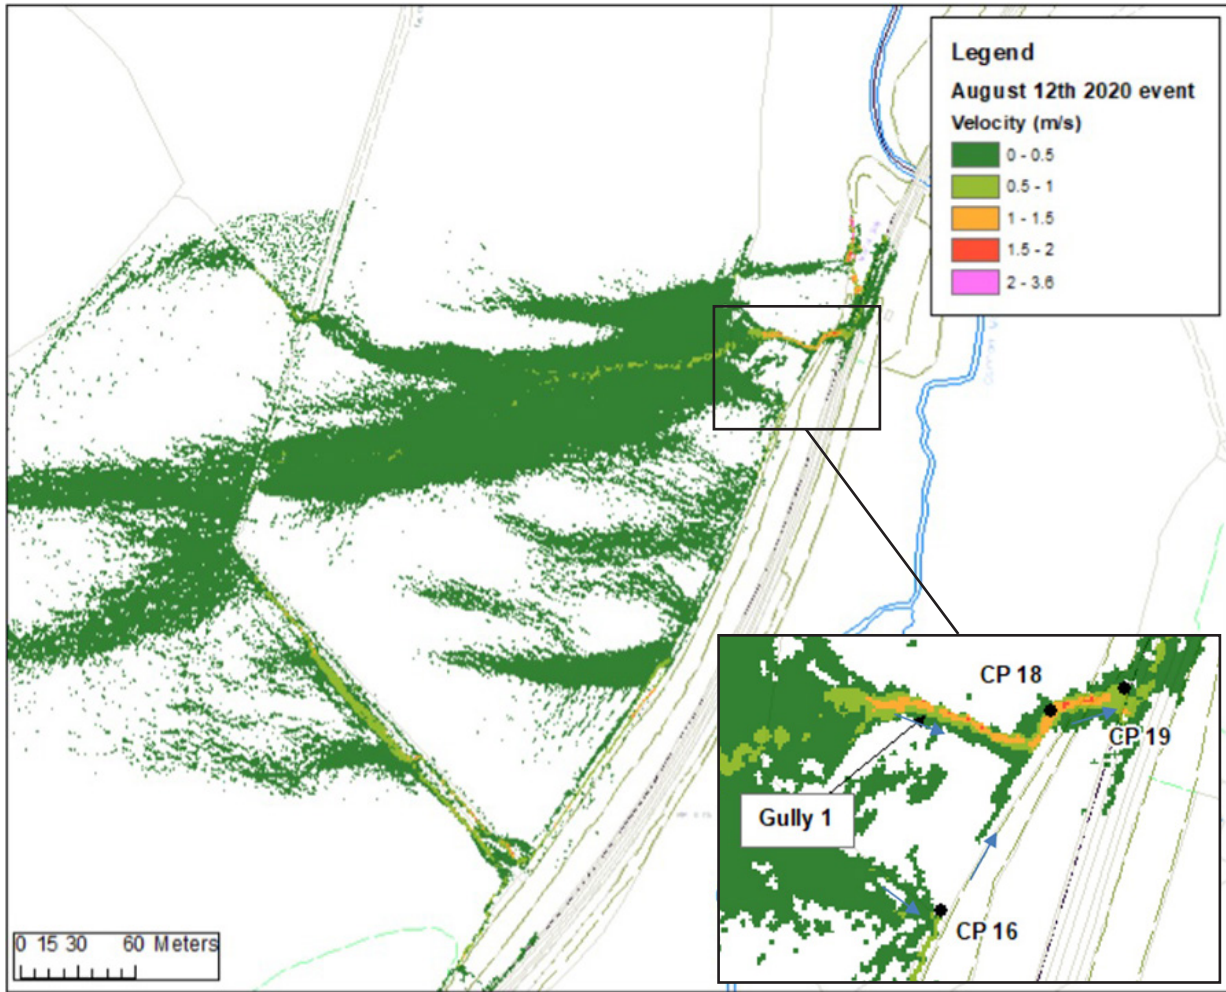
Figure 42: Overland flow maximum velocities, best estimate analysis (AECOM)

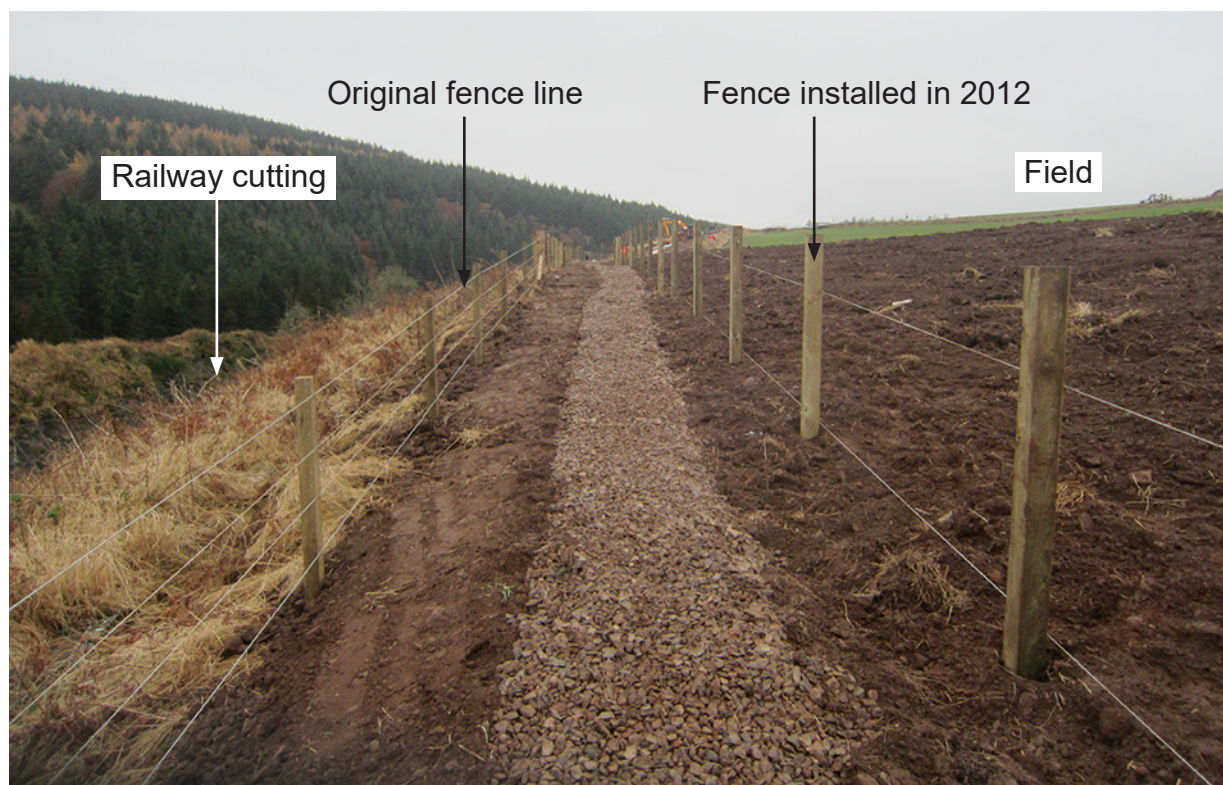
Figure 45: Drain shortly after completion in late 2012 showing section between CP11 and CP16 looking south (Network Rail)

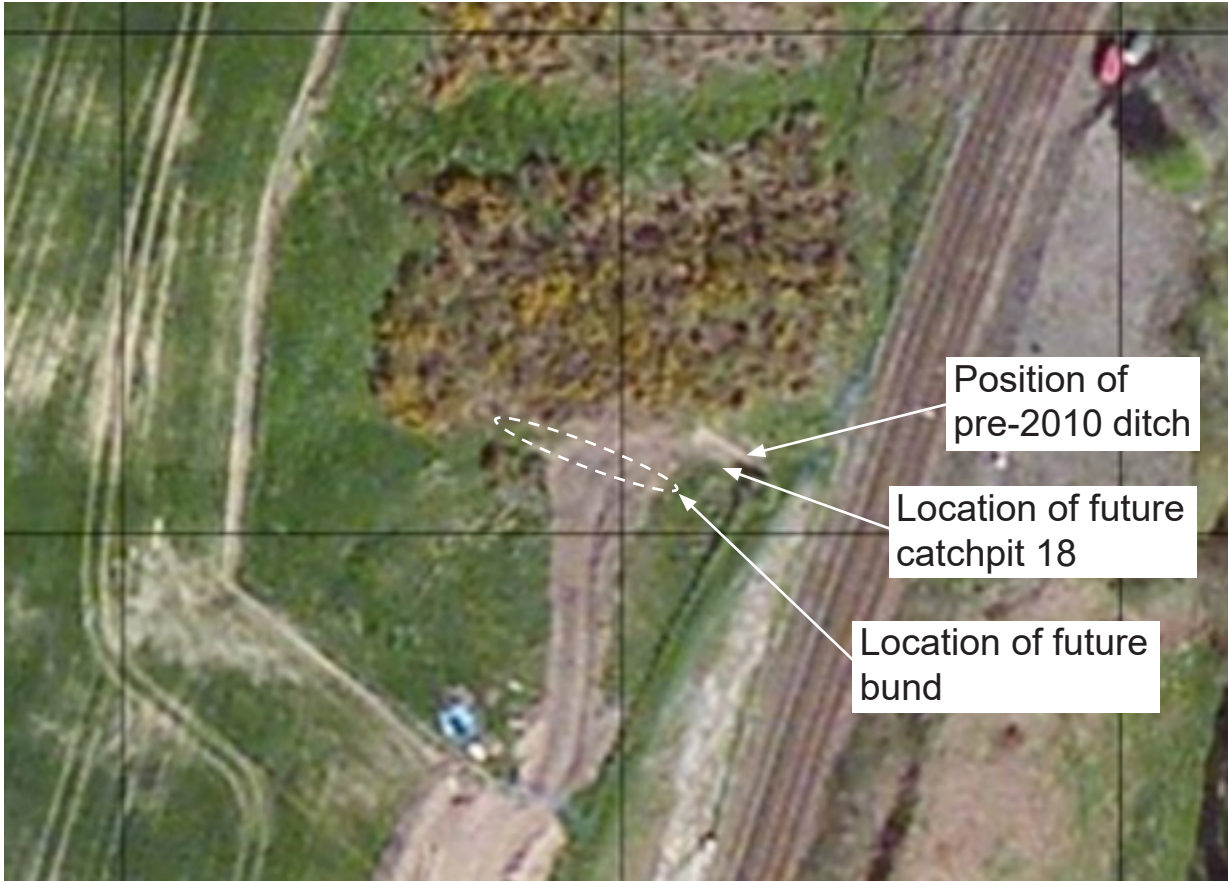
Figure 46: Satellite image April 2011 (Network Rail/ESRI Wayback imagery)

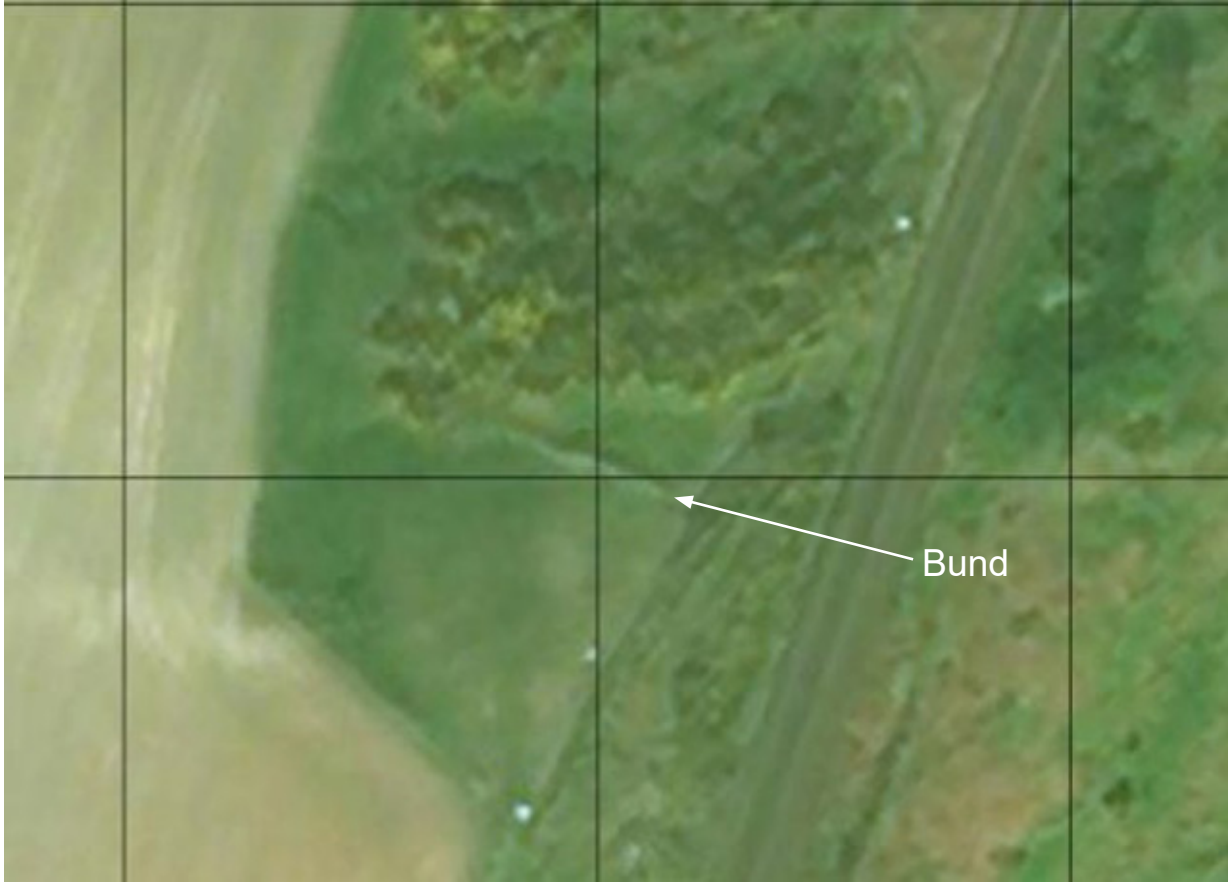
Figure 47: Satellite image April 2014 (Network Rail/ESRI Wayback imagery)

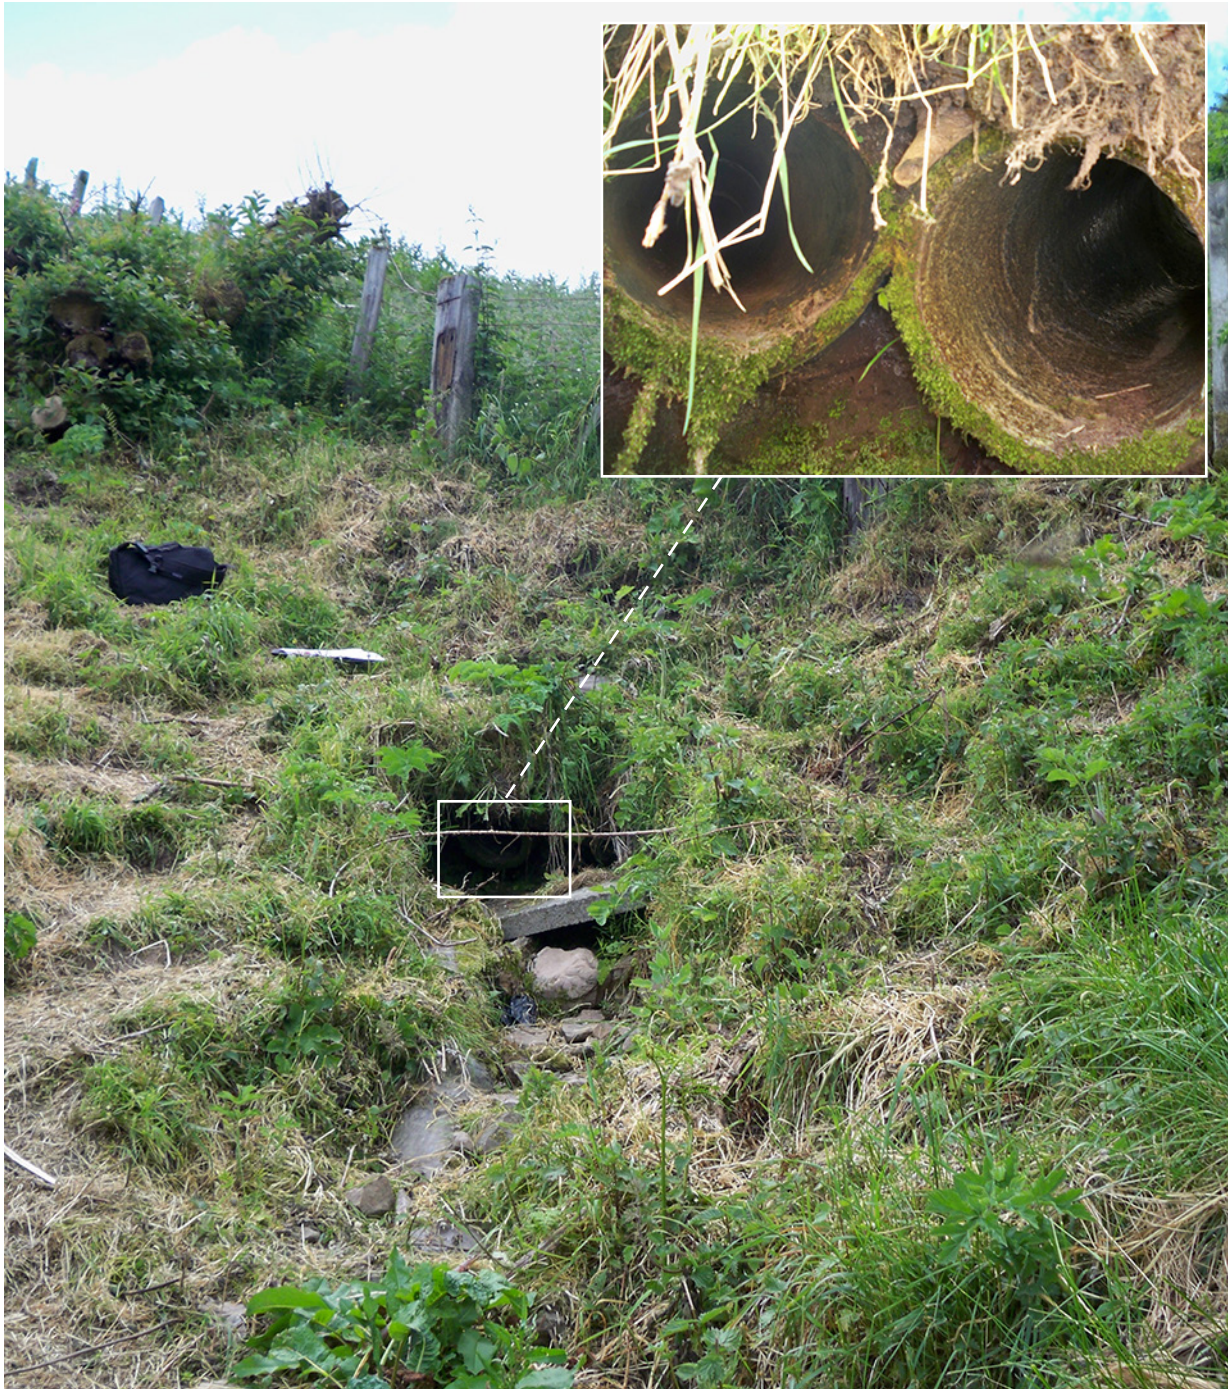
Figure 48: Pipes entering channel in pre-2010 drainage system at as-designed position of CP18 (Arup, June 2010). Inferred that left-hand pipe is from historic crest drain and right-hand pipe from pre-2010 drainage ditch as shown on figure 32
