Rail Accident Investigation Branch

Rail Accident Report

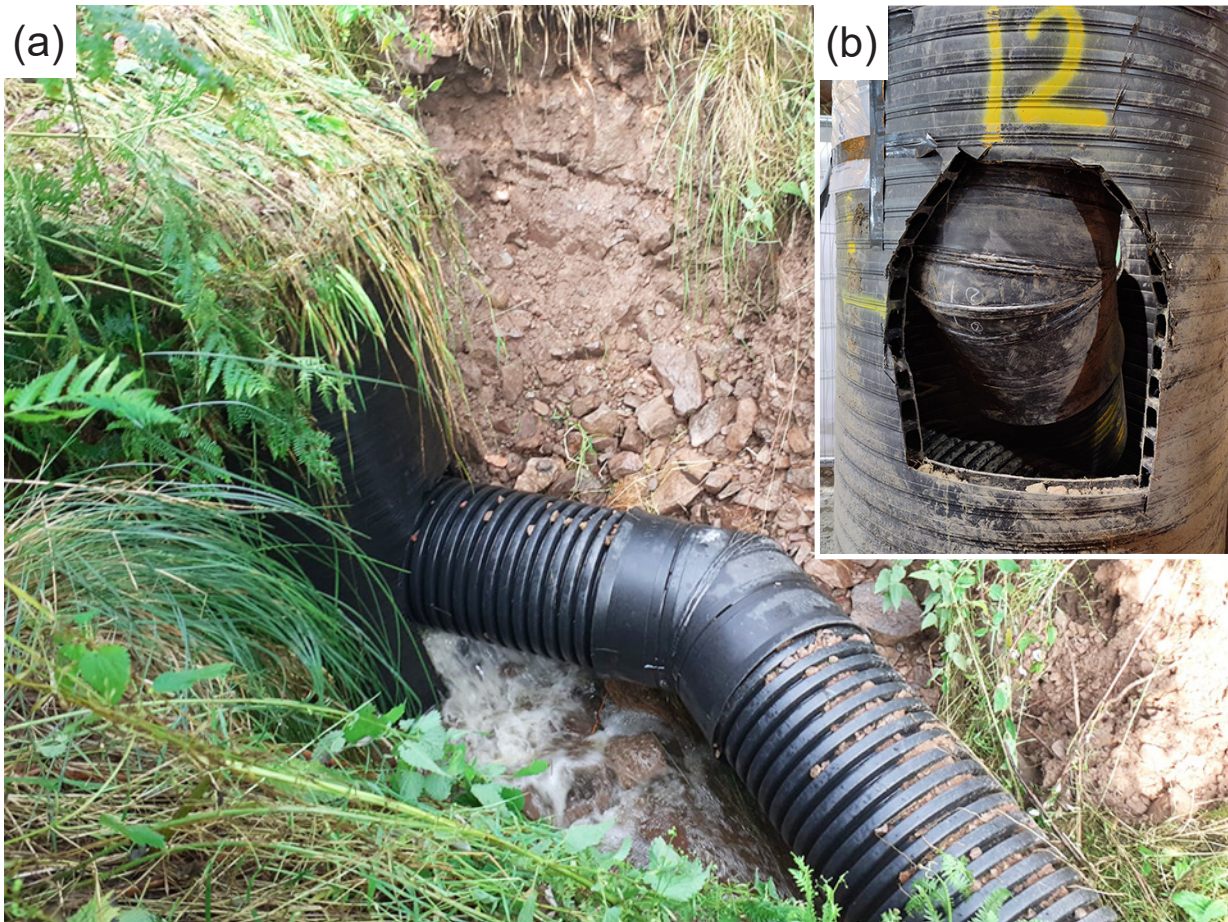
Figure 51: Downstream face of CP18 showing enlarged hole (a) on 12 August 2020 (Story Contracting), and (b) after removal (Note: a loose section of pipe has been subsequently placed inside the catchpit)

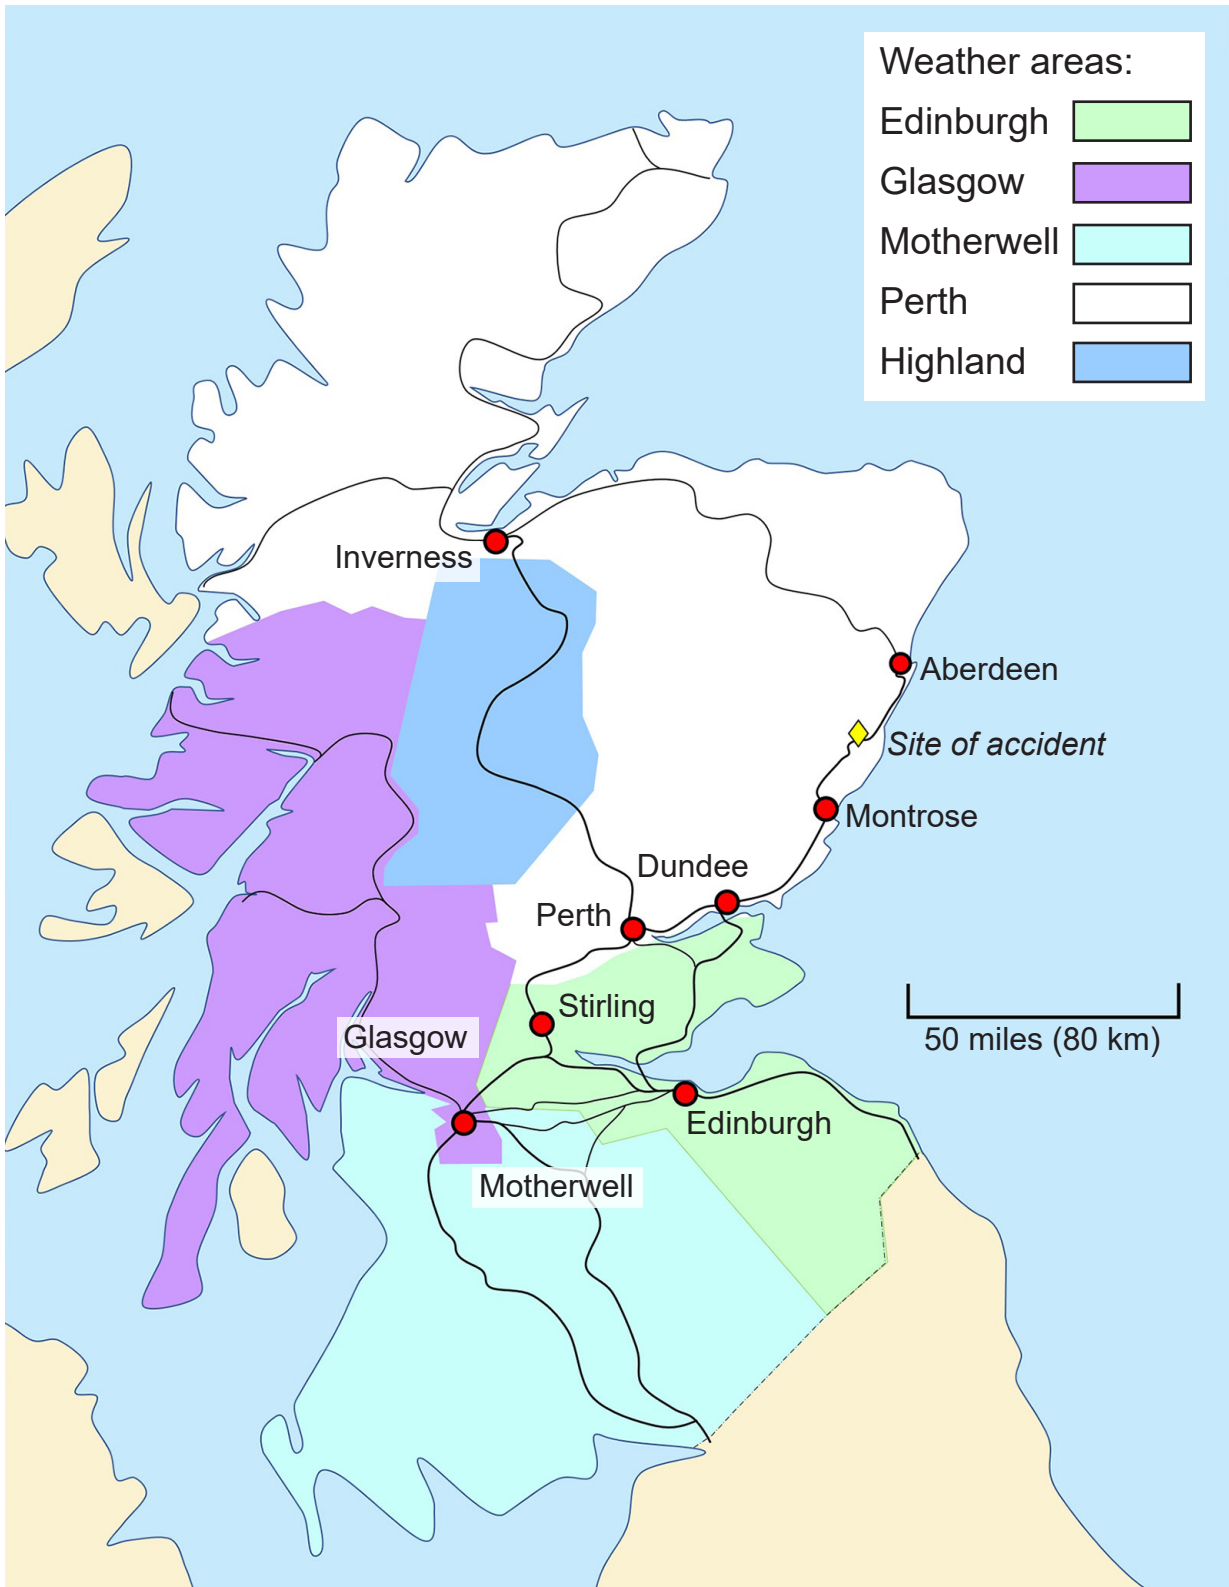
Figure 56: Forecast areas in Scotland (based on Network Rail drawing)

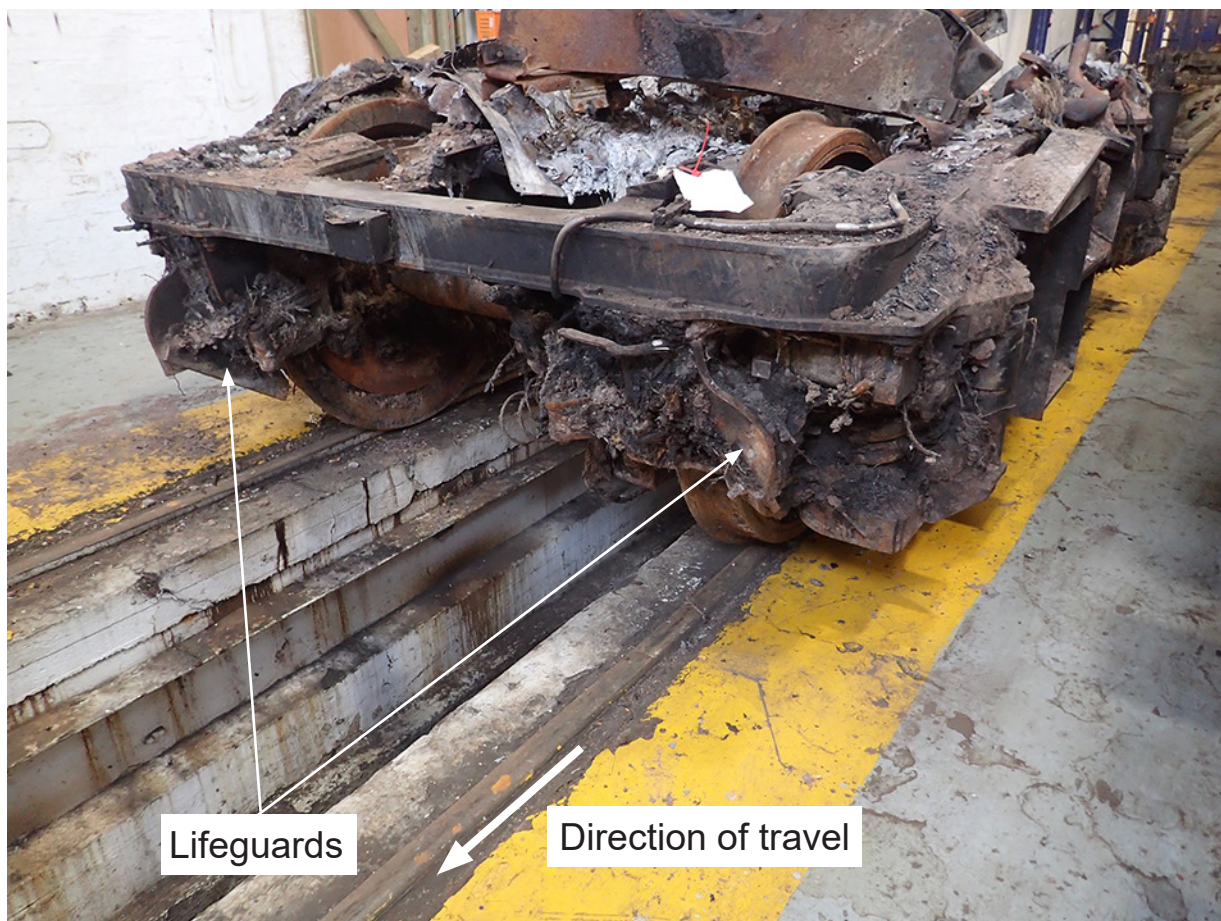
Figure 60: Damaged lifeguards on the leading bogie of the leading power car

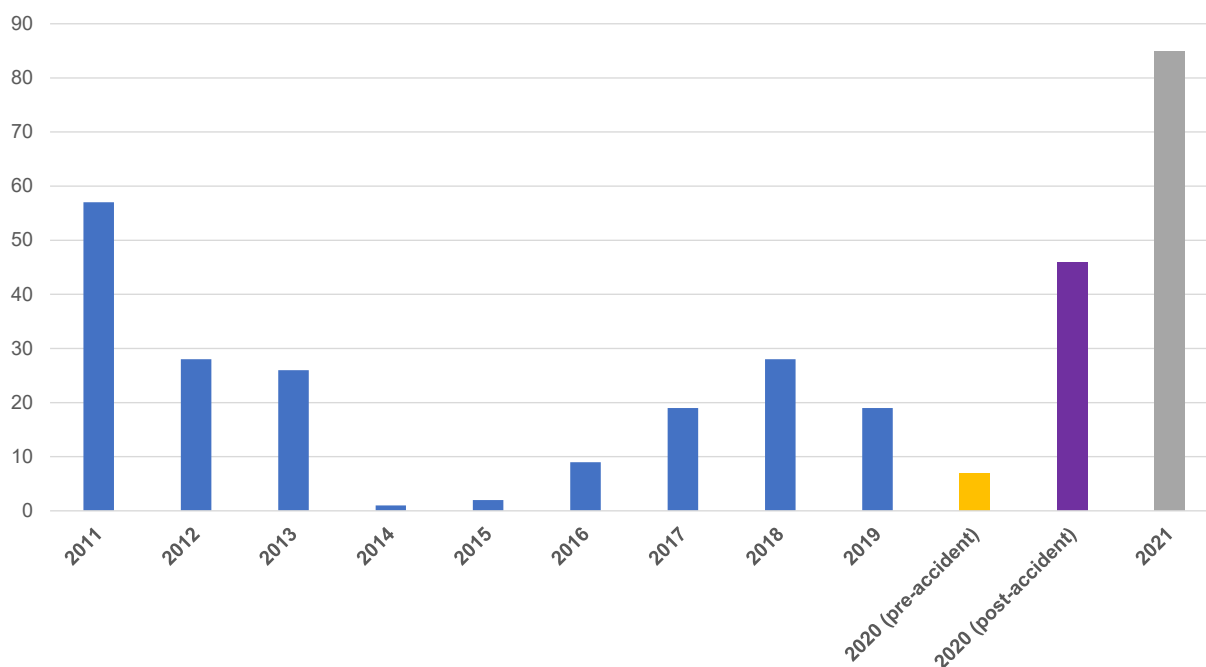
Figure 61: Number of EWATs convened in Scotland 2011 to 2021 (based on records provided by Network Rail and ScotRail)

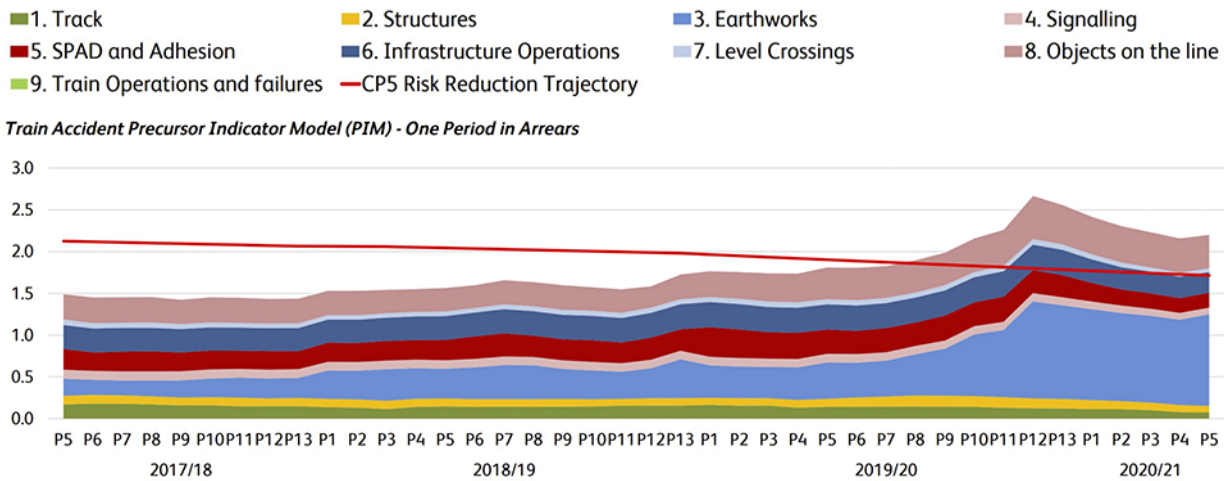
Figure 63: Outputs of the train accident precursor indicator model showing the rise in risk associated with earthwork failure, relative to other precursors. (Extract from Network Rail’s Safety, Health and Environment Performance report for period 6 of 2020/21).

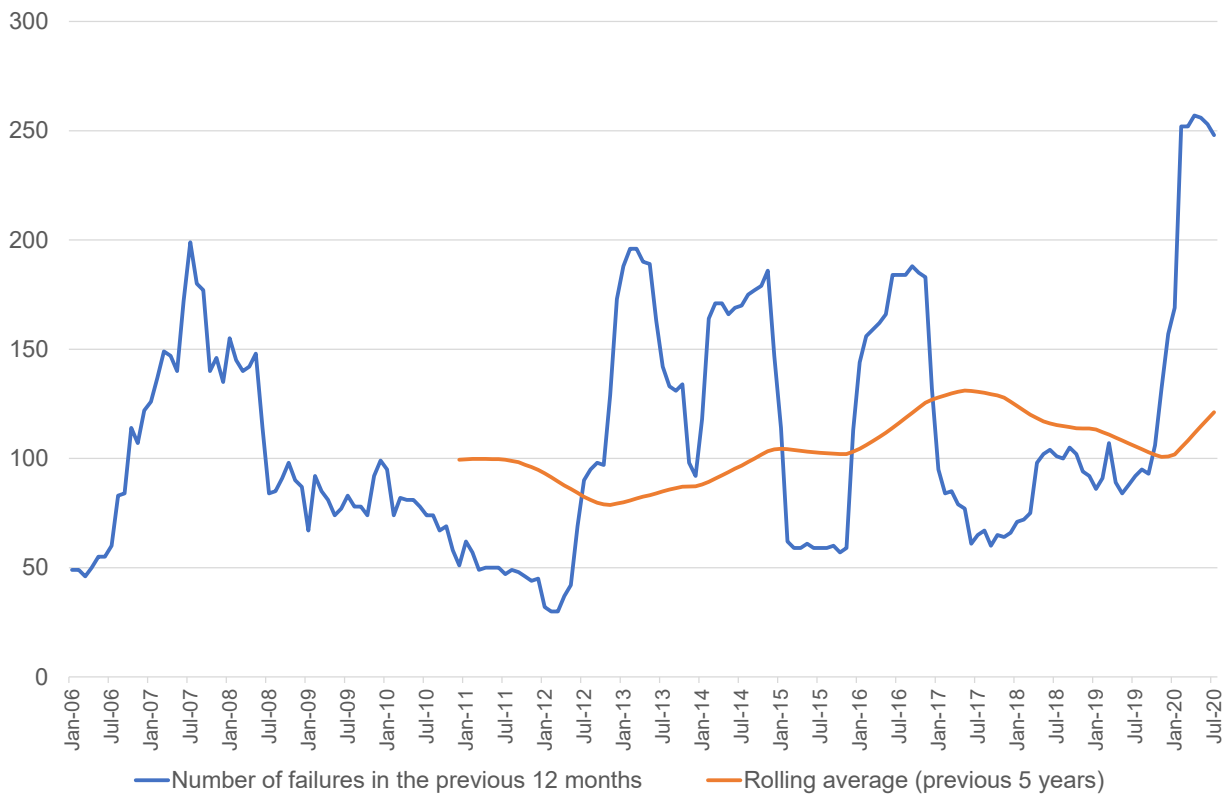
Figure 64: Recorded earthwork failures on Network Rail infrastructure July 2005 to August 2020 (as defined in accordance with Network Rail's standard NR/L3/CIV/185⁴⁵)

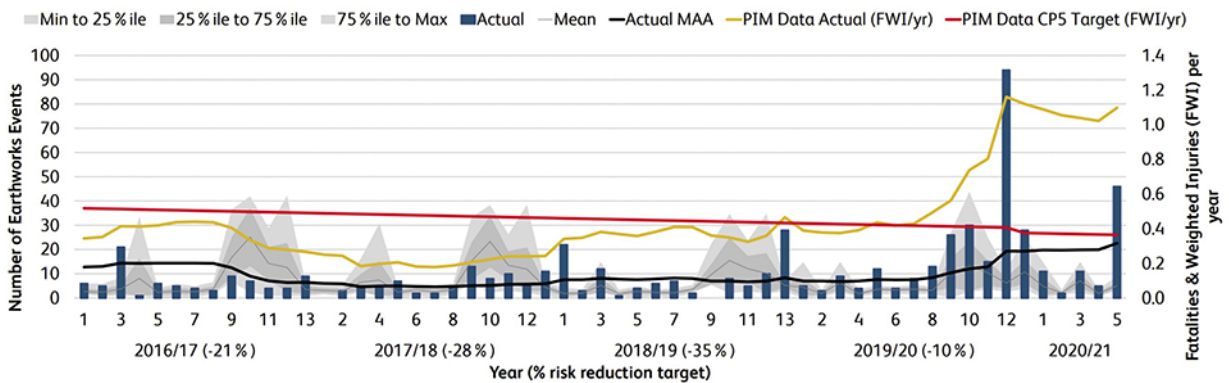
Figure 65: Earthworks PIM 2016/17 to 2020/21 (Extract from Network Rail’s Safety, Health and Environment Performance report for period 6 of 2021/22)

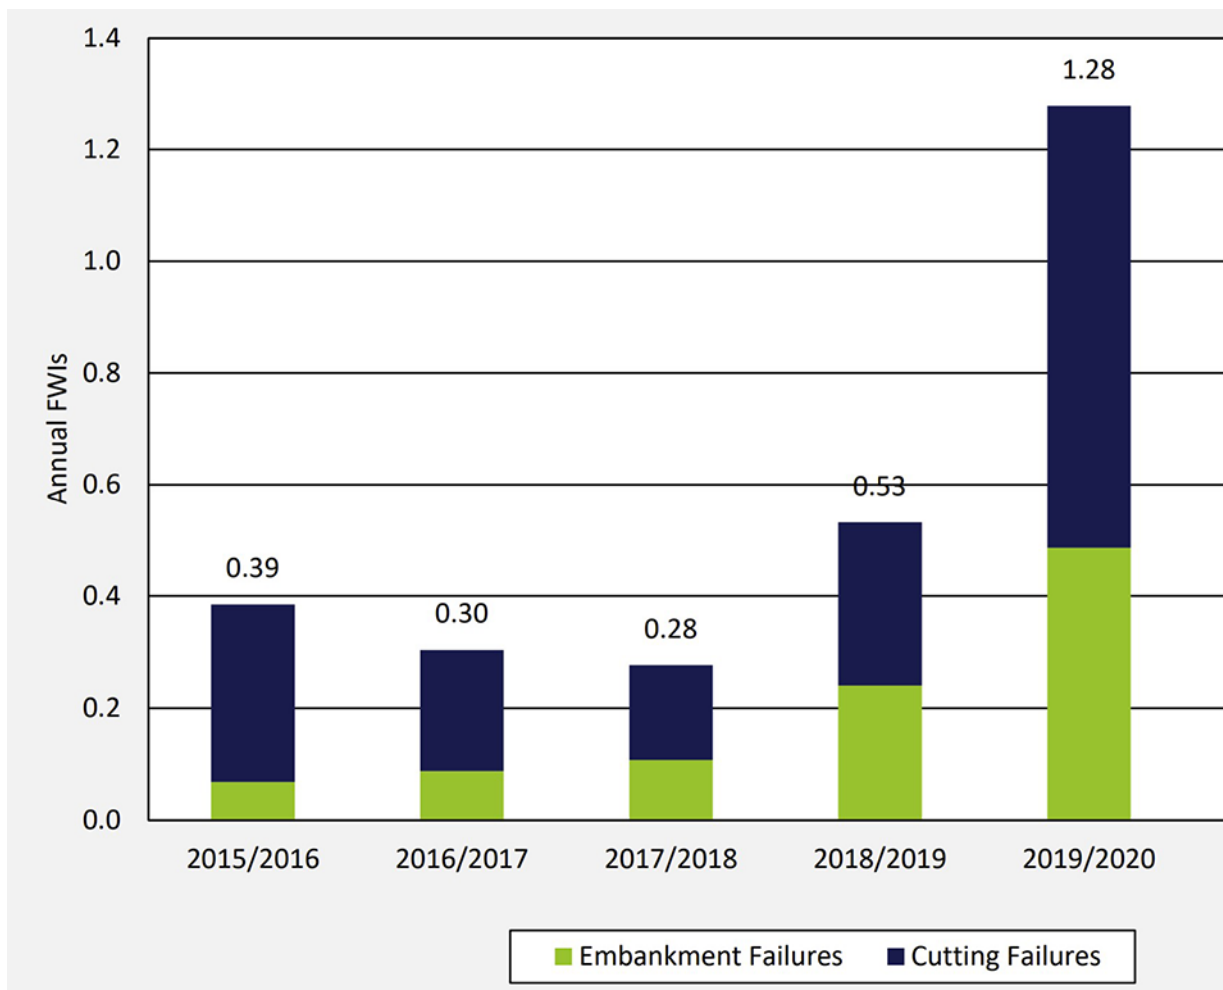
Figure 66: Train accident risk from earthwork failures 2016 to 2020 (RSSB)

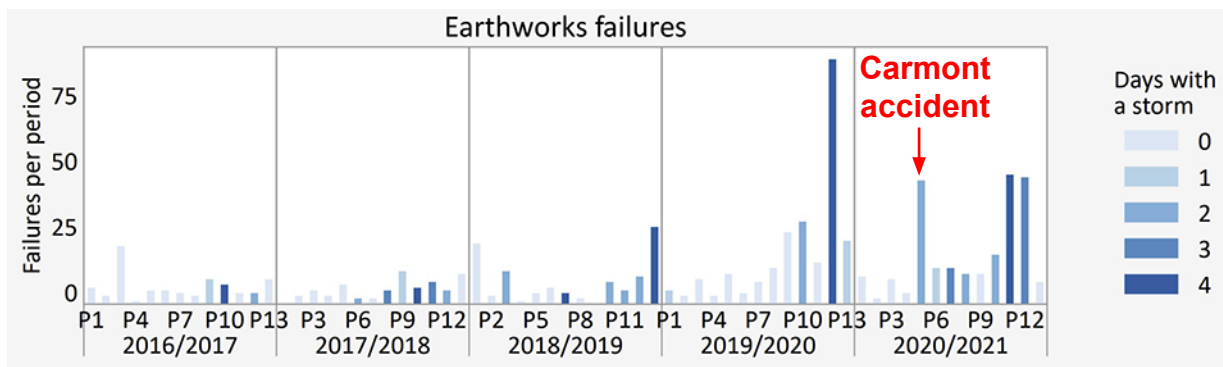
Figure 67: Earthwork failures and storm days plotted against time (RSSB)

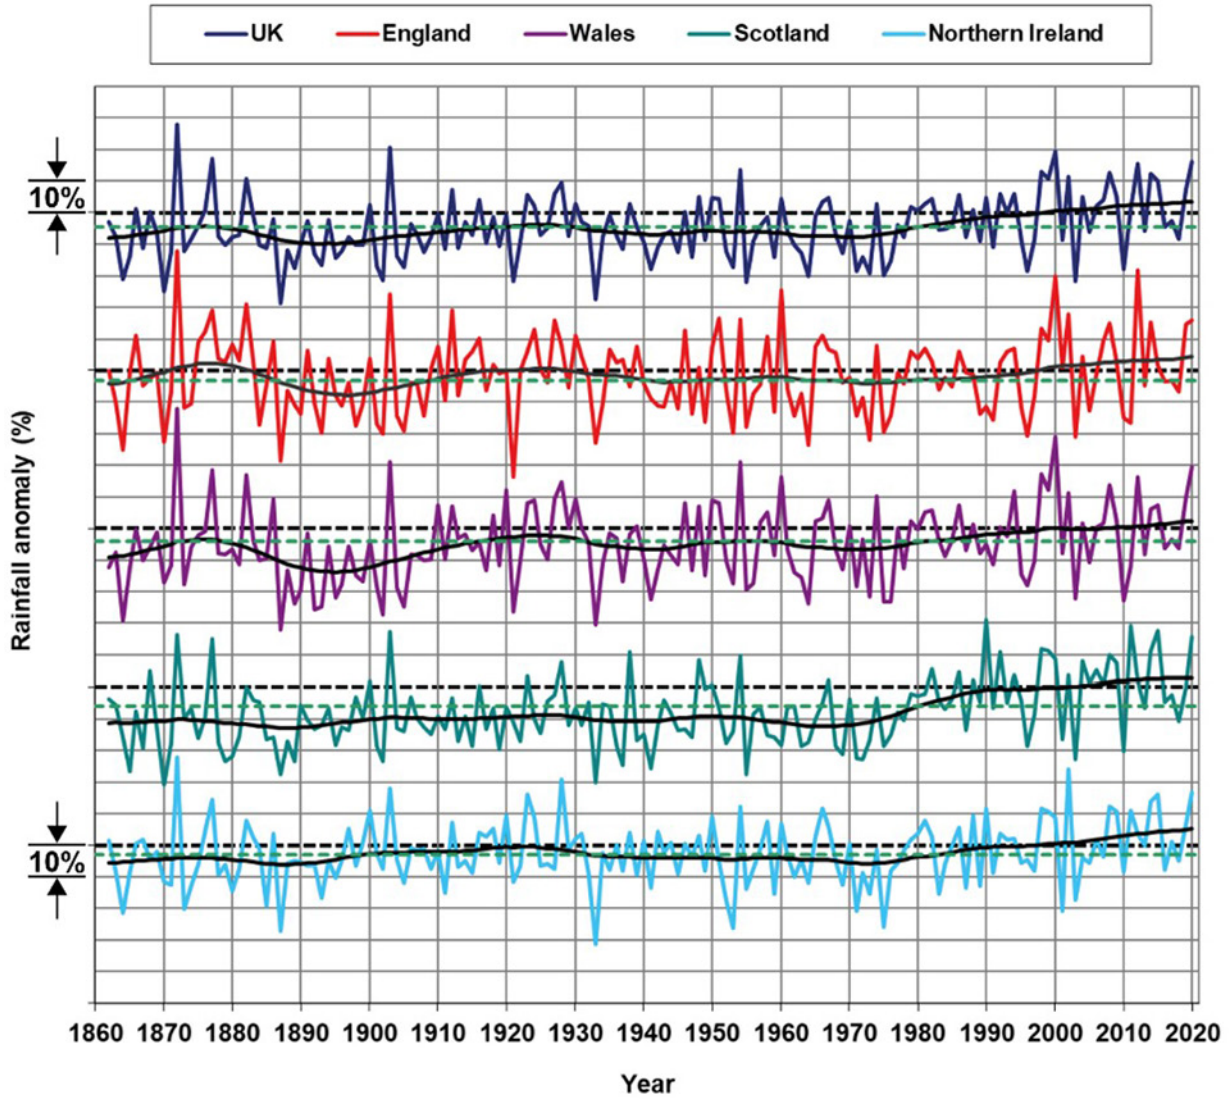
Area	1961–1990 average	1981–2010 average	2011–2020 average	2020
UK	1,099	1,150	1,197	1,336
England	827	853	891	989
Wales	1,405	1,463	1,496	1,747
Scotland	1,471	1,563	1,627	1,810
Northern Ireland	1,102	1,136	1,199	1,324

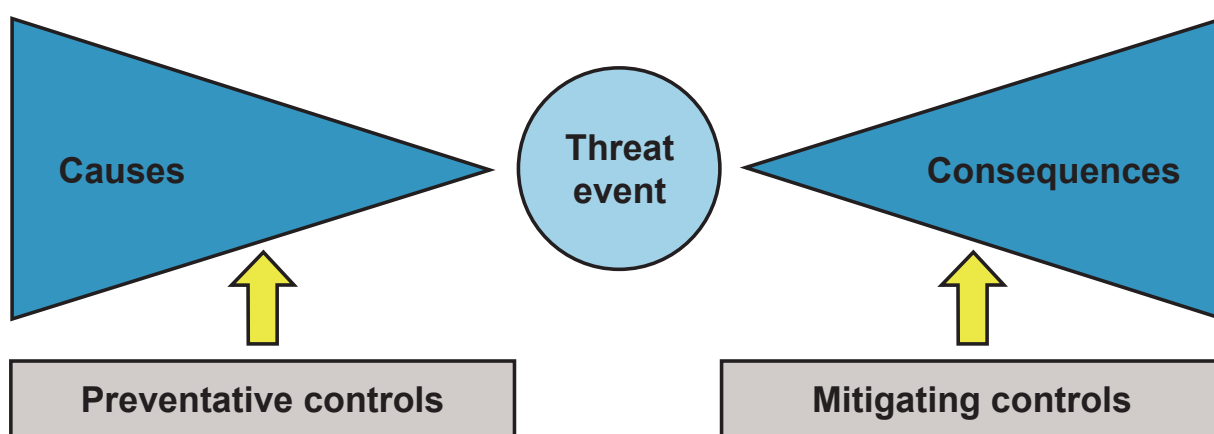
Figure 69: Bowtie methodology for assessing threats

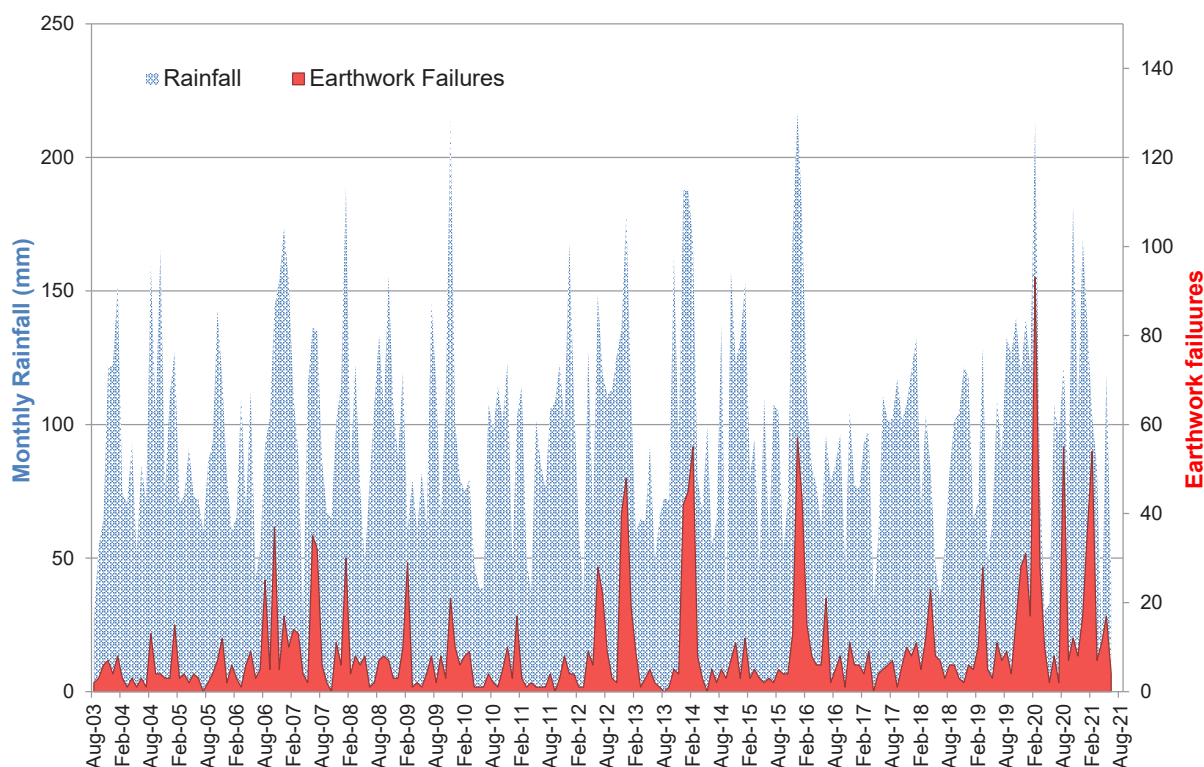
Figure 70: Timeline of earthworks failures and rainfall 2015 to 2020 (Network Rail NR/L3/CIV/185 failures and Met Office national average rainfall data (<https://www.metoffice.gov.uk/pub/data/weather/uk/climate/datasets/Rainfall/date/UK.txt>))

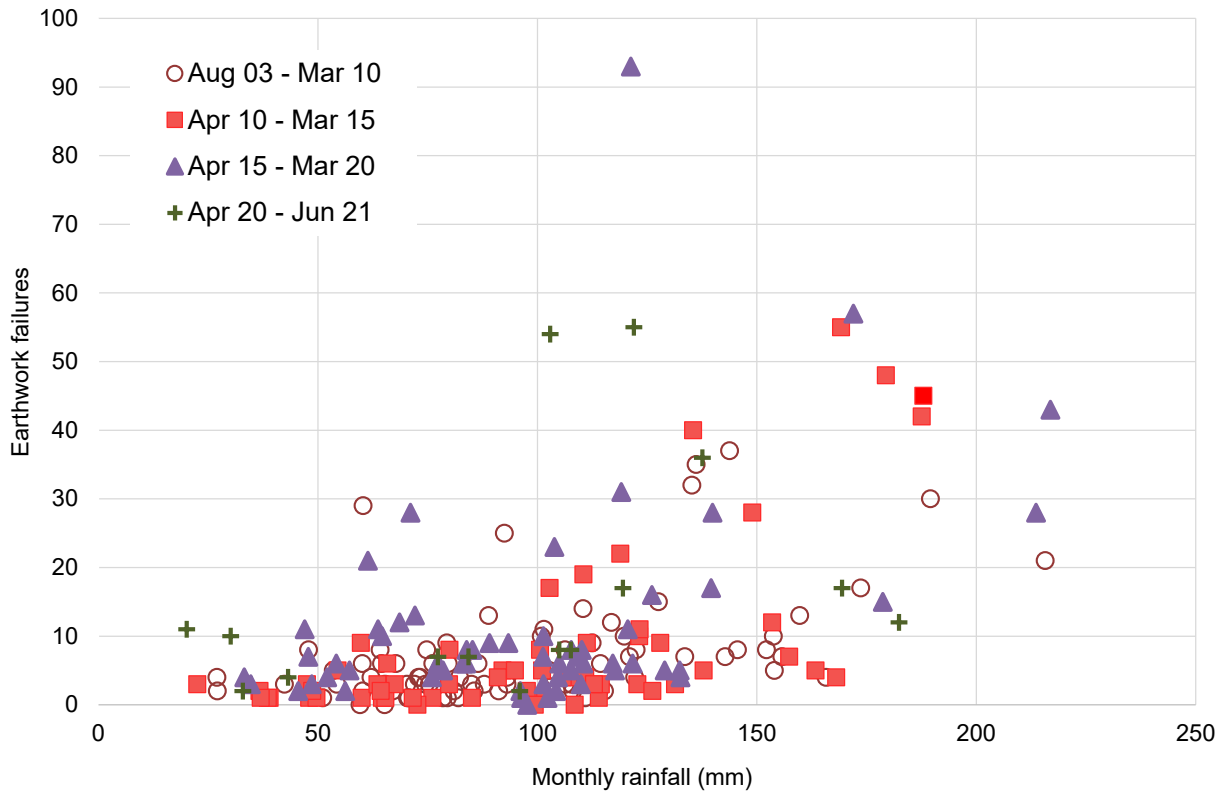
Figure 71: Relationship between earthwork failures and rainfall, 2015 to 2020 (data sources as figure 70)

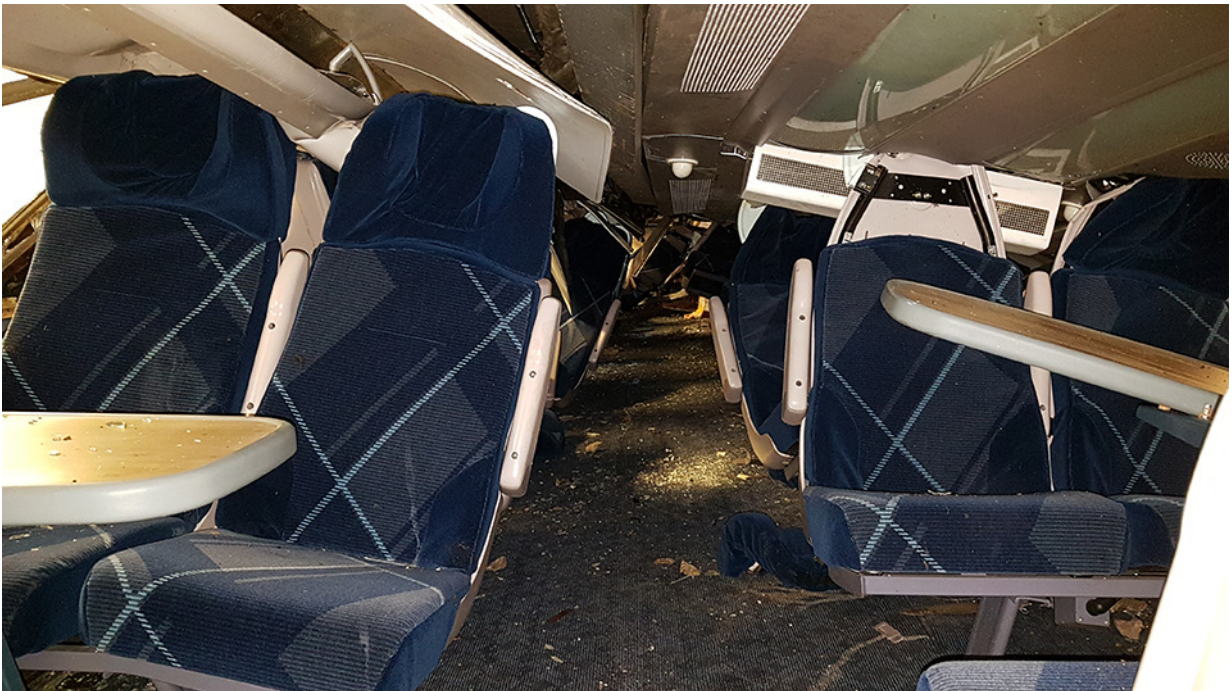
Figure 75: Interior damage at leading end of coach D

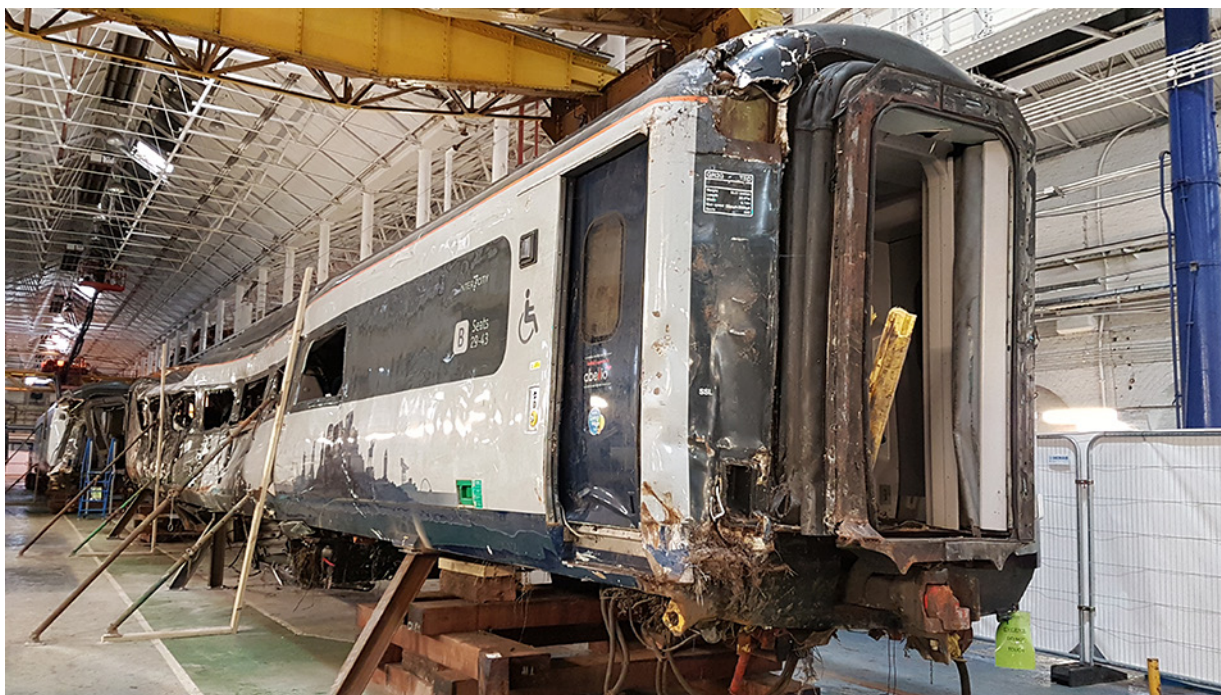
Figure 78: Damage to leading end and right side of coach B

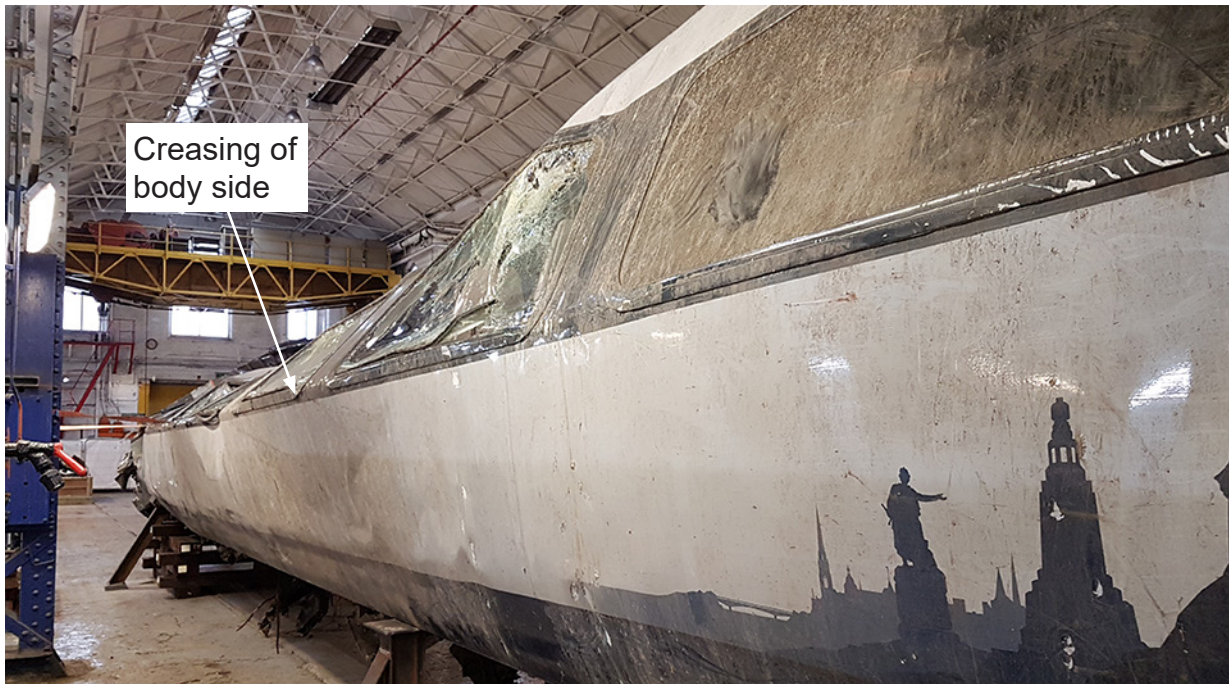
Figure 81: Creasing along left-hand bodyside of coach D

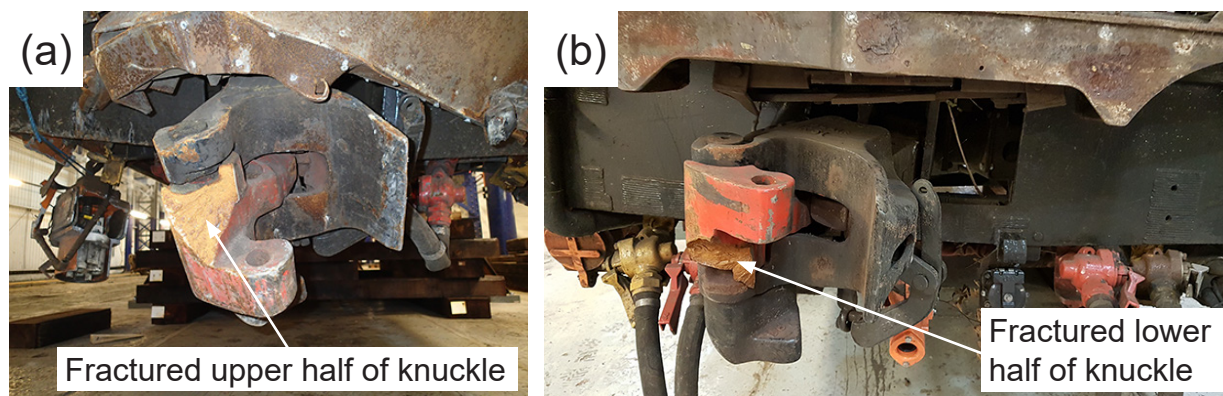
Figure 83: Fractured knuckles on the couplers of coach D leading end (a) and trailing end (b)

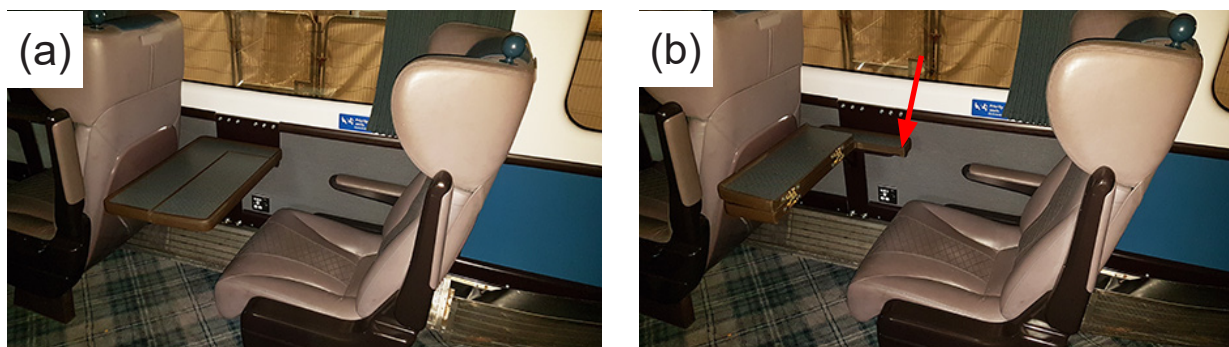
Figure 84: First class folding table from coach A in flat position (a) and folded position (b). Sharp corner indicated by red arrow. The same table design is also used at two positions in coach B

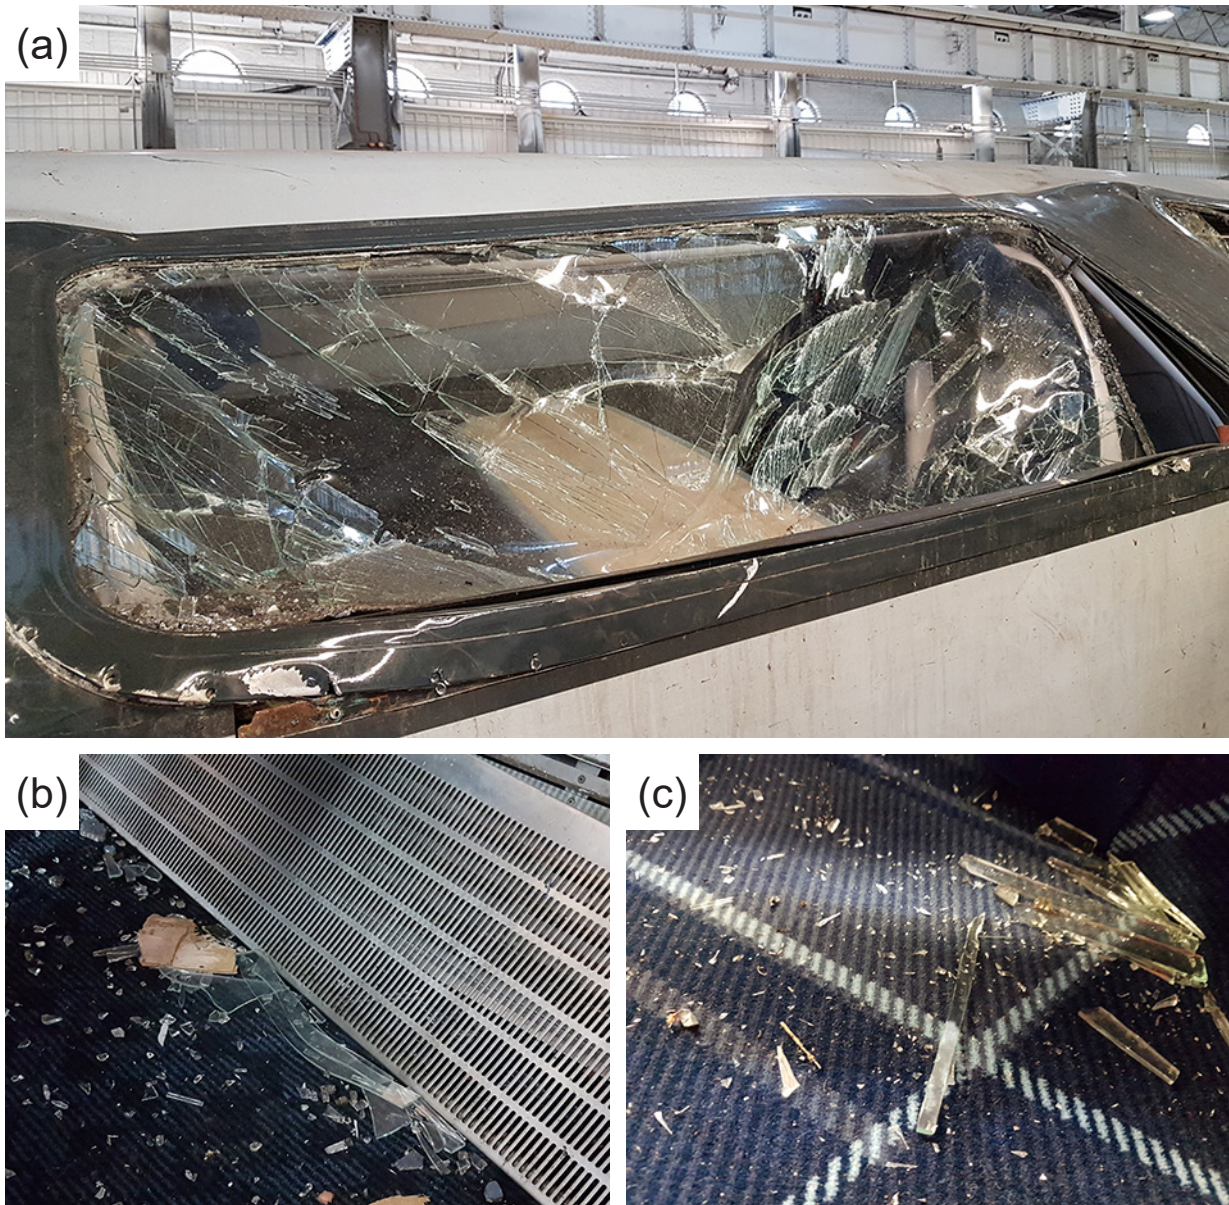
Figure 85: A broken window on coach D with remnants of inner laminated pane (a), ingress of large shards on the floor (b) and on a seat (c)

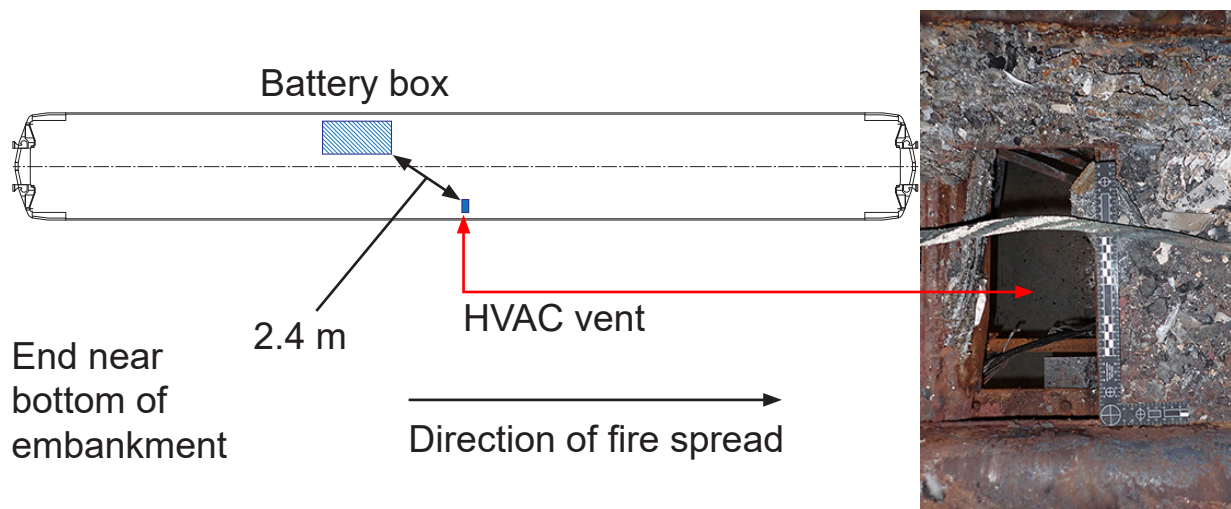
Figure 90: Opening for ventilation system in coach B floor

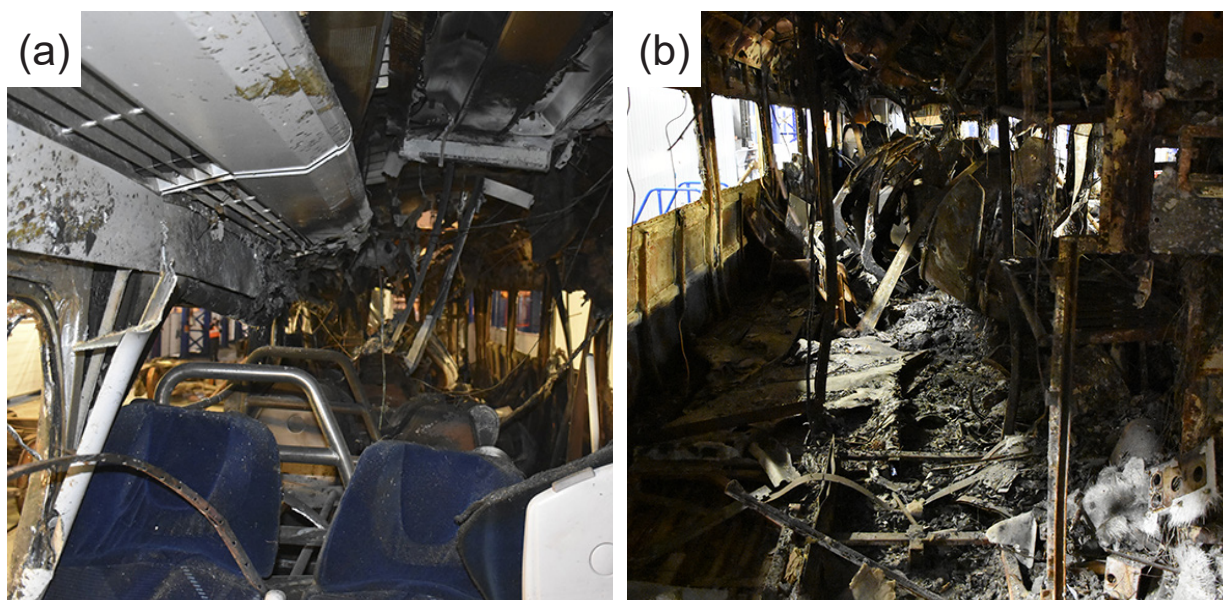
Figure 92: Coach B interior without fire damage at leading end (a) and fire damaged at trailing end (b)

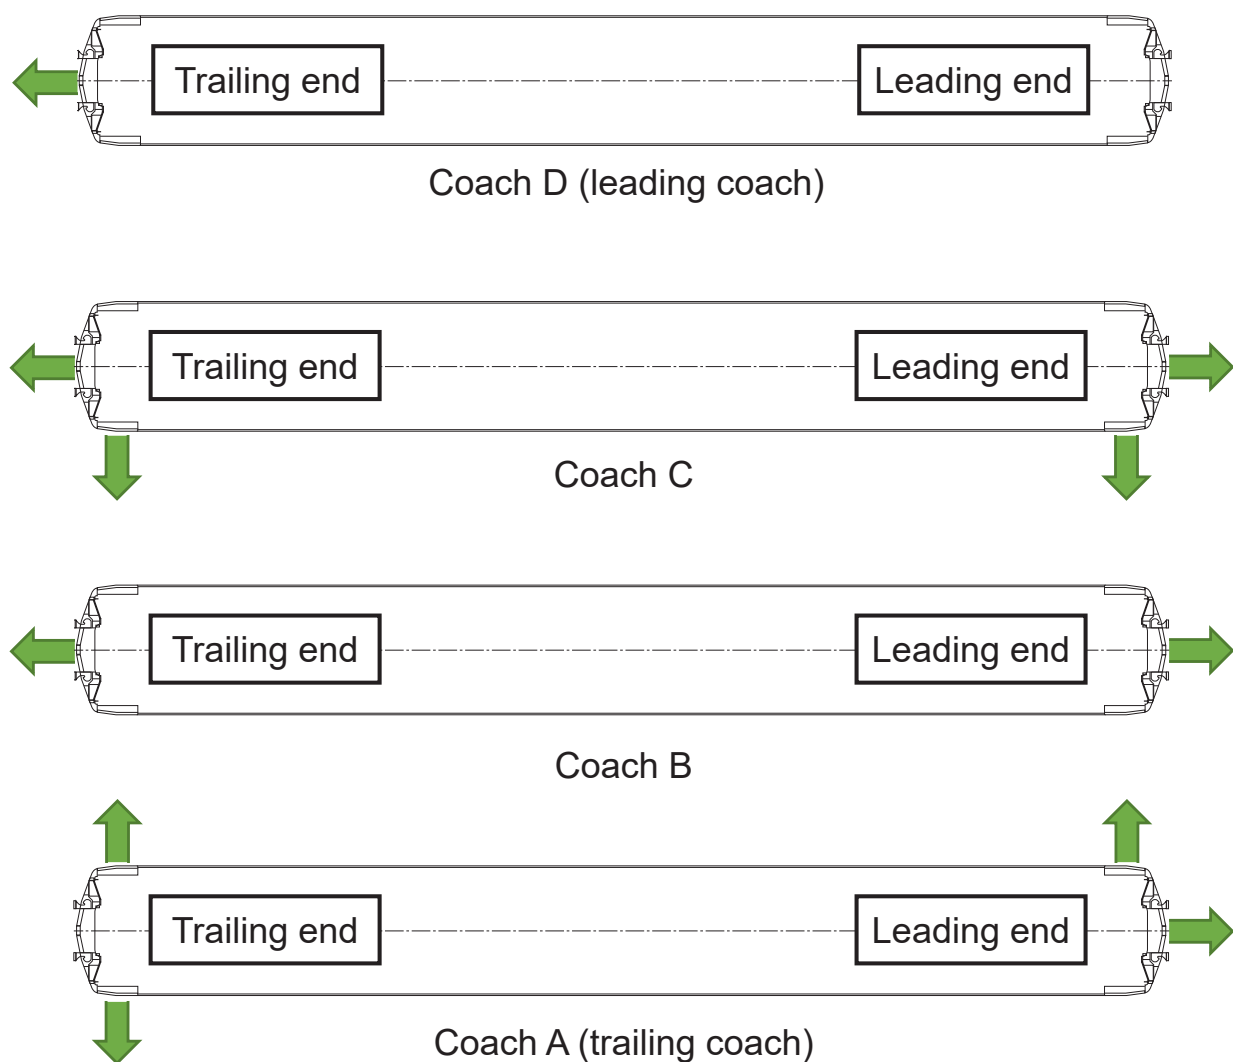
Figure 93: Egress routes available to survivors from each vehicle

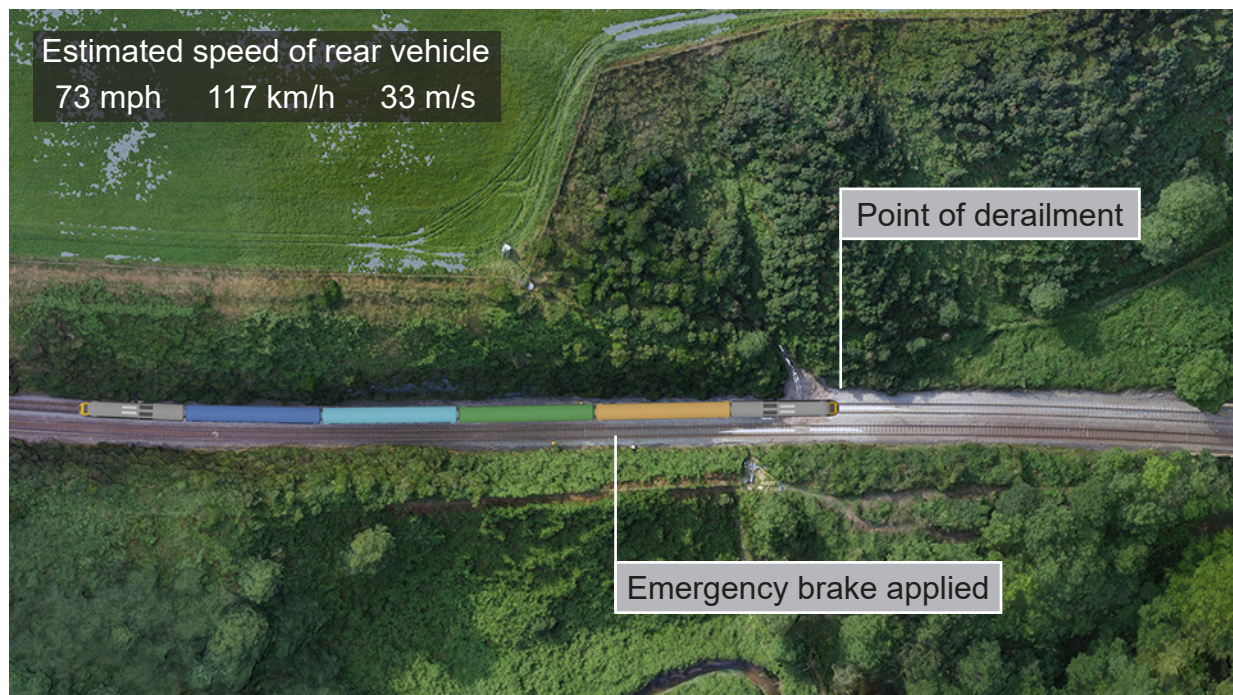
Figure E.1 (T= 0 seconds):

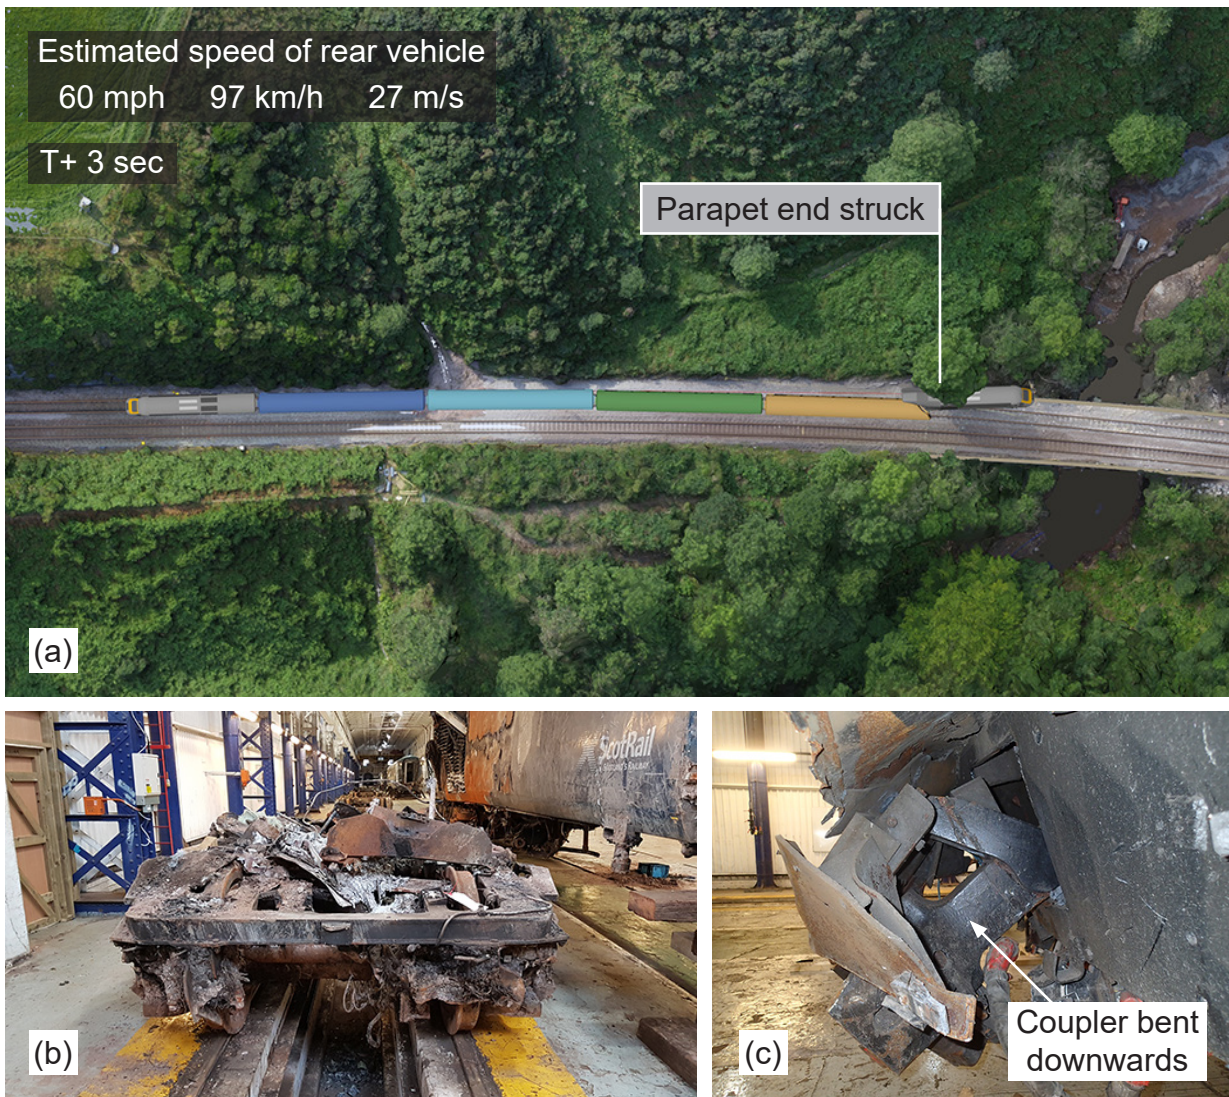
Figure E.4 (T+3 seconds):
