Rail Accident Investigation Branch

Rail Accident Report

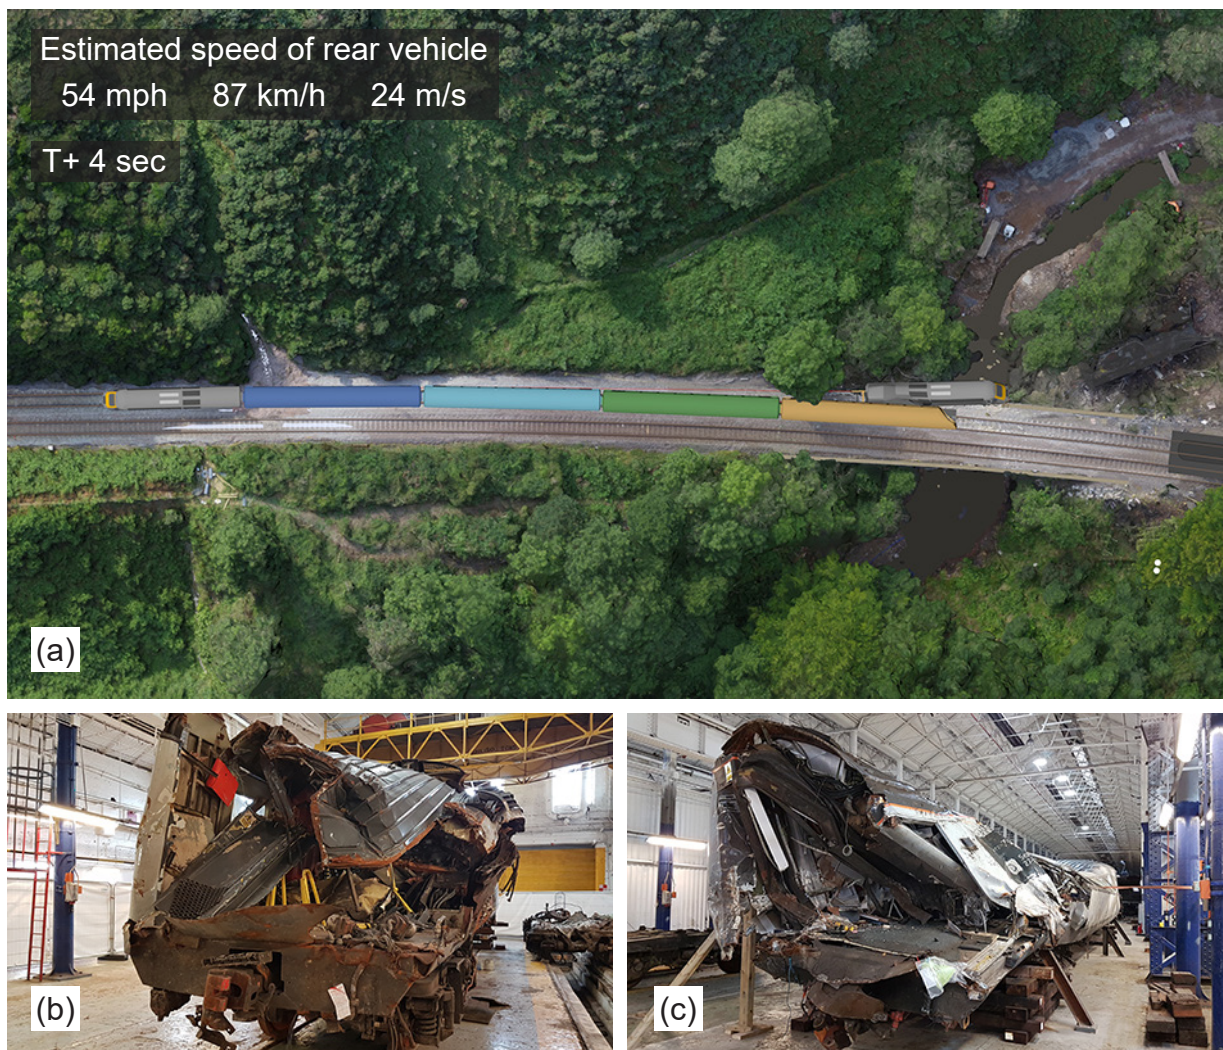
Figure E.5 (T+4 seconds):

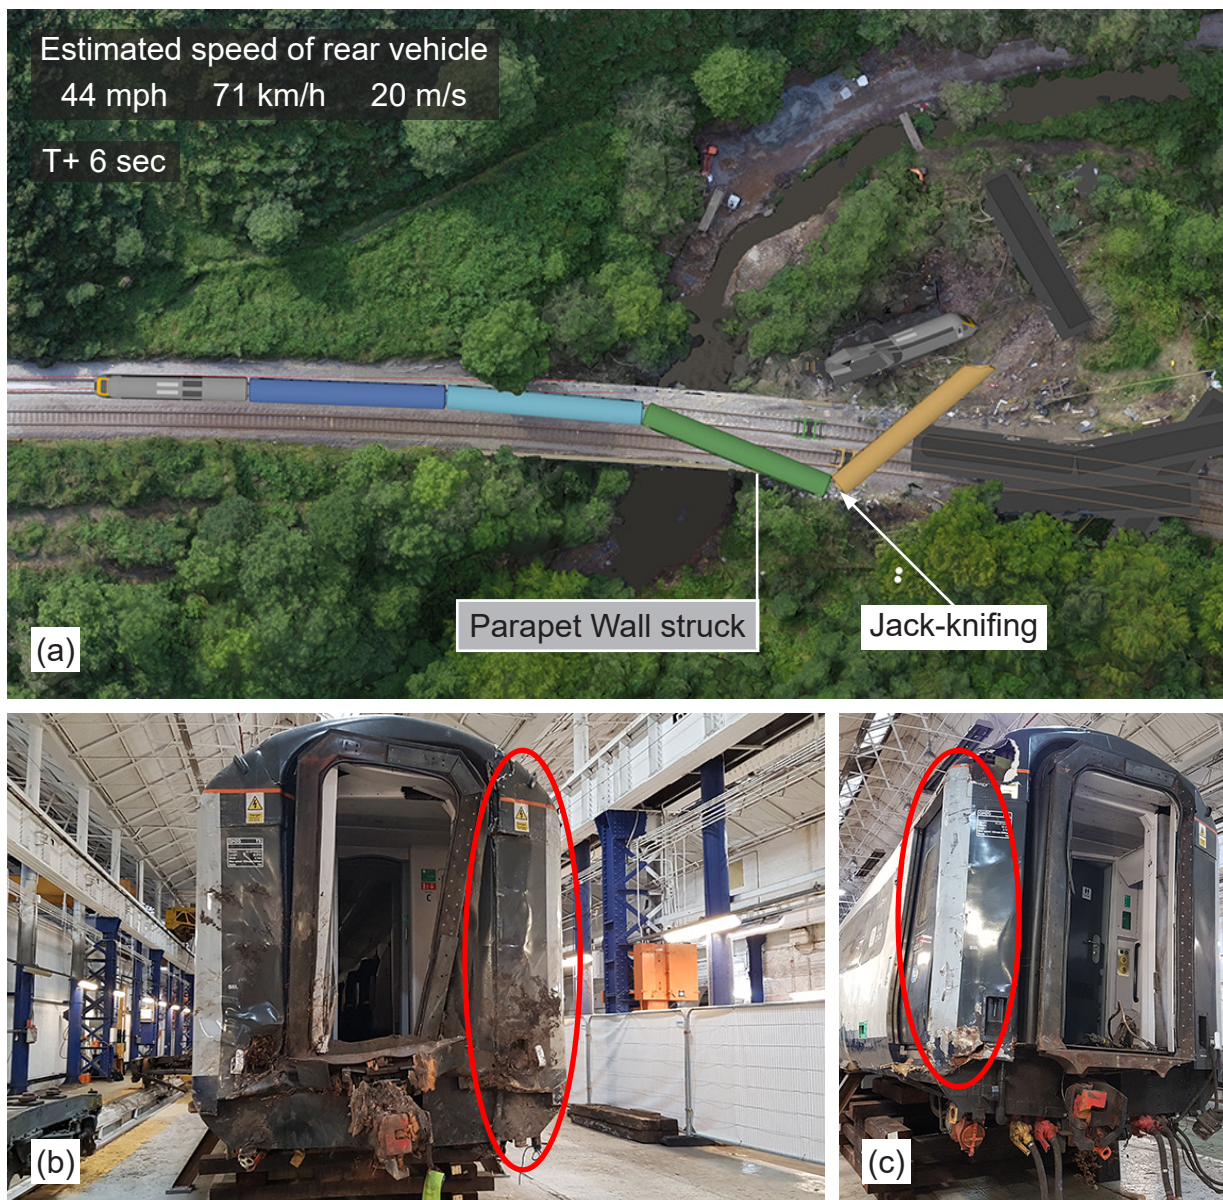
Figure E.7 (T+6 seconds):

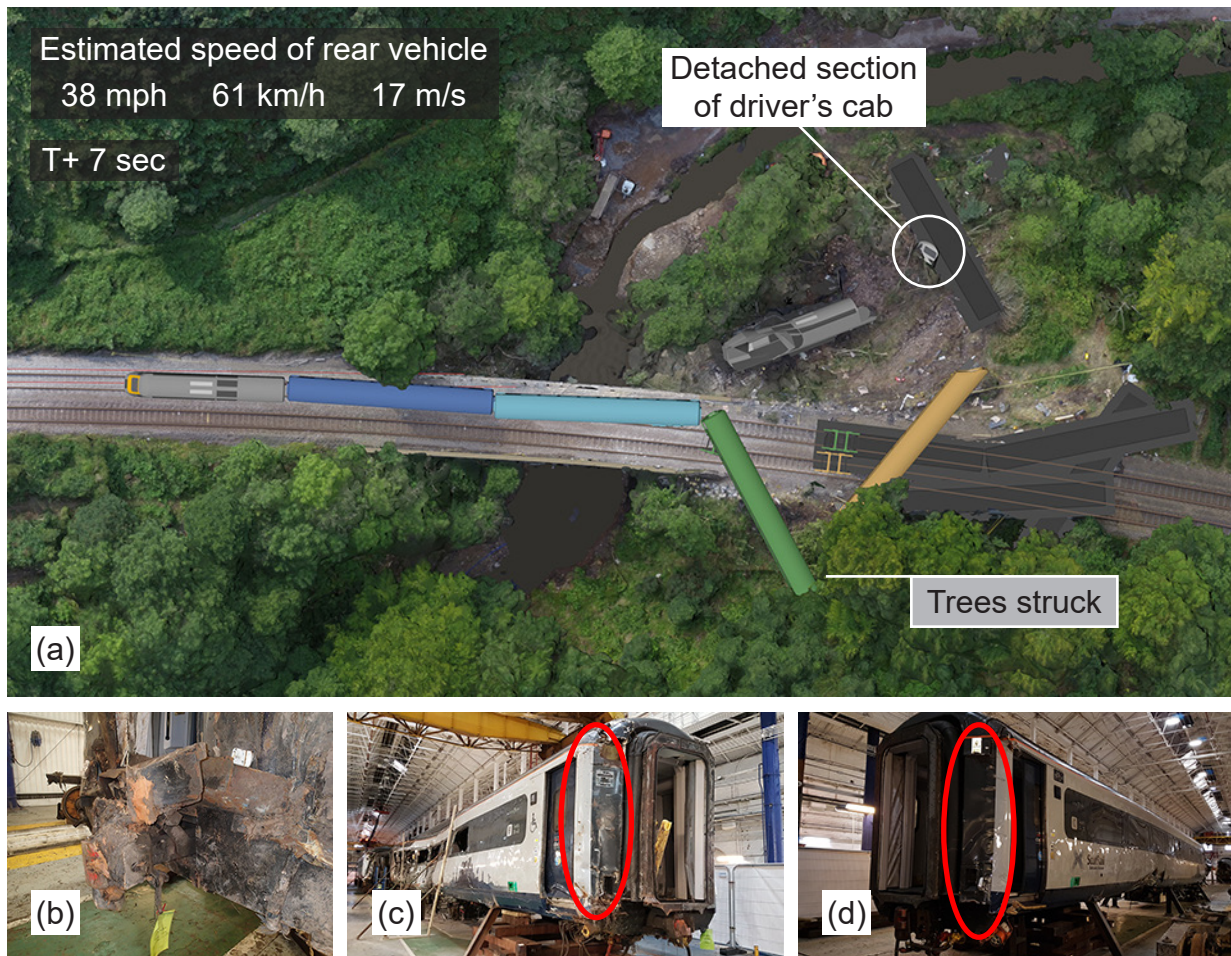
Figure E.8 (T+7 seconds):

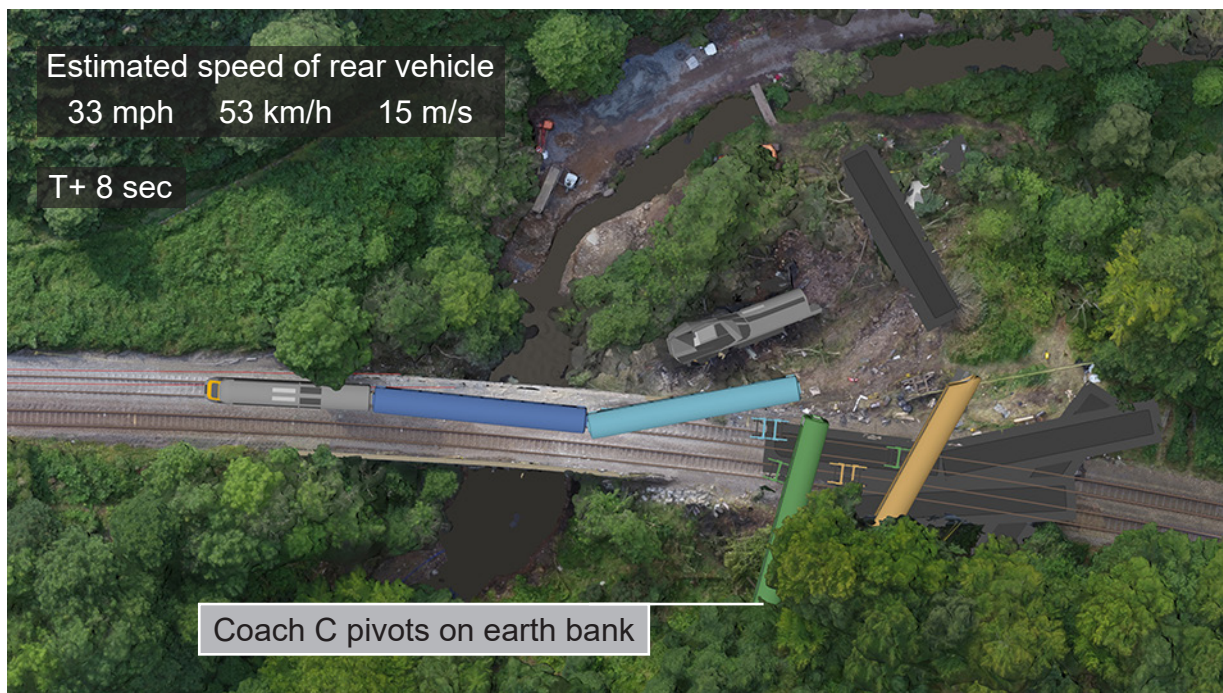
Figure E.9 (T+8 seconds):

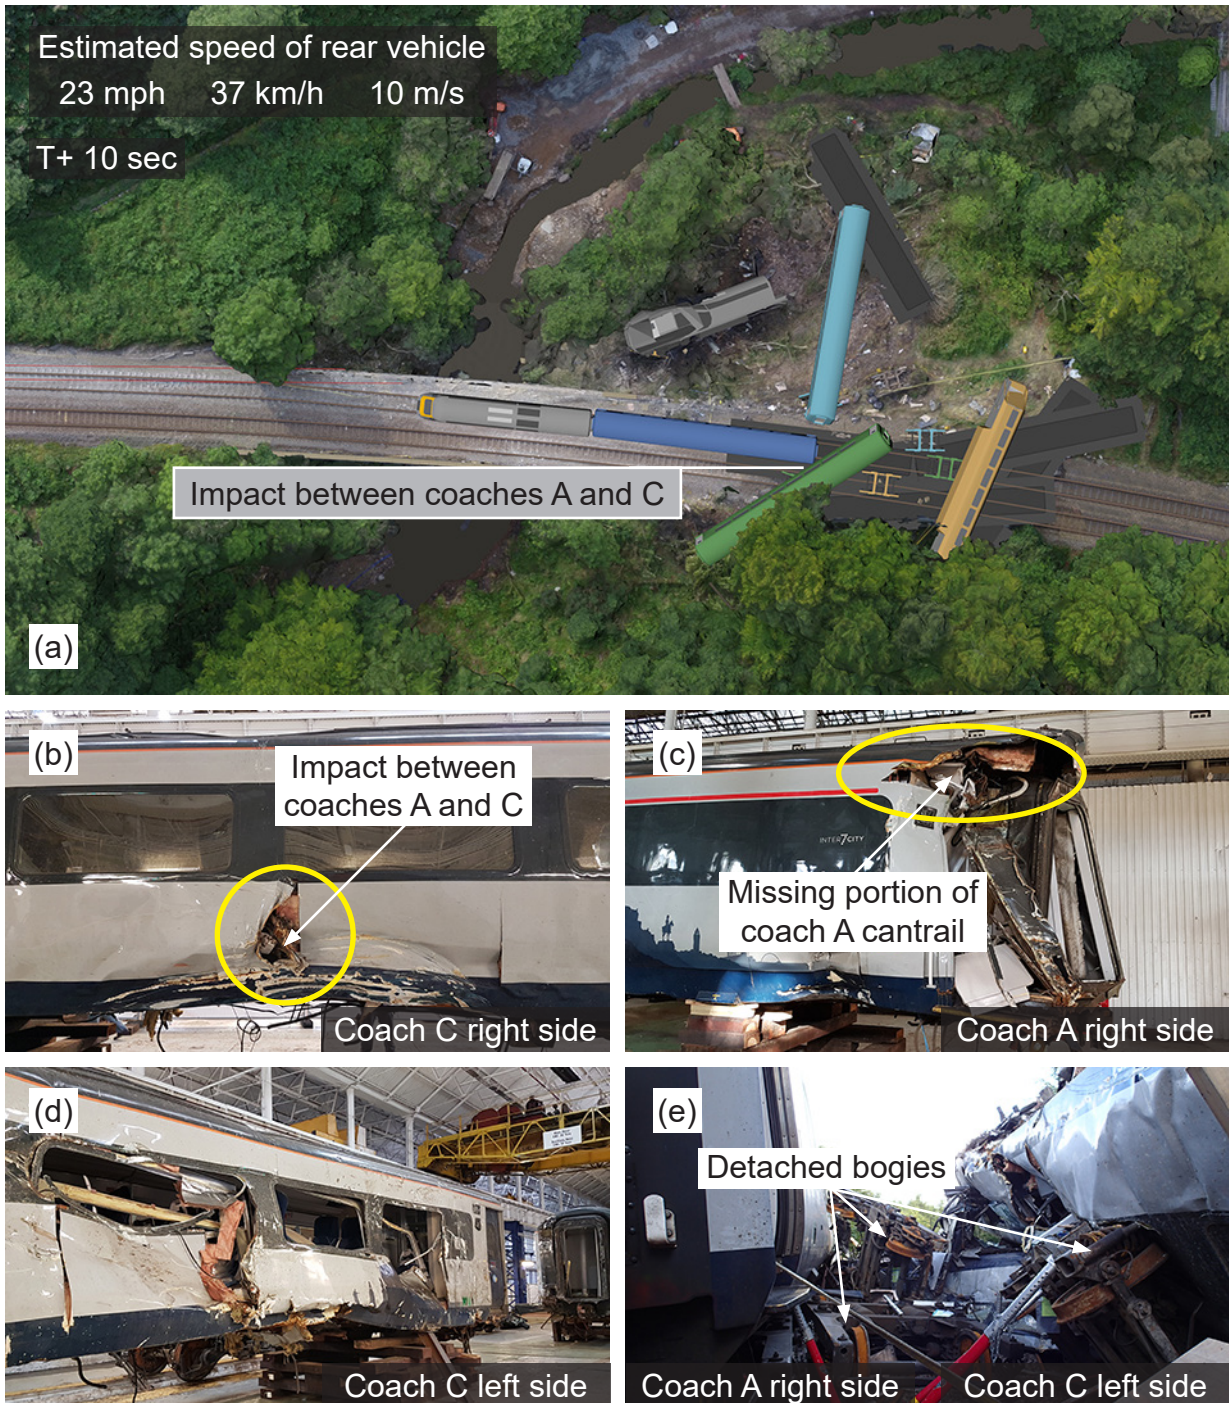
Figure E.11 (T+10 seconds):

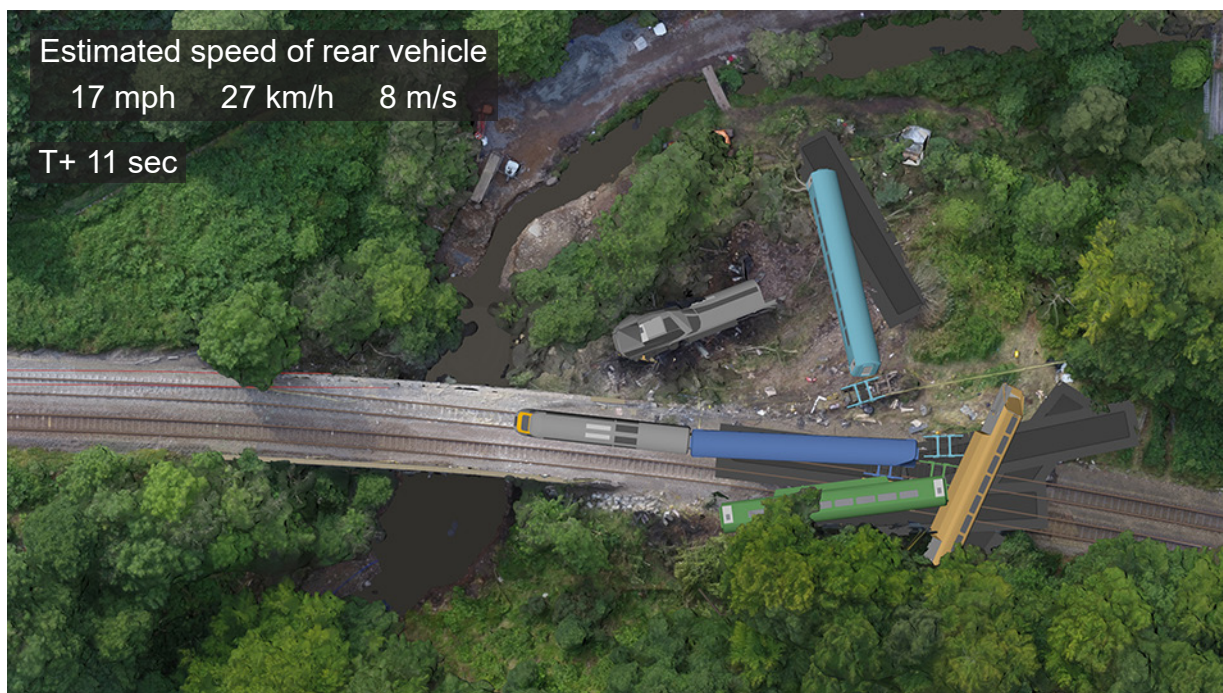
Figure E.12 (T+11 seconds):

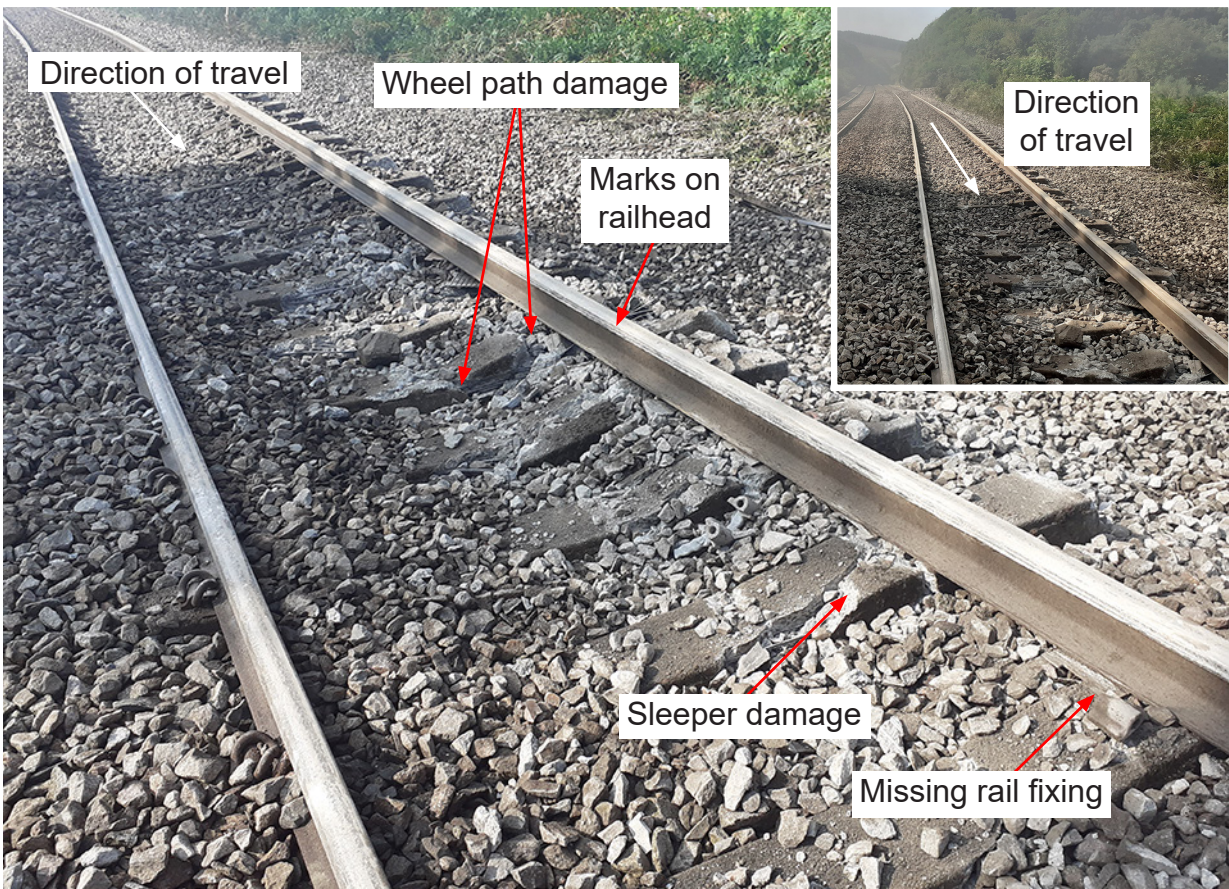
Figure F.1: Track damage looking south from sleeper 80 back towards washout location at 10:35 hrs on 12 August 2020 (Story Contracting)

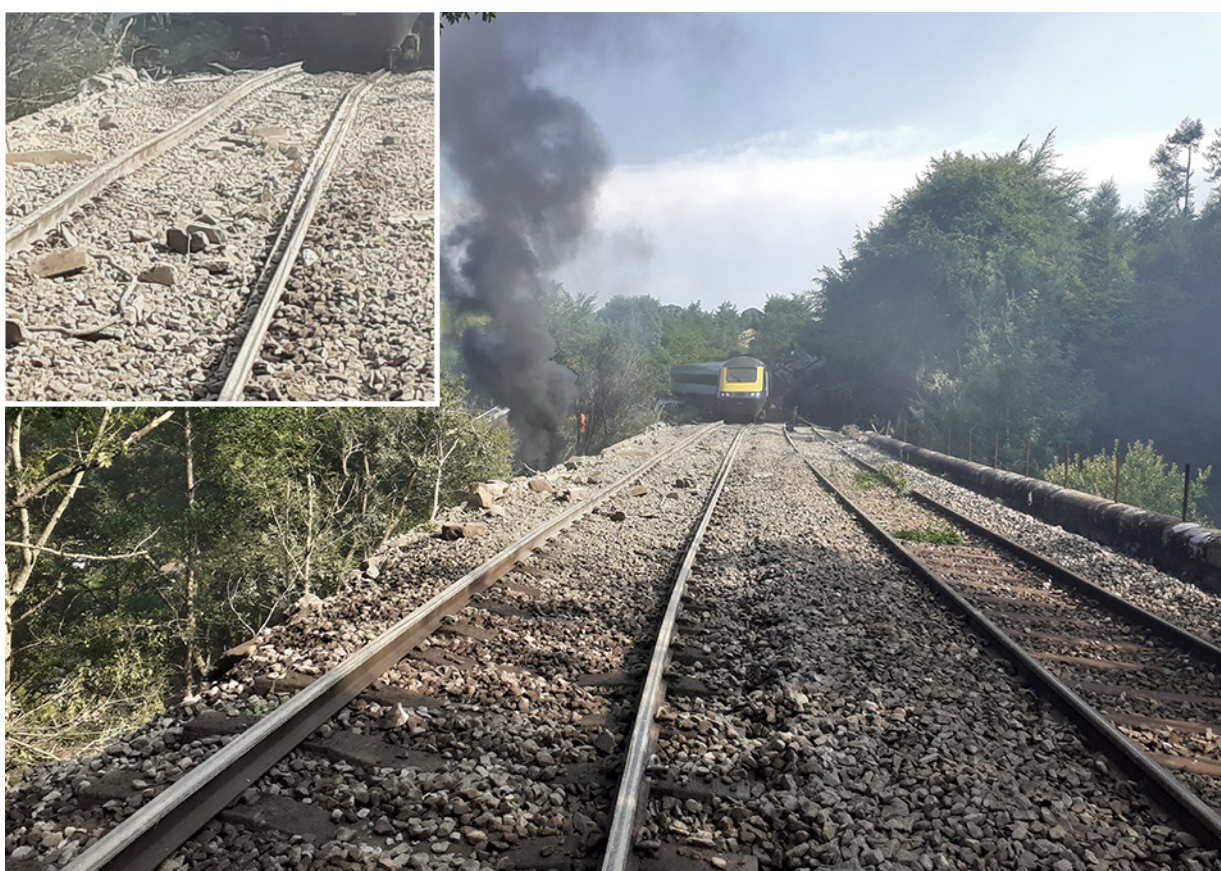
Figure F.2: Track damage across bridge 325 at 10:35 hrs on 12 August 2020 (Story Contracting)

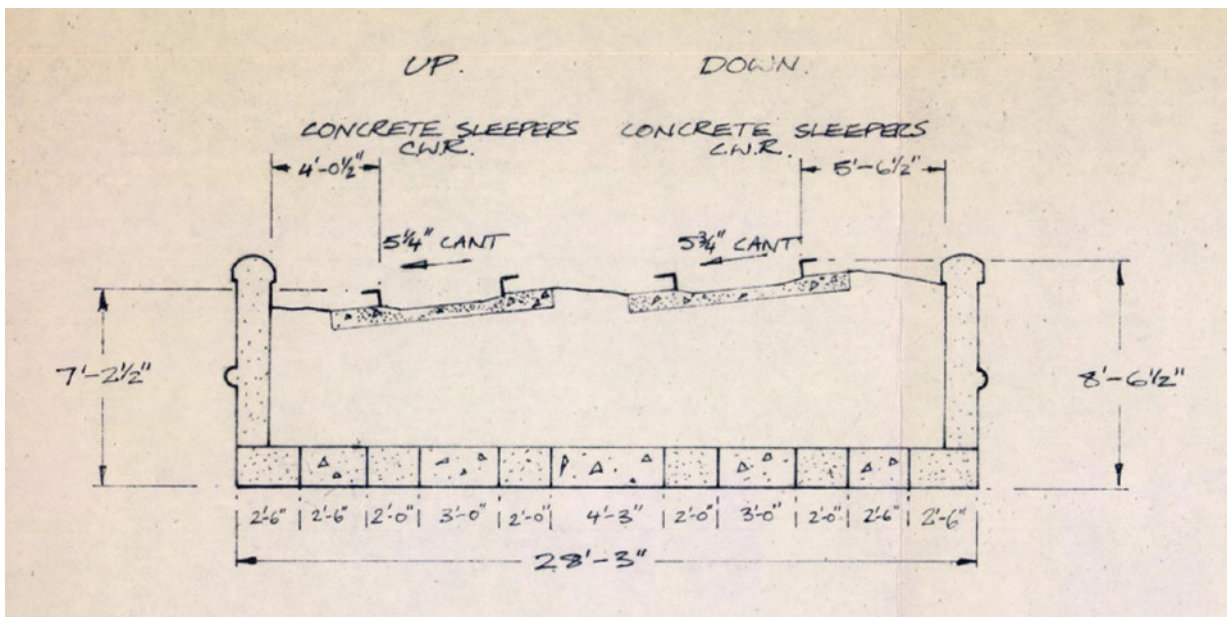
Figure F.3: Drawing showing level of the tracks relative to the parapets (British Rail)

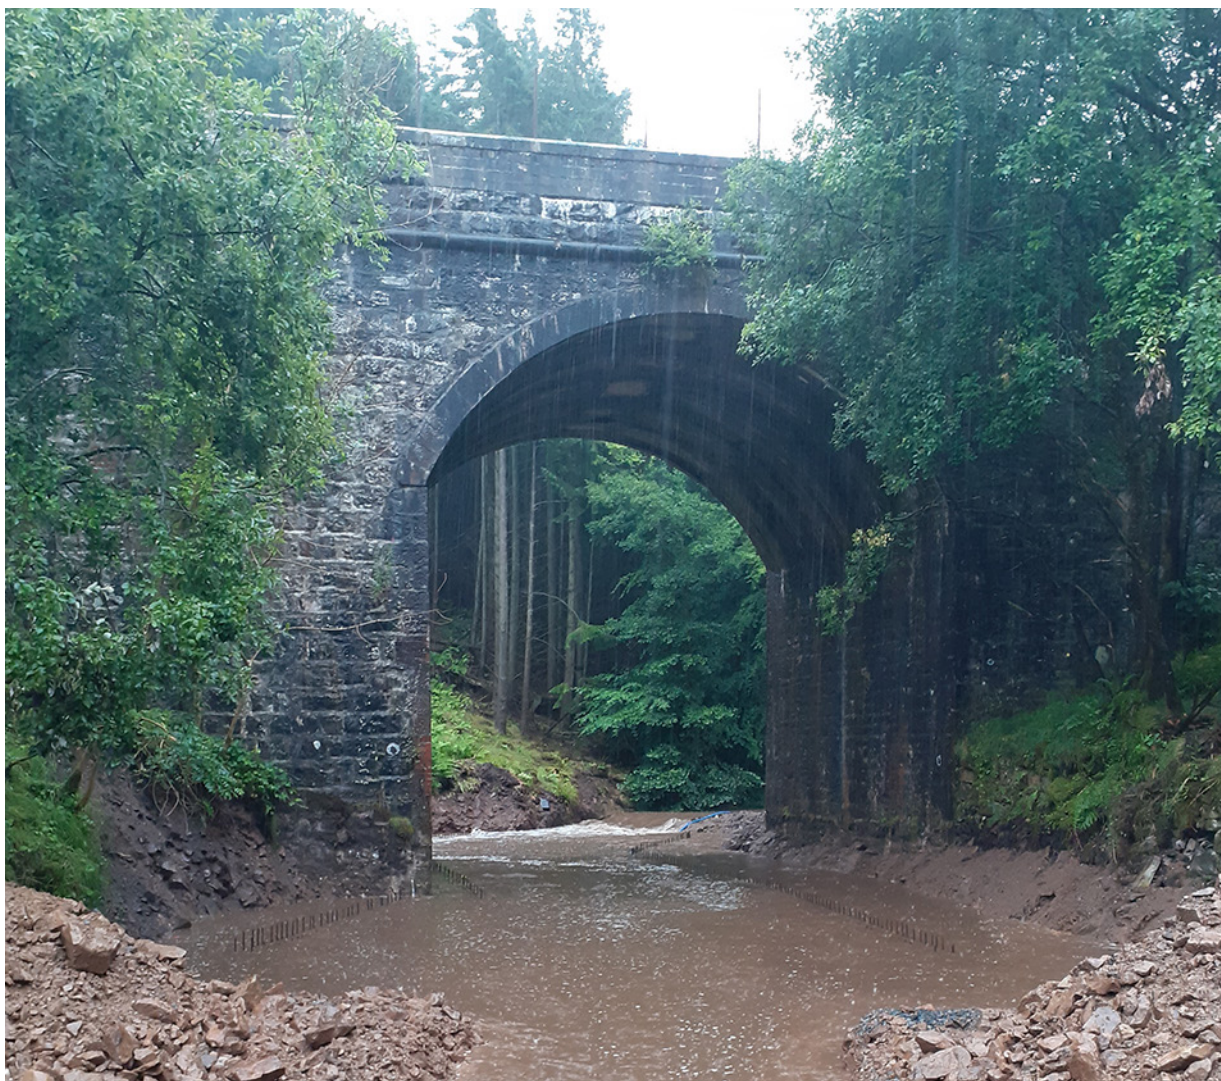
Figure F.4: Down-side elevation of bridge 325 at 08:19 hrs on 12 August 2020, shortly before the accident (Story Contracting)

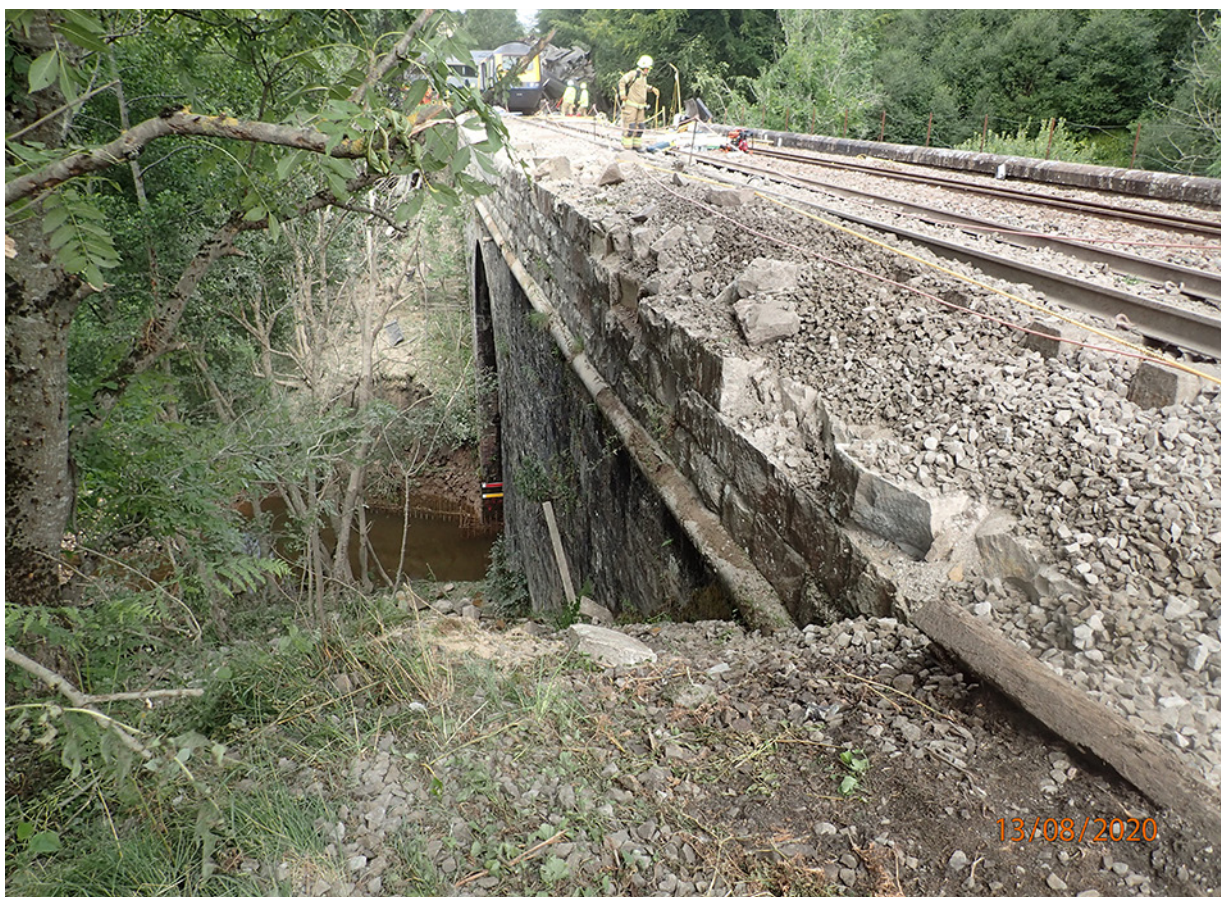
Figure F.5: Down-side parapet looking north showing damage to the parapet end

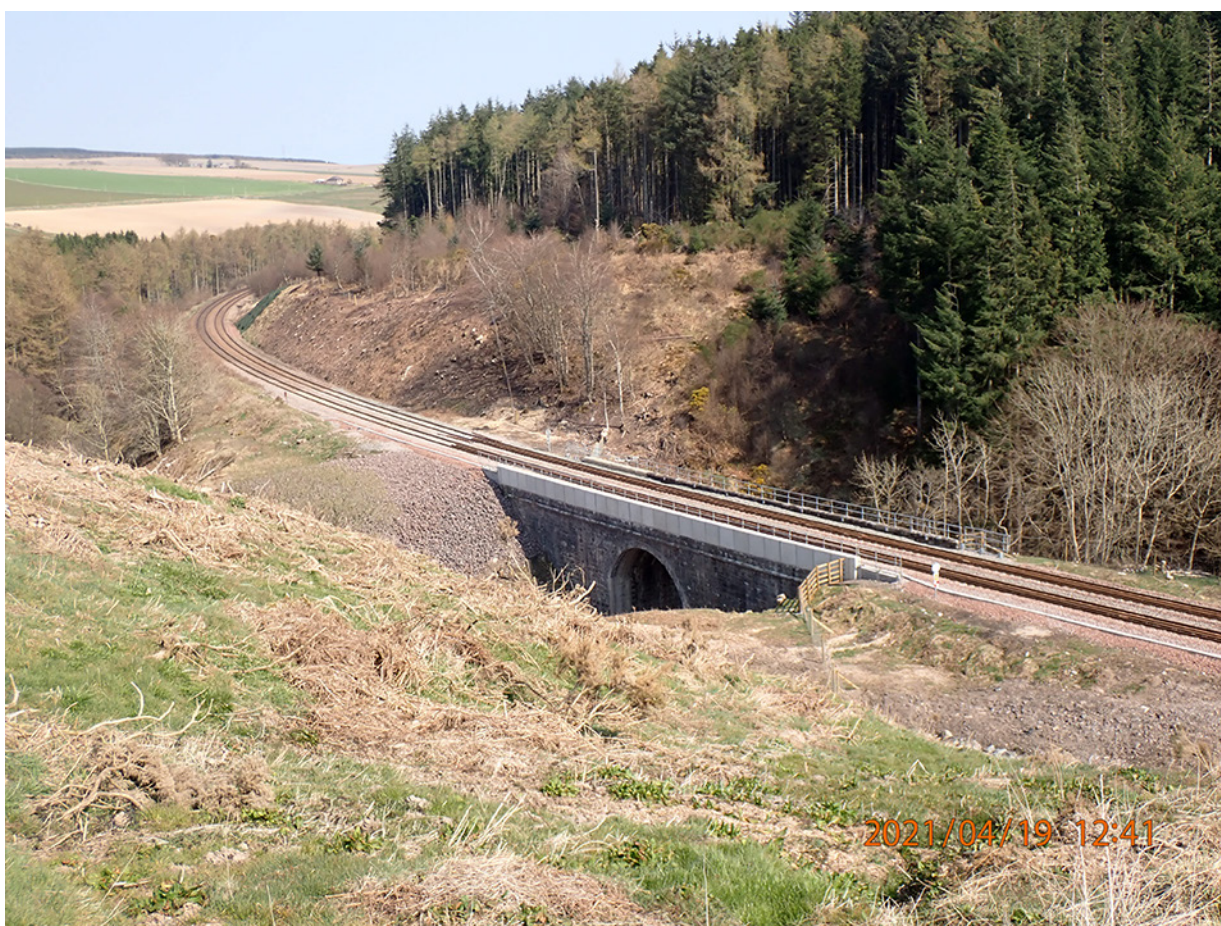
Figure F.9: Bridge 325 in April 2021 following the replacement of the down-side parapet and track

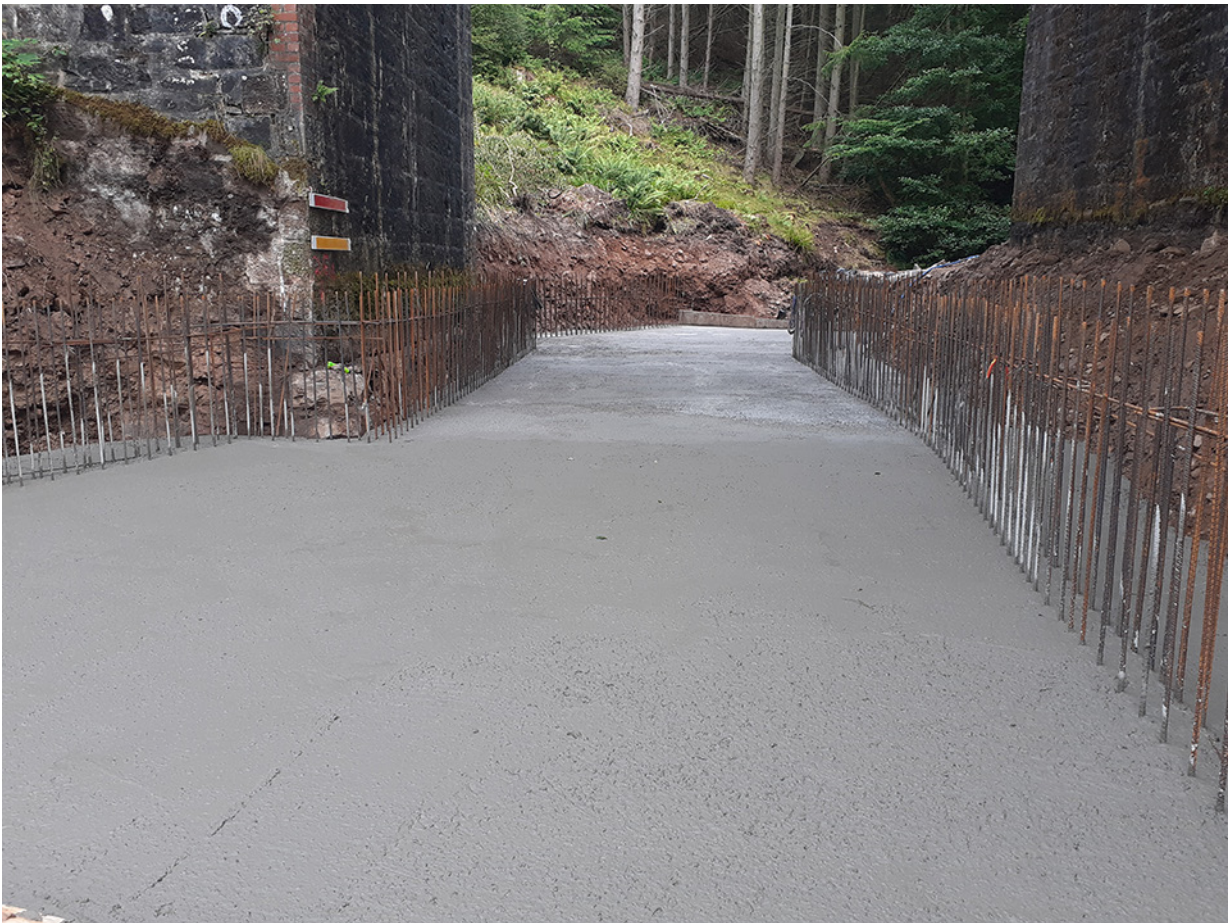
Figure F.10: Scour protection works at bridge 325 on 11 August 2020 (Story Contracting)

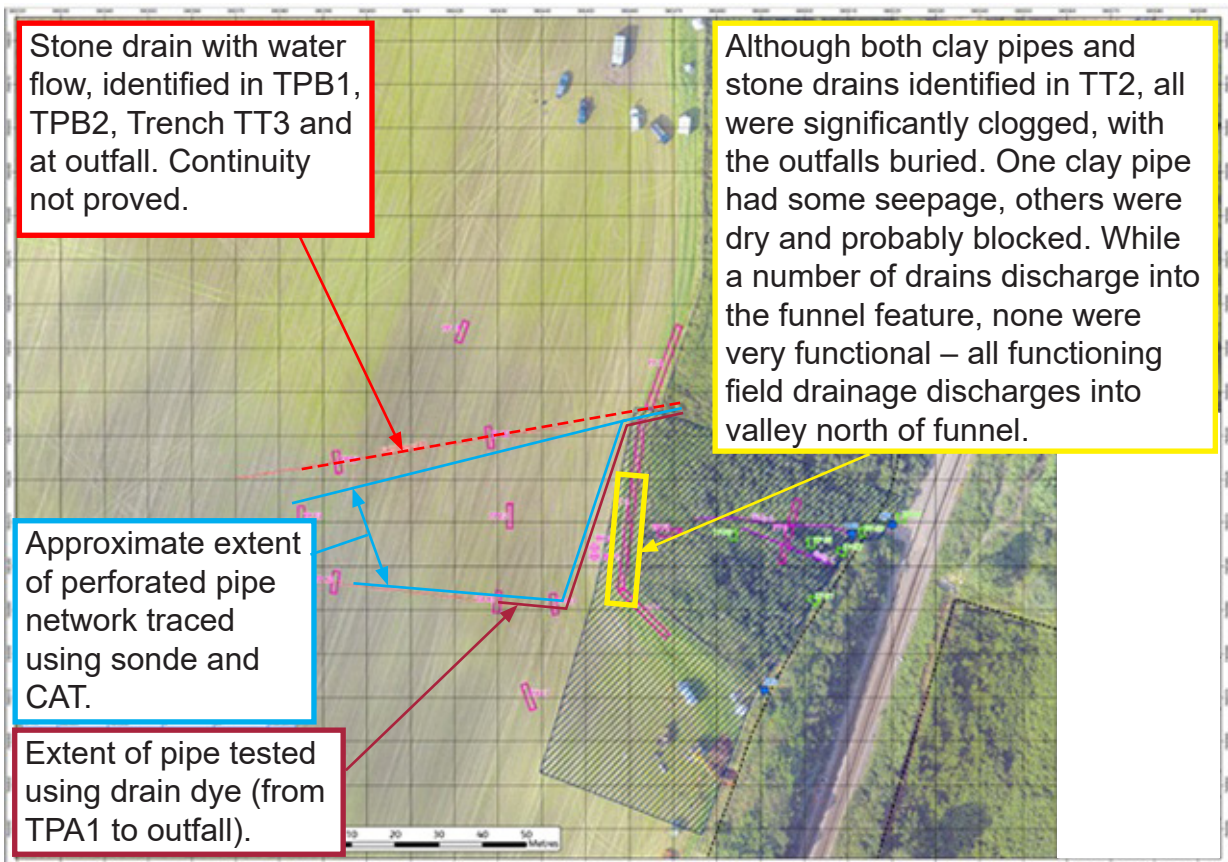
Figure G.5: Field drain survey findings (edited version of Network Rail drawing)

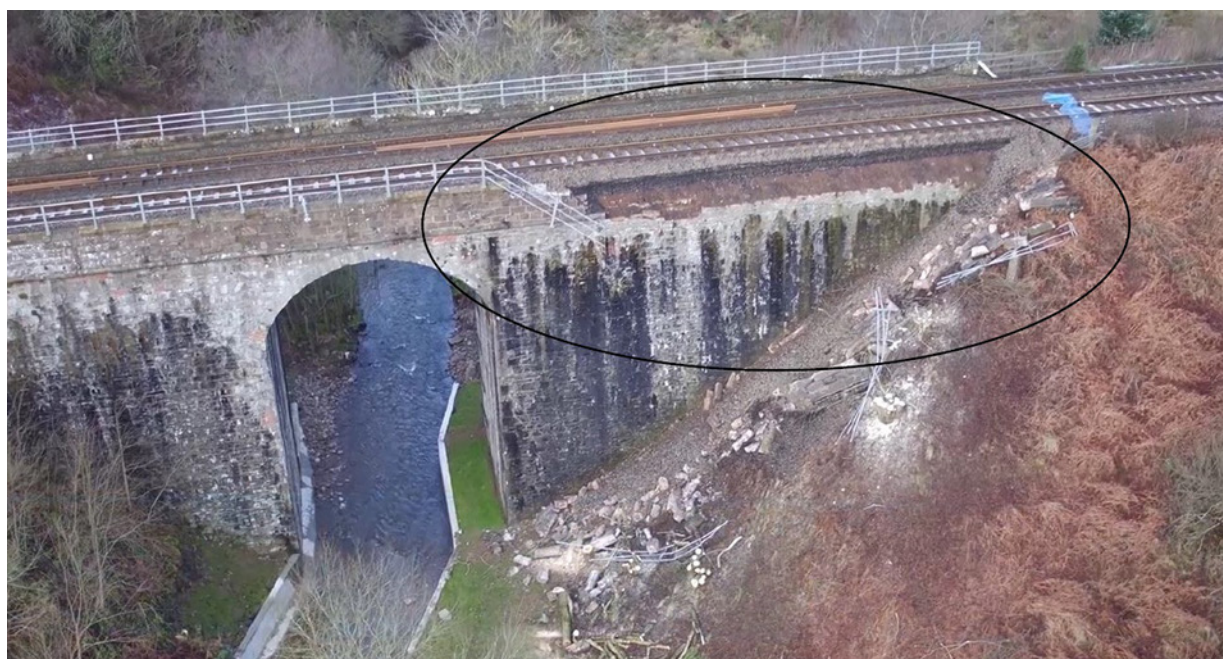
Figure M.1: South-east corner of bridge 328 following the failure of part of its parapet wall on 15 January 2021 (Network Rail)

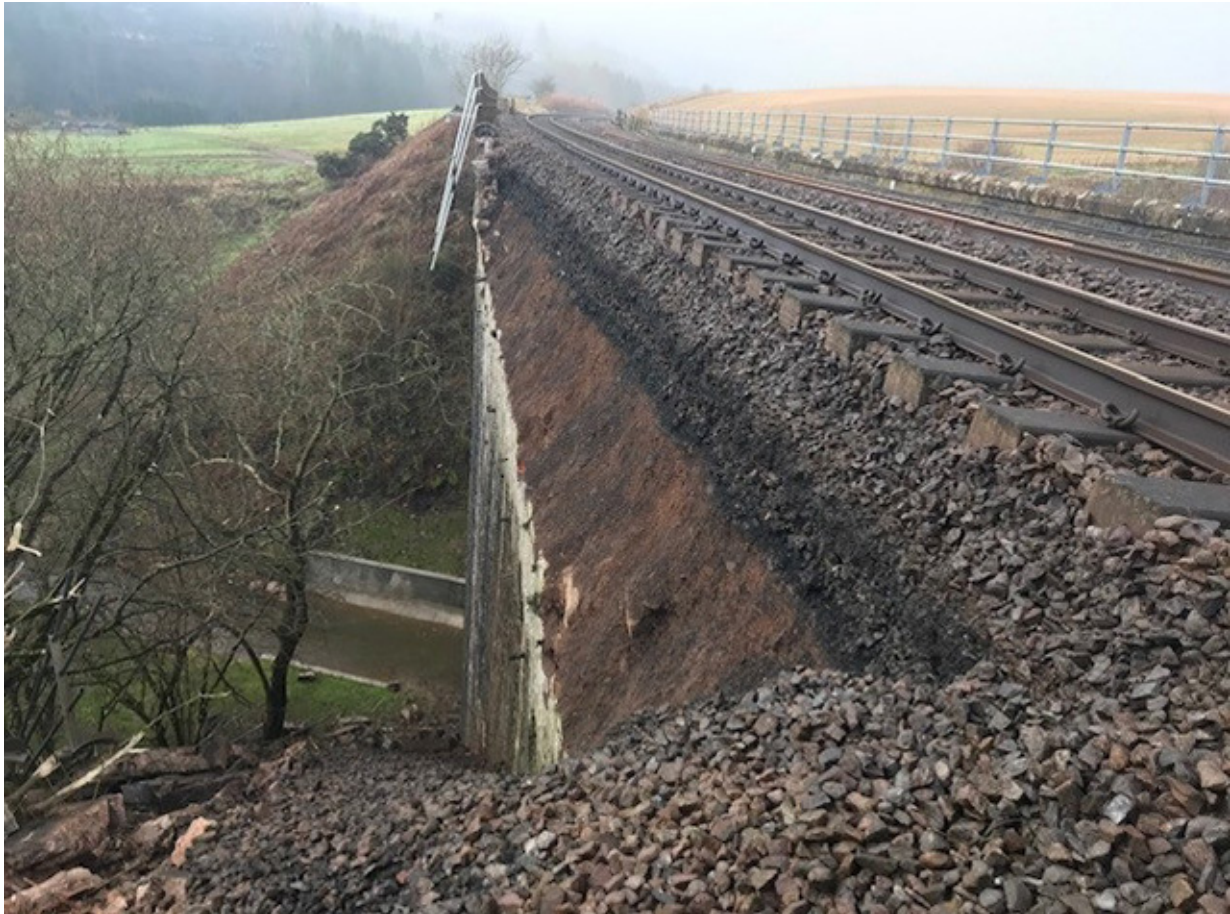
Figure M.2: Up line on bridge 328 looking south on 15 January 2021 (Network Rail)
