**ACCIDENT**

<b>Aircraft Type and Registration:</b>	Cessna 402, VP-AAK	
<b>No &amp; Type of Engines:</b>	2 Continental TSIO-520-EB engines	
<b>Year of Manufacture:</b>	1974 (Serial no: C402B)	
<b>Date &amp; Time (UTC):</b>	7 August 2023 at 1757 hrs	
<b>Location:</b>	Anguilla Airport, Anguilla	
<b>Type of Flight:</b>	Commercial Air Transport	
<b>Persons on Board:</b>	Crew - 1	Passengers - None
<b>Injuries:</b>	Crew - None	Passengers - N/A
<b>Nature of Damage:</b>	Damage to right propeller and right wing	
<b>Commander's Licence:</b>	Commercial Pilot's Licence	
<b>Commander's Age:</b>	52 years	
<b>Commander's Flying Experience:</b>	5,747 hours (of which 1,911 were on type) Last 90 days - 110 hours Last 28 days - 34 hours	
<b>Information Source:</b>	Aircraft Accident Report Form submitted by the pilot

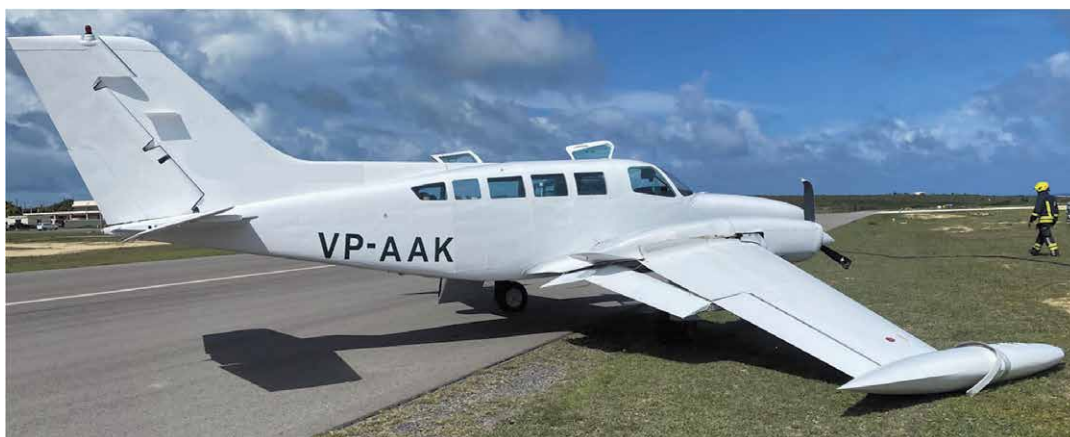
The pilot reported that, after departure, he heard a “high pitched whistling sound” coming from the crew door. He diagnosed that it came from the external handle not sitting flush, although the door was securely closed. The pilot elected to return to the airfield to restow the handle. As the aircraft approached the flare it experienced what the pilot described as a “strong windshear/downdraft” which resulted in a heavy landing on the nosewheel and right main landing gear. The heavy landing caused the right propeller to strike the ground and the right wing failed adjacent to the engine cowling (Figure 1).

**Figure 1**  
VP-AAK at the side of Runway 11
