ACCIDENT

Aircraft Type and Registration:	Czaw Sportcruiser, G-DVOY	
No & Type of Engines:	1 Rotax 912ULS piston engine	
Year of Manufacture:	2010 (Serial no: LAA 338-14976)	
Date & Time (UTC):	20 May 2023 at 1330 hrs	
Location:	Bute Airfield, Isle of Bute, Scotland	
Type of Flight:	Private	
Persons on Board:	Crew - 1	Passengers - None
Injuries:	Crew - None	Passengers - N/A
Nature of Damage:	Left wing leading edge ruptured, nose leg detached, main undercarriage structurally compromised, and propeller and spinner destroyed	
Commander's Licence:	Private Pilot's Licence	
Commander's Age:	61 years	
Commander's Flying Experience:	400 hours (of which 240 were on type) Last 90 days - 12 hours Last 28 days - 5 hours	
Information Source:	Aircraft Accident Report Form submitted by the pilot and further AAIB enquiries

Synopsis

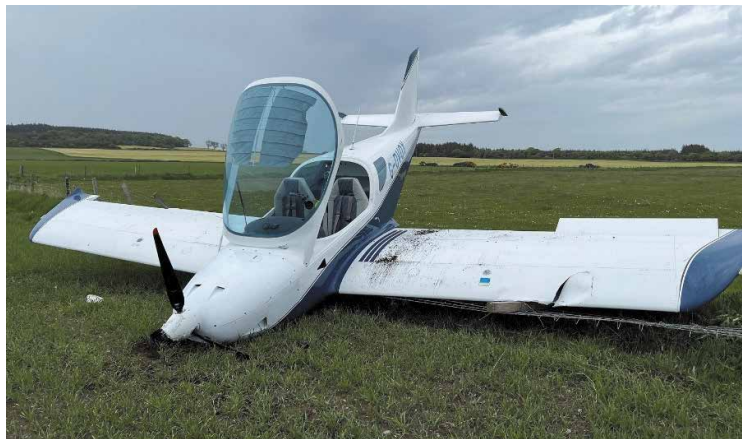
Figure 1

usually stopped the aircraft within 100 m of touchdown without having to brake so was not too concerned with landing long and fast; however, he quickly realised the aircraft was not slowing down as expected. He tried to brake but the aircraft skidded slightly to the right which he corrected back to the left. Further braking attempts were not enough to prevent the aircraft from colliding, at about 20 kt, with the airfield boundary fence on rough ground at the end of the grass strip. The pilot, realising he wasn't going to stop the aircraft in time, tightened his seat harness and loosened the canopy, and at the last moment, turned off the master and magneto switches. The nose leg detached as the aircraft went over the rough ground, before the left wing struck the fence as the aircraft came to a stop. Uninjured, the pilot turned off the remaining electrics and fuel, before exiting the aircraft.

Accident site (used with permission)

Once out of the aircraft, the pilot noticed that the runway grass was long, and “soaking wet” following the rain shower minutes earlier.
