Accident

Aircraft Type and Registration:	Skyranger Swift 912(1), G-CJXF	
No & Type of Engines:	1 Rotax 912UL piston engine	
Year of Manufacture:	2017 (Serial no: BMAA/HB/696)	
Date & Time (UTC):	25 September 2023 at 1012 hrs	
Location:	1 nm south of Dunstable, Bedfordshire	
Type of Flight:	Private	
Persons on Board:	Crew - 1	Passengers - None
Injuries:	Crew - None	Passengers - N/A
Nature of Damage:	Propeller damage and minor damage to fabric skin	
Commander's Licence:	Private Pilot's Licence	
Commander's Age:	56 years	
Commander's Flying Experience:	535 hours (of which 460 were on type) Last 90 days - 18 hours Last 28 days - 6 hours	
Information Source:	Aircraft Accident Report Form submitted by the pilot and further enquiries by the AAIB

Synopsis

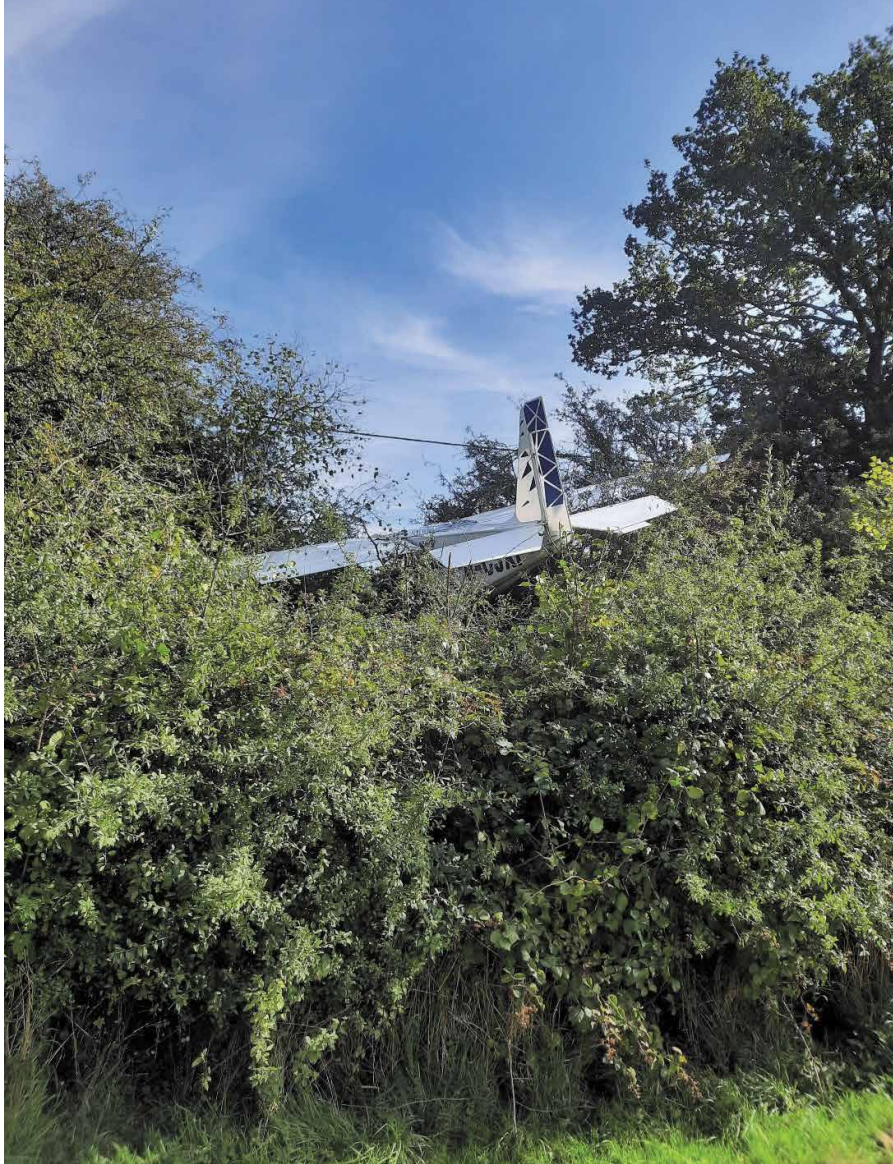
The pilot was taking off from a large field approximately 1 nm south of Dunstable. Shortly after becoming airborne he saw a heron flying on an intercepting course. He was expecting the bird to change course but when it became obvious they were about to collide, the pilot banked the aircraft to the left to avoid it. He estimated that the heron missed the aircraft's windscreen by 100 mm, but as the heron passed over the windscreen he heard another bird hit the propeller. The engine coughed for a few seconds but continued to run. However, he realised the loss of power meant he was not going to clear the trees ahead. He turned slightly to the right to avoid the tallest trees and focused on maintaining airspeed. Just prior to contact with bushes he switched off the engine. The aircraft settled into the hedgerow. The pilot was not injured and was able to exit the aircraft via a ladder.

Figure 1
G-CJXF after the accident

The aircraft collided with a bird shortly after takeoff, resulting in a loss of power. When the pilot realised he was not going to clear the tree line ahead, he maintained airspeed, steered the aircraft away from the tallest trees, switched off the engine and flew the aircraft in controlled flight into the hedges.

He reported that he was investigating installing a bird scarer which he could operate remotely before taking off or landing at the field.
