**ACCIDENT**

| <b>Aircraft Type and Registration:</b> | TL-3000 Sirius 600, G-SBOI | |
| <b>Date &amp; Time (UTC):</b> | 10 August 2023 at 0800 hrs | |
| <b>Location:</b> | Fishburn Airfield, County Durham | |

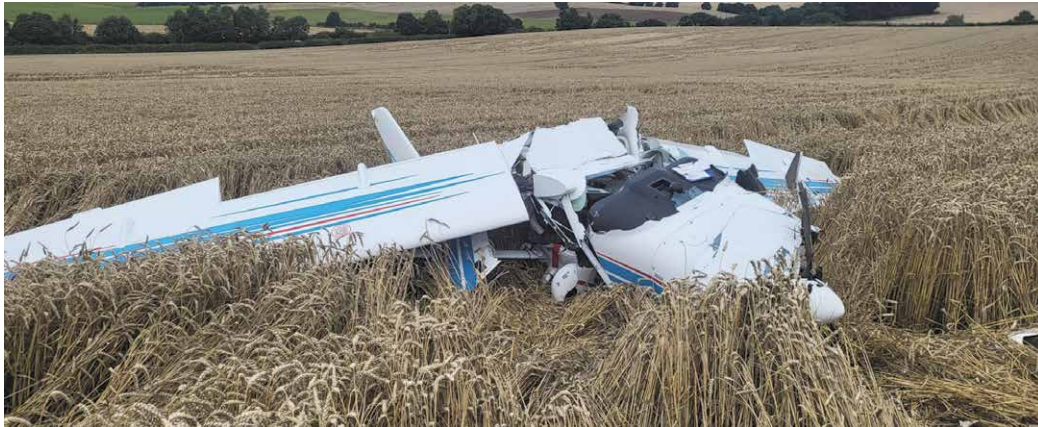
**Figure 1**

Damage sustained to G-SBOI (used with permission)

Damage to the aircraft was extensive and hindered the pilot's egress from the wreckage, but only minor injuries were sustained by the pilot and passenger, who were both wearing full harnesses.
