AAIB Bulletin

1/2024

Bombardier CL-600-2B16 Challenger 604	N999PX	31-Jan-22	3
---------------------------------------	--------	-----------	---

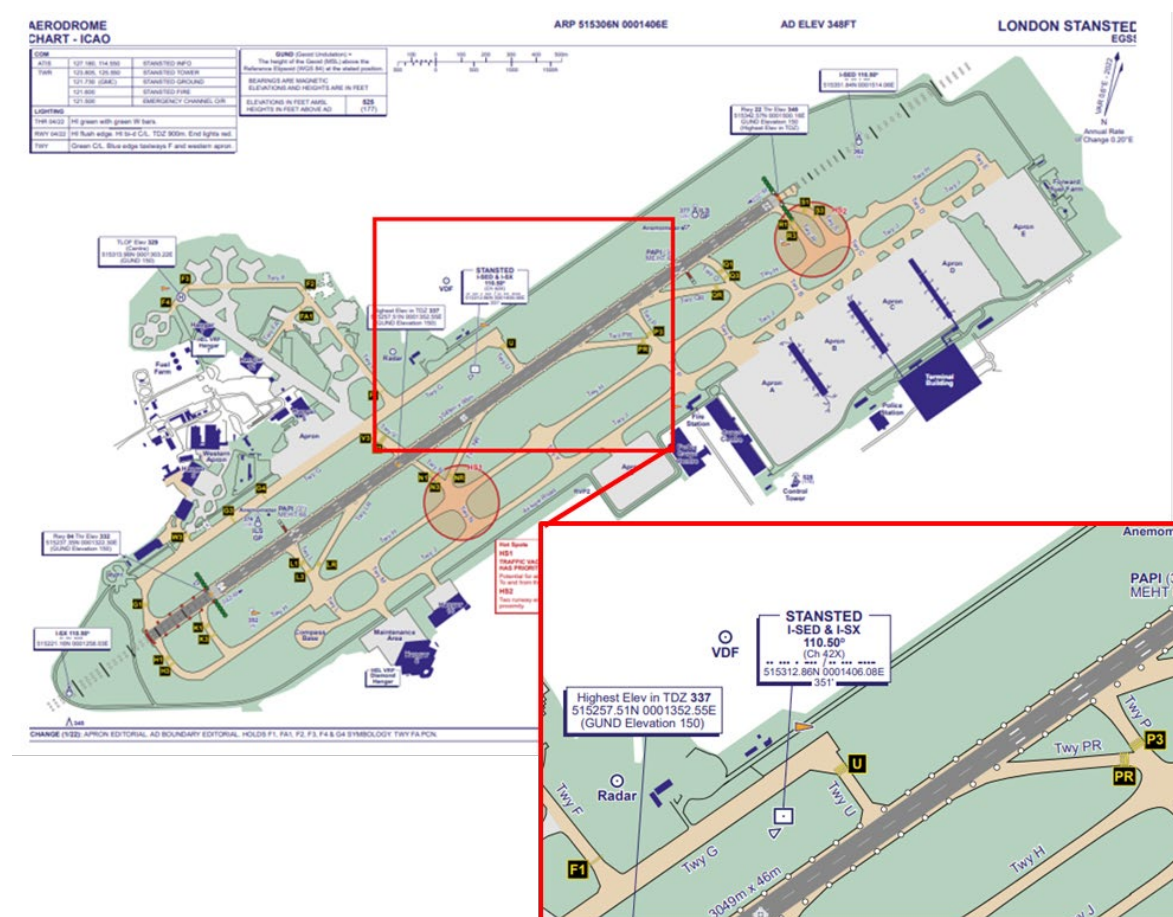
Figure 2

Examination of Runway 22 at London Stansted Airport showed three separate wing strike marks on the paved surface between the intersections of Taxiways Papa, Romeo and Uniform, each approximately 20 m long (Figure 2). Paint transfer from N999PX's wing was evident in the strike marks on the runway (Figure 3), becoming a furrow in the grass. As it continued to travel through the grass, the wingtip struck a concrete pad. Several pieces of debris were found in this area, including fragments of wingtip skin panel and wingtip light transparency.

London Stansted Aerodrome Chart, inset showing area where N999PX left wing struck the ground

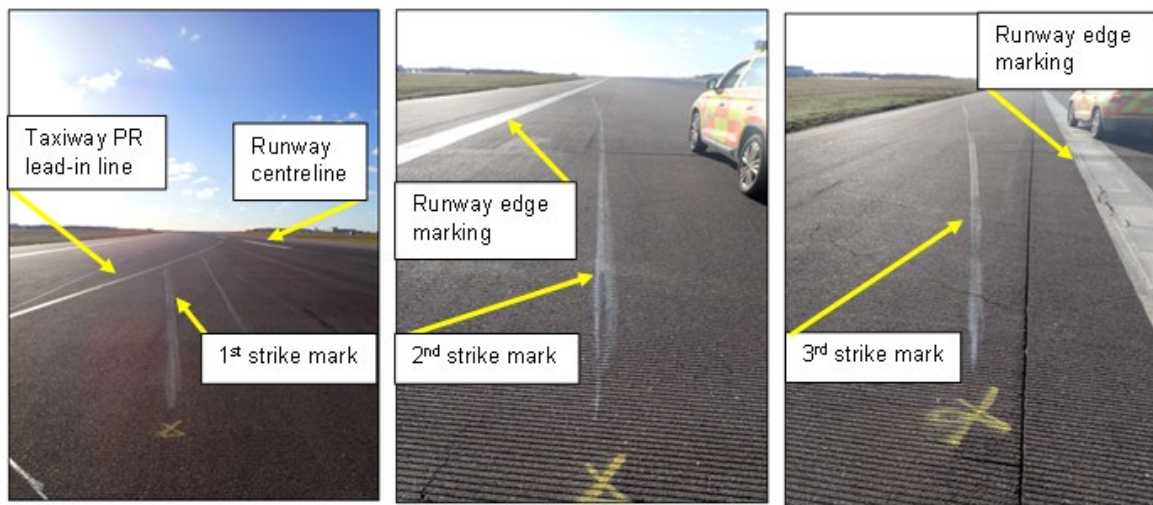
Figure 3

N999PX wing strike marks on Runway 22, viewed in direction of travel

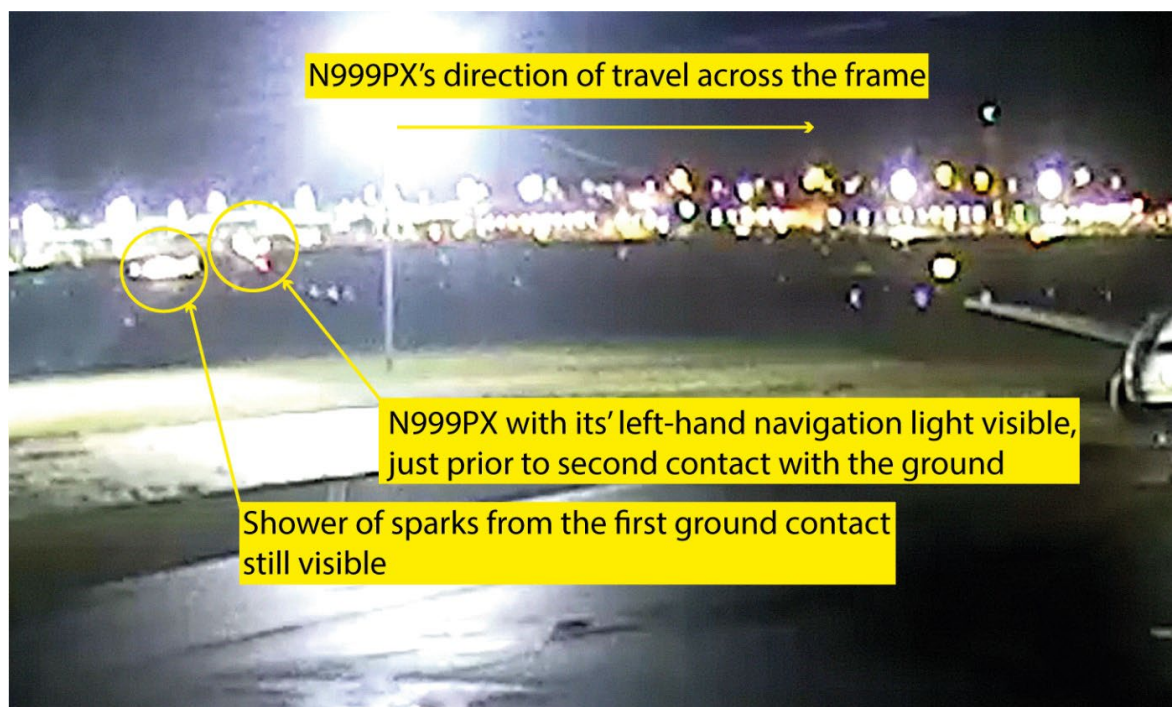
Figure 5

Closed-circuit television (CCTV) recordings from London Stansted captured the aircraft's approach and GA, showing that N999PX struck the ground at least twice. An image from one of these recordings is shown below (Figure 5).

CCTV from London Stansted showing N999PX striking the ground

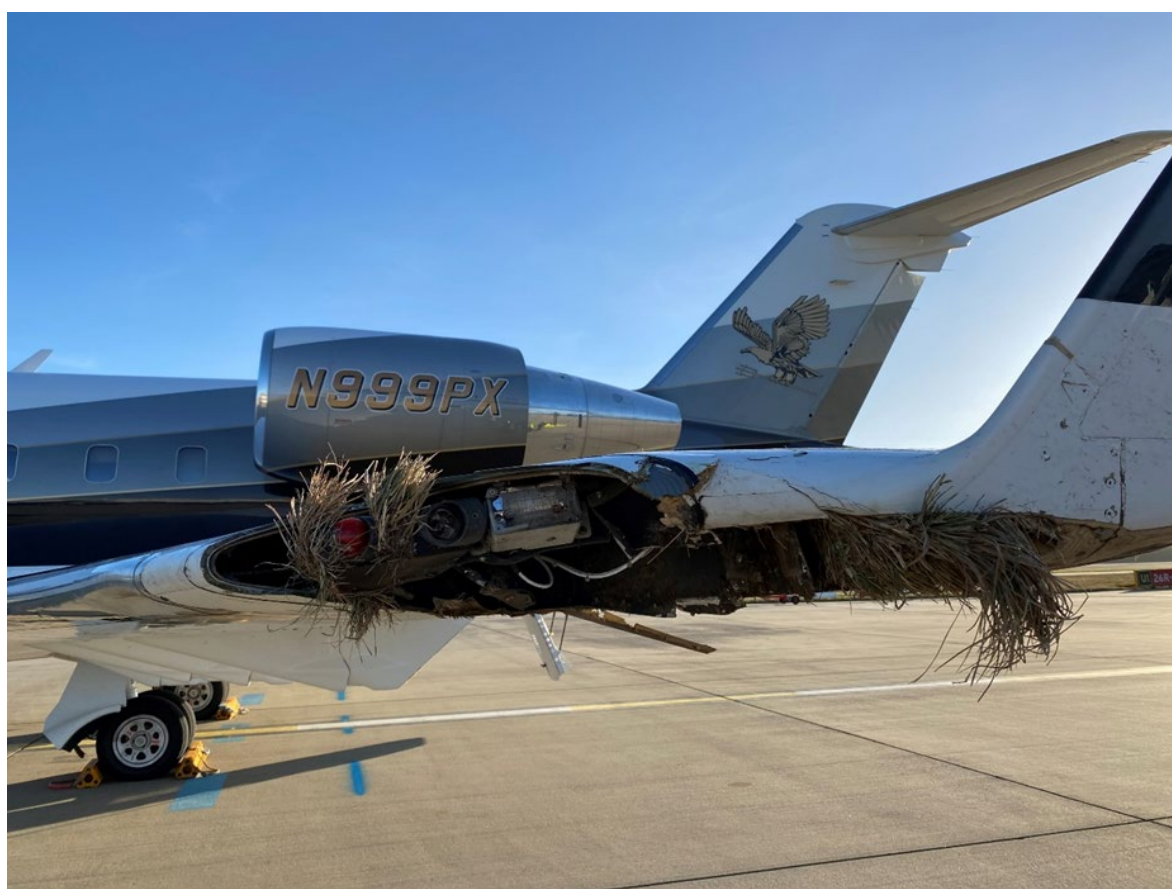
Figure 6

The aircraft was examined on Taxiway Juliet at London Gatwick the morning after the accident. The outboard portion of the left wing and winglet had suffered considerable damage (Figure 6). There was a dent on the lower surface of the outboard leading edge.

The landing light glazing at the wingtip and several fairings and skin panels were missing. The wingtip lower skin was abraded, in some locations through its entire thickness, and there was damage to the sub-structure. Grass and earth were lodged in the landing light housing and in the exposed structure at the base of the winglet. The winglet and wingtip trailing edge skin showed evidence of ground contact, including the mounting plate for the wingtip static discharge wick which was abraded flat. There was also evidence of ground contact on the outboard rear corner of the left aileron, a small section of which was missing, and on the aileron's outboard static discharge wick. The aileron upper skin was buckled. The trailing edge of the outboard flap fairing also showed evidence of ground contact.

Damage to N999PX left wing

A wing symmetry/alignment check identified that the degree of twist to the left wing was out of allowable limits. The aircraft manufacturer considered that this indicated permanent plastic deformation of the wing attachment point, meaning that ultimate strength of the materials had been exceeded. In order to return to service, the aircraft would have required a complete wing set replacement. The aircraft insurers considered that the damage to the aircraft was beyond economical repair.

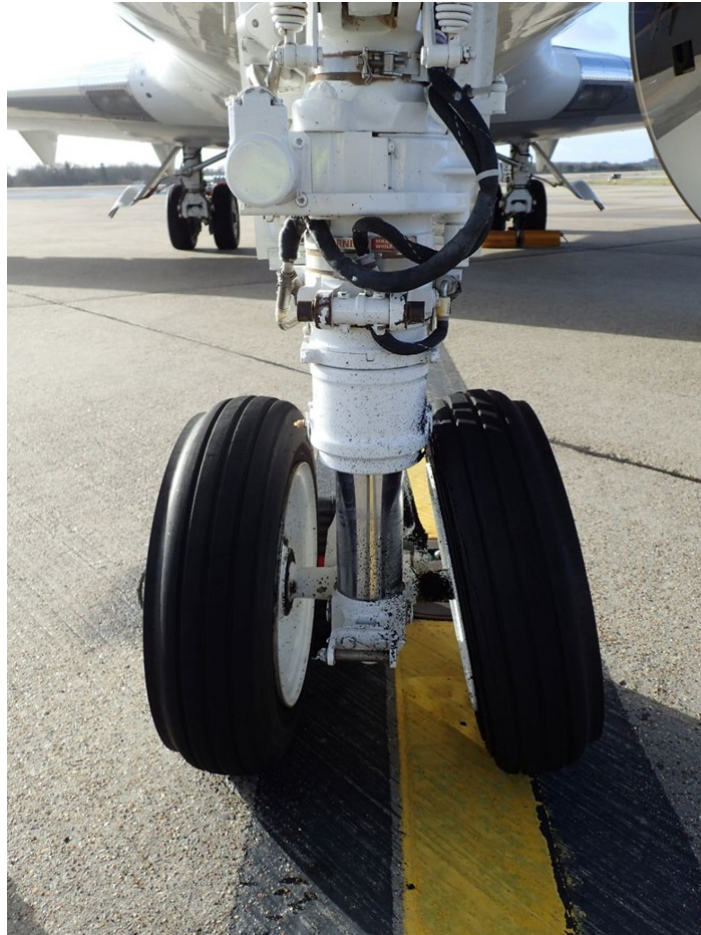
Figure 7

The nose landing gear left wheel axle had failed such that the top of the left wheel was angled towards the landing gear leg (Figure 7). Severe scoring and abrasion on the inboard sidewall of the left tyre had been caused by the tyre rotating against a grease nipple at the bottom of the oleo. Some localised buckling was evident on the lower fuselage skin immediately aft of the nosewheel bay.

Damage to N999PX nose landing gear (view looking aft)

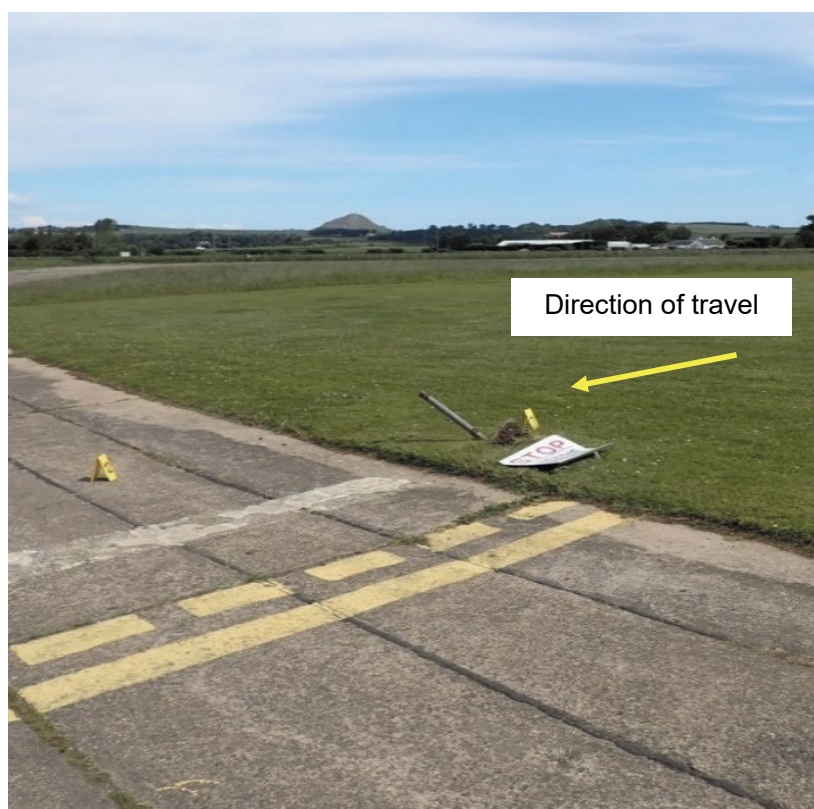
Figure 2

Marks made by the aircraft's wheels as they travelled across the grass stretched from where the aircraft was parked on the grass in front of the hangar to the edge of the concrete taxiway. The marks indicate that the aircraft travelled in a left arc, missing a wire fence approximately 30 m in front and perpendicular to the direction the aircraft was parked. As the aircraft travelled towards the concrete taxiway, its right main landing gear struck a runway stop sign concreted into the ground at the edge of the taxiway (Figure 2) before becoming airborne.

Runway stop sign struck by aircraft

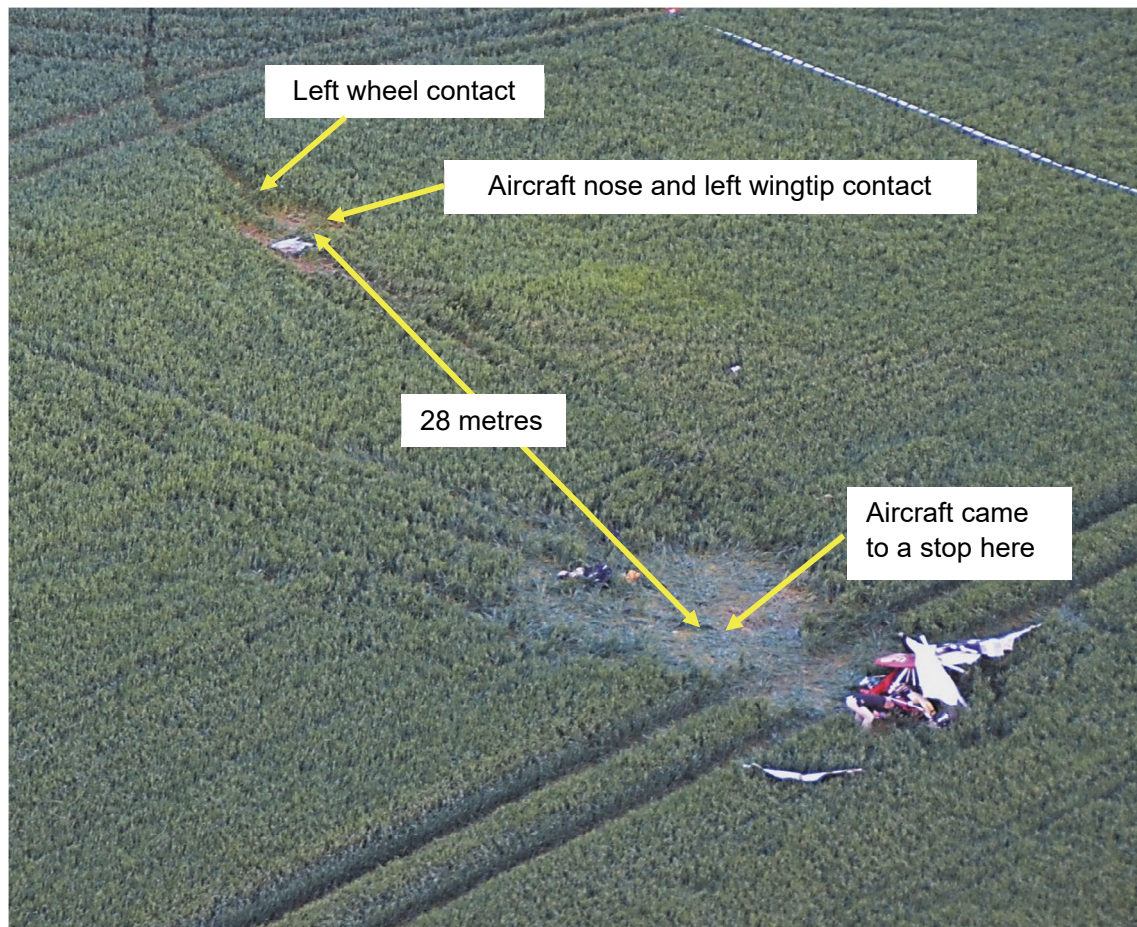
The aircraft came to rest in a field to the west of the airfield. Ground impact marks show that the aircraft's left wheel struck the ground first followed by the left-wing tip and the front of the trike. The aircraft cartwheeled and bounced before stopping approximately 28 m from the initial impact point. The trike came to rest on its right side with the pylon still attached to the wing (Figure 3).

Figure 3
Accident site

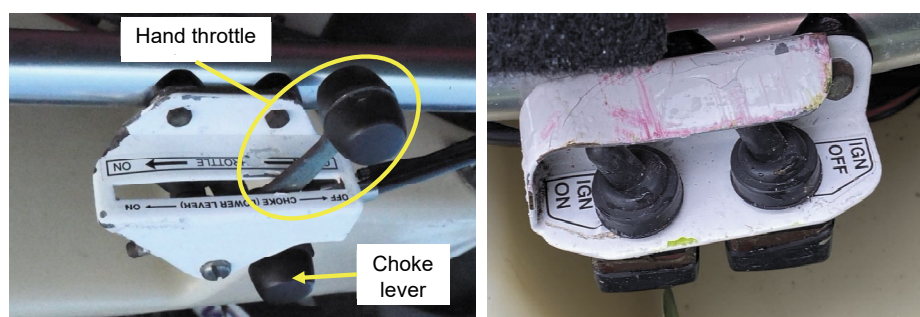
Figure 8

Both ignition switches located on the right side of the seat frame were found in the ON position with the switch guard bent over the switches preventing them from being moved. The friction-damped hand throttle lever located on the left side of the seat frame was positioned slightly forward of OFF. Located directly below the hand throttle was the choke lever which was selected to OFF (Figure 8).

Hand throttle and choke levers (left), ignition switches (right)

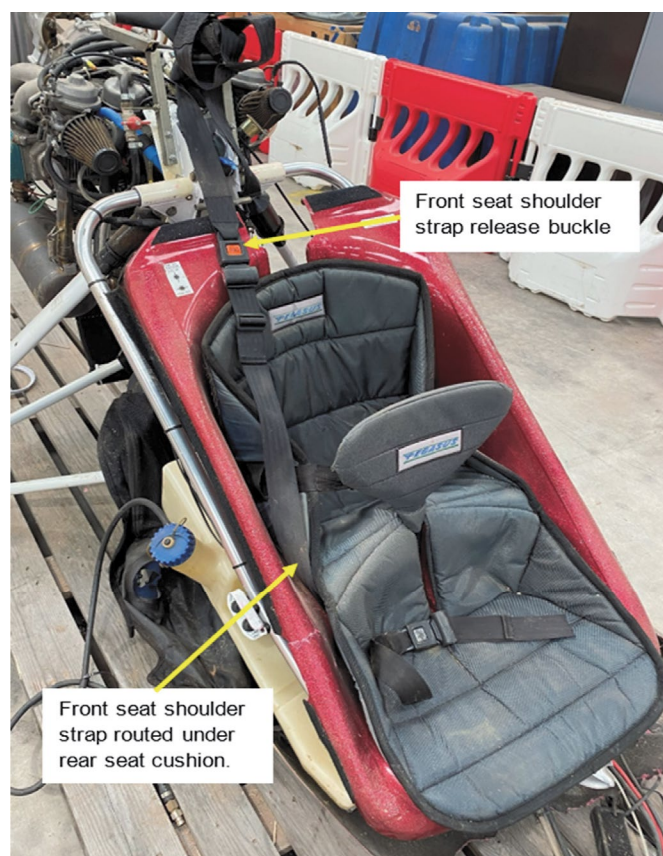
Figure 9

The rear seat shoulder straps were found disconnected from their lap strap and tied around the pylon. The rear seat lap strap had been adjusted so that it was tight against the rear seat cushion. The front seat diagonal shoulder strap had been tightened between the pylon and the base tube and routed under the seat cushion to prevent it from fouling the propeller during flight (Figure 9). In this configuration, the shoulder strap could not have been worn by the pilot during the flight.

Front seat diagonal shoulder strap positioned as found at the accident site

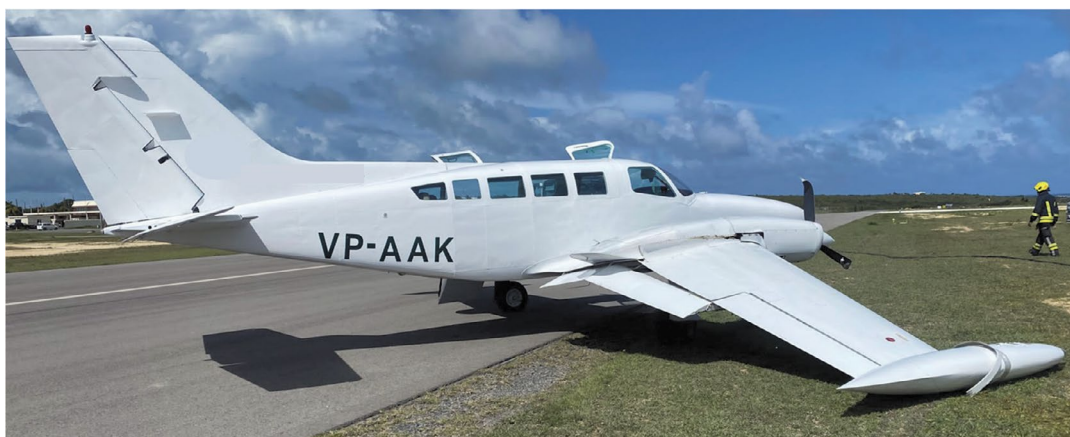
The pilot reported that, after departure, he heard a “high pitched whistling sound” coming from the crew door. He diagnosed that it came from the external handle not sitting flush, although the door was securely closed. The pilot elected to return to the airfield to restow the handle. As the aircraft approached the flare it experienced what the pilot described as a “strong windshear/downdraft” which resulted in a heavy landing on the nosewheel and right main landing gear. The heavy landing caused the right propeller to strike the ground and the right wing failed adjacent to the engine cowling (Figure 1).

Figure 1
VP-AAK at the side of Runway 11

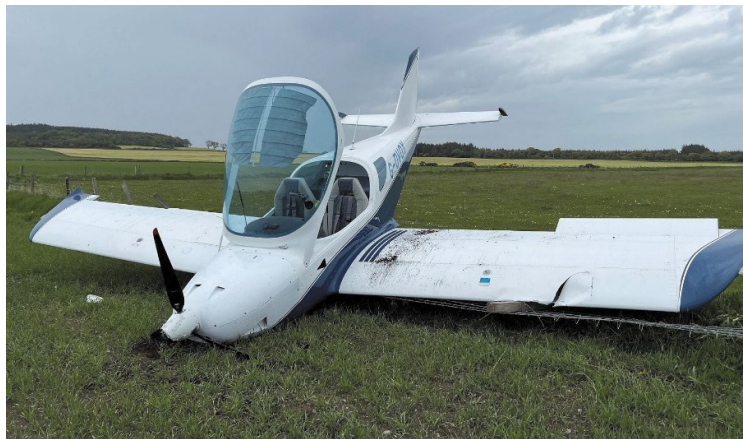
Figure 1

Accident site (used with permission)

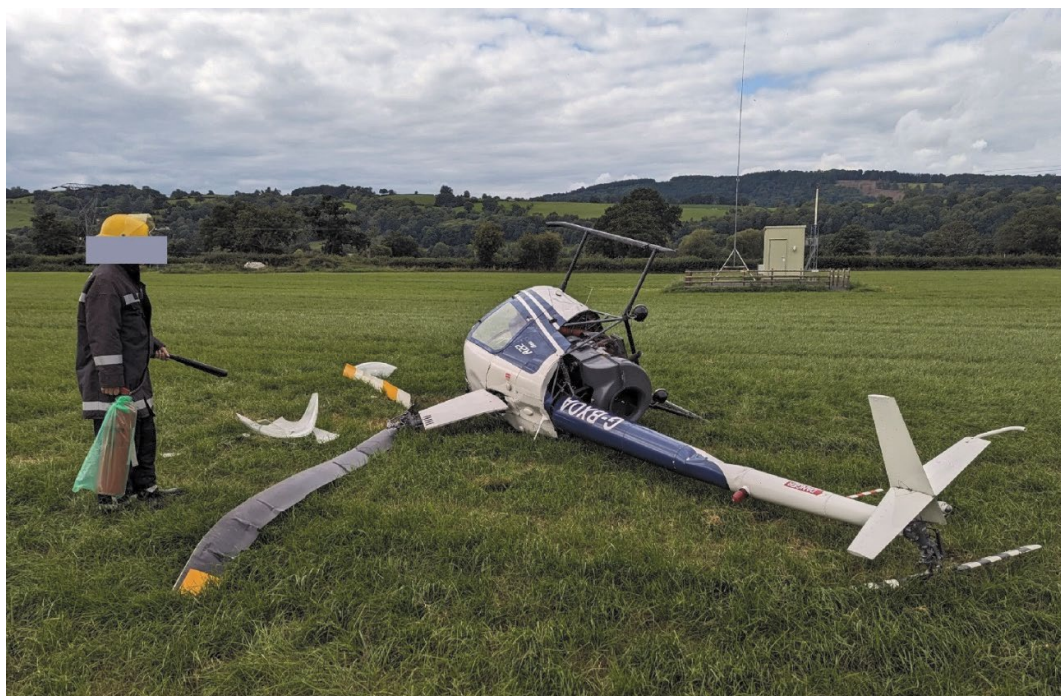
Figure 1
Accident site

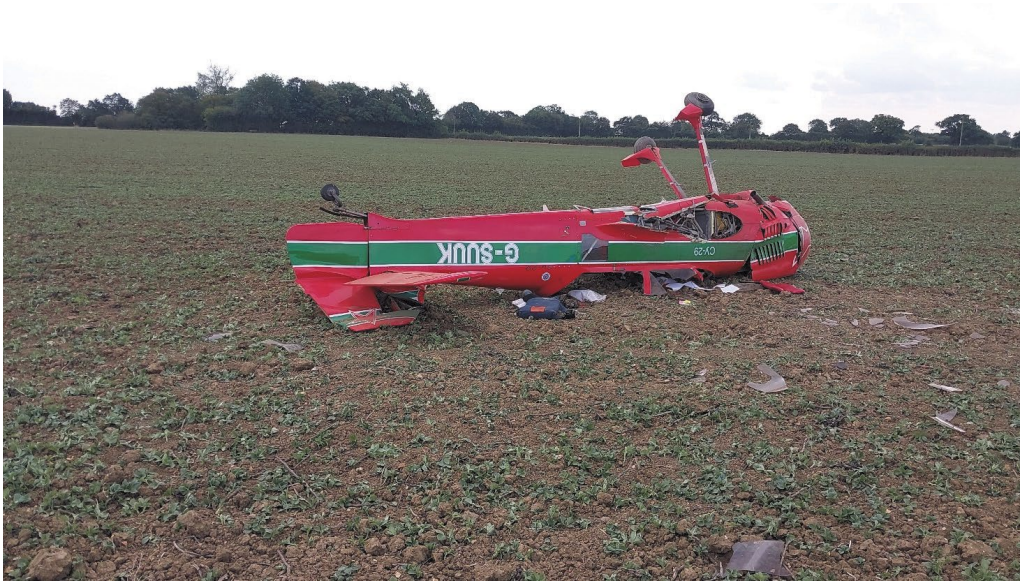
Figure 1
G-SUUK after the accident
