Defence
Safety Authority

Service inquiry

Death of a service person in an
accident with a Warrior
armoured vehicle on Salisbury
Plain Training Area

21 June 2022

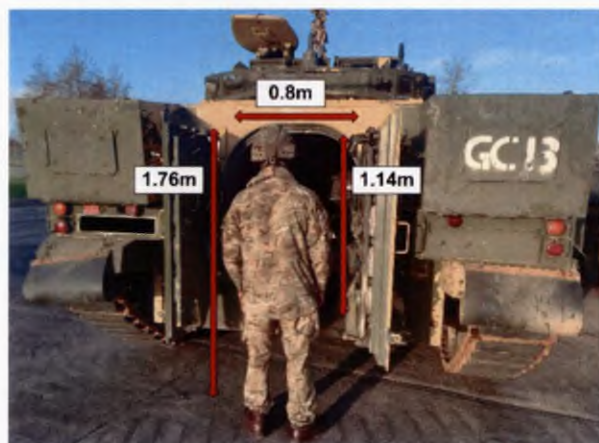
Figure 1.4.22 – FV511 rear door opening dimensions

e. **Rear door opening.** The rear door opening dimensions on the FV510, were wider than that of an FV511 (see figures 1.4.22 and 1.4.23). The smaller dimensions on the FV511 would, more likely than not, restrict the egress of personnel.

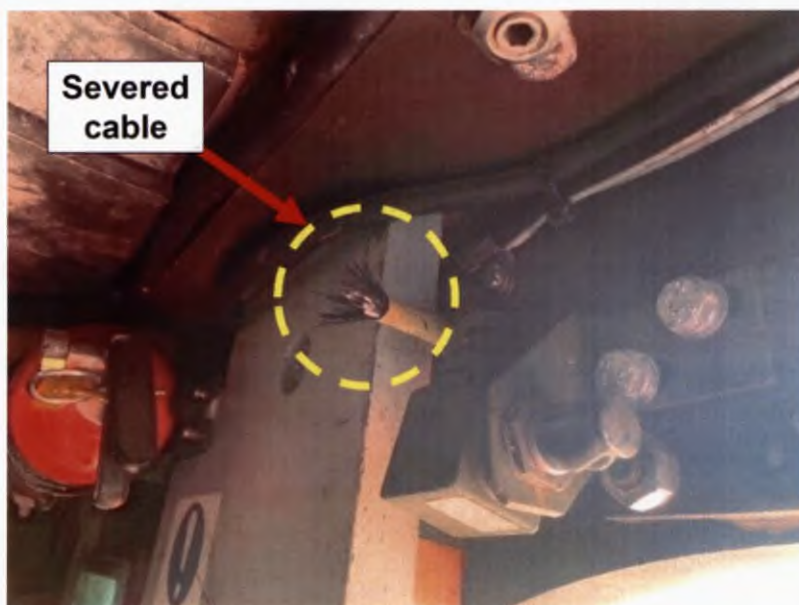
Figure 1.4.24 – Rear door switch severed cable

1.4.359. **Rear door alarm and rear door open lamp.** The rear door alarm and rear door open lamp on C/S 42A did not work due to a severed cable (see figure 1.4.24). Exhibit 44

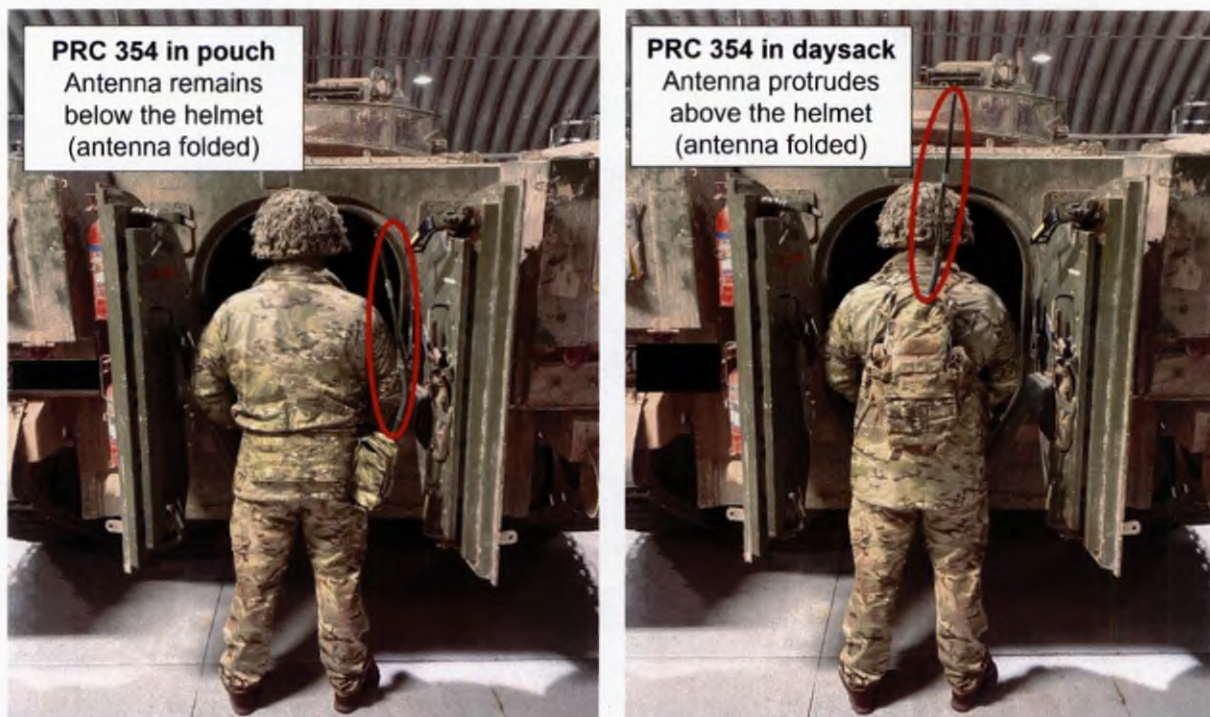
Figure 1.4.30 – Comparison of carriage of PRC 354 radio

- c. A radio being carried in an issued VIRTUS PRC 354 pouch would have lowered the antenna profile which in turn, may have reduced the risk of snagging whilst exiting the vehicle (see figure 1.4.30).

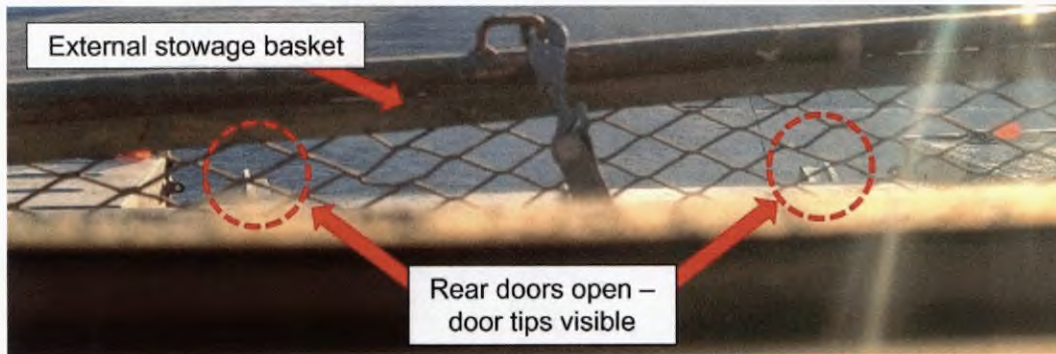
Figure 1.4.46 – An FV511 commander's view through a rear periscope with rear doors open (turret facing forward)

seen the tip of the doors, even if they were open. For this reason the panel formed the opinion that Student Commander 1 assessed the doors were closed, not because they were closed, but because they could not see them open.

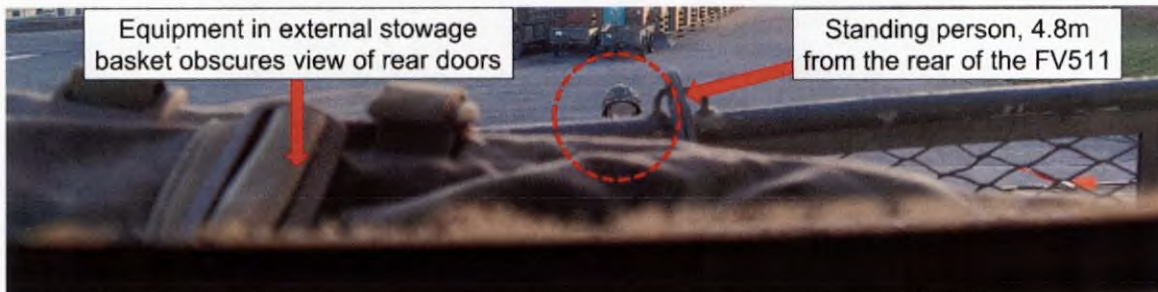
Figure 1.4.47 – An FV511 commander's view through a rear periscope with rear doors open (turret facing forward and equipment in external stowage baskets)

ii. At the time of the accident the external stowage baskets contained equipment. The panel determined it would have been unlikely that Student Commander 1 could have seen the rear doors open from a closed down position, with the turret facing forward, when the stowage basket contained equipment, as in figure 1.4.47.

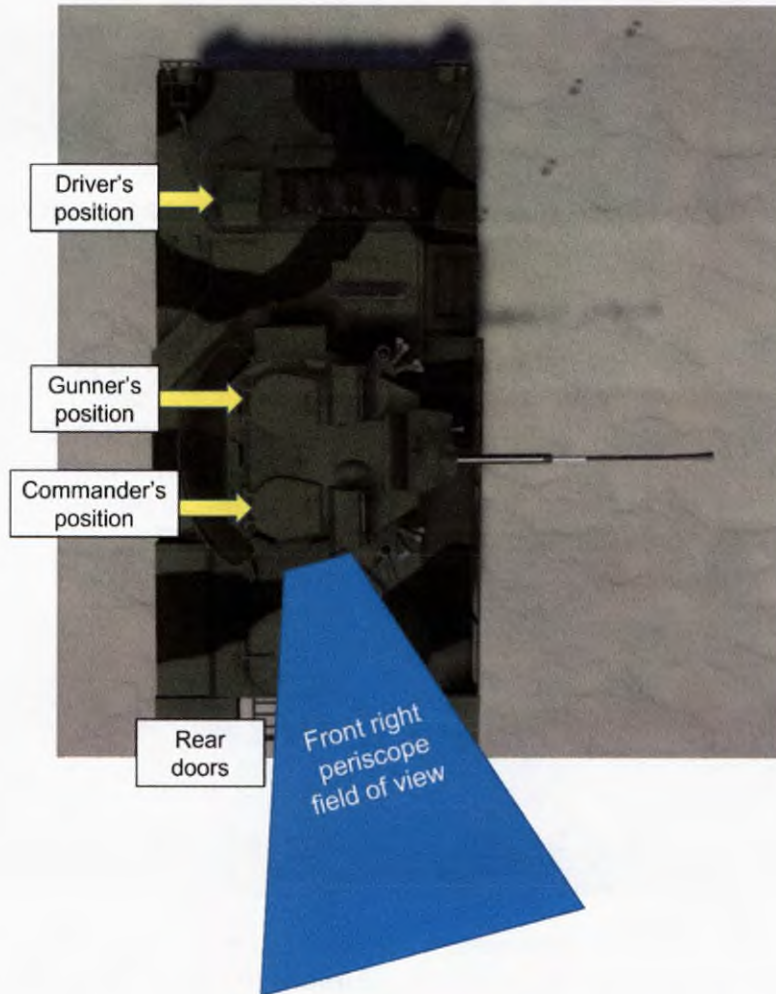
Figure 1.4.48 – An FV511 commander's field of view through the front right periscope (turret facing right)

iv. The panel explored one other plausible explanation for Student Commander 1 not being able to see the rear doors open. The movement of the turret may have momentarily disorientated them. Had they been looking out of the turret's rear periscope, they may have believed they were looking to the rear of C/S 42A, but actually would have been looking to the left-hand side of the vehicle (see figure 1.4.50). The panel discounted this as Student Commander 1 was clear that they looked to the right, which meant that they would have been looking out of the right-hand periscope as shown in figure 1.4.48.
