## Interim report on the investigation of a fatal fall from height while boarding the Finland registered roll-on/roll-off cargo ship *Finnhawk* from the UK registered pilot vessel *PV Humber Saturn* off the Humber Estuary, England on 8 January 2023

***The information contained in this interim report is based on the various aspects of the investigation completed to date. Readers are cautioned that there is the possibility new evidence may become available that might alter the circumstances as depicted in this report.***

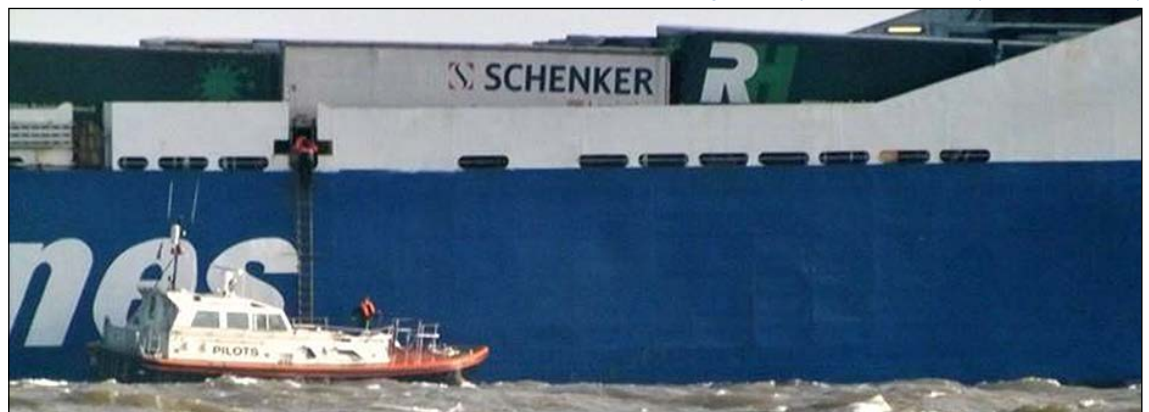
*PV Humber Saturn alongside Finnhawk on a previous occasion*
