**Serious Incident**

| <b>Aircraft Type and Registration:</b> | Bombardier CL-600-2B16 (604 Variant),<br>D-AAAY | |
| <b>Nature of Damage:</b> | Damage to the No 1 flap retract relay | |

**Synopsis**

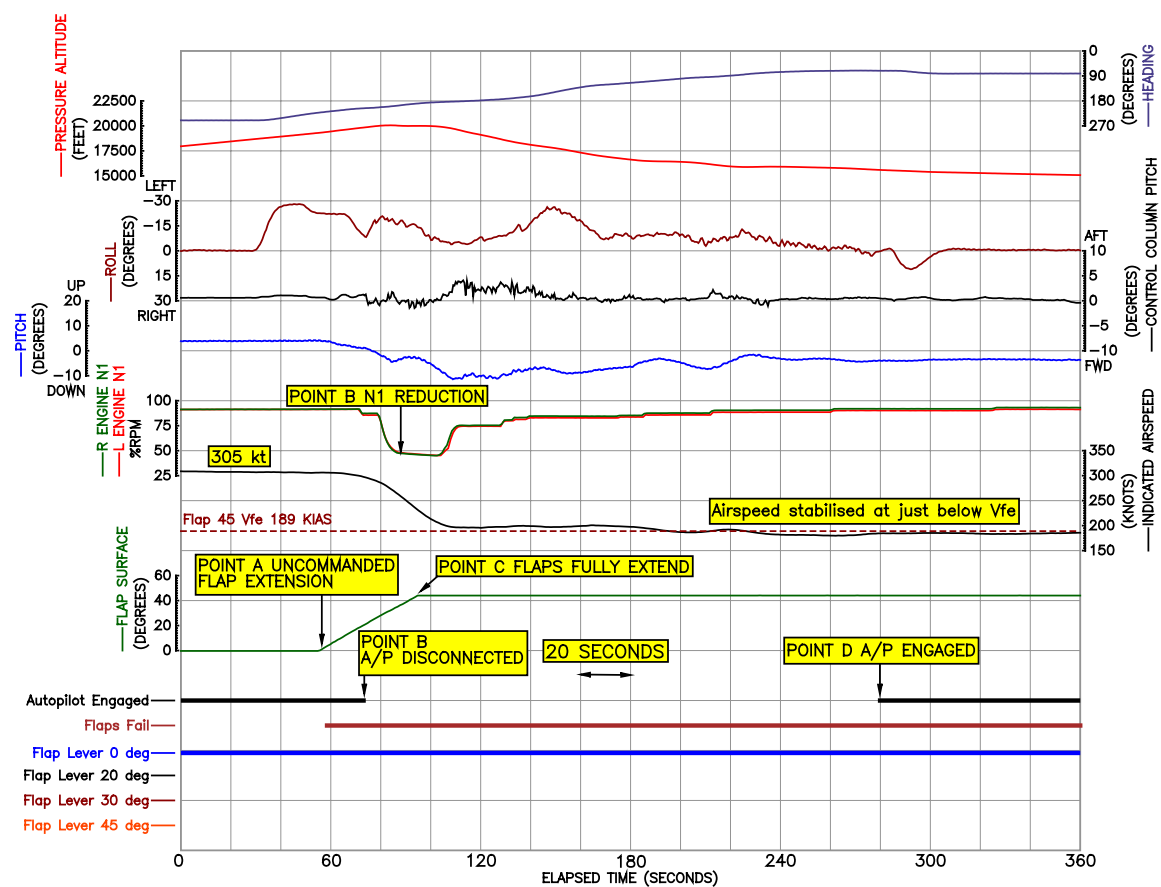
**Figure 5**

As the aircraft climbed through FL190, at a recorded airspeed of 305 KIAS, the flaps started to extend while the flap control lever remained in the flap 0 position (Figure 5, Point A). The rate at which the flaps extended was about 1.1°/sec. The flaps extended at a near linear rate from the flap 0 position, with no evidence of prior flap creep<sup>9</sup>. The autopilot remained engaged, and the aircraft's speed started to progressively reduce while the aircraft pitched down from 4° nose-up. Shortly after, a FLAPS FAIL caution was recorded which occurred when the flaps had extended by about 3°.

91% to 47% N1 (Figure 5, Point B). The flaps continued to extend over the next 21 seconds until reaching 45° where they stopped, at which point the airspeed was 234 KIAS, 45 kt above flap 45  $V_{FE}$  (Figure 5, Point C).

The aircraft's speed continued to reduce over the next 10 seconds, and as it approached 200 KIAS the crew started to increase engine thrust. This coincided with the aircraft starting to descend, having briefly climbed to FL200. The crew subsequently stabilised the aircraft's speed at about 183 KIAS with the engine thrust set at 92% N1. The autopilot was then engaged (Figure 5, Point D), and the aircraft levelled off at FL150. The flaps had experienced an overspeed for a period of about 170 seconds, which was the time between the flaps starting to extend from 0° and the airspeed stabilising at just below 189 KIAS with the flaps at 45°. During this period, the maximum flap overspeed was about 103 KIAS.

FDR data of uncommanded flap extension

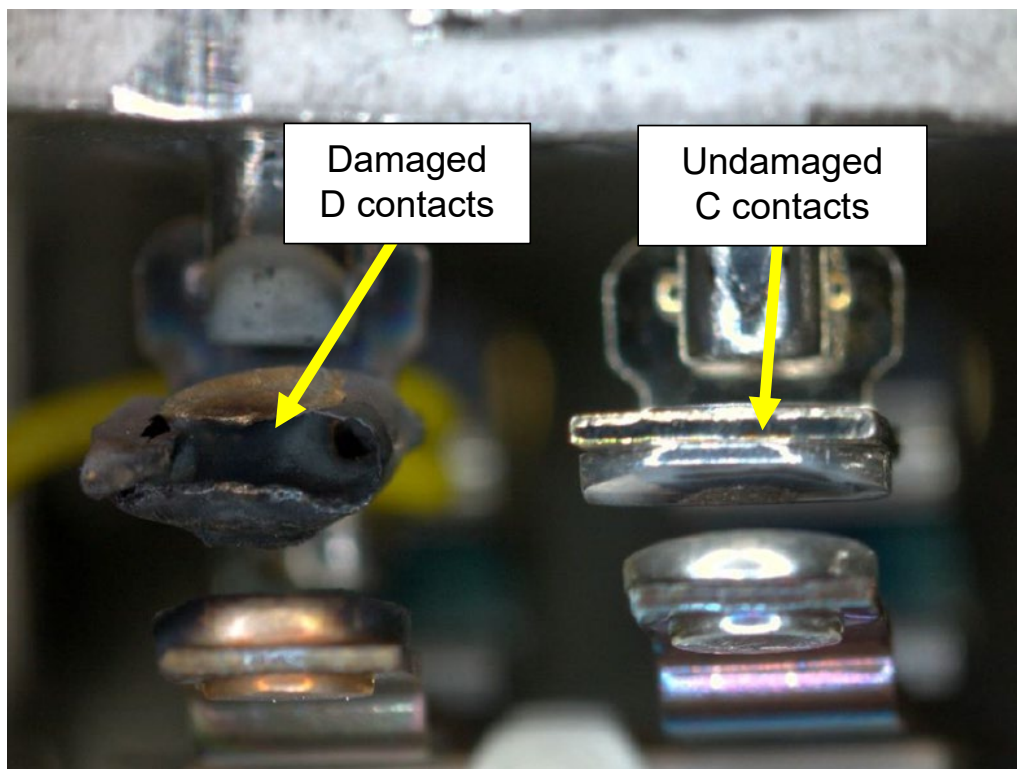
**Figure 6**

The relays from D-AAAY were subject to electrical testing and forensic examination. The testing found that the contacts in the No 1 retract relay did not always change state (switch) when the relay coil was energised.

When the relays were disassembled, the D contacts were found to exhibit varying amounts of damage that was typical of electrical arcing:

- On the No 1 extend relay, material had transferred from the moving contact to the stationary contact which reduced the airgap between the contacts.
- On the No 2 extend relay, the contact was significantly discoloured (blueing) indicating that it had been subject to localised heating. There was no significant material transfer between the moving and stationary contacts.
- On the No 1 retract relay, the material forming the stationary contact had melted and reformed and there was distortion of the moving contact which reduced the airgap. Figure 6 shows the damaged D contact alongside the undamaged C contact.

Damaged D contact (left) and undamaged C contact (right)

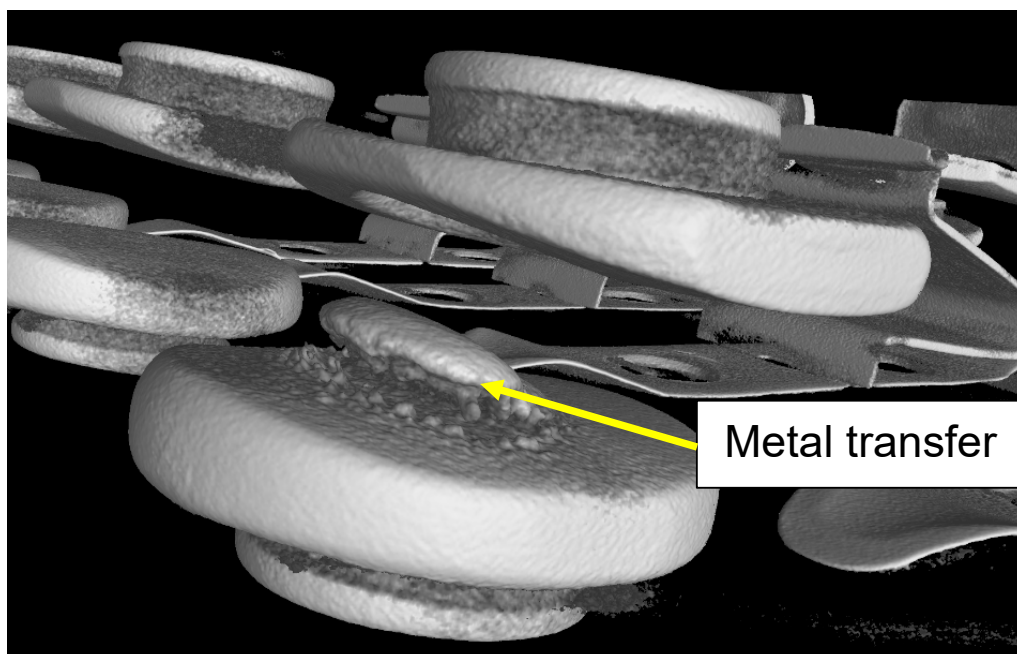
**Figure 7**

There was evidence of erosion and material transfer between the D contacts on the No 1 extend relay (Figure 7). It is possible that the contacts were initially welded together, which would explain why the flaps extended at half-speed during the on aircraft testing. Failure of the weld after the flaps had been cycled a number of times would allow the contacts in the relay to move, and the flaps operate at their normal speed.

Erosion and metal transfer on the D contacts

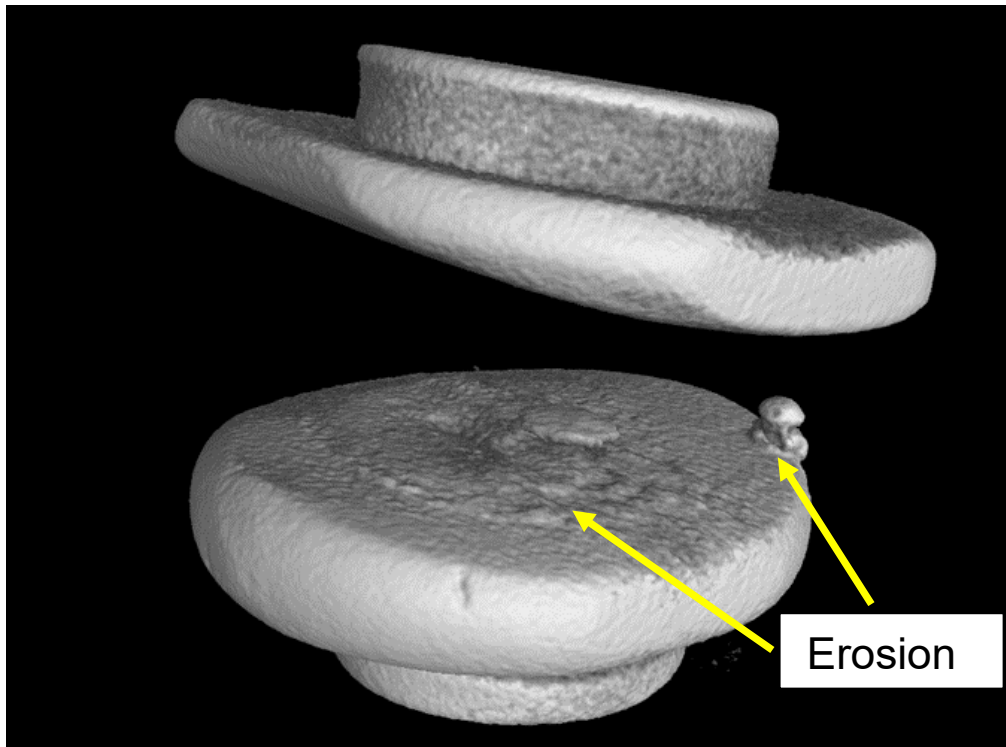
**Figure 8**

The No 2 extend relay, which had been in-service for approximately 2,700 flight hours and 1,372 flight cycles, showed evidence of material erosion and transfer between the D contacts (Figure 8). The aircraft maintenance records showed that this relay was fitted in April 2018 following a defect that generated a FLAPS FAIL EICAS caution; it was found that the BDU brake solenoids were permanently energised.

Material erosion on D contact

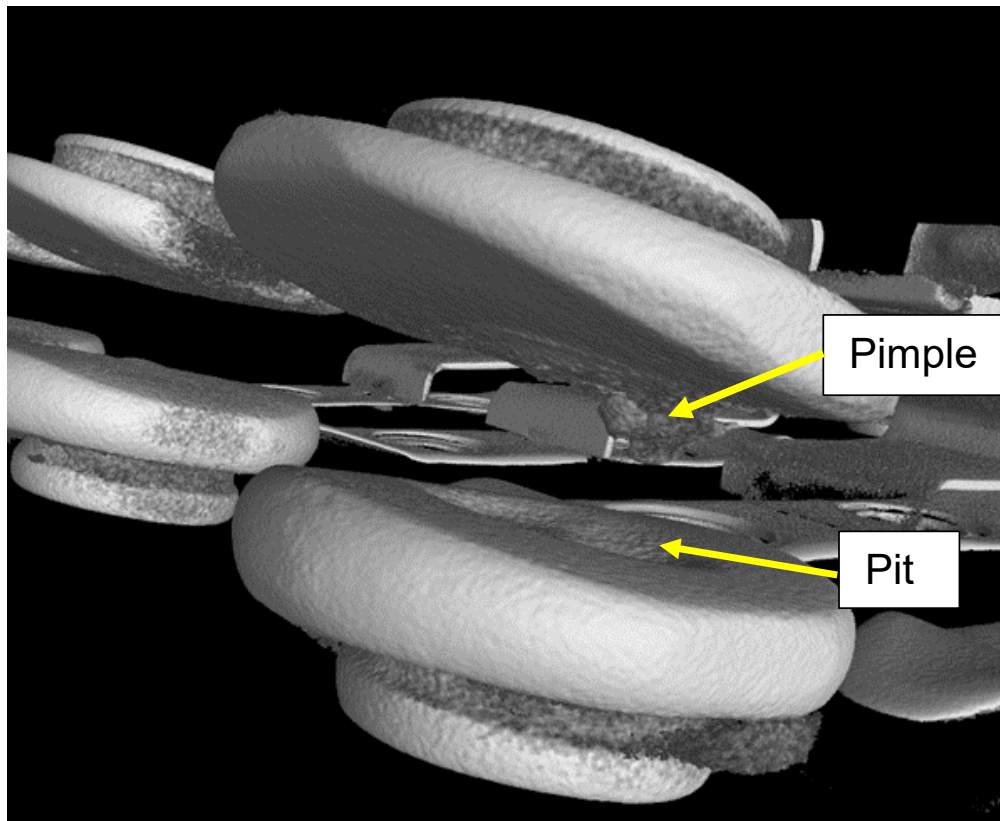
**Figure 10**

While the flaps operated normally during testing, on the No 1 retract relay, material had transferred across the D contacts. This damage was typical of electrical arcing, which leaves a 'pit' where material is eroded and a 'pimple' where it accumulates (Figure 10).

Metal transfer between the D contacts as seen by the pit and pimple effect

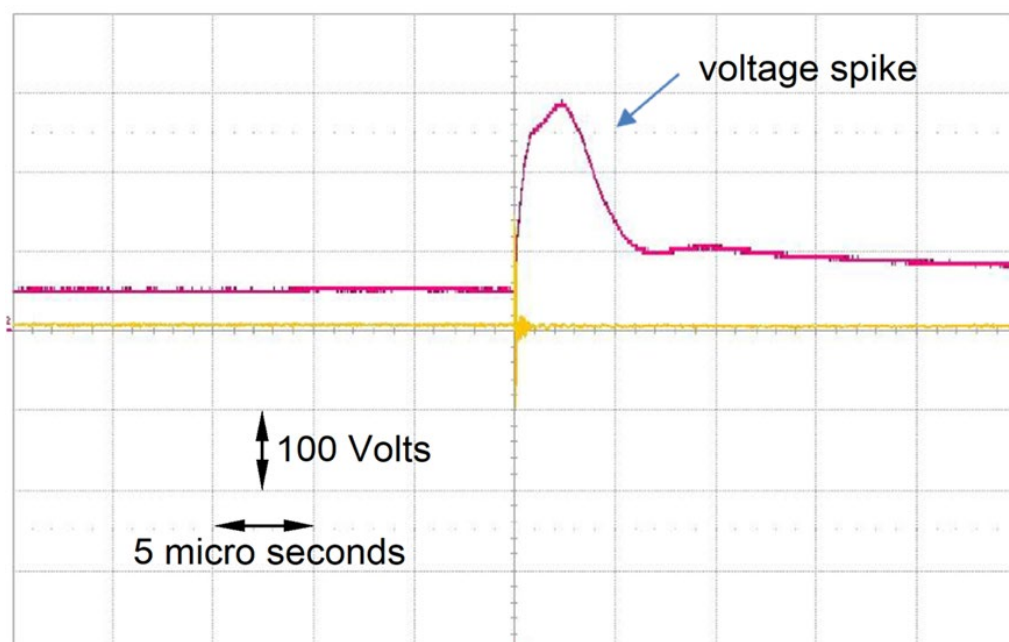
**Figure 11**

The current and voltage during solenoid switching was measured using an oscilloscope (Figure 11). When the solenoid was de-energised a maximum transient voltage spike of 300V was seen; this spike regularly exceeded 150V during repeated switching of the BDU. The voltage spike is caused by a back electro motive force (EMF), which occurs when removing electrical power from inductive loads such as the solenoid coils. There was no protection or suppression provided within the flap operating system to prevent or reduce this back-EMF, which could cause arcing across the D contacts.

Oscilloscope output showing voltage spike after de-energising coil

During testing, when the BDU brake solenoids were de-energised a back-EMF was observed, which could cause arcing across the D contacts in the flap relay. As the flap system on the Challenger aircraft has no protection to suppress this back-EMF, the following Safety Recommendation was made to Bombardier Aviation on 1 March 2023:
